Transmitted herewith are forty (40) copies of a report, WTR-49, which contains a description, analysis and conclusions concerning the partial destruction of a fuel element in the Westinghouse Testing Reactor on April 3, 1960.

**REPORT ON  
WTR FUEL ELEMENT  
FAILURE APRIL 3, 1960**  
JULY 7, 1960

**REPORT ON  
WTR FUEL ELEMENT  
FAILURE APRIL 3, 1960**

FUEL ELEMENT FAILURE  
IN THE  
WESTINGHOUSE TESTING REACTOR

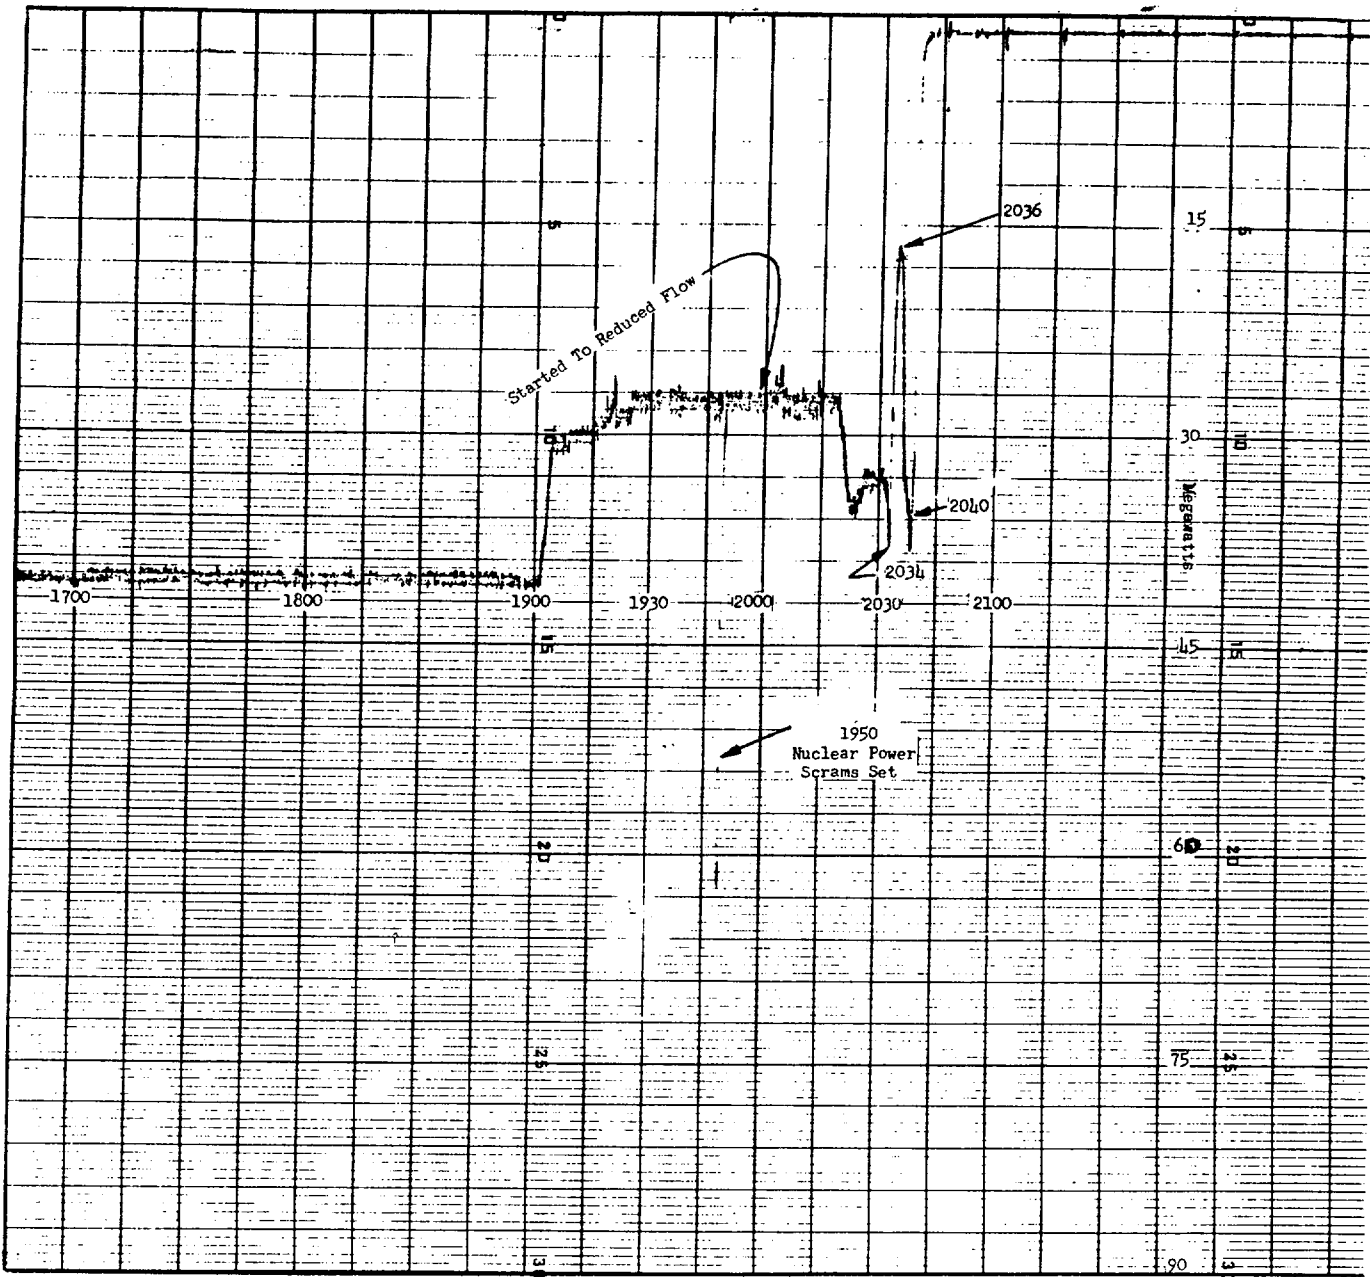
NEUTRON POWER LEVEL RECORDER CHART  
 NIGHT OF APRIL 3, 1960  
 FIGURE 1

The power reduction shown in Figure 19 at 20:34 is believed to have occurred as a result of a decrease in reactivity caused by the fuel element failure meltdown and subsequent blockage of the coolant channel. The blockage is presumed to have voided the water channels by the production of steam and bulk boiling in the failed element. A consideration of previously measured void coefficients for an element in this position would indicate a loss of 0.3 to 0.6% reactivity if all channels were voided. This reactivity loss

cannot be explained by simple bulk boiling with open channels at the top and bottom because the reactivity would then have been reinserted when boiling ceased at the reduced power level at 20:36. In addition the overall reactor temperature coefficient must have added approximately 0.18% reactivity as soon as the power level was reduced to 17 MW.

Another possible source of permanent reactivity loss is displacement of the fuel contained in the failed section of the element. An upper bound on this effect is that the worth of a fuel element in the failed position is 0.9%. This number obviously is a gross overestimate of what could have happened since the fuel element was not completely displaced from its core position. Later observation of the failed fuel element indicated a considerable amount of burnt up debris was lost from the element. That portion of the element which was severely damaged was worth about 0.6 - 0.7% in reactivity but only a small portion of this worth was lost. The total reactivity added by means of the control rod withdrawals previously described is approximately 0.6%  $\Delta k$ . Thus, the reactivity changes caused by the voiding theory and possibly by the loss of a small amount of fuel are consistent.

It is believed that the element failed at approximately the same time as it voided and later examination confirmed the melting and permanently blocking of the channel. The element remained voided after the reduction in power because of a lack of water about the blocked portion and because of the presence of steam above the blockage.

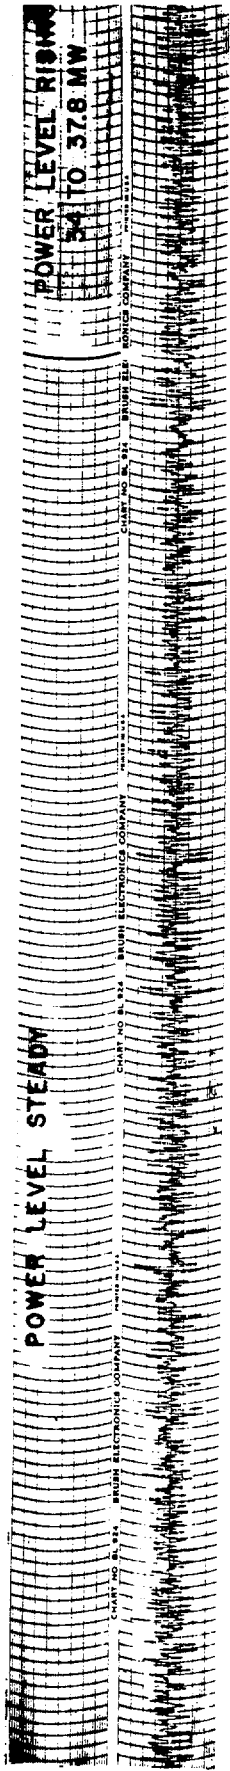
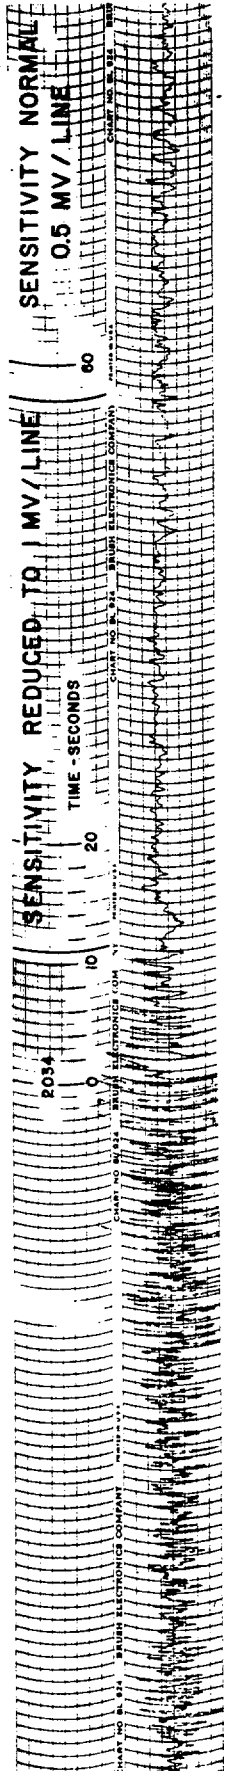
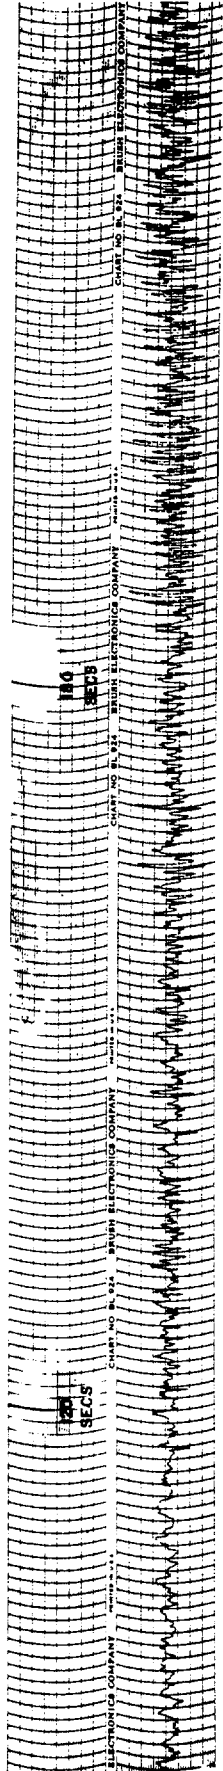
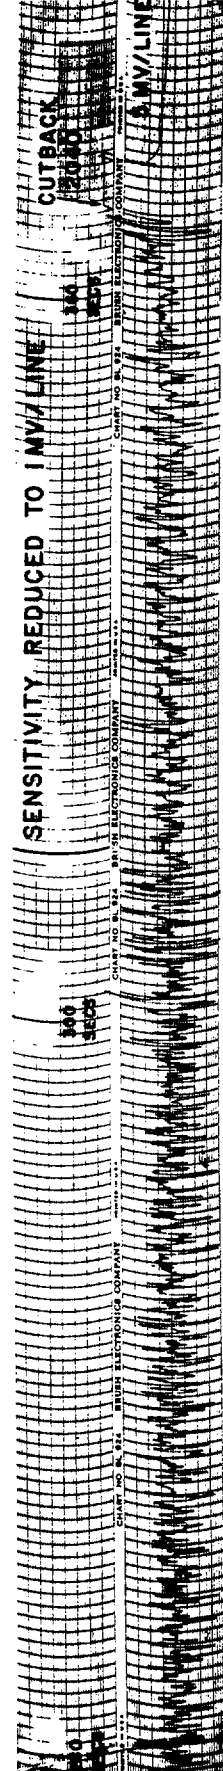
FIG. 21  
BOILING DETECTOR RECORD OF APRIL 3, 1960 DURING FUEL ELEMENT FAILURE

Figure 21 is a reproduction of the boiling detector Brush Recorder trace during the time interval under discussion. If time zero is taken at 20:34 corresponding to the first peak in power level of Figure 19, then the reduction in power level caused by the failure and voiding appears to have occurred in about eleven seconds. That a permanent block was established can be seen in that over the next three minutes the noise level remained approximately constant. Then as rod motion forced the power level back up, the boiling noise pattern increased in amplitude, but didn't quite return to the before failure amplitude when the cutback was initiated. An independent observation indicated that an alarm on top of the reactor, actuated by the radiation from the head tank went off at approximately 240 seconds on Figure 21. This further confirms the other deduction that the element failed at about 20:34 at the first power peak rather than at 20:40 the second peak in power.

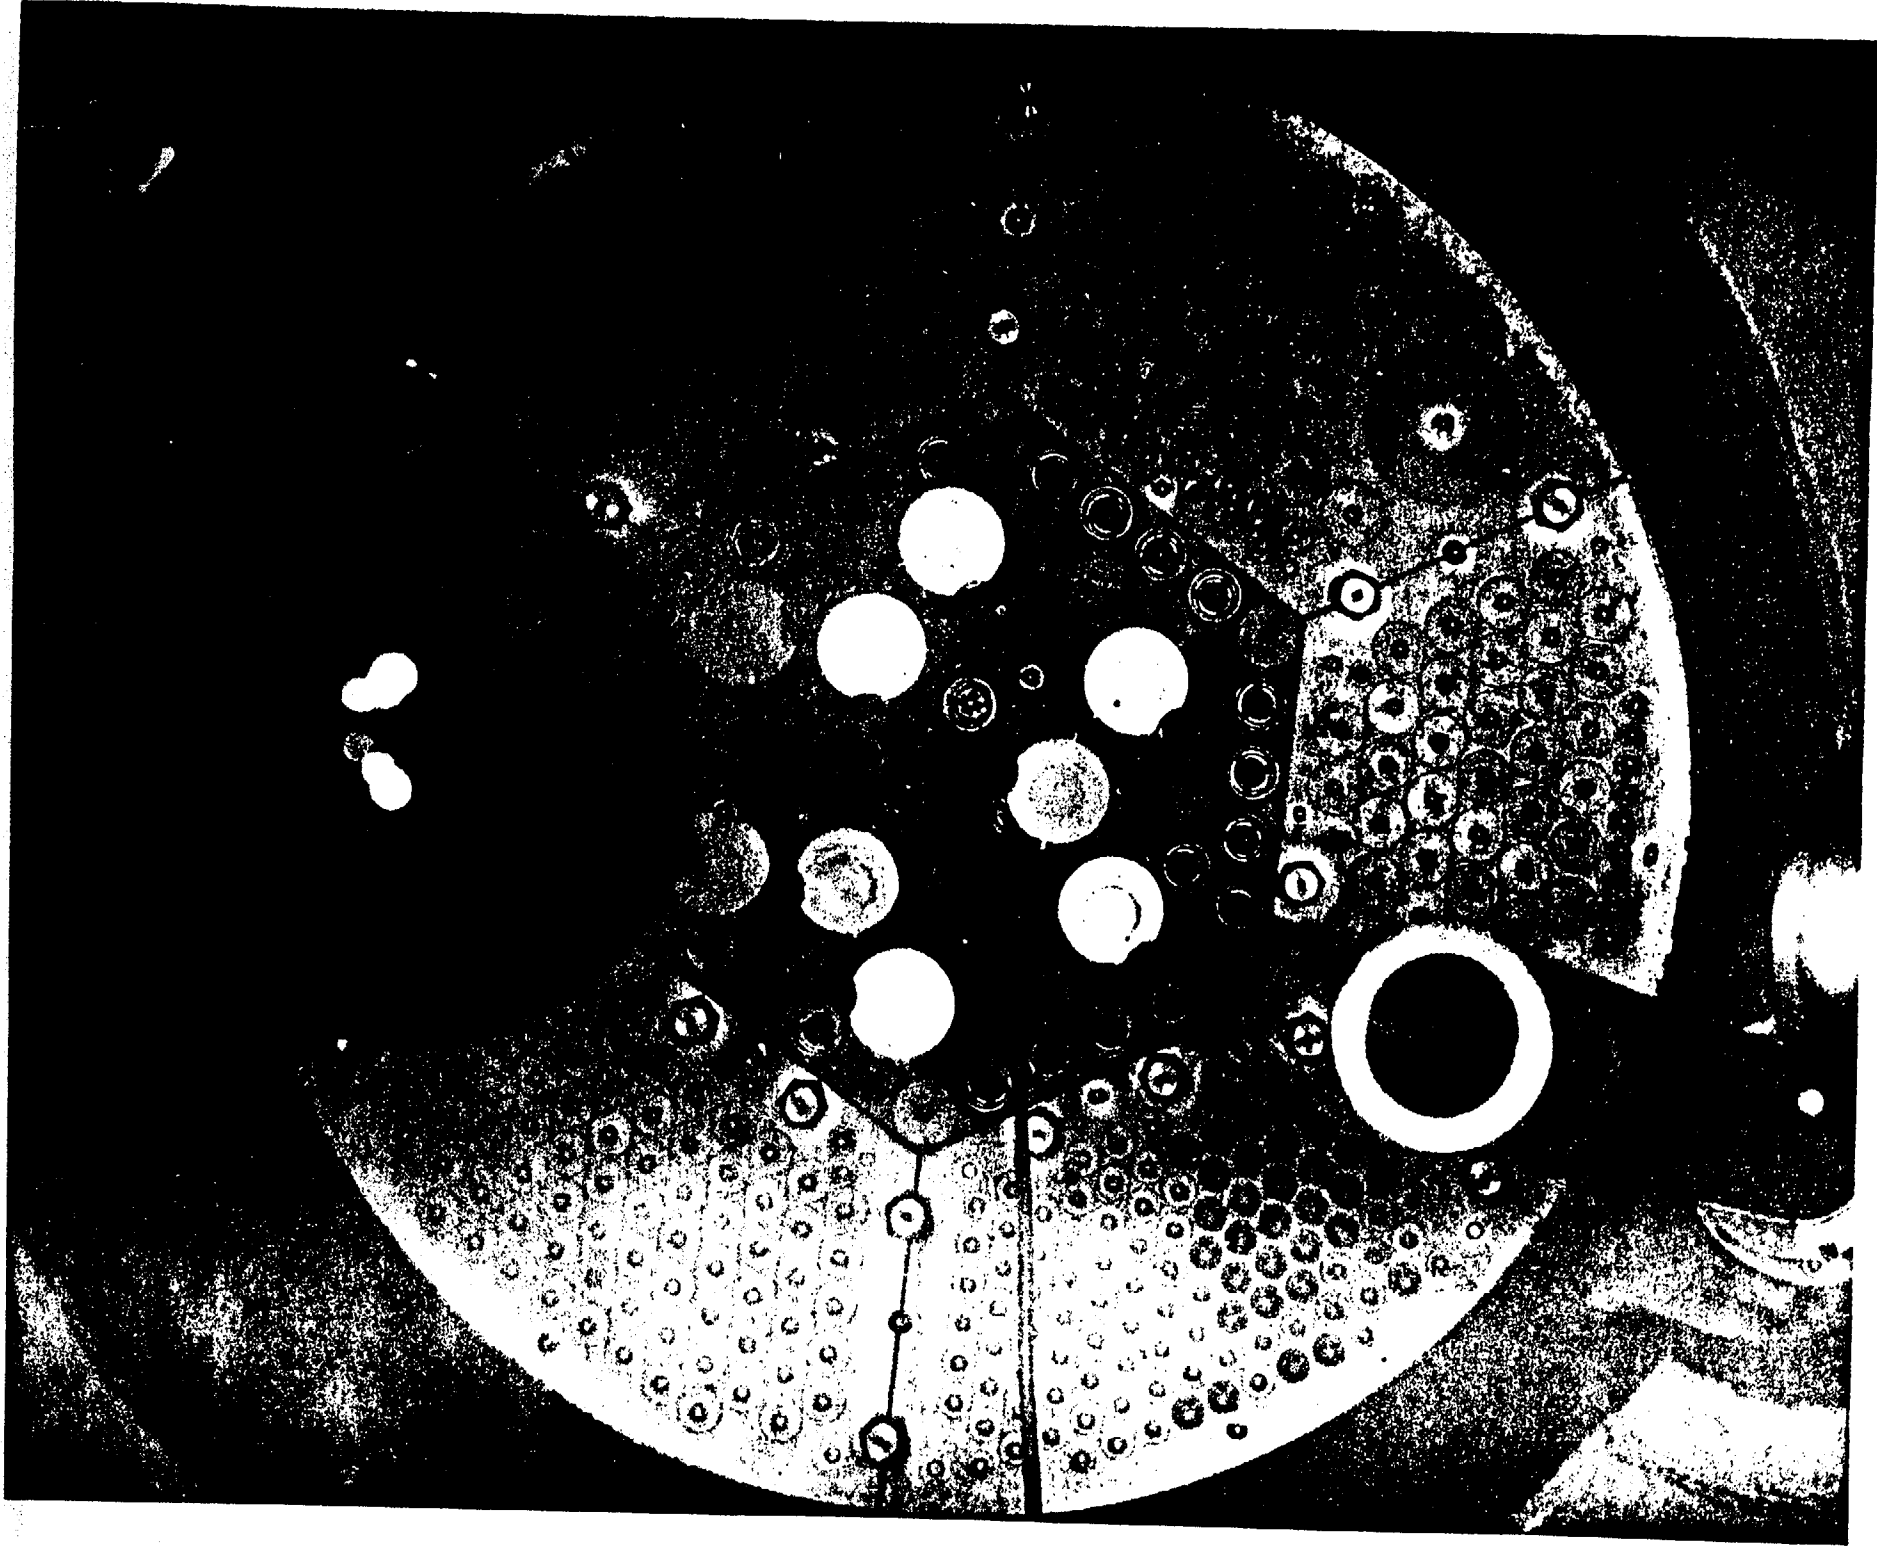
Figure 23a  
View of Core - April 11, 1960

In order to permit visual observation of the core and to begin unloading the core, a 3 inch thick iron shielding platform was constructed. This reduced the radiation level to 35 mr/hr gamma at the working level. Figure 23a shows a photograph of the core taken on April 11. No visible damage was apparent at the time.

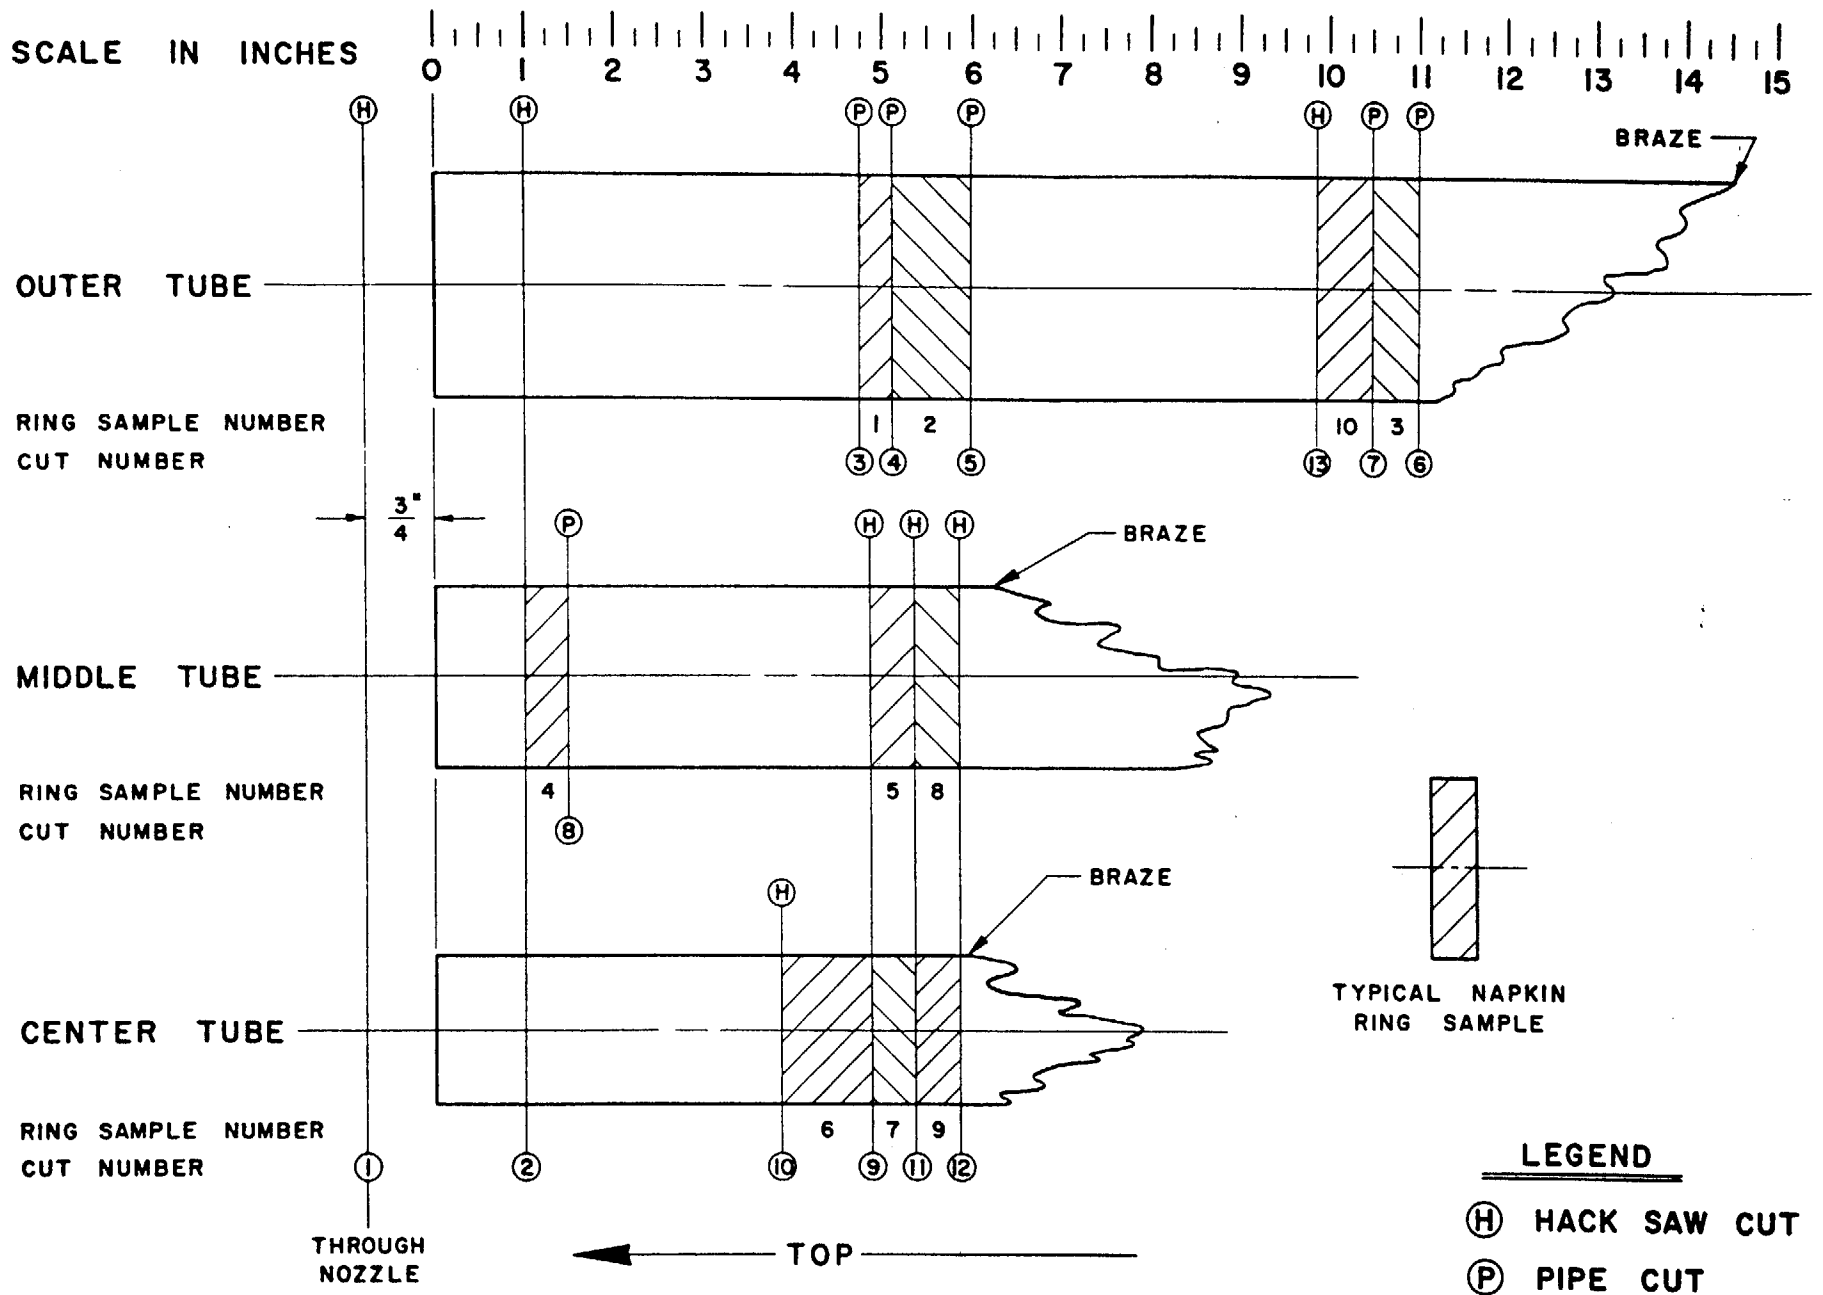
FIGURE 34  
VIEW OF FAILED ELEMENT SHOWING SECTIONING

A series of cuts were taken on these tubes. A rather surprising fact was observed that the alloy had run out between the cladding of the center tube all the way to the top portion of the meat. Figure 35 shows photographs of a section taken across this tube approximately 5-1/2 inches from its end. (The top 3 inches are dead aluminum). Although this cut was taken with a hacksaw and is as yet unpolished, it is quite evident that most of the alloy has run out. In external appearance the section seemed sound. Figure 35a is an enlargement of the lower right hand photo of Fig. 35. The small holes observed suggest inhomogeneities in the fuel or poor bonding. The other two tubes when sectioned in the same place were solid. The pattern of the melted run out in the one tube is curious and is presented in Figure 36. The funnel shaped appearance seems to indicate that the tube was hotter at the top than at the bottom, a phenomenon which might have been caused by poor bonding at the element top.

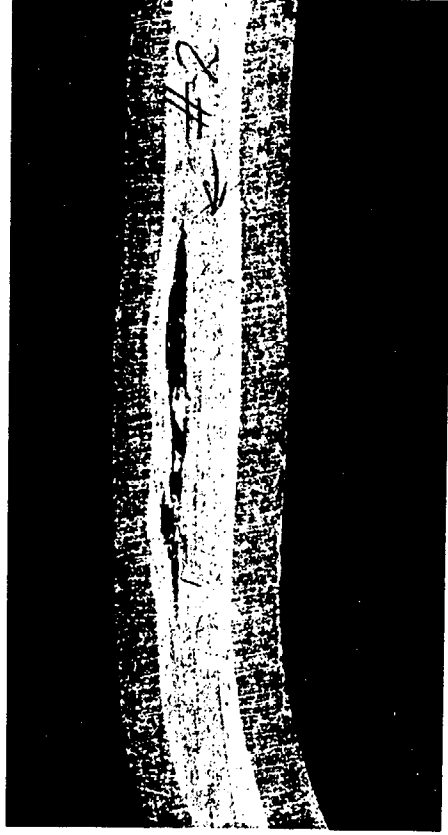
FIGURE 37  
TYPICAL ULTRASONIC TRACE WITH DEFECT PHOTO

To confirm the ultrasonic inspection method several tubes were sectioned at typical indicated flaw points in the ultrasonic record. Some of these records and the photographs of the sectioned flaws are indicated in Figures 37 and 38. The pictures by no means indicate the worst cases, but as indicated are representative. In each case of a suspected flaw the ultrasonic technique proved infallible and sectioning always produced the defect. All types of defects were discovered including poor bonding, cracks in the fuel, foreign inclusions, and voids. The conclusion reached is that the inspection requirements originally specified were not sufficiently rigid. In view of new tightened specifications this particular batch of fuel was of questionable quality, with over 1464 defects having been found, and with 133 of them over 1/2-inch in size in a sampling of 237 tubes.
