REPORT OF AIRCRAFT ACCIDENT INVESTIGATION

F - 16C
SN 87 - 0274
8th FIGHTER WING (PACAF)
KUNSAN AB, REPUBLIC OF KOREA

F - 15C
SN 78 - 0530
18th WING (PACAF)
KADENA AB, JAPAN

**REPORT OF INVESTIGATION
MID-AIR COLLISION BETWEEN
F-16C, SN 87-0274
F-15D, SN 78-0530
6 May 1994**

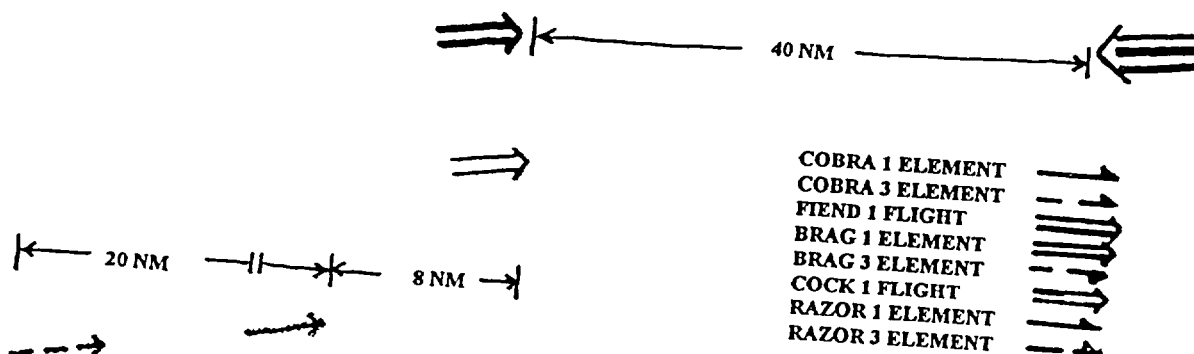
Figure 1

D.2. As the mission began, the F-16s were in the western portion of the assigned airspace in three separate groups, Brag 01 flight in the north, Fiend 01 flight in the center and Cobra 11 flight in the south. At approximately 1349, Fiend 01 flight and Brag 01 flight pushed in an easterly direction. One minute later, at 1350, the Cobras pushed from the south [VTR assessment]. As the Cobras pushed, the Cobra 11 element was approximately 20 NM ahead of Cobra 13 [Tab V-6.2]. At the same time, Razor 01 flight and Cock 01 flight committed from the east on a westerly heading in an eight-ship line-abreast formation (Figure 1) [Tab V-8.5]

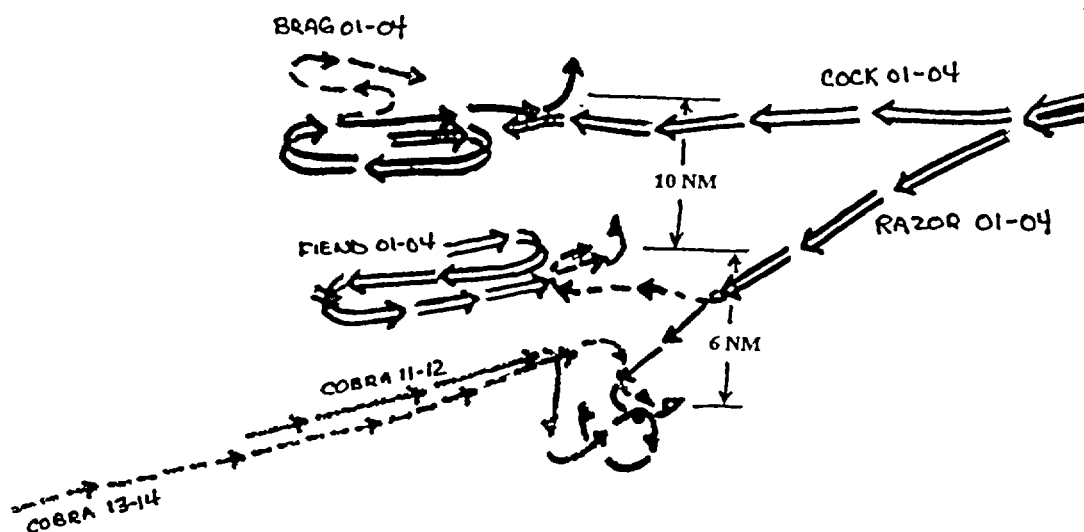
Figure 2

D.3. As Fiend and Brag flight approached within 22 NM of the F-15s (1351 hrs), Brag 01 flight and Fiend 01 flight executed a preplanned course reversal to the west with Fiend 01 flight descending to approximately 12,000 ft Above Ground Level (AGL) [VTR assessment]. The Cobra 11 element continued to the northeast with the Cobra 13 element still 20 miles in trail. At this point, Cock 01 flight and Razor 01 flight split into two separate four-ships with Cock 01 flight responsible for the northern portion of the area (against Brag 01 flight) and Razor 01 flight operating in the south (against Fiend 01 flight and Cobra 11 flight) [Tab V-2.7]. At approximately 1352, Cobra 11 turned right to south, setting up to make his HARM shot timing correct. Approximately 2 minutes later, Cobra 11 element turned back left to the northeast to take a HARM shot, but, feeling threatened by Razor 01 element, took his shot early (1354:30) and maneuvered defensively in a right turn back to the south and then west [VTR assessment]. Meanwhile, Cock 01 flight and Brag 01 flight engaged in fights to the north with mutual shots exchanged. At the same time, noting on the radar that Fiend 01 flight turned back to the east and descended to 3000 ft AGL, the Razor 03 element split from the Razor 01 element, and took up a northwesterly heading to engage Fiend 01 flight (approximately 5 NM to the north, and heading northeast) [Tab V-1.6, 2.7, 2.9]. After Razor 03 split from Razor 01, the Cobra 13 element engaged the Razor 01 element with mutual shots exchanged. Meanwhile, the flight path of the Cobra 11 element took them approximately 2 NM west of this engagement and then to the north as they supported the Cobra 13 element (Figure 2). Cobra 11 flight, and Razor 01 element terminated the engagement in the south, while Brag, Fiend, Cock, and Razor 03 terminated their engagements in the north [VTR assessment]

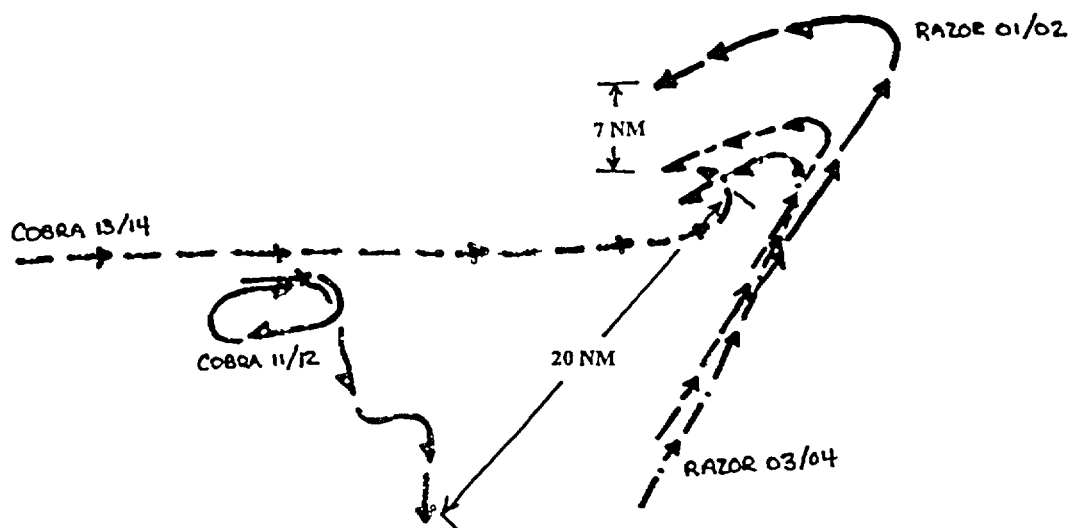
Figure 3

D.5. While the northern fighters were resetting their fight, and Razor 01 flight was rejoining and setting up at their reset point, Cobra flight was maneuvering for subsequent HARM shots, still to the southwest of Razor flight (Figure 3). The Cobra flight did not reset. Cobra 11 turned right to the northeast for his second HARM shot at 1400:15 hrs, and then executed a right 360 degree turn and set up for Cobra 12 to take his HARM shots. Cobra 12 took two HARM shots (at approximately 1402 hrs) and the Cobra 11 element maneuvered right to south and then left to northeast following their shots (Figure 3) [VTR assessment].

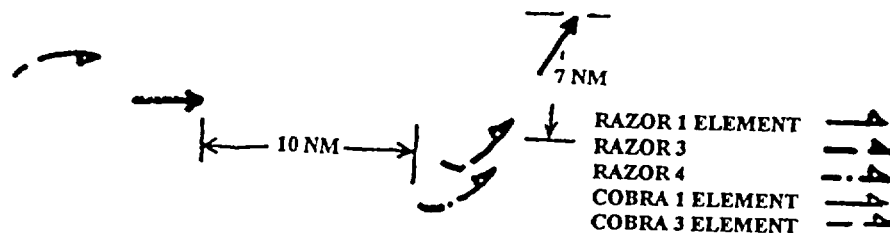
Figure 4

D.6. Meanwhile, as Cobra 11 took his second HARM shot, Cobra 13 element passed north of Cobra 11, heading east, in pursuit of Razor 01 flight [Tab V-4.11, VTR assessment]. Razor 01 element and Razor 03 element had rejoined into a seven mile trail and had turned northeast toward their western reset point (Figure 4) [VTR Assessment]. As Razor 01 flight prepared to turn southwest in their reset area (cold in their reset CAP), the Cobra 13 element prepared to engage [Tab V-6.5]. Cobra 11 element was approximately 20 NM to the south-southwest (Figure 3).

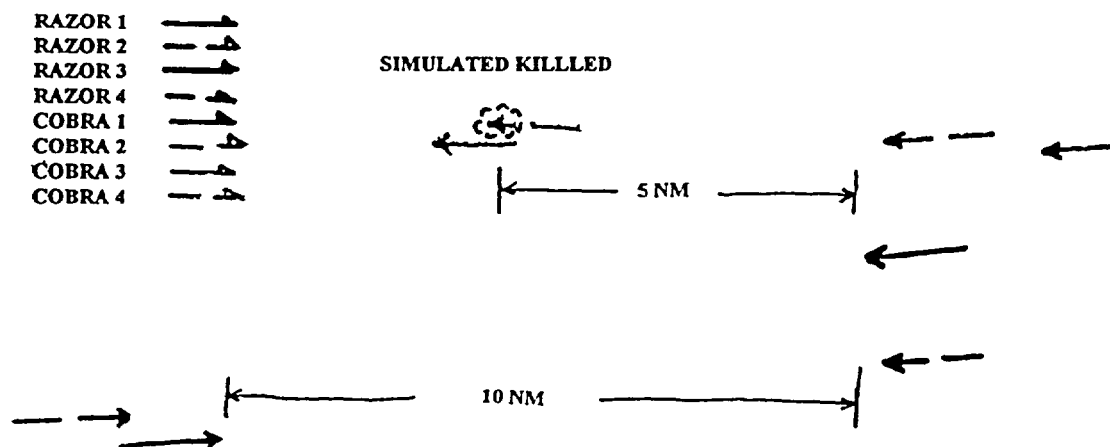
Figure 5

D.7 As Razor flight turned southwest, with Razor 01 element approximately 7 NM north of Razor 03, Cobra 13 engaged Razor 03 element, while Cobra 14 split to the north (approximately 6-7 miles initially) to engage the Razor 01 element. Cobra 13 and 14 both called tally on four eagles during this engagement, but Cobra 11 did not acknowledge hearing either call, and assumed an unknown number of Eagles in each group [Tab V-4.12]. Mutual shots were exchanged during this engagement, after which the Cobra 13 element departed the fight to the west, and then southwest, as they attempted to reestablish visual mutual support. Cobra 14 believed he had been simulated killed [Tab V-6.6]. Razor 01 called for a terminate and disengaged to the southwest, with Razor 02, 03, and 04, near line abreast and in front of Razor 01 (Figure 5) [Tab V-1.4, 2.8, 3.6]. Razor 01's terminate call was not acknowledged by Brigham or relayed to Cobra 11 flight [Tab N-1]. At the terminate call, Cobra 11 was still approximately 6 miles southwest of this engagement, flying towards it at 30,000 ft AGL [VTR assessment].

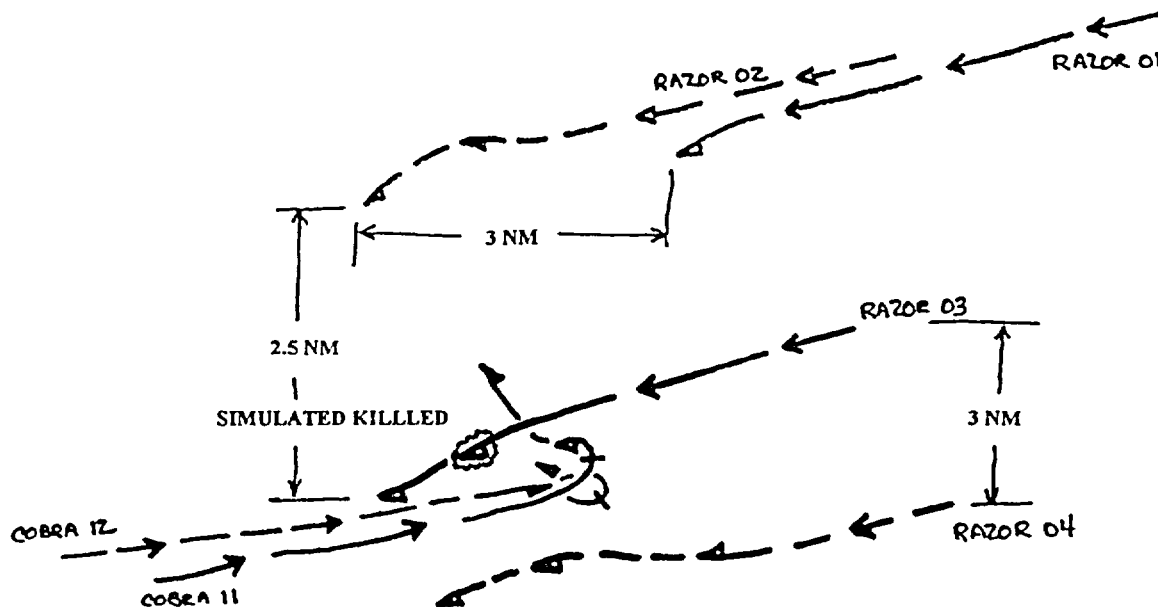
Figure 6

D.8. At approximately 1407 hrs the Cobra 11 element engaged Razor 01 flight. Cobra 11 saw Razor 03 heading southwest at approximately 20,000 ft, and began a steeply descending left hand turn to engage Razor 03. As he descended from 30,000 ft to engage, Cobra 11 gained sight of Razor 02, approximately 2 1/2 miles to the north of Razor 03's position. Cobra 11 testified that he was confident he had tally on all flight members in the area, thinking he had engaged the southern two-ship [Tab V-4.14] In reality, he had engaged the entire four-ship, but saw only two aircraft in that flight. Cobra 12 delayed slightly to clear the outside of the formation, and then followed Cobra 11 in a spiraling right hand turn which put him approximately 1.5 miles in trail, slightly offset, behind Cobra 11 [Tab V-5.7]. Cobra 11 took an unobserved radar missile shot on Razor 03, from approximately 2.1 NM in trail and called a kill on an F-15 in a left-hand turn (Figure 6) [Tab N-2, V-4.16]. Because of another kill shot being called by Brag flight in a northern engagement, Brigham did not understand Cobra 11's call and asked him to repeat it [Tab N-2] The kill call was never relayed to Razor flight [Tab N-1] Note: at the time Cobra 11 made his kill call, there were no F-15s in a left turn [Tab V-5.7, 5.9, 5.10, AA-1.2]

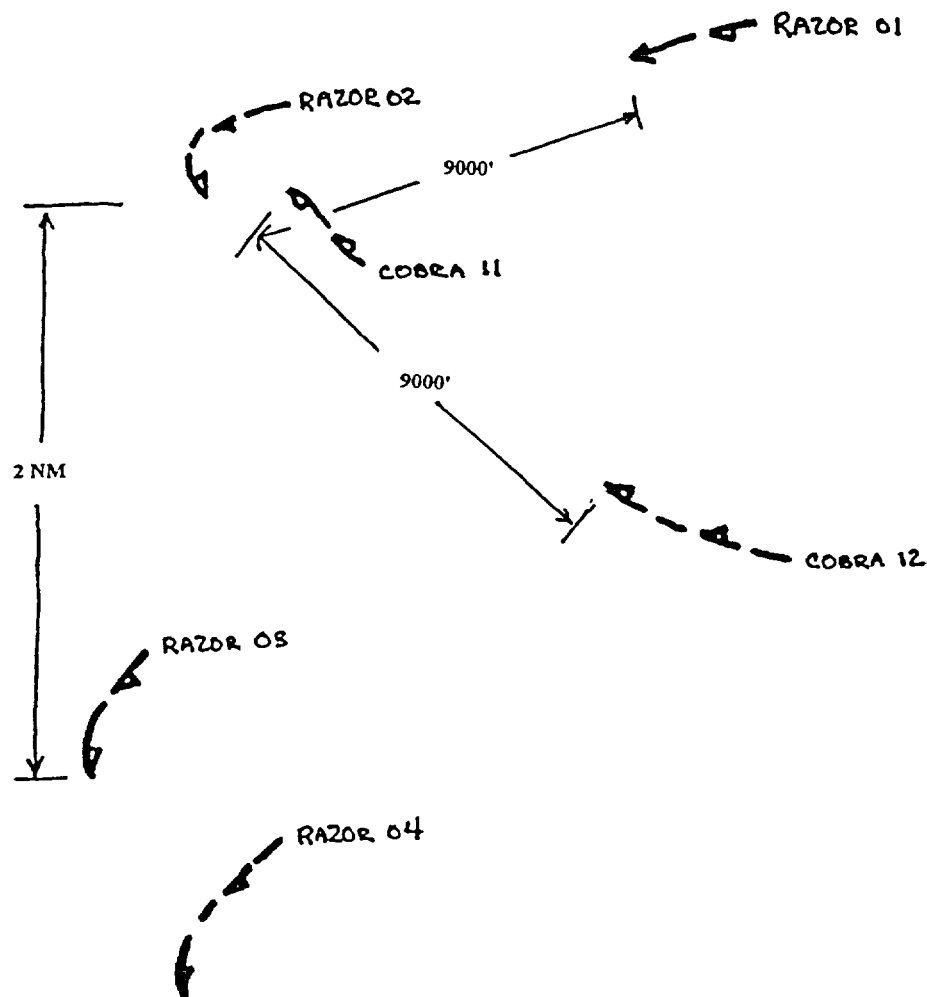
Figure 7

D.9. As Cobra 11 made his kill call on an F-15, he maneuvered his aircraft approximately 50 degrees to the right (heading 300 degrees), in pursuit of Razor 02 [Tab V-4.46, VTR assessment]. However, unknown to Cobra 11, Razor 01, approximately 2 NM northeast of Cobra 11 (at Cobra 11's 2 O'clock position), picked up the tally on Cobra 11 and called engaged. At the same time Razor 02 also gained sight of Cobra 11 and began a hard left-hand defensive turn, and expended flares. At 1407:45, Razor 02 and Cobra 11 passed each other in a left-to-left high aspect pass [Tab V-1 5, 1 13, 4.16, 4.19, 4.41] Meanwhile, the Razor 03 element began an

easy 180 degree left-hand climbing turn maneuvering back toward the expected threat axis (northeast), as yet unaware of the presence of Cobra 11 and 12 (Figure 7) [Tab V-2.15].

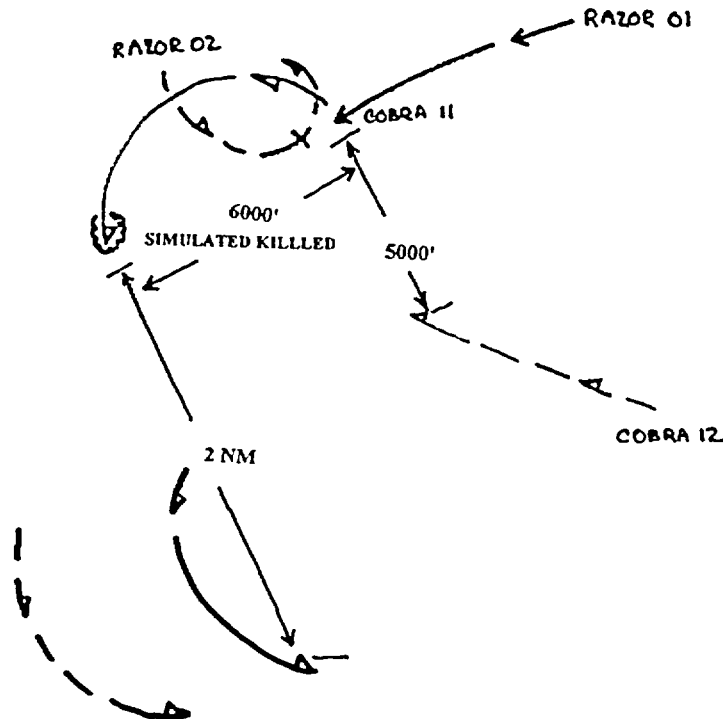
Figure 8

D.10. As Razor 02 and Cobra 11 passed, approximately 2000-3000 ft apart, Razor 02's testimony and Razor 02's videotape indicate Razor 02 began a deeply descending left spiral [Tab V-1.5, AA-1.2]. However, according to Cobra 11's testimony, Razor 02 rolled out to the southwest, in an extension maneuver, and, after Cobra 11 completed a slight left pitch-to-slice maneuver he rolled out approximately 9000 ft in trail [Tab V-4.19, 4.41, 4.42]. Meanwhile, Razor 03 and 04 were approximately 2-3 miles to the south in a left hand turn back to the northeast [Tab AA-1.3]. At 1407:52, as Cobra 11 completed his pitch-to-slice maneuver, Razor 01 positively identified Cobra 11 as a bandit and called a simulated kill (Figure 8) [Tab N-1]. This kill was not acknowledged by Brigham and was not passed to Cobra 11 flight. In addition,

Razor 01's kill call specified an F-16 at 28,000 ft, whereas Cobra 11 was actually at approximately 19,000 ft [Tab N-1, N-2].

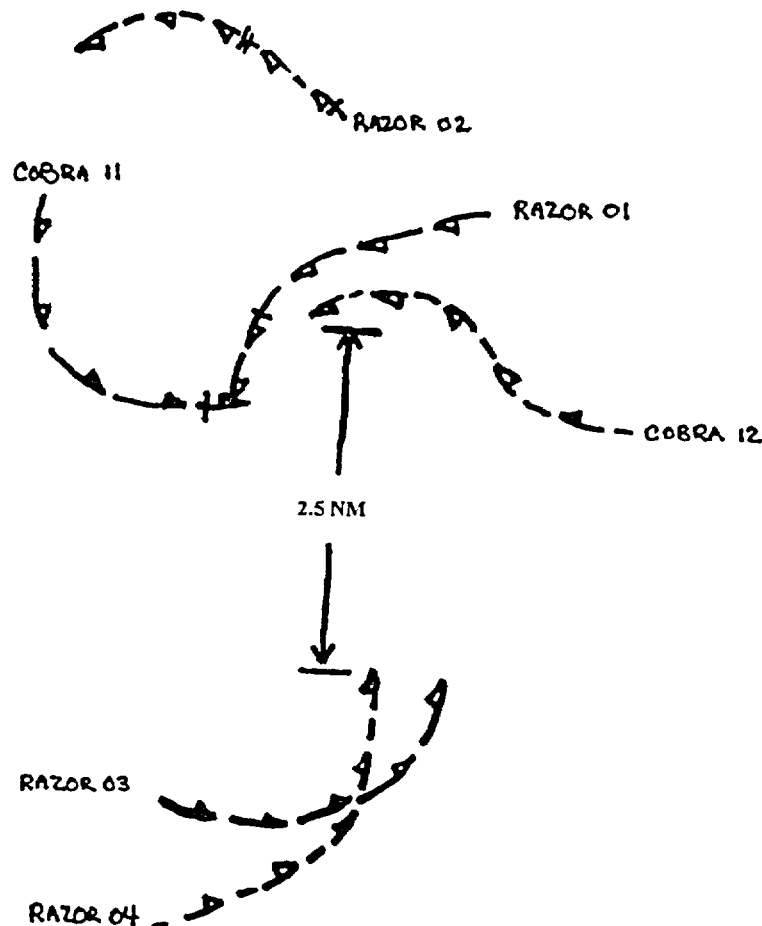
Figure 9

D.11. Cobra 12 observed Razor 01 attacking Cobra 11 and, at 1407:54, called for Cobra 11 to break defensively to the left [Tab N-2]. Cobra 11 began a hard left turn, which he testified was approximately 90 degrees of bank, and 10 degrees nose low, while Cobra 12 maneuvered to the right and then back to the left to attack Razor 01 [Tab V-4.20, 4.21, VTR assessment]. At the same time, from the northeast, Razor 02 saw Cobra 12 attacking Razor 01, and called for Razor 01 to react defensively to the left (1407:56). Razor 01 began a left turn and dispensed flares [Tab V-1.16]. Razor 02 continued his left turn, low and to the northeast of the fight [Tab V-1.5]. Razor 04 saw the fight approximately 3 NM to the north and maneuvered Razor 03 element left to point toward Cobra 12 from the South [Tab N-1, VTR assessment]. Cobra 11 continued in a left turn and testified that he gained sight of Razor 01 after about 40 degrees of turn, when Razor 01 was approximately 4000 ft away from Cobra 11, with his nose pointed slightly aft of Cobra 11's aircraft. Cobra 11 further testified that, at that point, it appeared Razor 01 would pass approximately 1000 ft behind and slightly above him [Tab V-4 21]. Cobra 12 engaged Razor 01 from behind at a distance of approximately 3,000 ft., attempting to maneuver for a gun shot but stopped his shot attempt as he perceived a closure problem developing between Razor 01 and Cobra 11, approximately 2 seconds prior to impact [Tab V-5 12]. Cobra 11 testified that at 2,000 ft Razor 01's aircraft appeared to move to pure pursuit -

- pointing right at Cobra 11's aircraft [Tab V-4.21]. Cobra 11 further testified that he initiated a negative G-maneuver, pushing the nose of his aircraft down, to avoid a collision as Razor 01 closed to a range of approximately 1500 ft. Cobra 11 and Cobra 12 testified that Razor 01 initiated a roll out of the left turn approximately 1,000 ft prior to impact [Tab V-4.21, 4.42 through 44, 5.14]. Two seconds later, Cobra 11 and Razor 01 impacted (1408:08) at approximately a 90-110 degree heading crossing angle [Tab V-4.21, 5.14] (Figure 9)
