**SUMMARY OF FACTS AND STATEMENT OF OPINION  
F-16 MID-AIR ACCIDENT  
7 JAN 98**

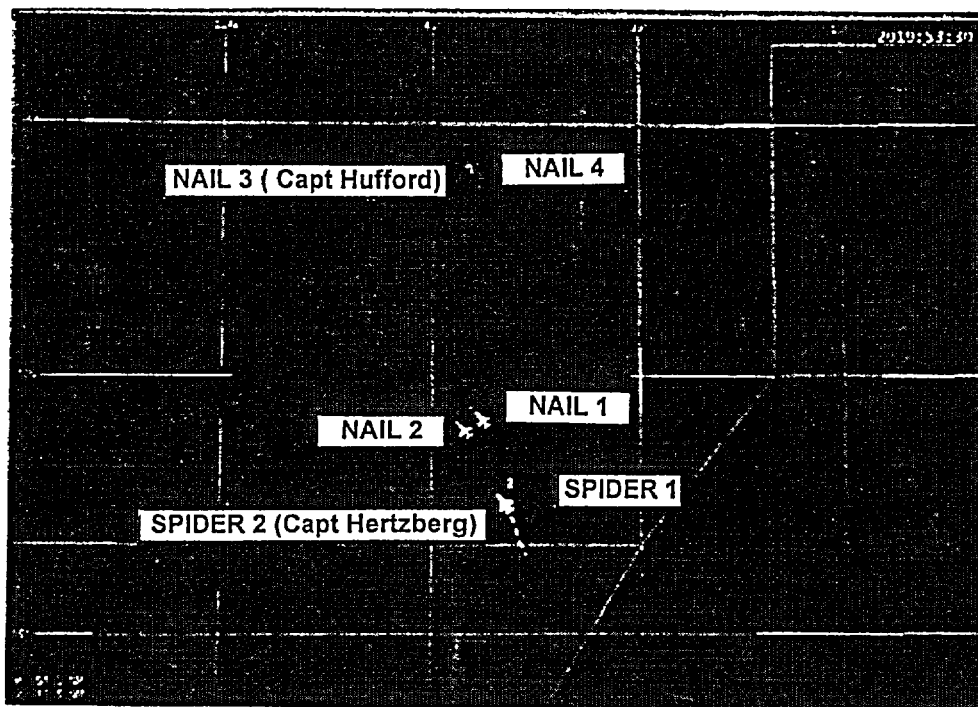
FIGURE 1 (ABOVE) - 20 NAUTICAL MILES (NM) APART

(4) The mishap intercept began with Nail 3 and 4 in the north. Nail 1 and 2 and Spider 1 and 2 were in the south (Tab Z-3) (see fig. 1 and 2 on pg. 2). The four ship target presentation was two groups with a five mile range split in the 25,000-29,000 (ft) block and wingman in a line abreast formation. Nail 1 and 2 were in the front of the presentation in the high part of the block and Spider 1 and 2 were the trailing group in the lower half of the 25,000-29,000 block. The wingmen, Nail 2 and Spider 2, were located on the west side of the formation and both groups, as per the coordination brief, were non-maneuvering on a heading of 320 degrees (Tab V-5.7, Z-3, and N-10) (see fig. 1 and 2 on pg. 2).

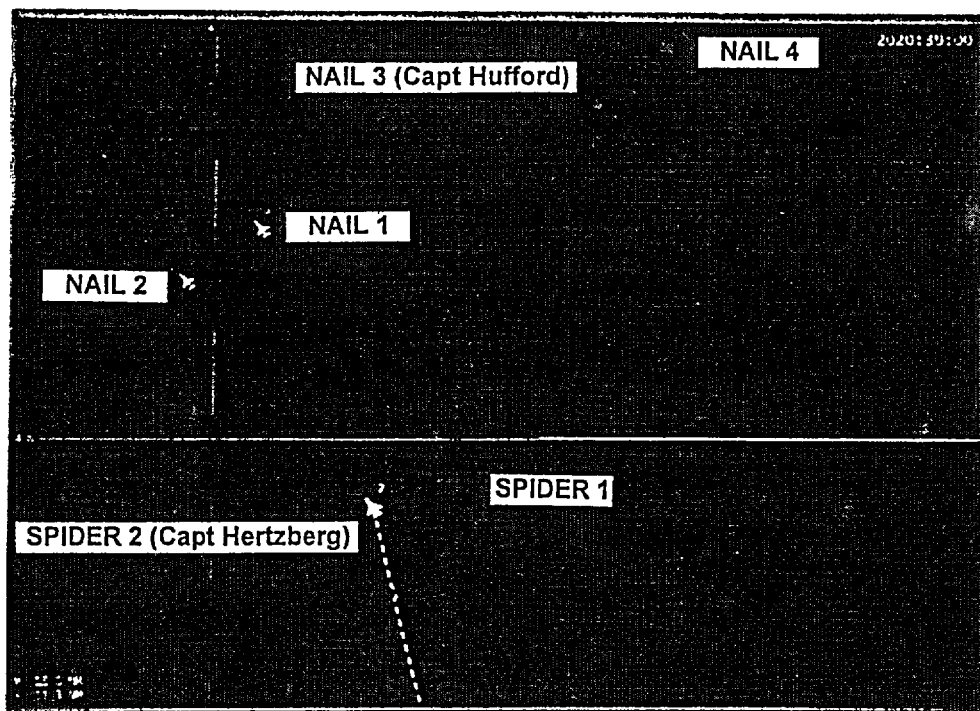
FIGURE 2 (ABOVE) - 7.6 NAUTICAL MILES (NM) APART  
SPIDER 2 (CAPT HERTZBERG) TALLY 2 (SAW NAIL 3 & 4) RADIO CALL

(6) As the intercept began, Clover (GCI) accurately portrayed the red-air formation and Nail 3, in accordance with the prebriefed plan, used his radar to monitor the movement of the lead group (Nail 1 and Nail 2). Because of the red-air formation and Visual Identification (VID) situation required prior to shooting, Nail 3 (Capt Hufford) and Nail 4 had to bypass the lead group and engage the trail group (Tab V-3.10 thru 3.11). At 10 miles from the lead group, Nail 3 (Capt Hufford) told his wingman to monitor the trail group with his radar (Tab N-5). About the same time and just prior to losing radar contact of the lead group off the right side of his (Capt Hufford) radar scope, Nail 3 (Capt Hufford) told Clover (GCI) to monitor the lead group (Tab N-5) (see Fig. 2, on pg. 2).

(7) When Spider 2 was 7.6 miles away from Nail 3, Spider 2 (Capt Hertzberg) obtained the tally (visual sighting) on both Nail 1 and 2 (Tab Z-7 and N-11). Shortly after this, Spider 1 called tally two (Tab N-11). As per the coordination brief, Spider flight was required to have tally-two and 3/9 o'clock passage (passing the wingline) before they could react (Tab O-30) (see fig. 2 on pg. 2).

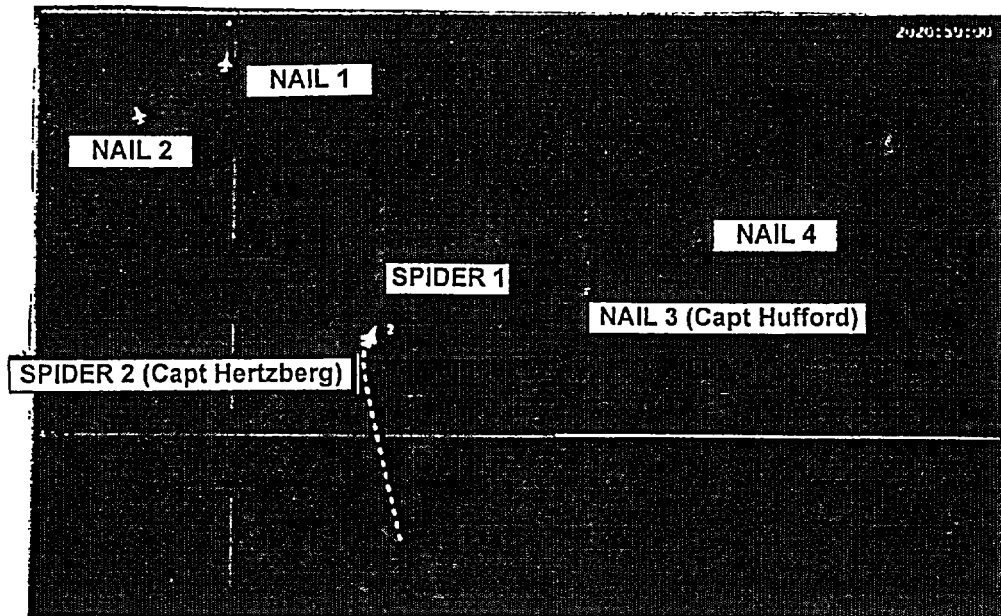
FIGURE 3 (ABOVE) - 3.5 NAUTICAL MILES (NM) APART  
NAIL 3 (CAPT HUFFORD CONVERTING - CLIMBING RIGHT TURN)  
SPIDER 2 (CAPT HERTZBERG - HARD DESCENDING RIGHT TURN)

(8) At 5.6 miles from Spider flight, Nail 3 (Capt Hufford) called "engaged" and told his wingman to deploy to the prebriefed weapons employment zone (wez)-in-depth (1.5 to 3.0 NM trail) formation (Tab Z-8 and V-3.11). Nail 3 (Capt Hufford) then began his conversion to intercept (right turn) and identify Spider 1 and 2 flight. As Nail 3 (Capt Hufford) passed Spider flight's 3 o'clock position (4.5 miles away), Spider 1 directed Spider flight to break right (turn hard to the right) (Tab Z-10). At the time of the hard right break turn, Spider 1 and 2 testified that they saw both Nail 3 and 4. Also, Nail 3 (Capt Hufford) saw both Spiders (Tab V-1.6, V-3.11, V-5.7). The Spiders began the break turn from a line abreast formation and as a result of the maneuver (approximately 90 degrees), Spider 2 (Capt Hertzberg) was now 5,600 feet in trail of his flight lead, Spider 1. During this maneuver Spider 2 lost altitude and left his altitude block (below 25,000); however, he saw both members of the opposing flight. Both flights (Nail 3-4 and Spider 1-2) were now high aspect (approximately 180 degrees) to one another (head-to-head) and remained head-to-head until the mishap occurred. (Tab Z-11) (see fig. 3 and 4 on pg. 3).

Spider 2 (Capt Hertzberg) began a climbing turn to the right in an attempt to pass to the south of Nail 3 (Capt Hufford); i.e., Spider 2 (Capt Hertzberg) maneuvered right in an attempt to lag Nail 3's expected flight path (Tab V-1.6). Spider 2 (Capt Hertzberg) testified that he was just outside of 1.5 miles from Nail 3 (Capt Hufford) when he started this maneuver to the south (Tab V-2.4). By doing this, Spider 2 (Capt Hertzberg) put Nail 3 (Capt Hufford) under his nose and out of view. Just prior to this, Spider 2 (Capt Hertzberg) thought he saw Nail 3 (Capt Hufford) in a climbing right hand turn. Since Spider 2 (Capt Hertzberg) was focusing his attention on taking his shot (simulated) on Nail 4, he may have not recognized that Nail 3 (Capt Hufford) who was directly in front of him, had reversed his turn direction to the left. Spider 2 (Capt Hertzberg) testified that he anticipated that Nail 3 (Capt Hufford) would continue turning right. At the start of Spider 2's (Capt Hertzberg's) maneuver, Air Combat Maneuvering Instrumentation (ACMI) data shows that Spider 2 (Capt Hertzberg) was 5 degrees nose low and in 48 degree right bank. ACMI lost track of Spider 2 (Capt Hertzberg) when he was 1.9 miles from Nail 3 for about 0.6 NM. However, when ACMI regained track on Spider 2 (Capt Hertzberg), the track was a zero filter (excellent) ACMI track. Even though the zero track was only for a moment the data was reliable and accurate. The track then converted to a one filter track, which is still good data with some positional drift [i.e., the aircraft attitude (bank angle/pitch) airspeed, Gs, etc are still good] (Tab V-19.3, Z-2.2). At the zero filter track, Spider 2 (Capt Hertzberg) was 1.3 NM from Nail 3 (Capt Hufford), who was also on a zero filter track. ACMI showed that Spider 2 (Capt Hertzberg) had only changed his heading by two degrees from 1.9 NM to 1.3 NM and now he was in a left hand turn; i.e., he had reversed his turn directly towards Nail 3 (Capt Hufford). The ACMI also showed, that Spider 2 (Capt Hertzberg) had lost 213 feet of altitude during his maneuver (Tab V-2.3 and Z-20 thru 26.1). Capt Hertzberg testified that after leveling off from his initial turn away from Nail 3 (Capt Hufford), he started a bank to the left and a slight unload to check Nail 3's position (Tab Z-25, Z-25.1). This fact is substantiated by ACMI with Spider 2 (Capt Hertzberg) in a 35 degree left bank (Tab Z-25, Z-25.1) (see fig. 3 and 4 on pg. 3).

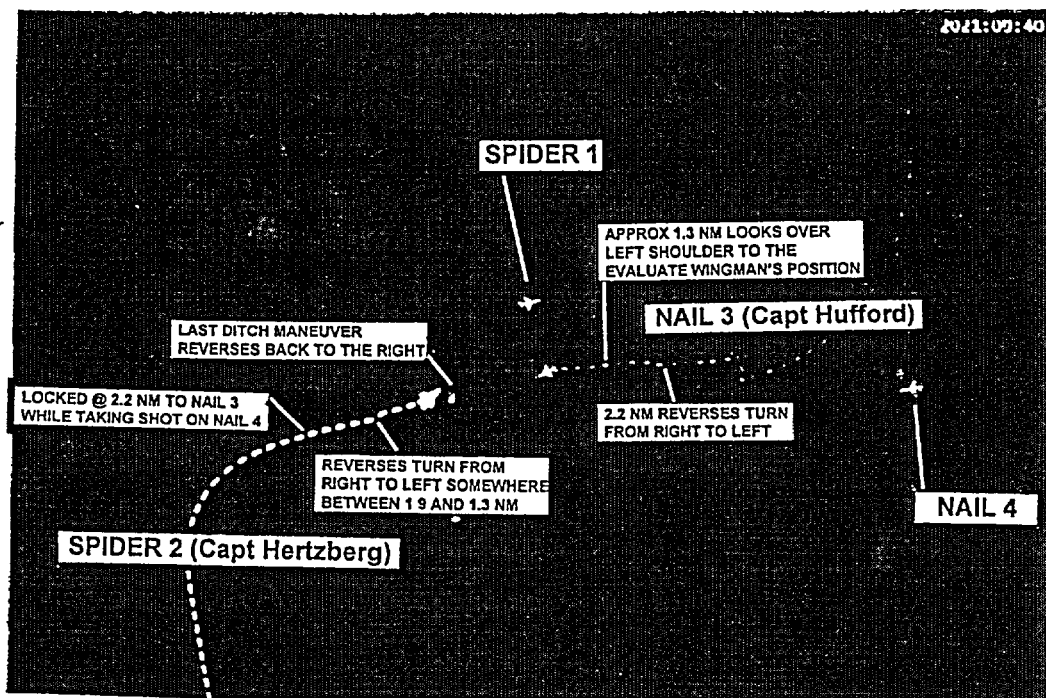
FIGURE 4 (ABOVE) - APPROXIMATELY 4300 FEET APART  
NAIL 3 (CAPT HUFFORD CLIMBING LEFT BANK)  
SPIDER 2 (CAPT HERTZBERG - DESCENDING LEFT BANK)  
SPIDER 2 (CAPT HERTZBERG) JUST STARTING TO REVERSE TURN TO THE RIGHT

(11) Spider 2 (Capt Hertzberg) continued to bank slightly nose low to the left, and was looking left (9-10 o'clock) for Nail 3 (Capt Hufford). Spider 2 (Capt Hertzberg) was maneuvering his aircraft towards Nail 3 without seeing him. ACMI showed Nail 3 (Capt Hufford) was slightly low and directly in front of Spider 2 (Capt Hertzberg) (Tab Z-26, Z-26.1) (see fig. 4 on pg. 3).

(12) Nail 3 (Capt Hufford), after aborting his attempt to lock Spider 2, noticed that there was no line of sight movement in the HUD (meaning that they are on a collision course) (Tab V-3.12). Nail 3 (Capt Hufford) testified that he "basically froze" because he thought if he maneuvered hard left or right, it may have matched Spider 2's (Capt Hertzberg's) collision avoidance maneuver. Capt Hufford's (Nail 3) continued testimony adds, "About two-seconds prior to impact, I realize he is not doing anything and there is absolutely no line of sight in my HUD. So at that point I roll to about a 120 degrees of bank (to the left) and I see basically the belly of his aircraft, his centerline bag passes over my head" (Tab V-3.13) (see fig. 4 on pg. 3).

(13) As Spider 2 (Capt Hertzberg) regained the tally on Nail 3, he expected to see Nail 3 (Capt Hufford) going by to the north (left side), instead, he "saw an F-16 coming straight uphill at me" (Tab V-1.7). Spider 2 (Capt Hertzberg) saw the imminent collision and reacted by selecting full afterburner and "pulling as hard as I could (to the right)" (Tab V-1.7). By turning right, Spider 2 (Capt Hertzberg) reversed his turn and ended up moving in the same direction as Nail 3's last-ditch collision avoidance maneuver (see fig. 4, pg. 3).
