# ***Nuclear & Environmental Operations***

## ***Davis Besse Reactor Vessel Head Examination***

BWXT Services, Inc.

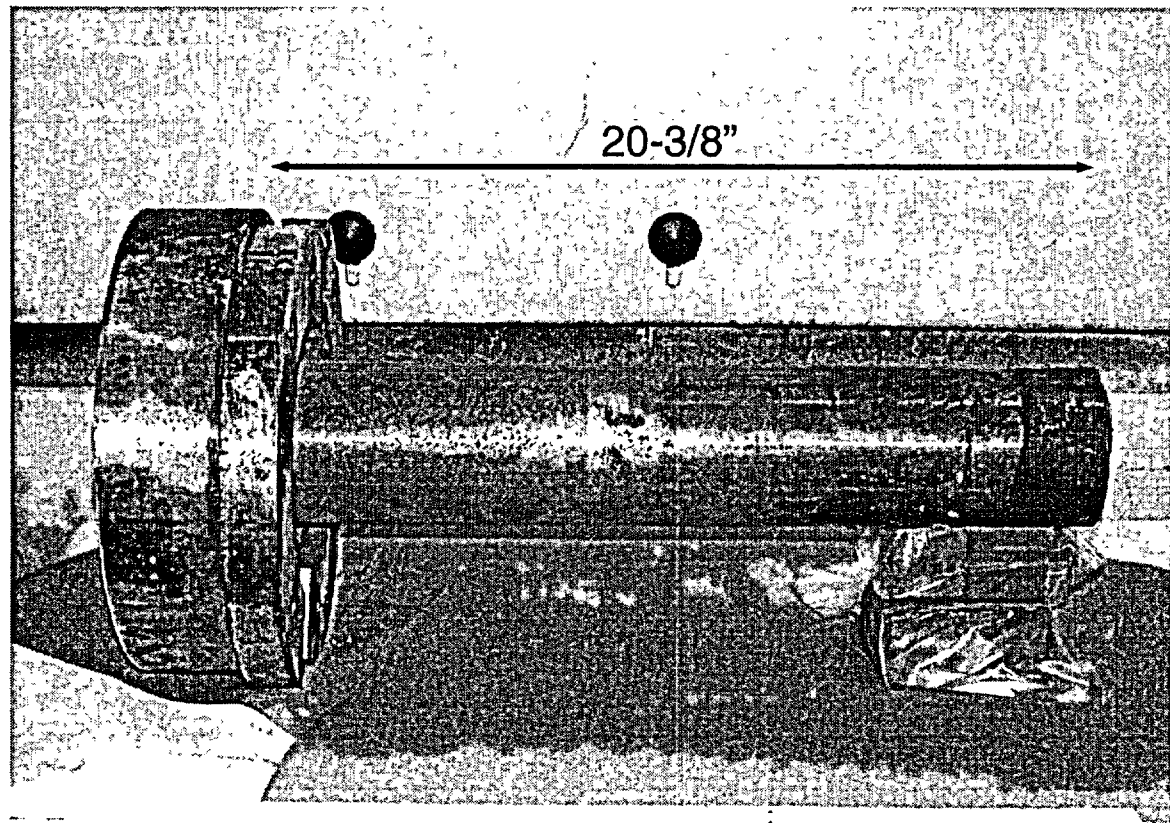
## Nozzle 2 – Side View

~7-5/8" Bored Away During Removal

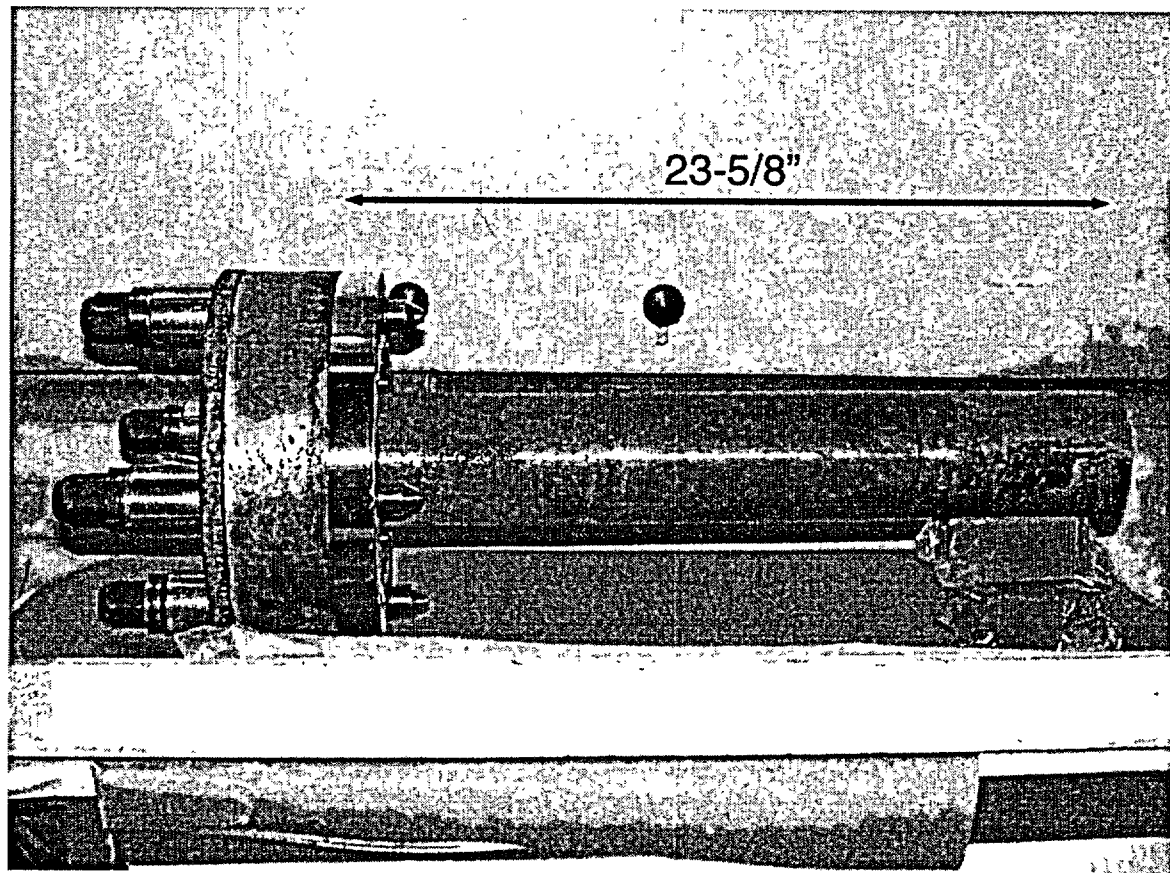
## ***Nozzle 3 – Side View***

~4-1/2" Bored Away During Removal

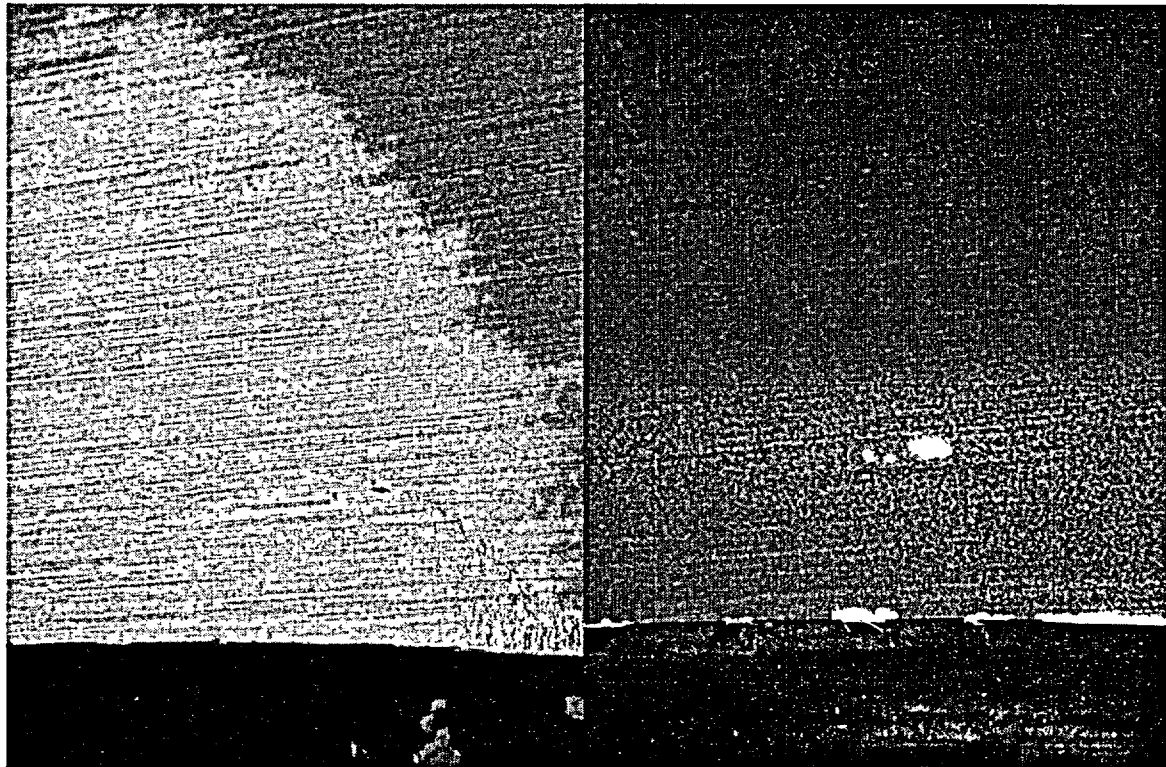
# ***Penetrant Test – Cuts #1, #2, & #3***

**Small void near nozzle 11 J-weld root (Cut #3). No evidence of cladding disbond on any cut surfaces.**

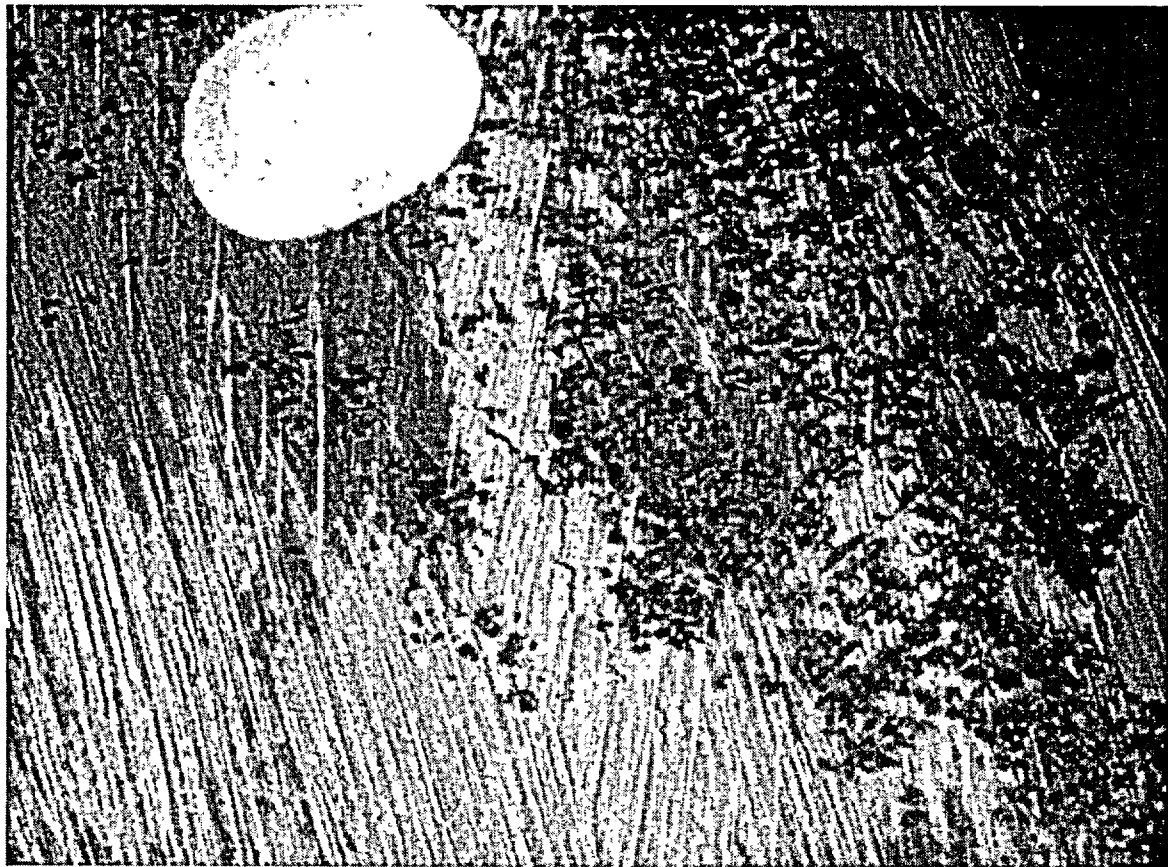
## ***Nozzle 3 J-Weld Cracking***

**Circumferential cracks on RCS side of nozzle 3 J-weld  
between 0° and 45°. 6X**

- Examine J-Weld Cracks (Axial at 10° and 180°; Circumferential at 0°- 45°) by Metallography/ Microhardness (Depth and Morphology)
- Open Portion of a J-Weld Crack for SEM/EDS
- Examine Nozzle 3 Cracking by Metallography/ Microhardness (Depth and Morphology)
- Open Portion of Nozzle 3 Crack for SEM/EDS

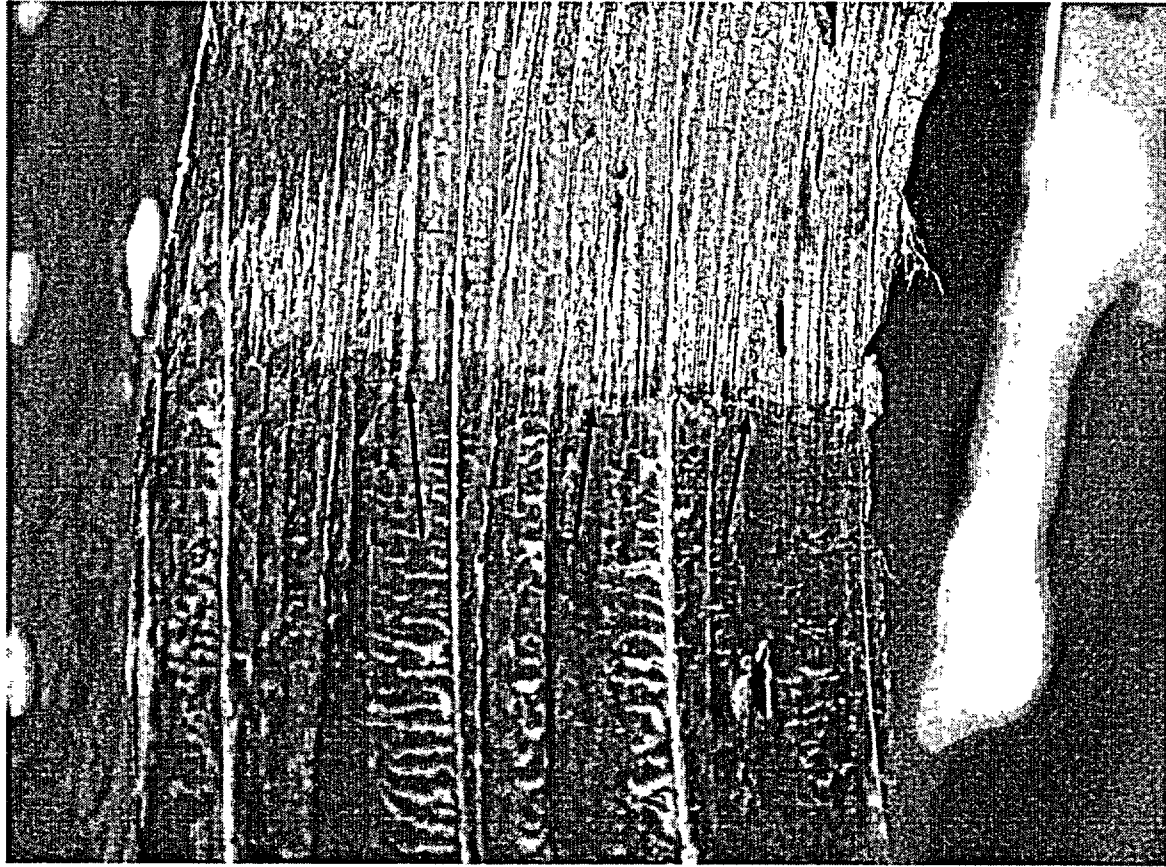
# ***Nozzle 3 J-Weld Cracking***

**Axial crack on bored surface of nozzle 3 J-weld near 10°.**

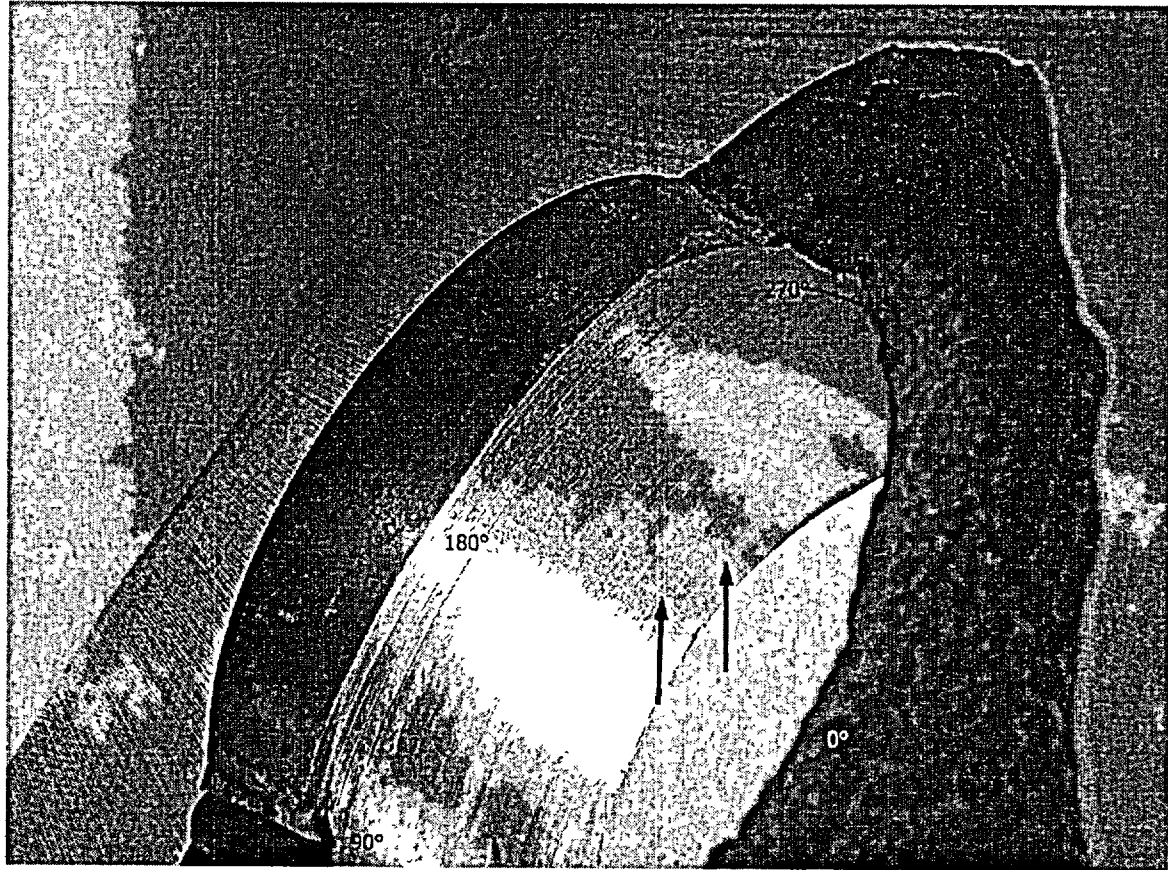
# ***Nozzle 3 J-Weld Cracking***

**Axial crack on bored surface of nozzle 3 J-weld near 180°.**

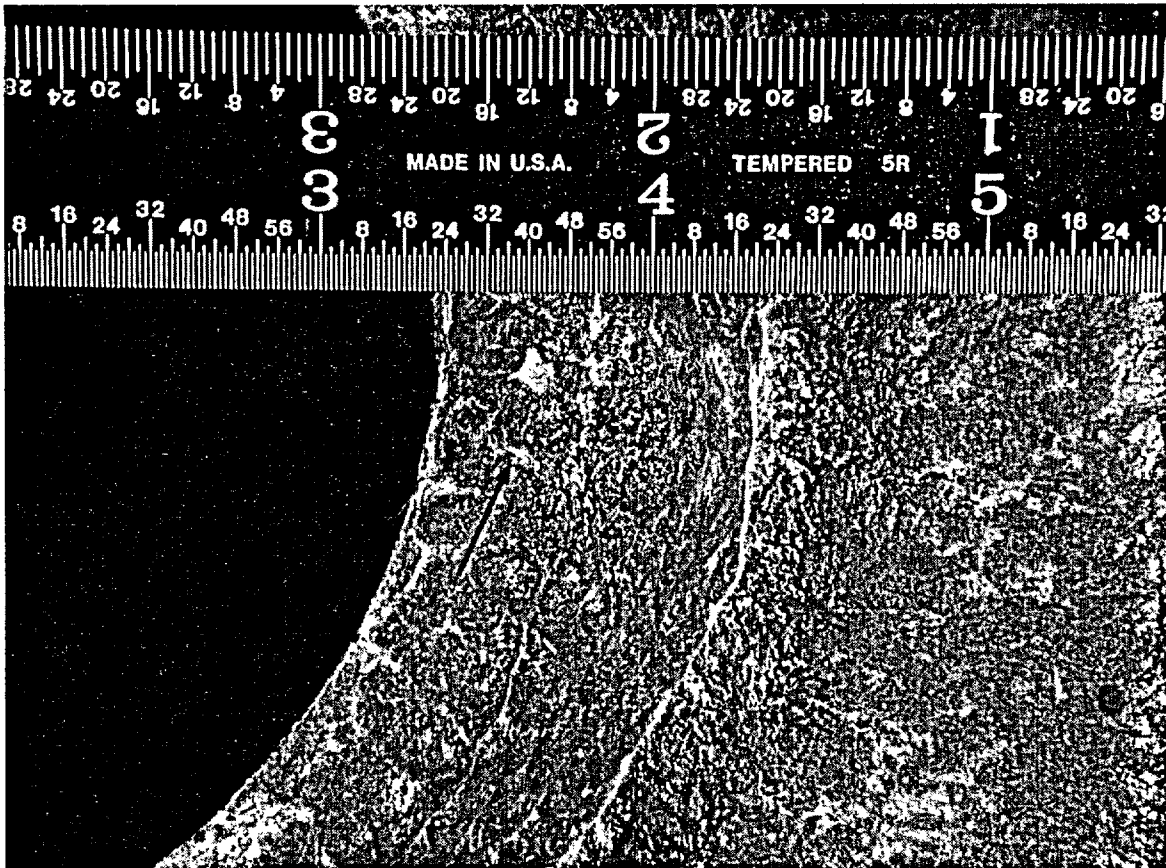
# Nozzle 3 J-Weld Cracking

Axial crack on top surface of nozzle 3 J-weld near 10°.

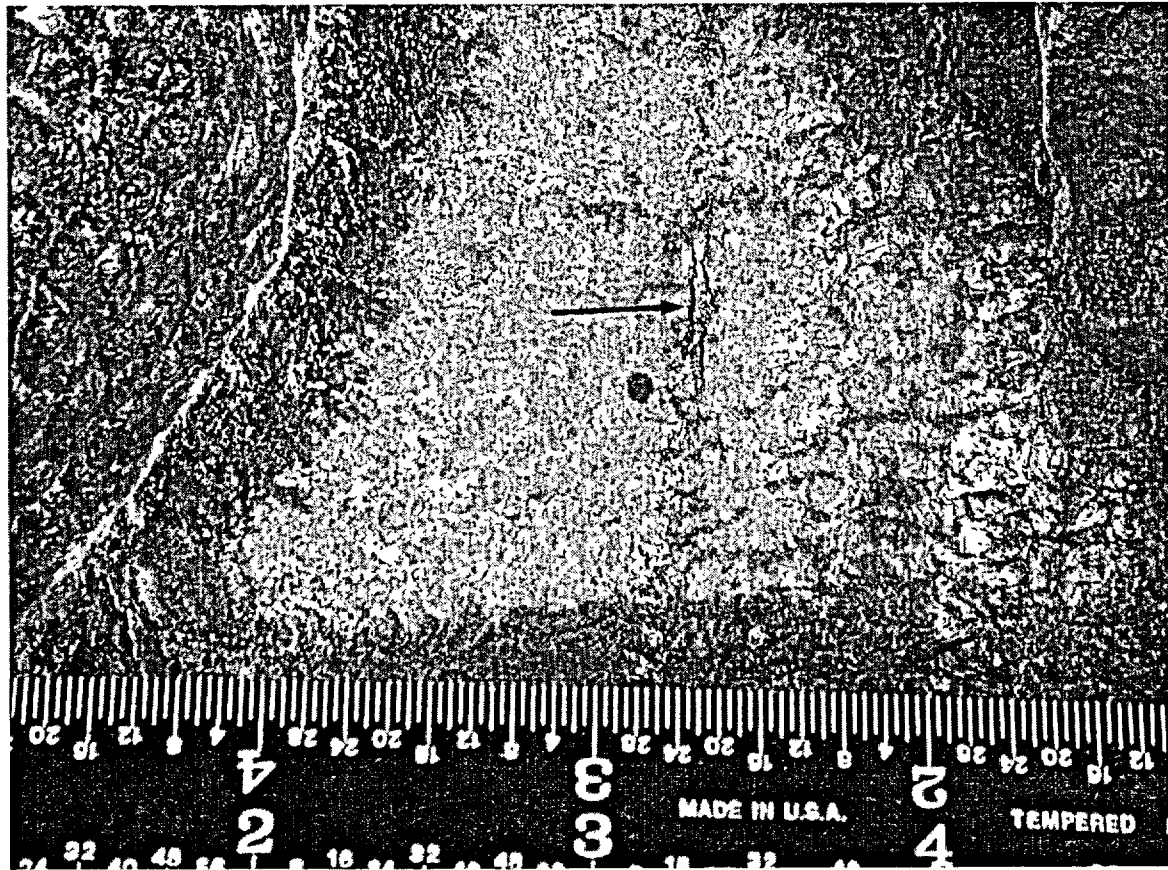
# ***Cladding Cracking***

**Crack on exposed surface of cladding.**

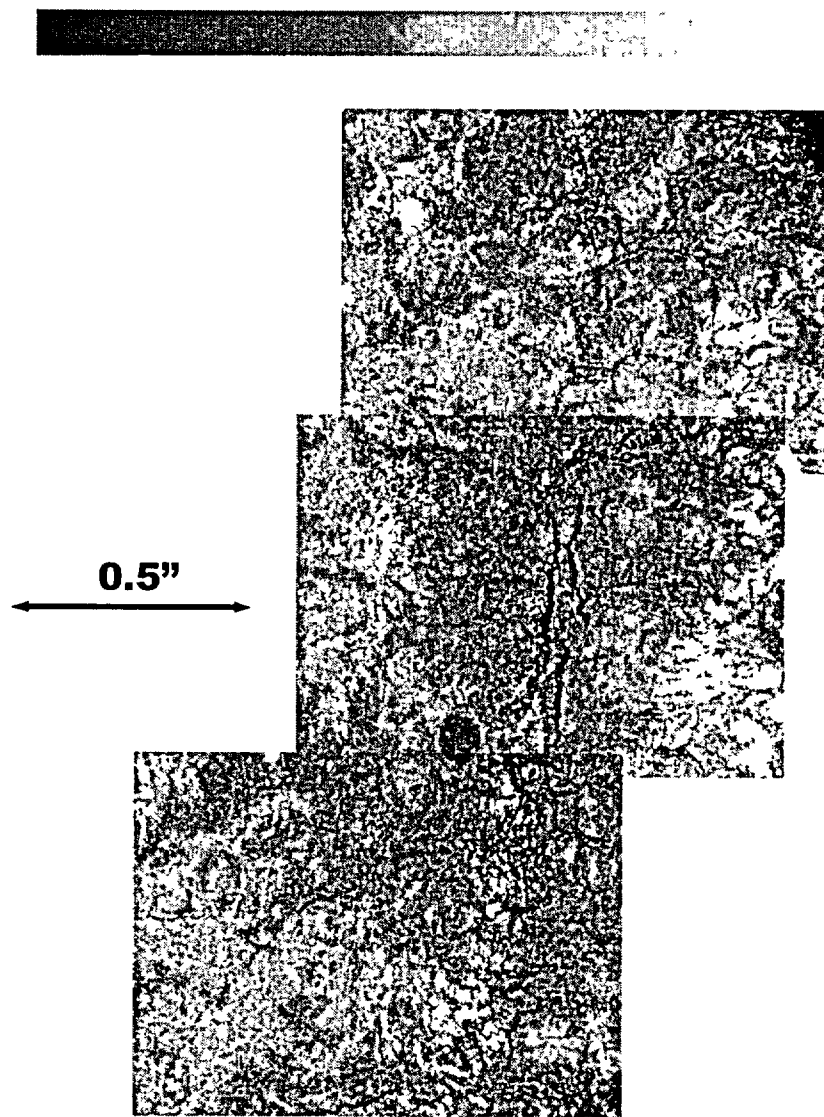
# Cladding Cracking

Crack on exposed surface of cladding. Red dot denotes (0,0) for cladding thickness measurements and was located in area of maximum upward deflection of cladding.

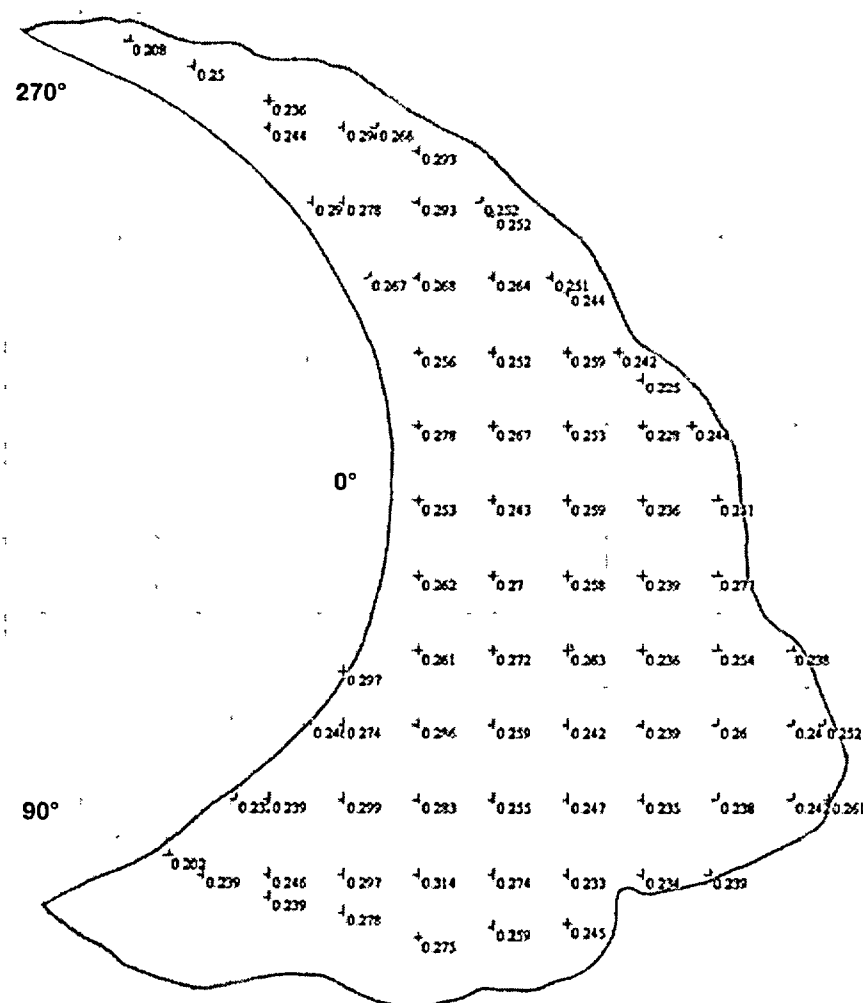
# Cladding Thickness Measurements

Exposed Cladding: ~17 in<sup>2</sup>  
Average Thickness: 0.256"  
Minimum Thickness: 0.202"  
Maximum Thickness: 0.314"

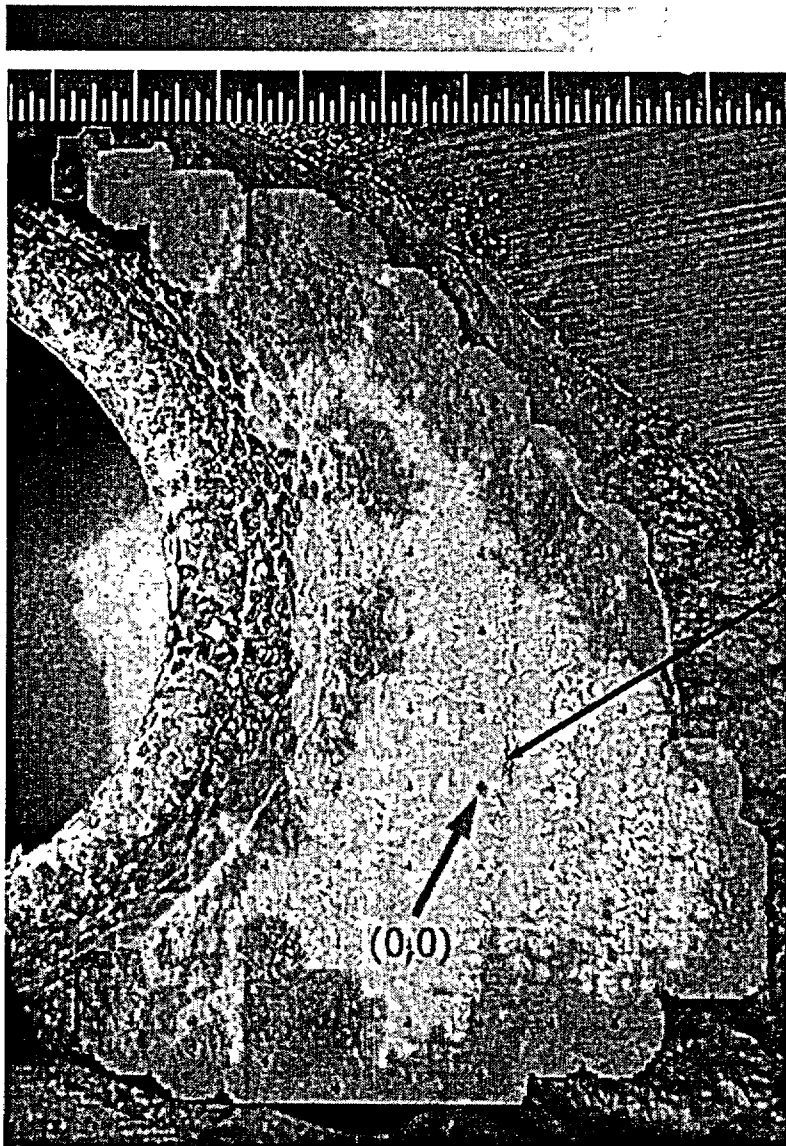
# ***Cladding Thickness Measurements***

**Crack on exposed surface  
of cladding with cladding  
thickness overlay.**

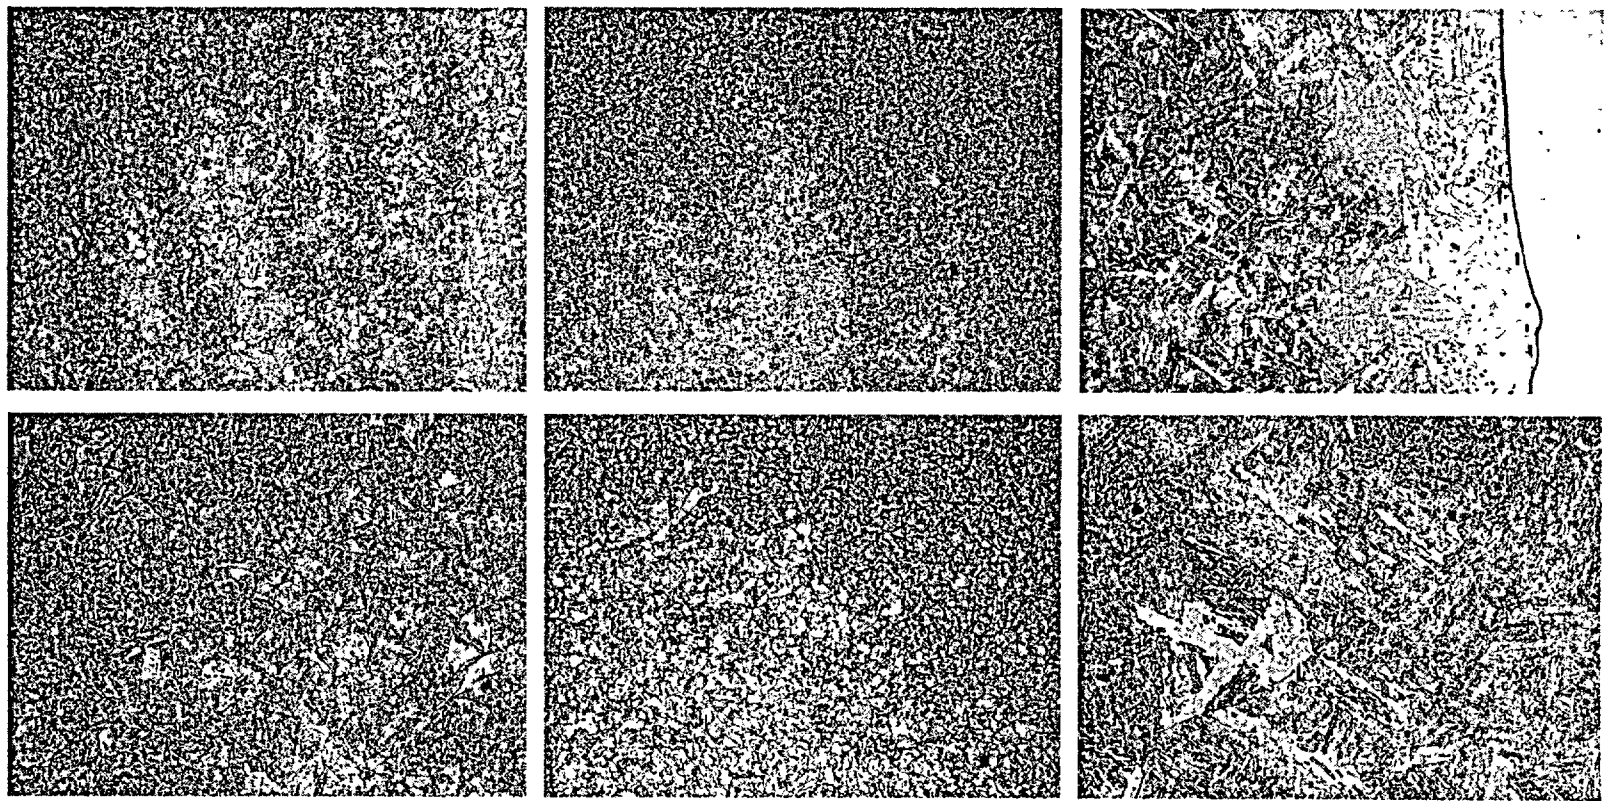
# ***Low Alloy Steel Metallography***

**Low alloy steel metallography (100X top; 475X bottom). 2% nital**

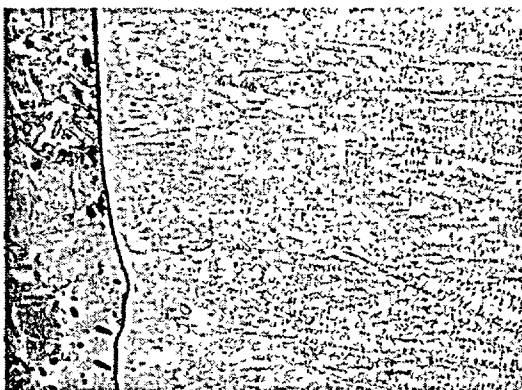
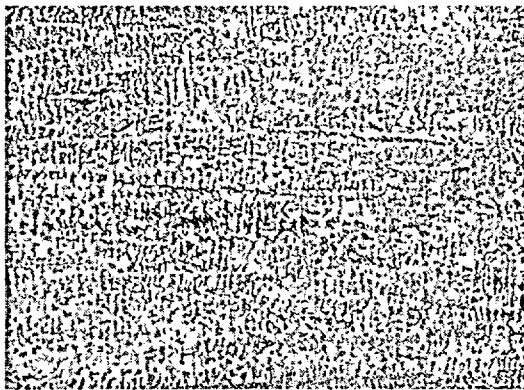
# Cladding Metallography

Cladding metallography (100X top; 475X bottom). Ferrite number between 5.0 and 7.5 (Severn). Acetic, nitric, hydrochloric etch

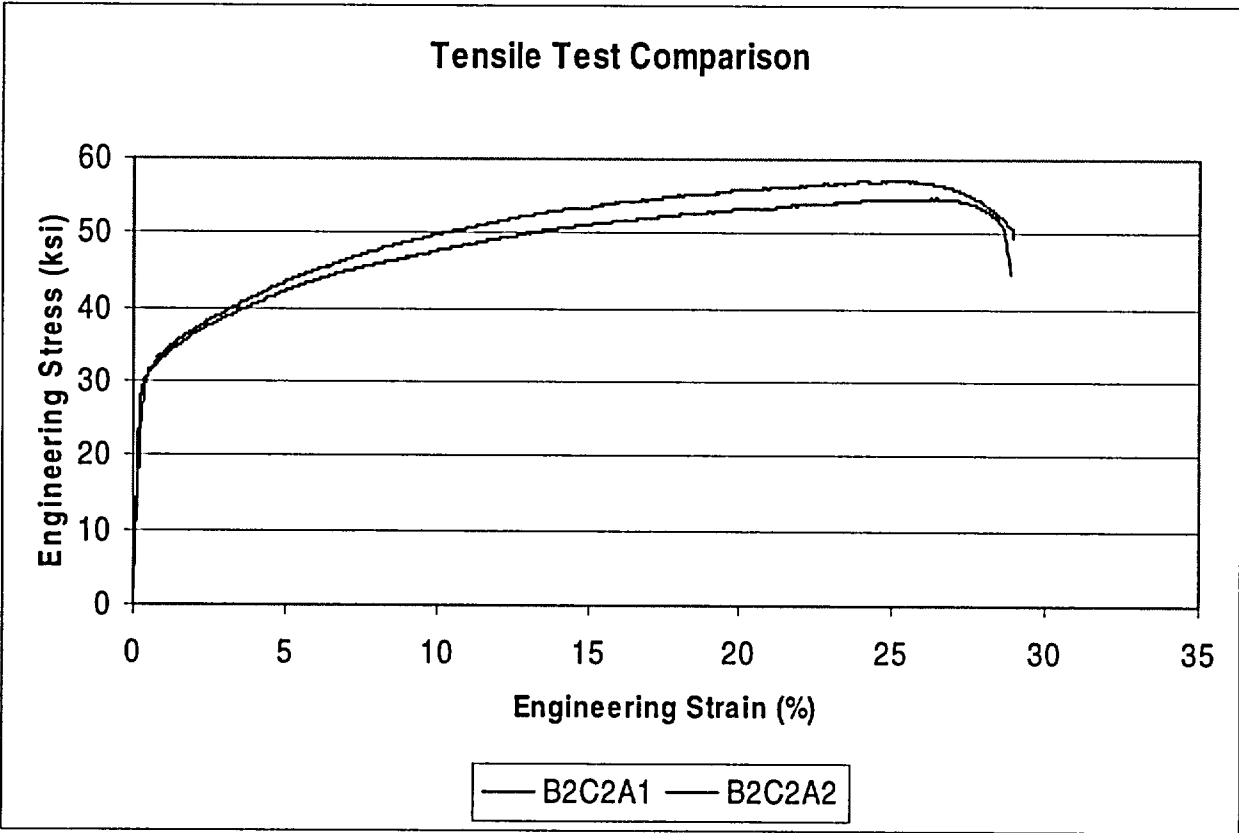
# Tensile Test Results

Specimen B2C2A1 (near RCS)	Specimen B2C2A2 (near low alloy steel)
UTS	54,800 psi	57,100 psi
2% Offset YS	30,500 psi	31,300 psi
Elongation	28.7%	28.7%
RA	39.3%	34.3%
