From: Mark Kirk *RES*
To: Bass, Richard - ORNL
Date: 10/29/02 9:28AM
Subject: Permanent set "Measured" in DB Clad

Davis-Besse Reactor Head Sample Characterization

Phase 3 Status Report, 9/19/02

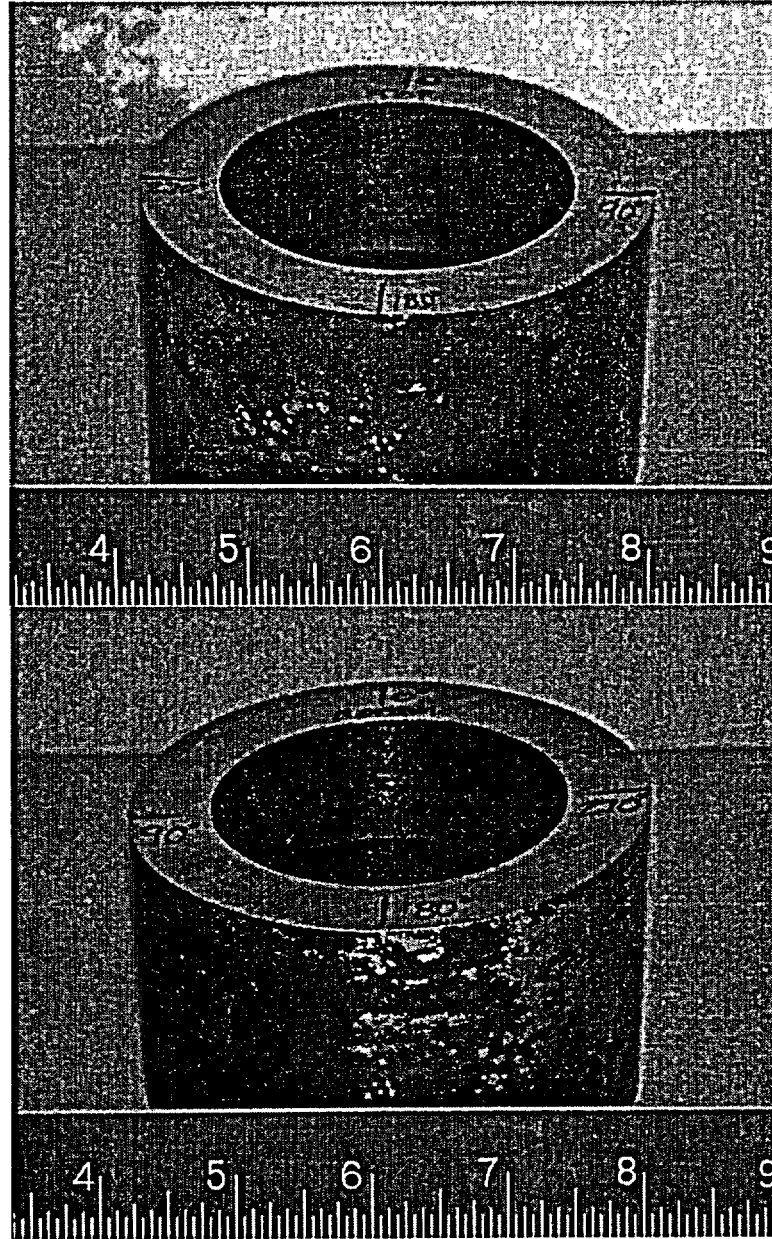
Figure 2(d). 2.5" long ring cut from Nozzle 3. Top face (from the 3.5" cut) and Bottom Face (from the 1" cut). The 0, 90, 180, and 270° markings are approximate.

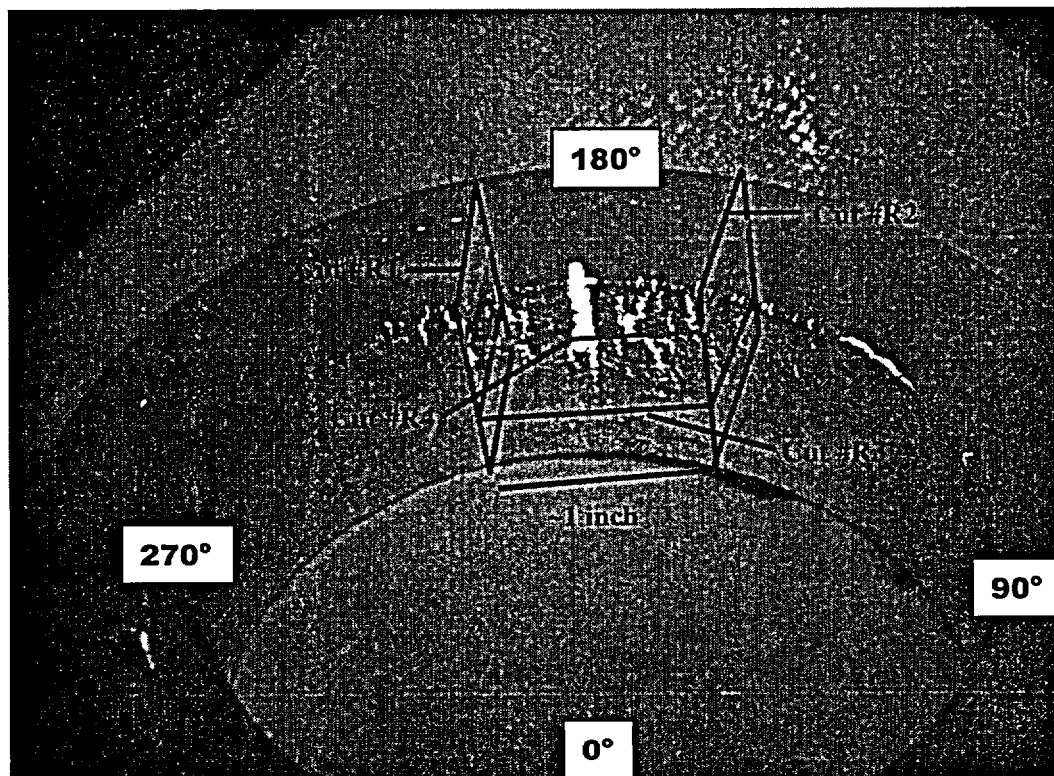
- (e) NRC and FENOC shipment authorization and ANL contact information received on 09/03/02. Shipment was received by ANL on 09/17/02. contact: John R. McDade, (630)252-5168, Fax (630)252-7367, jmcdade@anl.gov
- (f) Completed on 8/26/02; a patch of axial crack-like indications was observed on the lower end of the nozzle OD. The largest indication extended ~0.5" axially and ~1/8" into the nozzle wall. These indications were located on the uphill side of the nozzle (i.e., 180° or the side facing toward nozzle #1).

Figure 2(f). Viewing orientation: looking at the Nozzle 3 lower end face.

Proposed sectioning plan for 1" ring from end of nozzle #3 (Dated 09/03/02).

The majority of cracks will be sectioned out of the ring (cuts #R1-3). Also, after Cuts #R1-2, the I.D. surface of the nozzle segment will be examined under SEM. Cut #R4, which is parallel to Cut #3, will be made transverse through the cracks (red line) and the two mirror surfaces will be mounted. This will permit observation of the cracks in two directions with further progressive grinding.

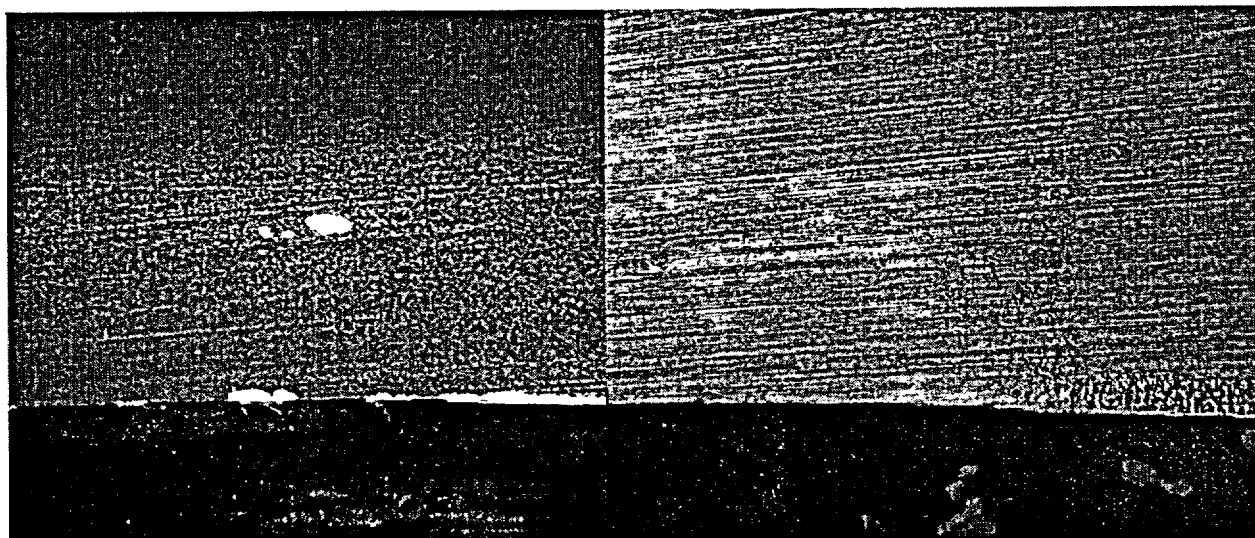
- (e) Completed on 8/23/02; no evidence of disbond noted between the stainless steel clad and low alloy steel. One small void measuring $\sim 1/8$ " in length was present near the nozzle #11 J-groove weld root. See photos below, before and after removing the PT dye and developer.

Figure 3(e). PT of stainless steel cladding and low alloy steel interface.

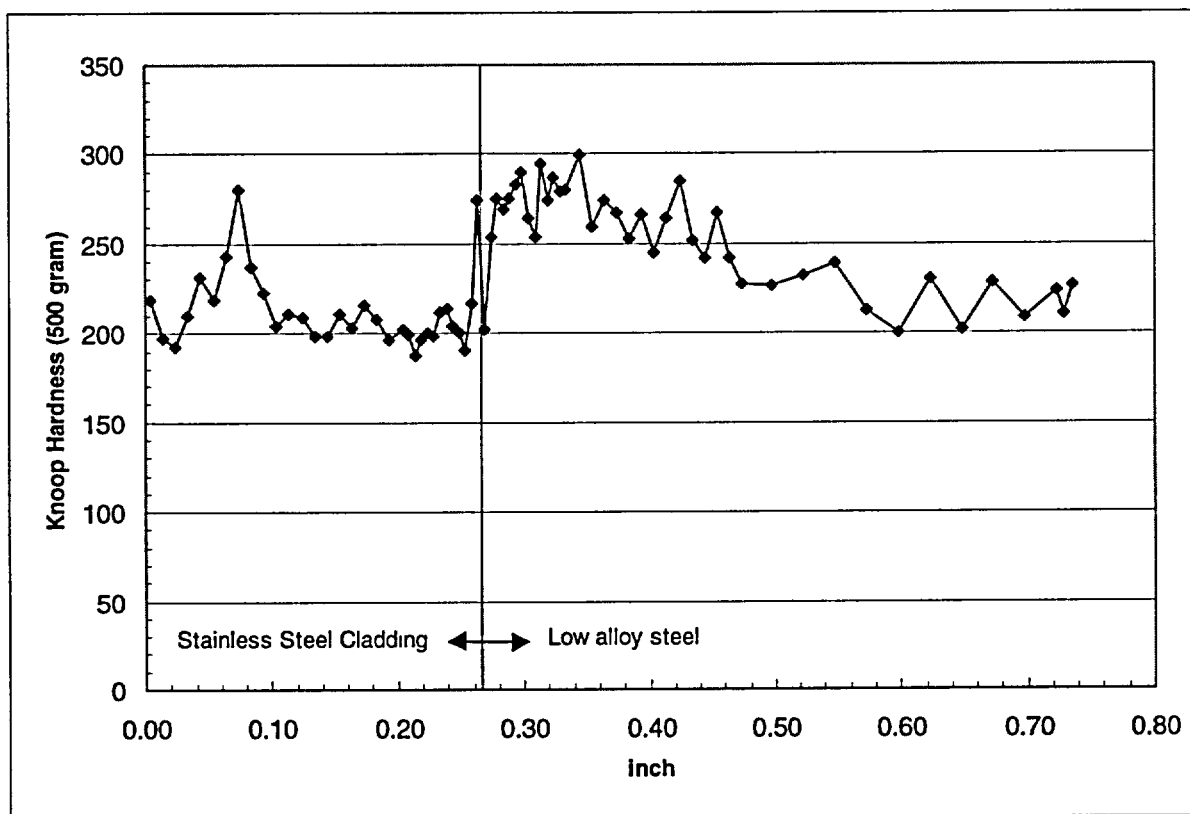
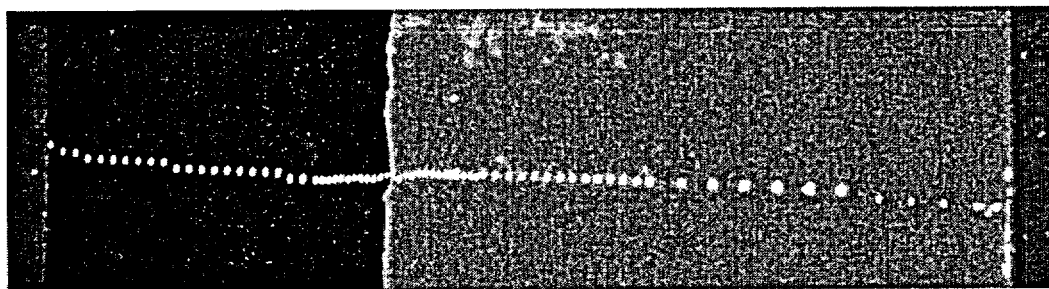
- (f) Microhardness (Knoop 500gram) traverse on Block B completed on 9/6/02.
See plot below.

Figure 3(f). Microhardness traverse across stainless steel cladding and into low alloy steel

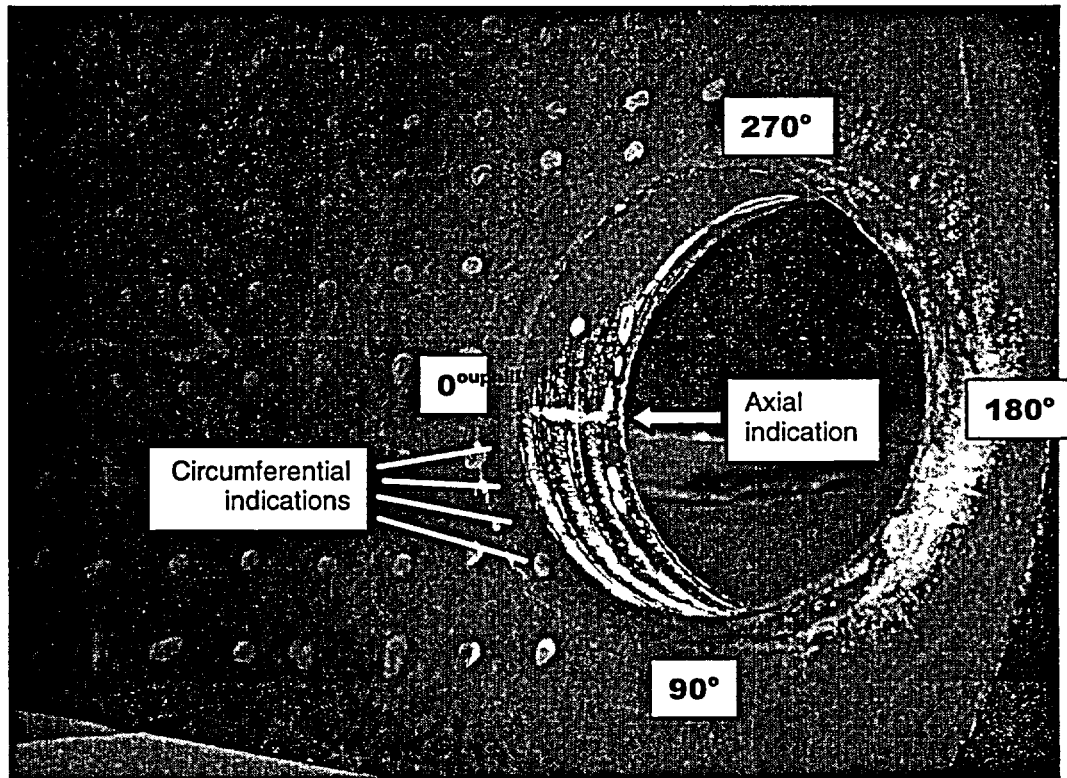
- (i) Completed on 8/28/02; linear crack-like indication present on ID surface; circumferential cracking present on the J-groove weld's underside surface (RSC side, the same as stainless steel cladding surface); linear voids present in J-groove weld. See the following three photos.

Figure 3(i)-1. PT results for nozzle #3 J-groove weld. Orientation: looking at stainless steel clad surface (or underside, i.e., RCS side). 0° is downhill side facing the cavity, and 180° is uphill side. A crack-like indication measuring ~1.4" long was present at ~10 degrees on the J-groove weld bore (arrow). This crack was visible on the top of the J-groove weld and was aligned with the deepest portion of the cavity. Circumferential cracking was observed on the J-groove weld's underside surface (same as stainless steel cladding surface). These circumferential cracks are located ~3/4" radially from the penetration bore and between 0° and 45° (higher magnification photos follow). Linearly aligned voids were also present on the J-groove weld bore ~0.3" below the top surface of the J-groove weld. These voids extended from 240 degrees to 30 degrees (through 0 degrees) and measured a maximum ~0.1" wide and ~1.4" in length. These voids likely formed during original welding.

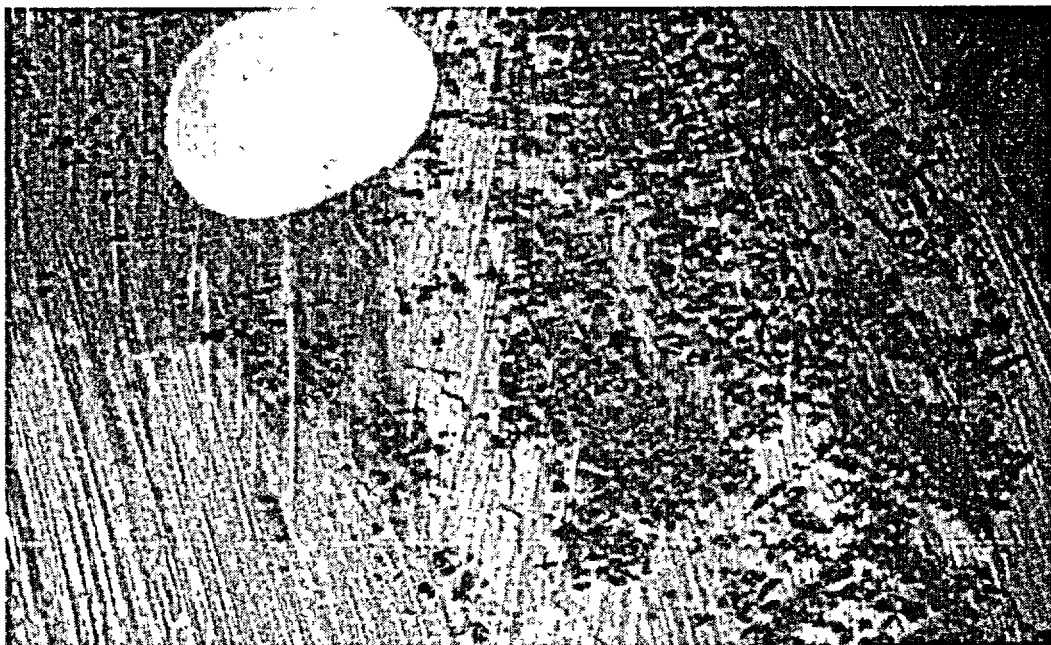
Figure 3(i)-2. Circumferential cracking on the J-groove weld underside or RCS side (6X). The yellow spot at the top of the photo is a grid marking for the UT thickness measurement performed at the Davis-Besse site.

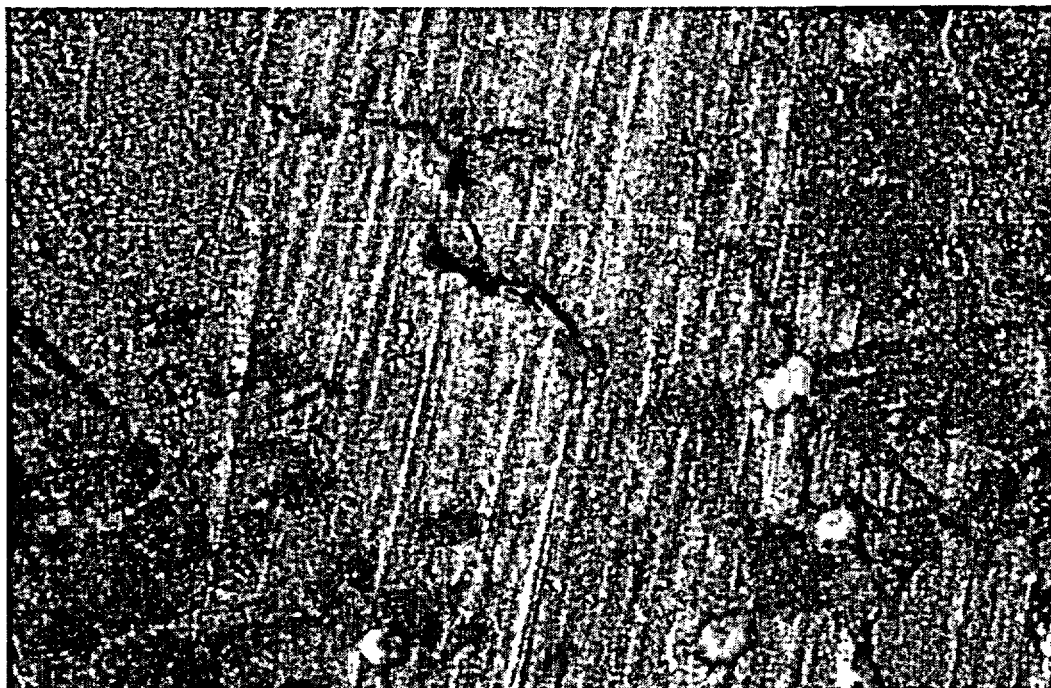
Figure 3(i)-3. Detail of circumferential cracking (40X).

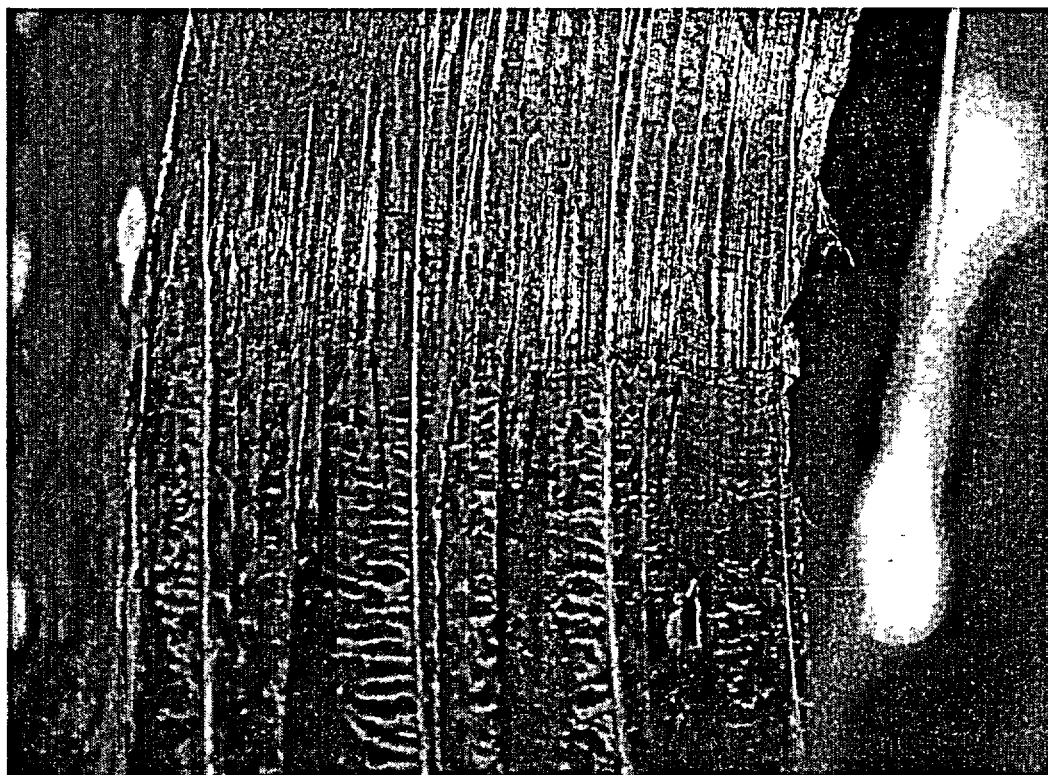
The PT performed did reveal one axial crack indication on the J-groove weld bore surface (180°) and some circumferential crack indications on the J-groove weld un-machined undersurface (0-45°) see above. However, the surface condition of the J-groove weld, especially the upper surface and the machined bore of the J-groove weld are not conducive to PT. Hence, it was decided to use the stereo microscope (up to X50) to completely scan the J-groove weld area. This led to the following new information to the PT indication, cracking indications not revealed by the PT, and cracking in the exposed stainless steel cladding top surface.

Figure 3(i)-4. Looking at J-groove weld underface (bored surface). Crack indication corresponds to axial crack (near 0°) indication in Figure 3(i)-1.

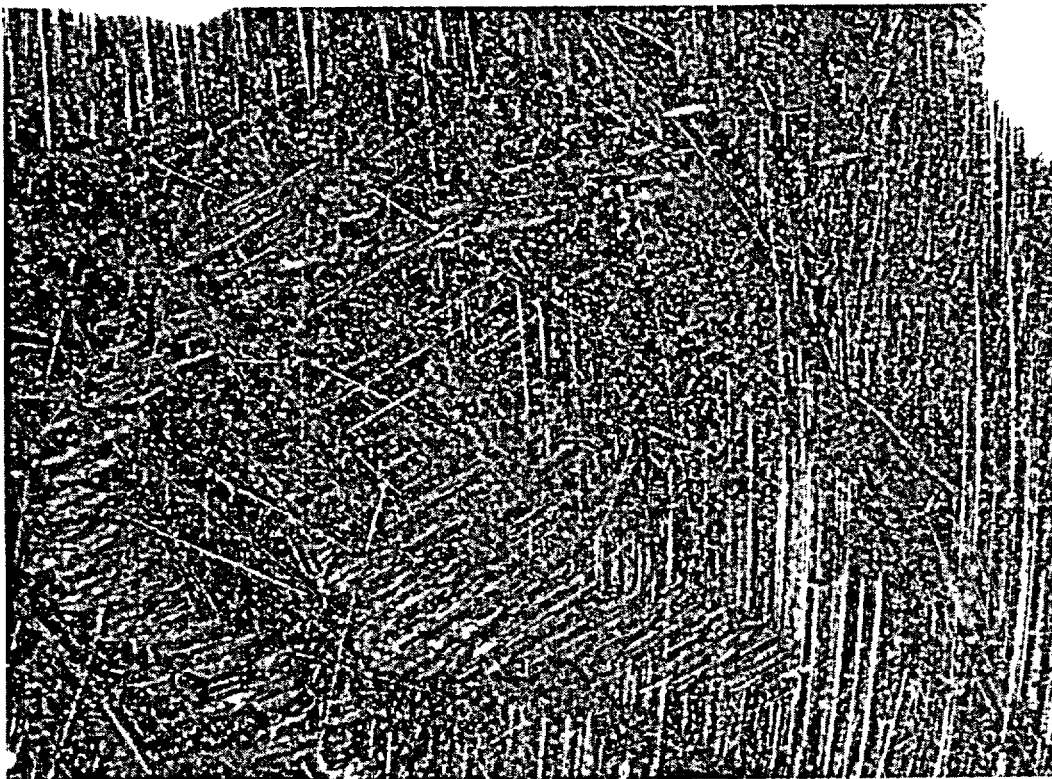
Figure 3(i)-11. Close-up of underside (RCS side) of the corrosion cavity, inside the maximum deflection 6X. No indication of cracking is found on the underside with stereo microscope scanning.

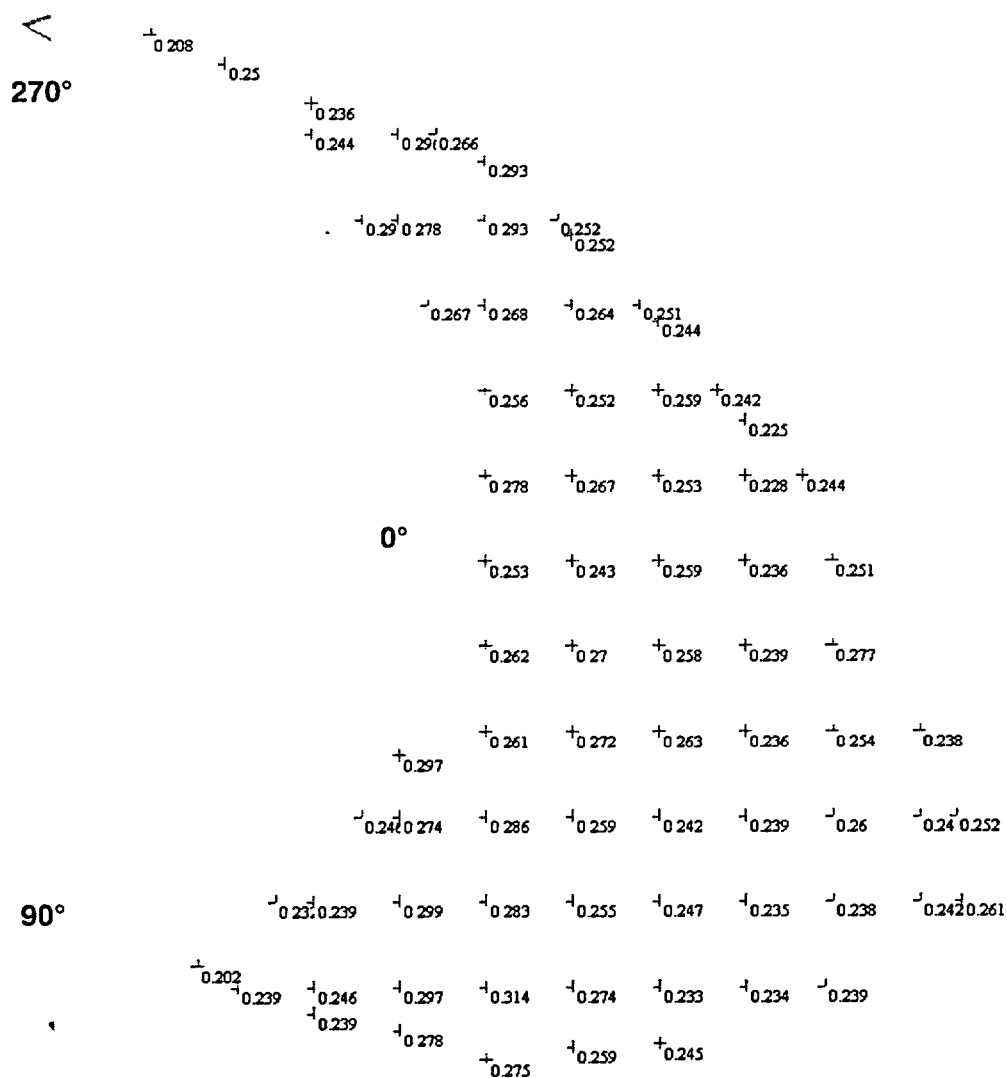
The Figure below shows the cladding thickness measurements superimposed on the exposed stainless steel cladding contour taken from the cavity molding*. It should be noted that some portion of the exposed cladding along its edge is inaccessible for measurement due to the undercutting close to the bottom. The #5 cut did not remove all the overhang above the exposed cladding surface.

Average thickness of all 78 readings: 0.256"

Minimum measured clad thickness: 0.202"

Maximum measured clad thickness: 0.314"

Figure 3(j)-1. Exposed stainless steel cladding thickness measurement.

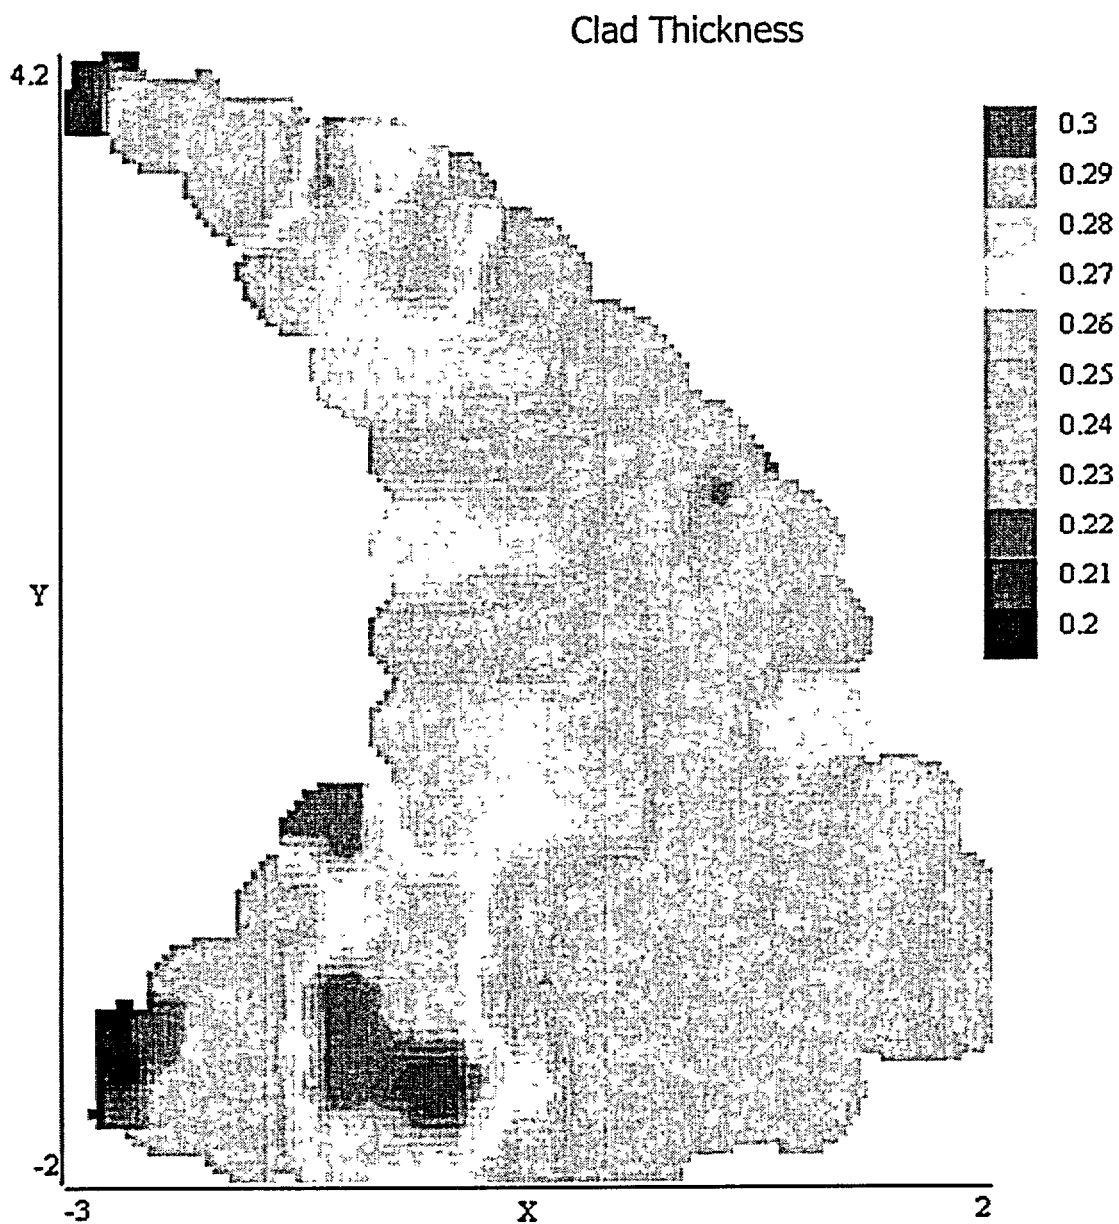
Figure 3(j)-2. Color representation of the exposed stainless steel cladding thickness based on Figure 3(j)-1 numbers.

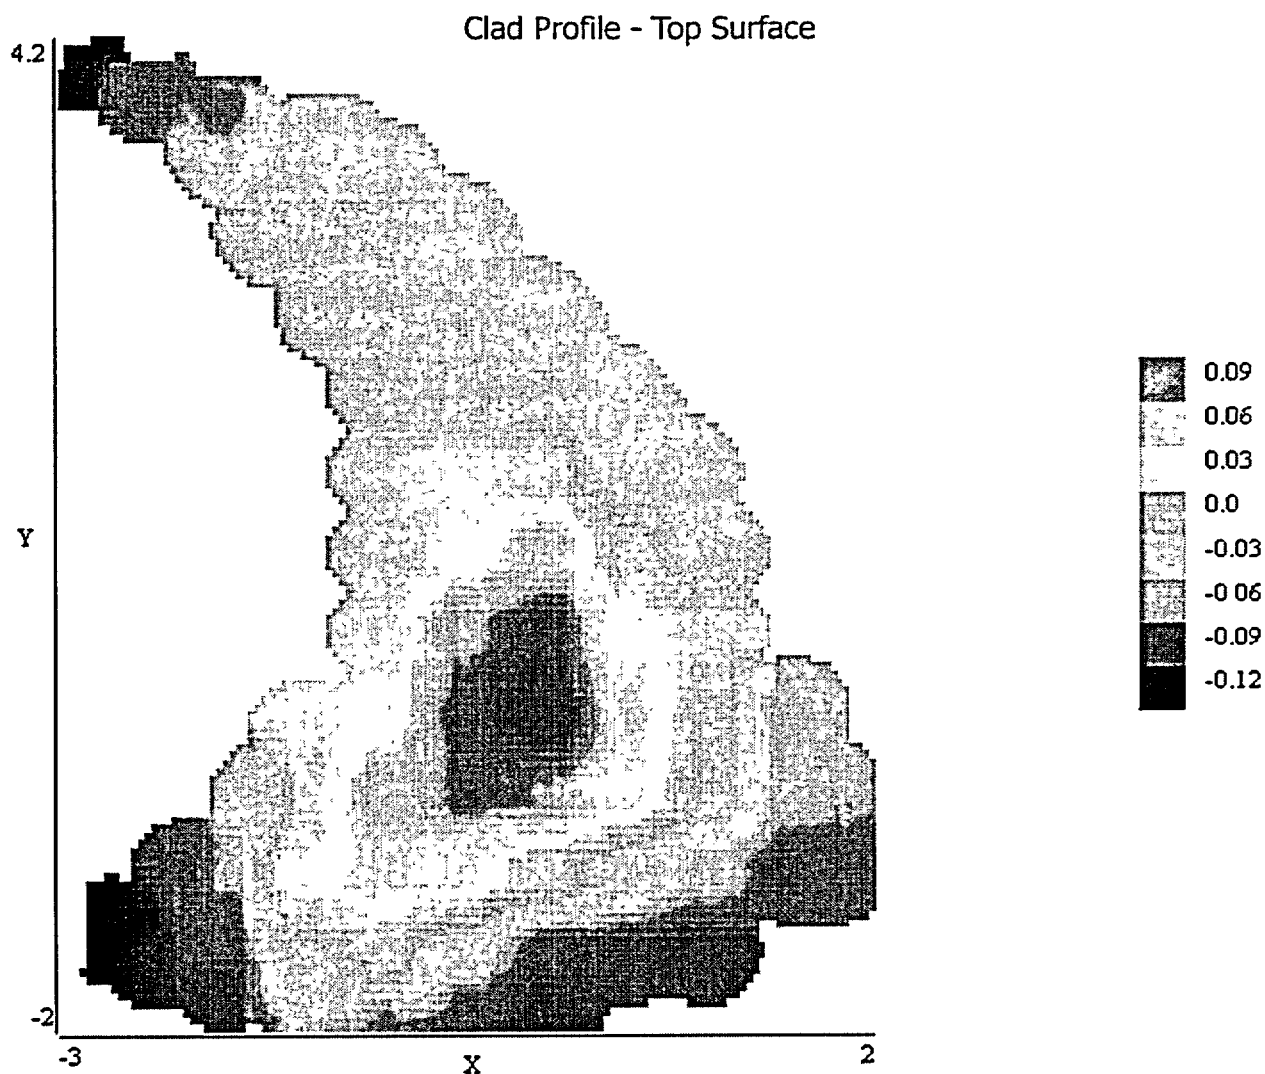
Figure 3(j)-3, Color representation of the elevation profile of the upper exposed cladding surface.

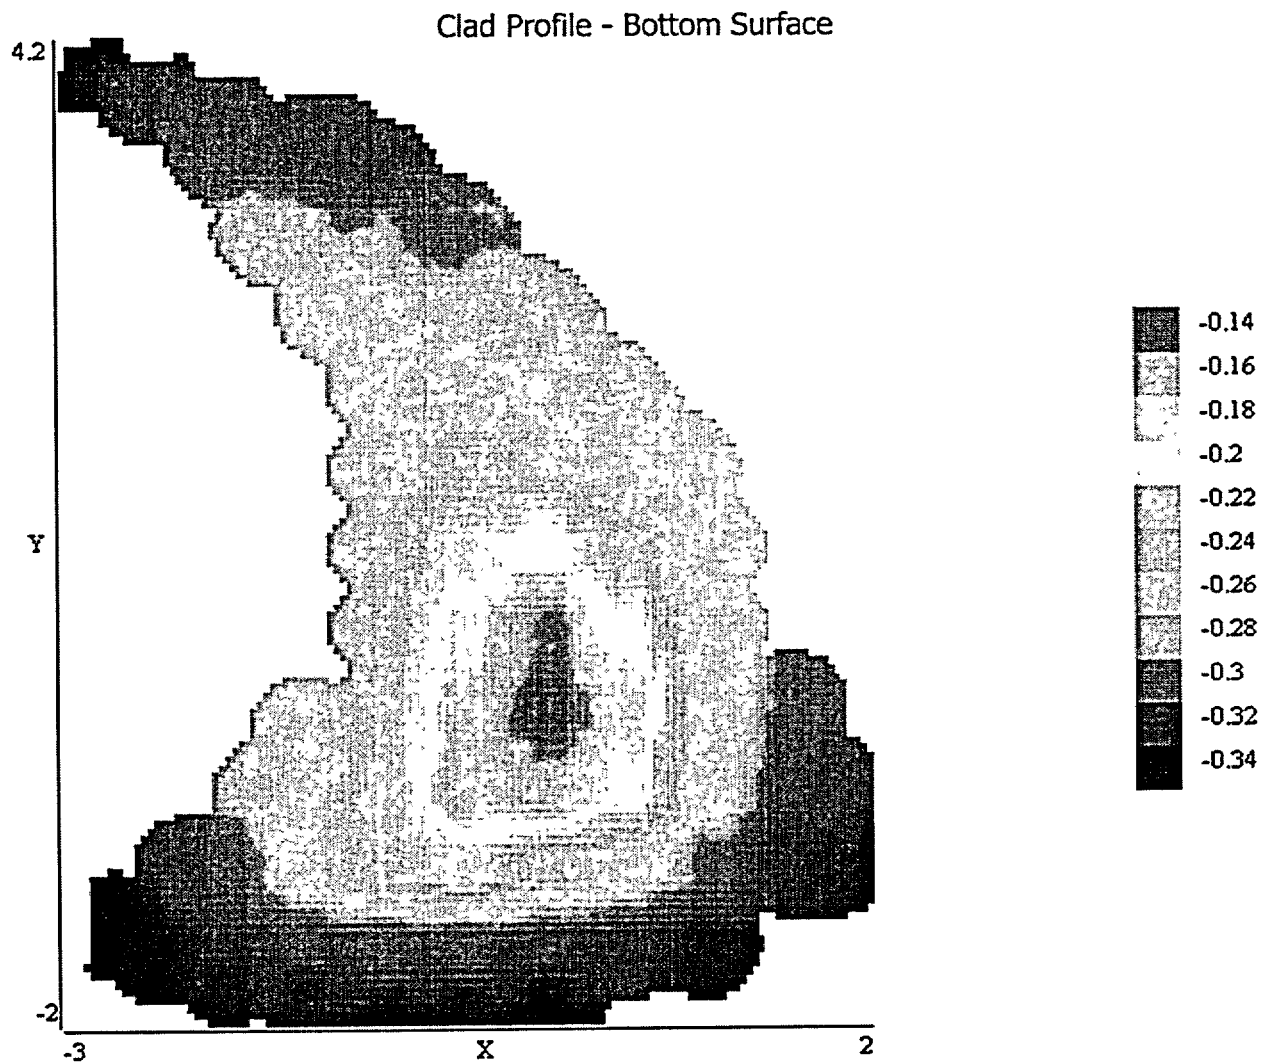
Figure 3(j)-4, Color representation of the elevation profile of area on the lower cladding surface corresponding to the exposed cladding on the upper side.
