Reactor Vessel Head Inspection Current Status and Future Plans

Calvert Cliffs
Nuclear
Power Plant
Unit 2

March 18,
2003

Enclosure 2

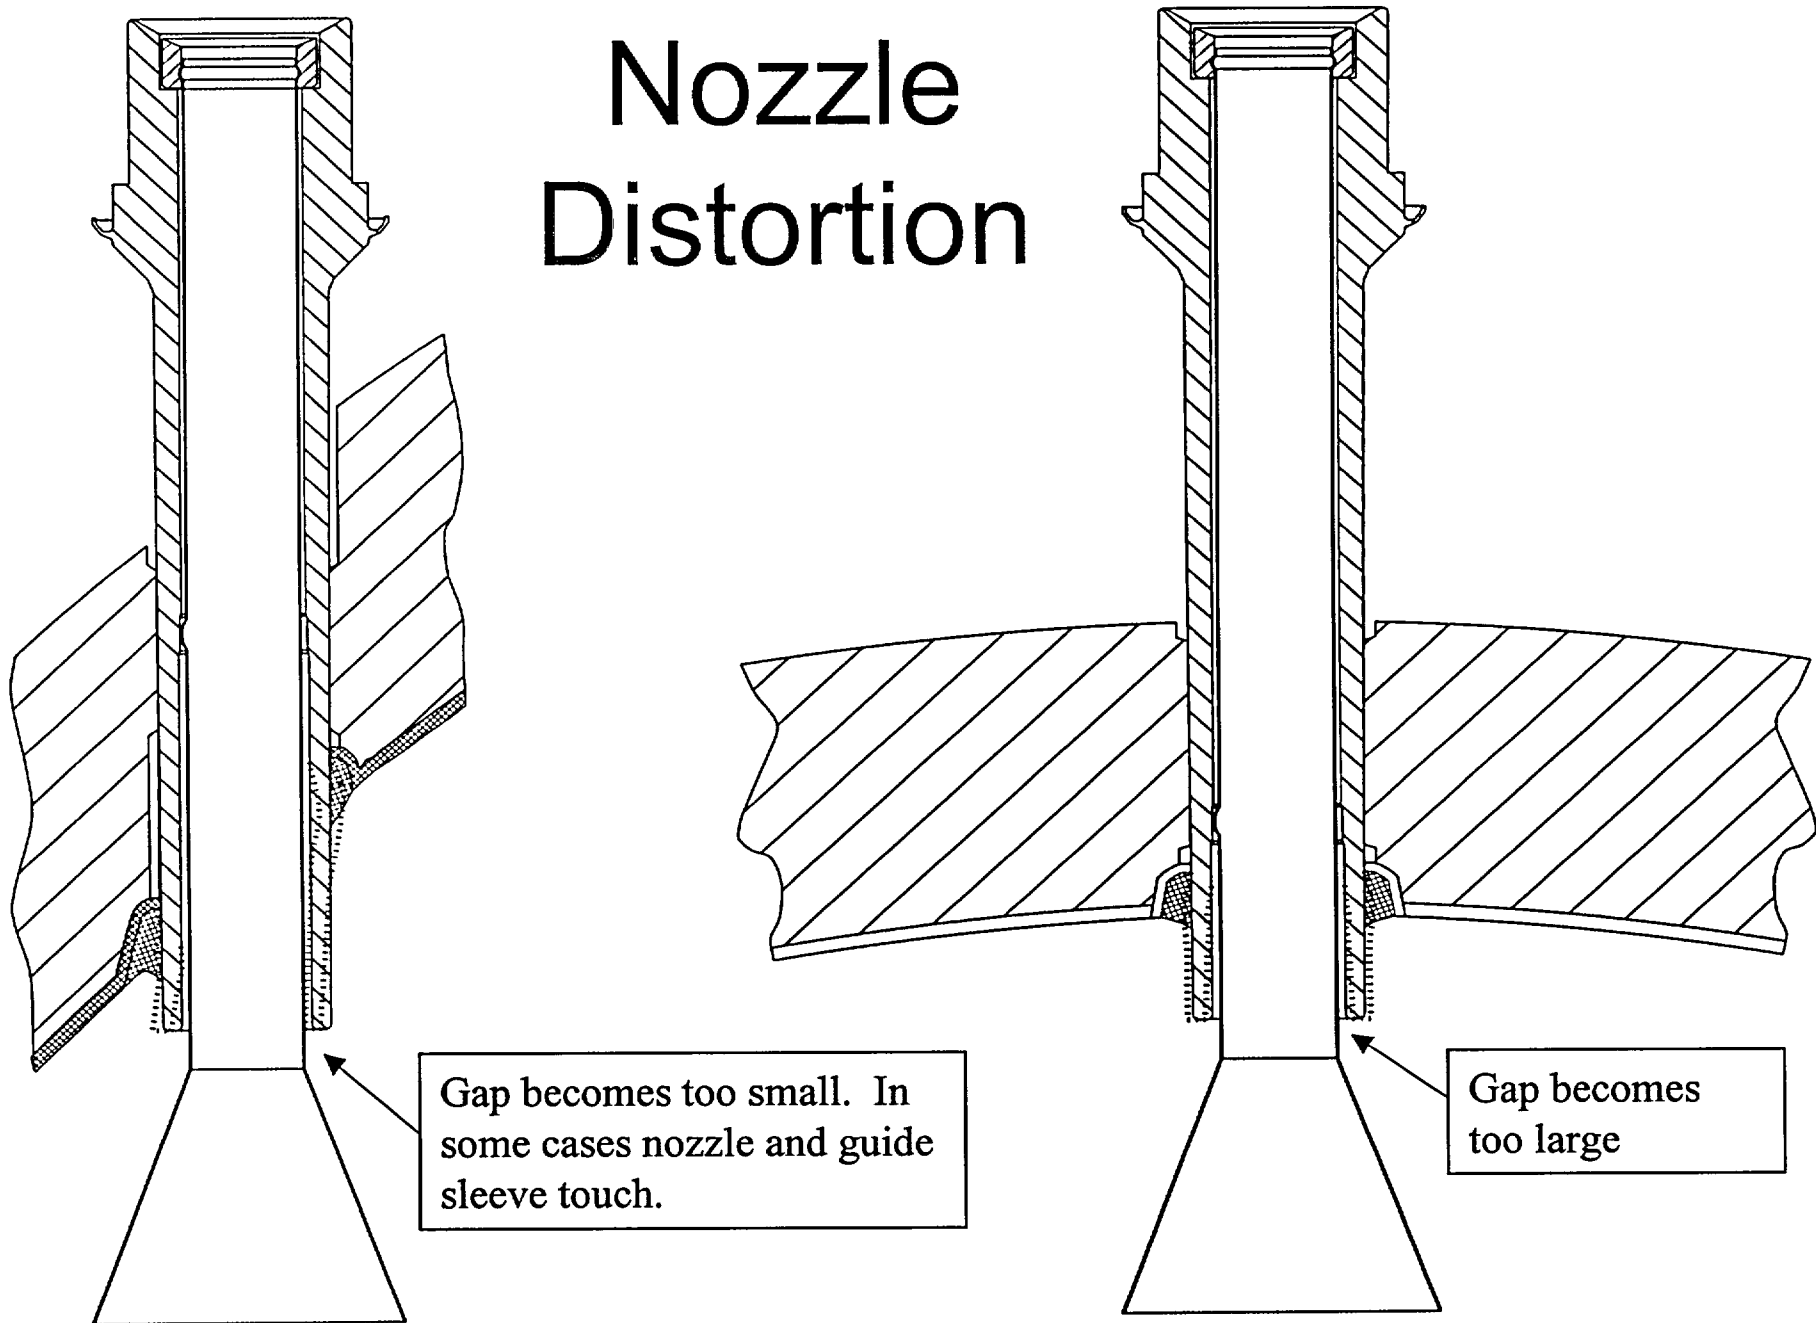
Nozzle Distortion

- Nozzle distortion
 - Probe coupling
 - Probe access

- Working with vendor to improve probe design, mockup/testing
- Assessed removal of guide sleeves
 - Acceptable level of quality and safety without removal
 - Dose and new residual stress considerations

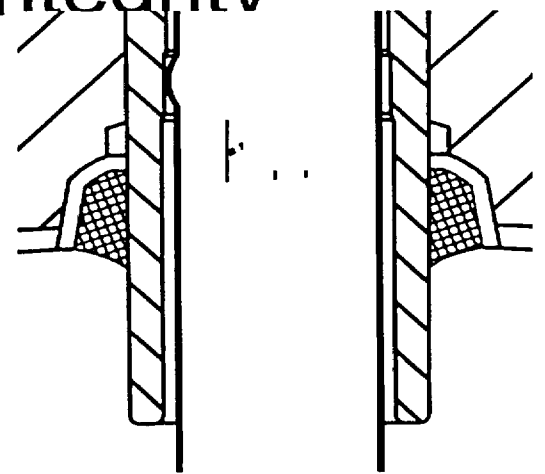
Coverage Above Weld Region

- Have achieved examination of approximately 214 of 227 in²
- Unavailable azimuths assessed deterministically for structural integrity
 - 11 nozzles have 360° coverage
 - One has 355° coverage
 - One has 117° coverage

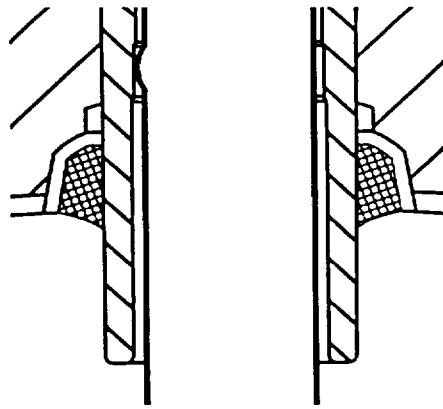
Material Adjacent to Weld Region

- Have examined approximately 37 of 117 total in²
- Fewer structural integrity concerns for unavailable azimuths in welds
