UNITED STATES
NUCLEAR REGULATORY COMMISSION
OFFICE OF NUCLEAR REACTOR REGULATION
WASHINGTON, D.C. 20555

April 22, 1988

NRC INFORMATION NOTICE NO. 88-17: SUMMARY OF RESPONSES TO NRC BULLETIN 87-01,
"THINNING OF PIPE WALLS IN NUCLEAR POWER
PLANTS"

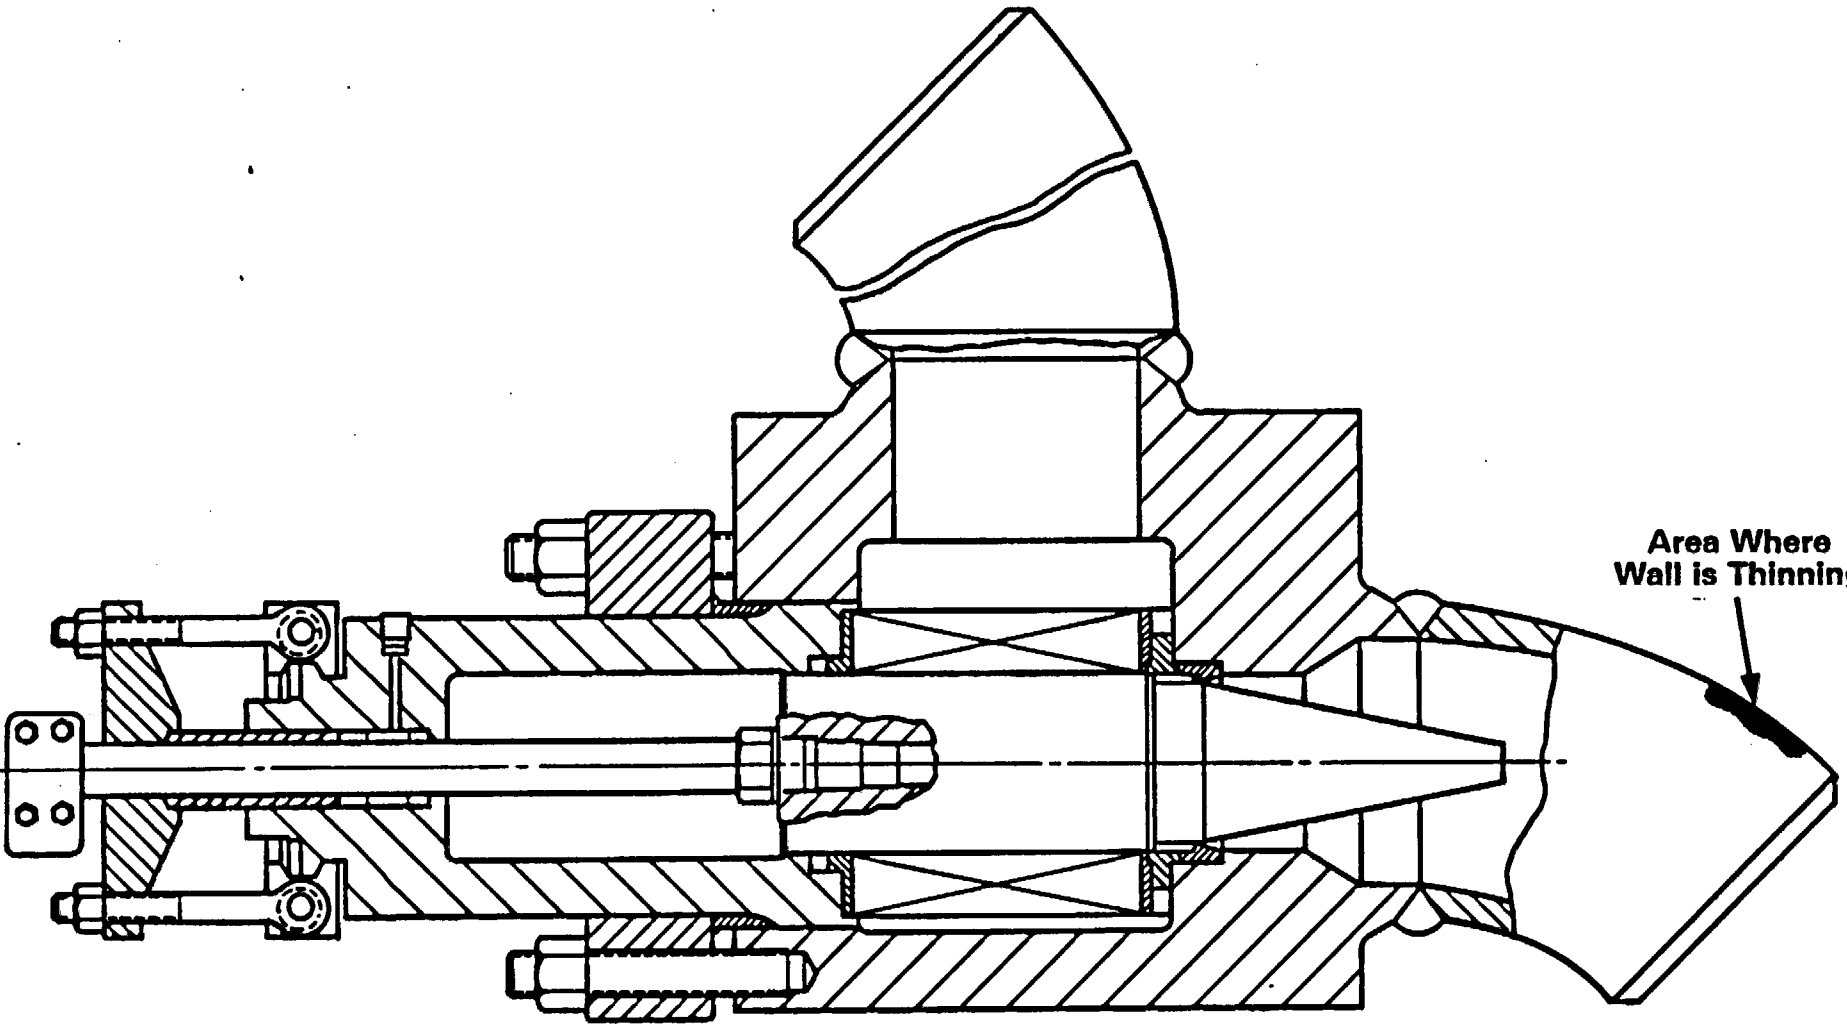
LaSalle Minimum-Flow Control Valve

The erosion pattern was thought to be caused by the design of the minimum-flow control valves and the geometry of the downstream piping. The valves were manufactured by Control Components, Inc., and were pressure breakdown "drag" valves. The valves have a cone-shaped disk and are not designed to be leak tight. Any feedwater leaking past the seat flashes to steam because of a vacuum pulling on the water from the condenser. With a cone-shaped disk, the steam is then directed, like a jet, immediately onto the opposing wall of the elbow or reducer, causing the erosion (see Attachment 3).

Area Where
Wall is Thinning

The feedpump minimum-flow lines are not considered to have a safety-related function and, therefore, this failure did not affect the ability to achieve a safe shutdown. However, this could present a plant personnel safety concern in the event of a catastrophic failure. The licensee did a weld overlay repair of the wall thinning areas of all four minimum-flow lines. The lines will be replaced during the next refueling outage. The licensee is evaluating a modification to the control valve disk to prevent flow or leakage through the line from being focused onto the downstream piping because of the conical shape of the disk.
