UNITED STATES
NUCLEAR REGULATORY COMMISSION
OFFICE OF NUCLEAR REACTOR REGULATION
WASHINGTON, D.C. 20555

August 20, 1992

NRC INFORMATION NOTICE 92-61: LOSS OF HIGH HEAD SAFETY INJECTION

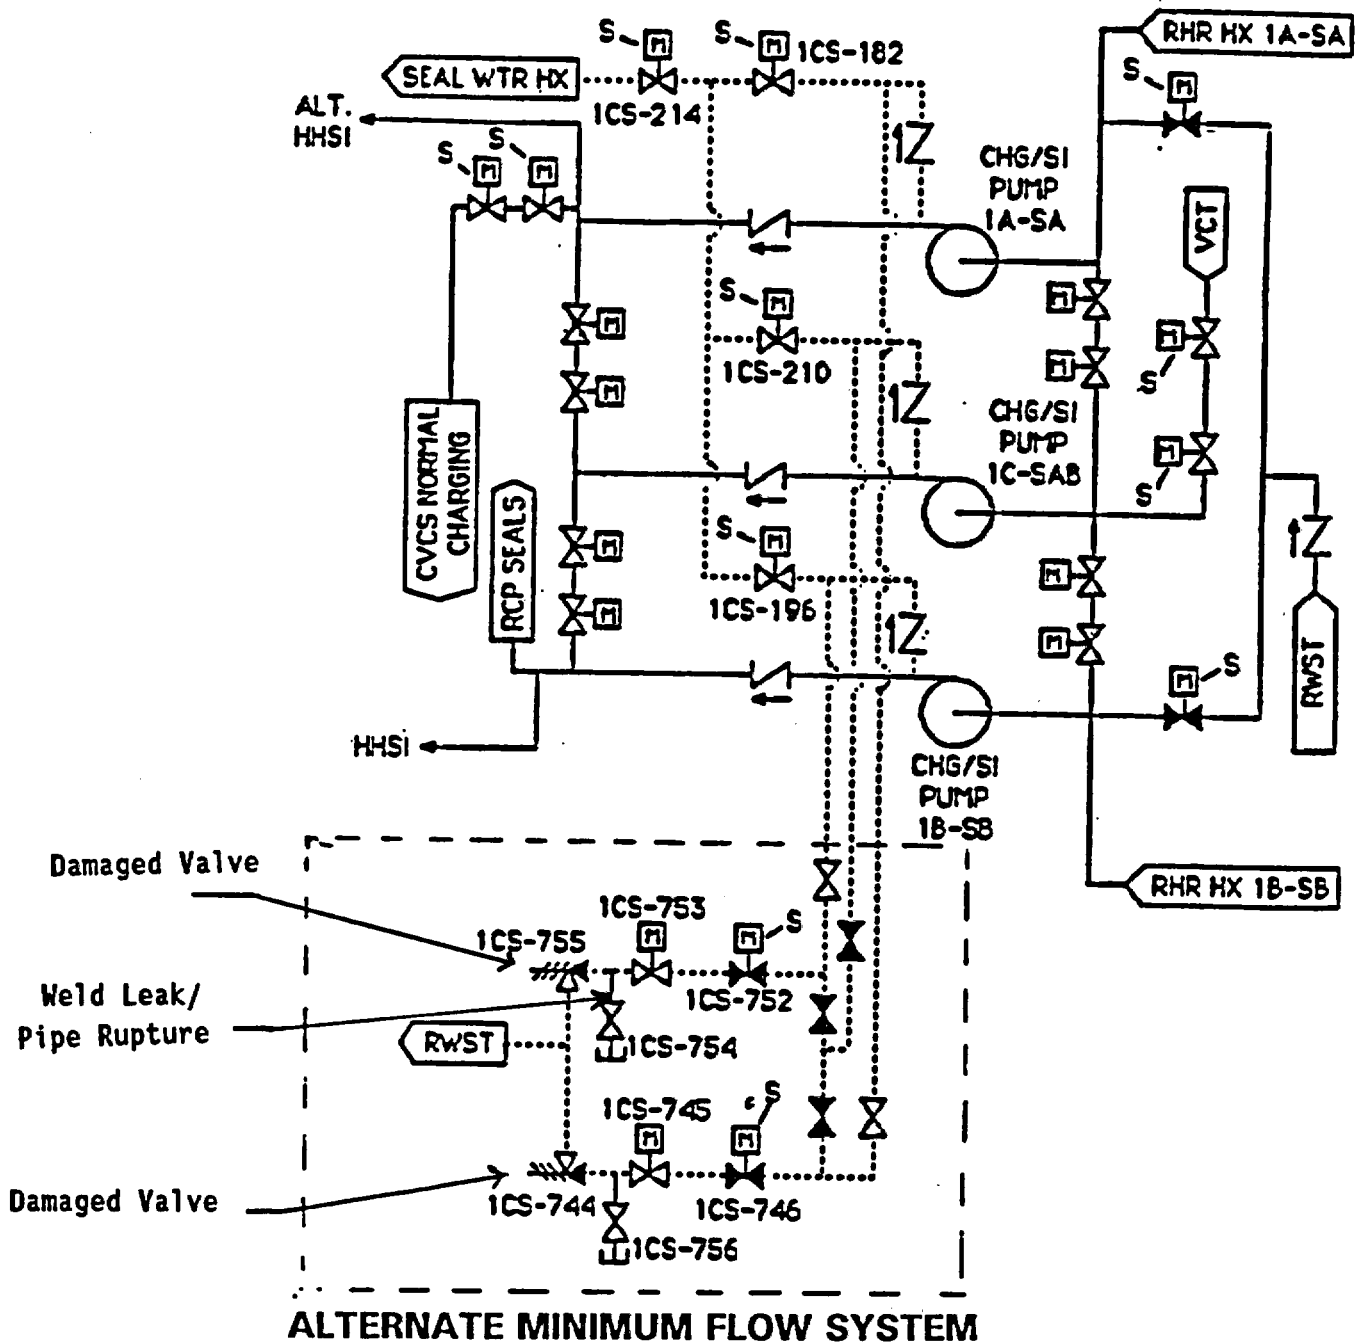
SHEARON HARRIS HIGH HEAD SAFETY INJECTION SYSTEM

The AMF system (Attachment 1) is designed to prevent a deadhead condition on the CSIPs by providing a flow path for these pumps to the refueling water storage tank if the reactor repressurizes following a main steam line break or feedwater line break accident. The AMF system is designed only to pass flow when the CSIP discharge pressure is above the lift setpoint of 2300 +/- 69 psig for relief valves 1CS-744 and 1CS-755. The AMF system was a modification to the original design in response to a Westinghouse 10 CFR Part 21 report. This report identified the potential for deadheading the CSIPs during repressurization of the RCS following secondary side breaks.

- 1) Relief valve 1CS-744 had a broken bellows and a cracked spring and was found to have a reduced relief setpoint of 1100 psig.

- 2) Relief valve ICS-755 had a broken bellows. Its relief setpoint could not be determined due to valve seat leakage.
- 3) The piping connection upstream of ICS-754 failed due to a water hammer during engineered safety feature (ESF) testing. A small leak had previously existed in this weld and was scheduled for repair during the 1991 refueling outage.

The physical layout of the AMF system piping at the Shearon Harris Nuclear Power Plant results in air being trapped upstream and downstream of the relief valves when they are removed and reinstalled in the system. The upstream isolation valves ICS-746 and ICS-752 remain closed until an SI signal is received. This prevents water from refilling this piping. Also, piping upstream of the relief valves does not have high point vents to remove the trapped air.

The NRC sent a special inspection team to the Shearon Harris site to review the event circumstances. The team determined that several water hammer events could have occurred in the AMF system over the past 6 years. They concluded that the water hammer events likely occurred when the CSIP pressurized the AMF system piping which contained air during ESF testing and during ESF system actuations.

- 1) The potential for water hammer events upstream and downstream of the relief valves had not been analyzed.
- 2) The AMF system piping had not been analyzed for transient or water hammer loads.
- 3) The potential for relief valve chatter and setpoint drift had not been analyzed.

The licensee has taken corrective actions by revising plant procedures to require the piping upstream of the relief valves to be refilled prior to installation of the relief valves and vented through the relief valves by hydraulic pressure to eliminate the air. The licensee has also repaired the damage identified above. The licensee reported this event to the NRC in LER 050-400/91-008-01 in May of 1991. The licensee is currently evaluating the potential for water hammer downstream of the relief valves.
