UNITED STATES
NUCLEAR REGULATORY COMMISSION
OFFICE OF INSPECTION AND ENFORCEMENT
WASHINGTON, D.C. 20555

April 4, 1980

IE Bulletin No. 80-07

BWR JET PUMP ASSEMBLY FAILURE

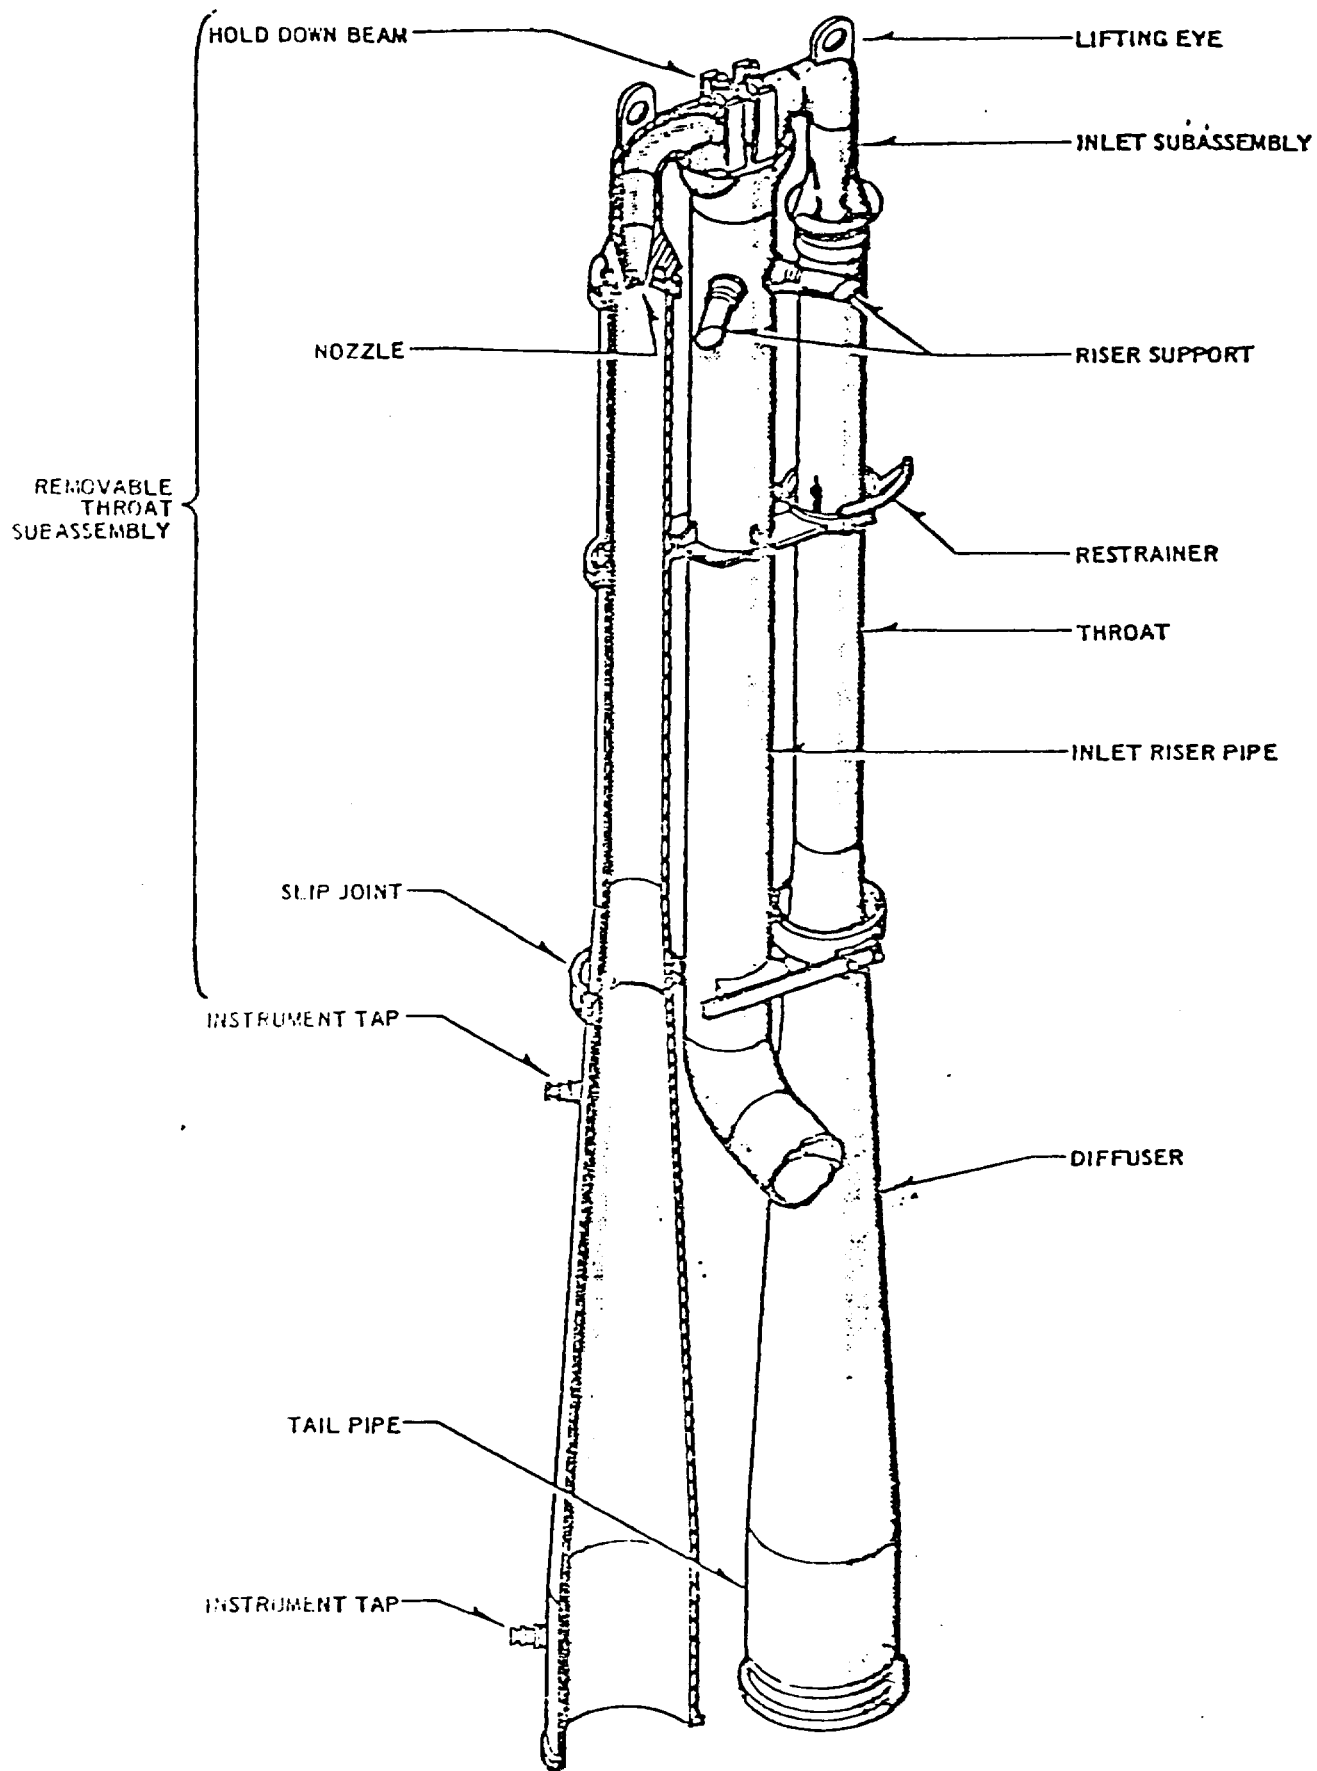
FIG. 1

Following vessel head removal and defueling, TV camera and visual inspections of the jet pumps and vessel annulus revealed the hold-down beam assembly of the suspect jet pump had broken across its ligament sections at the mean diameter of the bolt thread area. Failure of the beam assembly resulted in pump decoupling at the diffuser connection. Subsequent insitu ultrasonic examination of all other jet pump hold-down beams, using a special UT technique developed by General Electric revealed ultrasonic indications of cracking at the same location in 6 of the remaining 19 beams examined. Initial estimates of crack depth ranged from 6 to 20 mils. A sketch of the typical jet pump assembly is shown in figures 1 and 2.

1. Visual inspections assisted by TV camera shall be conducted to assess the integrity of the jet pump structures, the hold-down beam assembly, hold-downs, wedge and restrainer assembly. Particular attention should be given to areas of unusual wear, failed keeper welds or other evidence of distress that could be indicative of loss of beam assembly preload.

2. Ultrasonic examinations, utilizing GE procedure TP-508.0642 (Rev. A) or equivalent, shall be conducted to assess the integrity of the jet pump hold-down beams at the mid length ligament areas bounding the beam bolt.

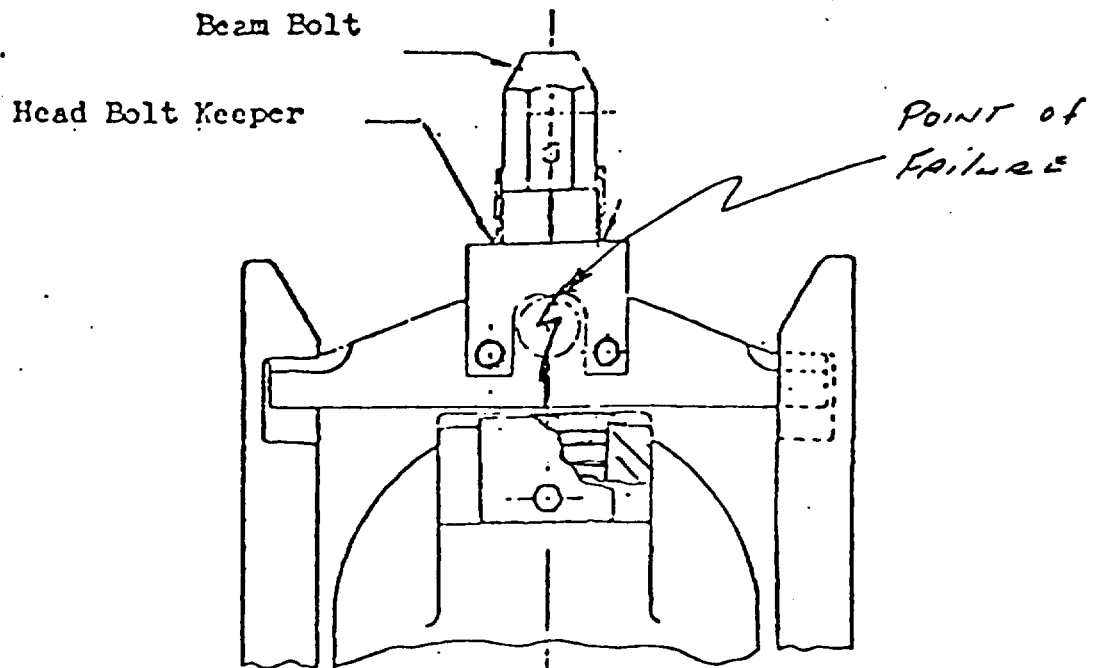
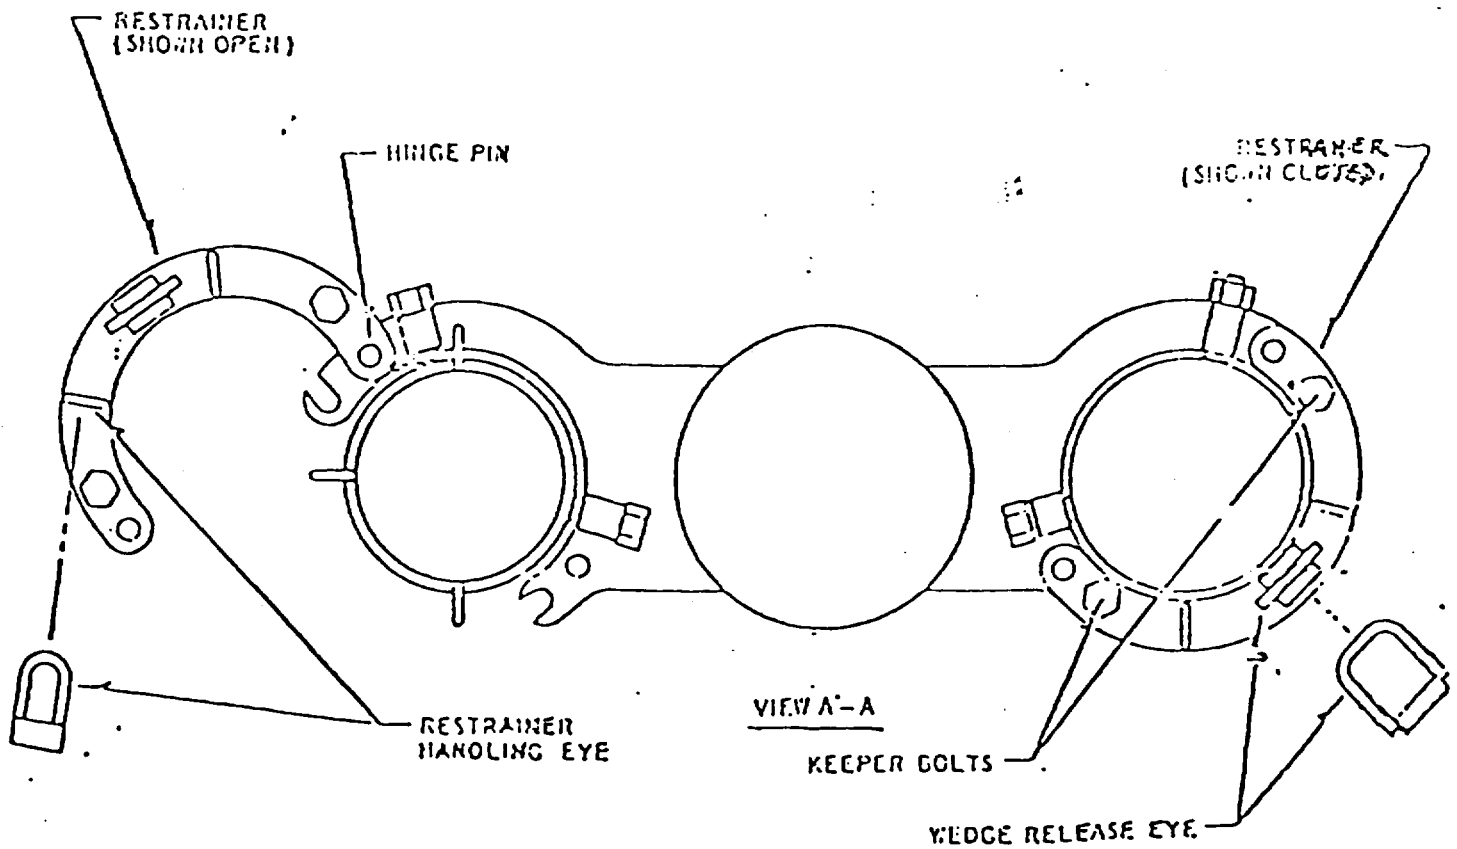
FIG. 2

View B
Jet Pump Beam Details
