PRAIRIE ISLAND NUCLEAR GENERATING PLANT
DOCKET 50-282
LICENSE NO. DPR-42
TRANSMITTAL OF WESTINGHOUSE PRAIRIE ISLAND UNIT 1 – LOWER ROW
TUBE DENT ROOT CAUSE ANALYSIS

**WCAP-16059-NP
Revision 0**

February 2003

Lower Row Tube Dent Root Cause Analysis

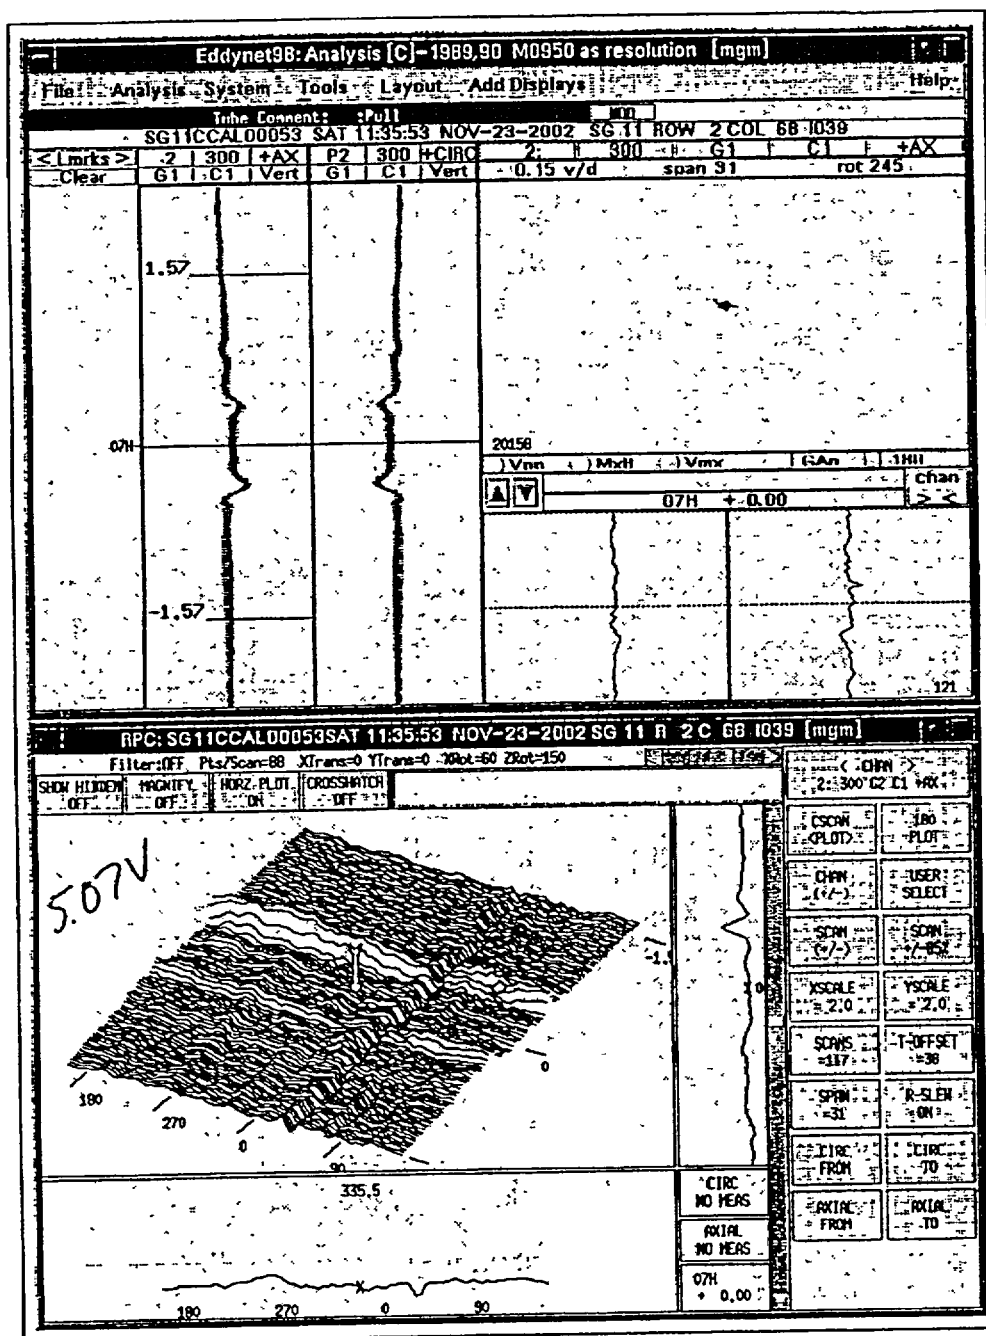
Figure 1 +Pt Eddy Current Response of a Typical Tube

Both bobbin coil and +Pt eddy current inspections were performed during the most recent Fall 2002 outage at Prairie Island Unit 1. During the bobbin coil inspection of the Row 1 and Row 2 tubes, it was determined that some tubes had indications of signals that could be classified as dents. Table 1 contains a summary of tubes found with signals greater than 2 volts near the upper tube support plates. With relatively few exceptions, signals found near TSP 7 are located near the bottom surface of the plate, and signals found near TSP 6 are located near the top surface of the plate. In addition, it was determined that there are 3 tubes with simultaneous indications on both the 6th and 7th tube support plate. All Row 1 and Row 2 tubes, both with and without dent signals, were examined using the +Pt probe as part of the normal small radius U-bend inspection program. Figure 1 contains a typical +Pt response (horizontal component only) for tube R2 C68, SG11, at 07H. A response is noted to extend for nearly 360 degrees around the tube. The vertical component for this tube shows essentially no dent-like response. The design of the +Pt coil minimizes geometry transition influences from uniformly affected conditions, such as expansion transitions at the top of tubesheet. If the bobbin signals truly represent a geometry change in the tube, the +Pt data can be used to judge that the geometry deformation is more uniform around the circumference, and does not mimic geometry patterns observed for more classical denting conditions resultant from corrosion of the carbon steel TSP. The largest of the dent signals was approximately 6 volts by bobbin. For a circumferentially uniform geometry change of approximately 1 mil, bobbin dent signals exceeding 6 volts are expected.
