Re: Turkey Point Unit 3
Docket No. 50-250
Reportable Event: 2003-005-00
Date of Event: March 1, 2003
Disabling Both Auxiliary Feedwater Trains Inadvertently During Mode 3

LICENSEE EVENT REPORT (LER)

Disabling Both Auxiliary Feedwater Trains Inadvertently During Mode 3

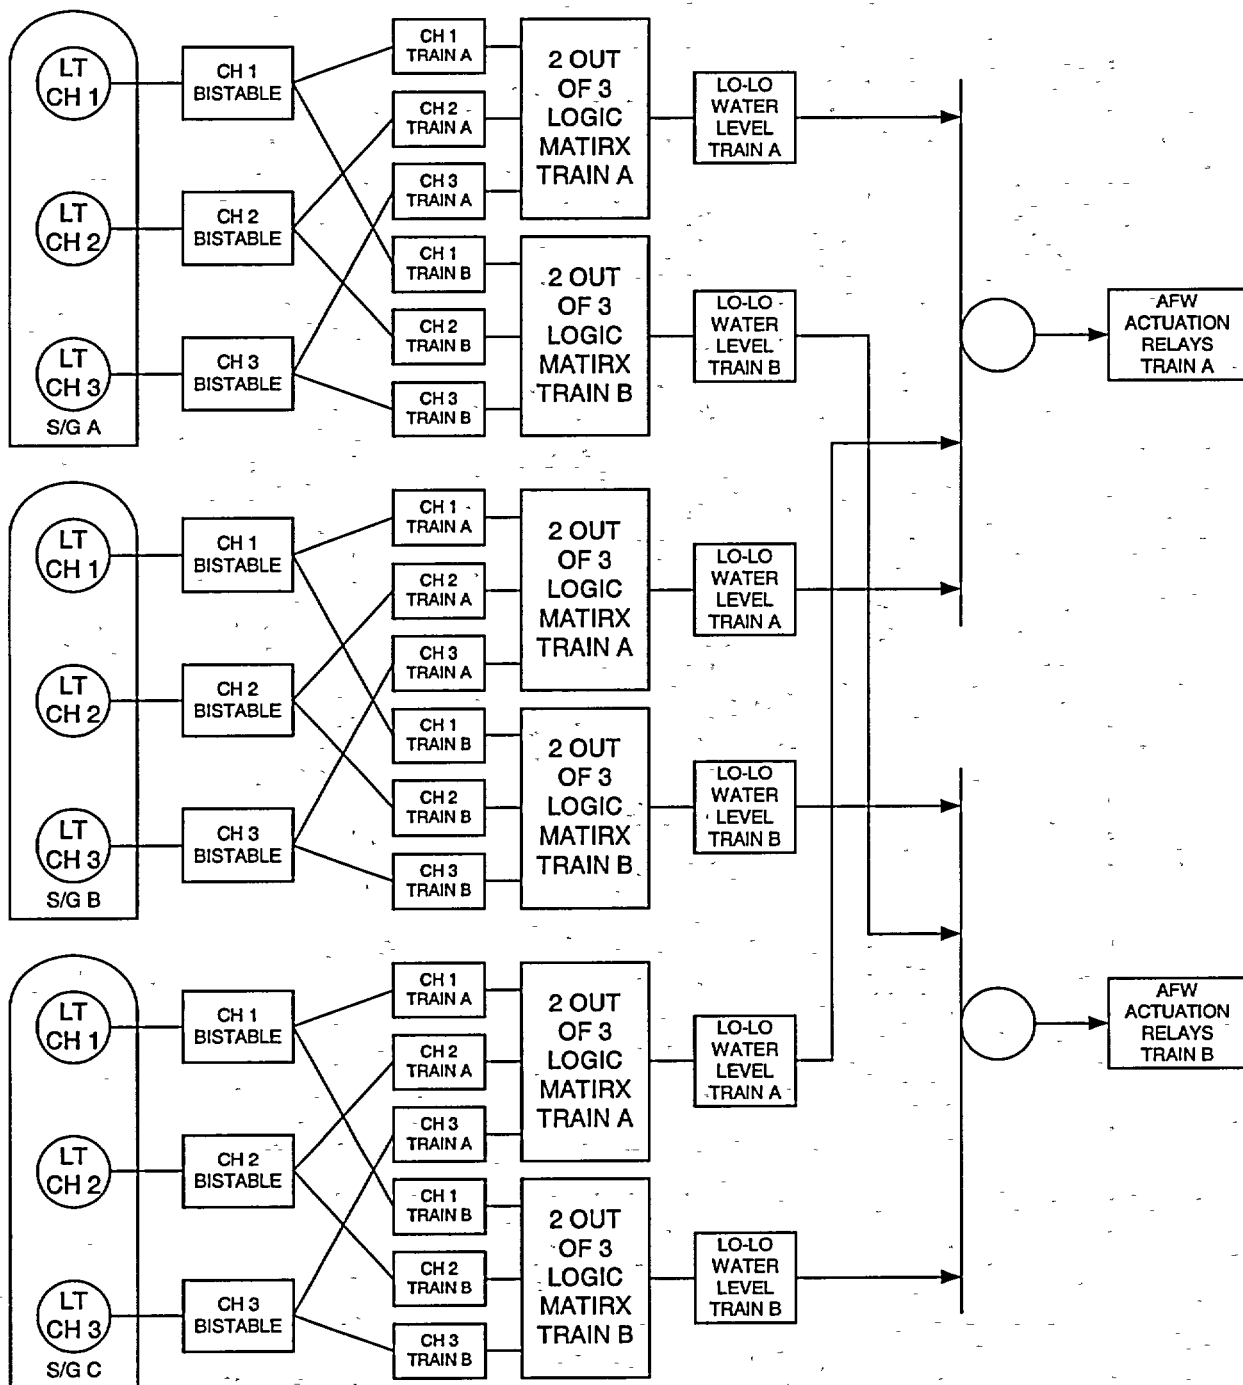
Figure 1

For the low-low Steam Generator water level signal, the actuation of AFW requires that two out of three level transmitters [LT] on a single Steam Generator measure water level below 10%. If this condition occurs, each affected Steam Generator level comparator [CPT] will trip a bistable. The output of these bistables energizes relays in the AFW actuation logic matrix and AFW automatic start actuation relays. The output of the AFW actuation relays provides a start signal to the AFW pump steam admission valves. A simplified diagram, Figure 1; of this process is provided.

STEAM GENERATOR LOW-LOW WATER LEVEL AUXILIARY FEEDWATER ACTUATION

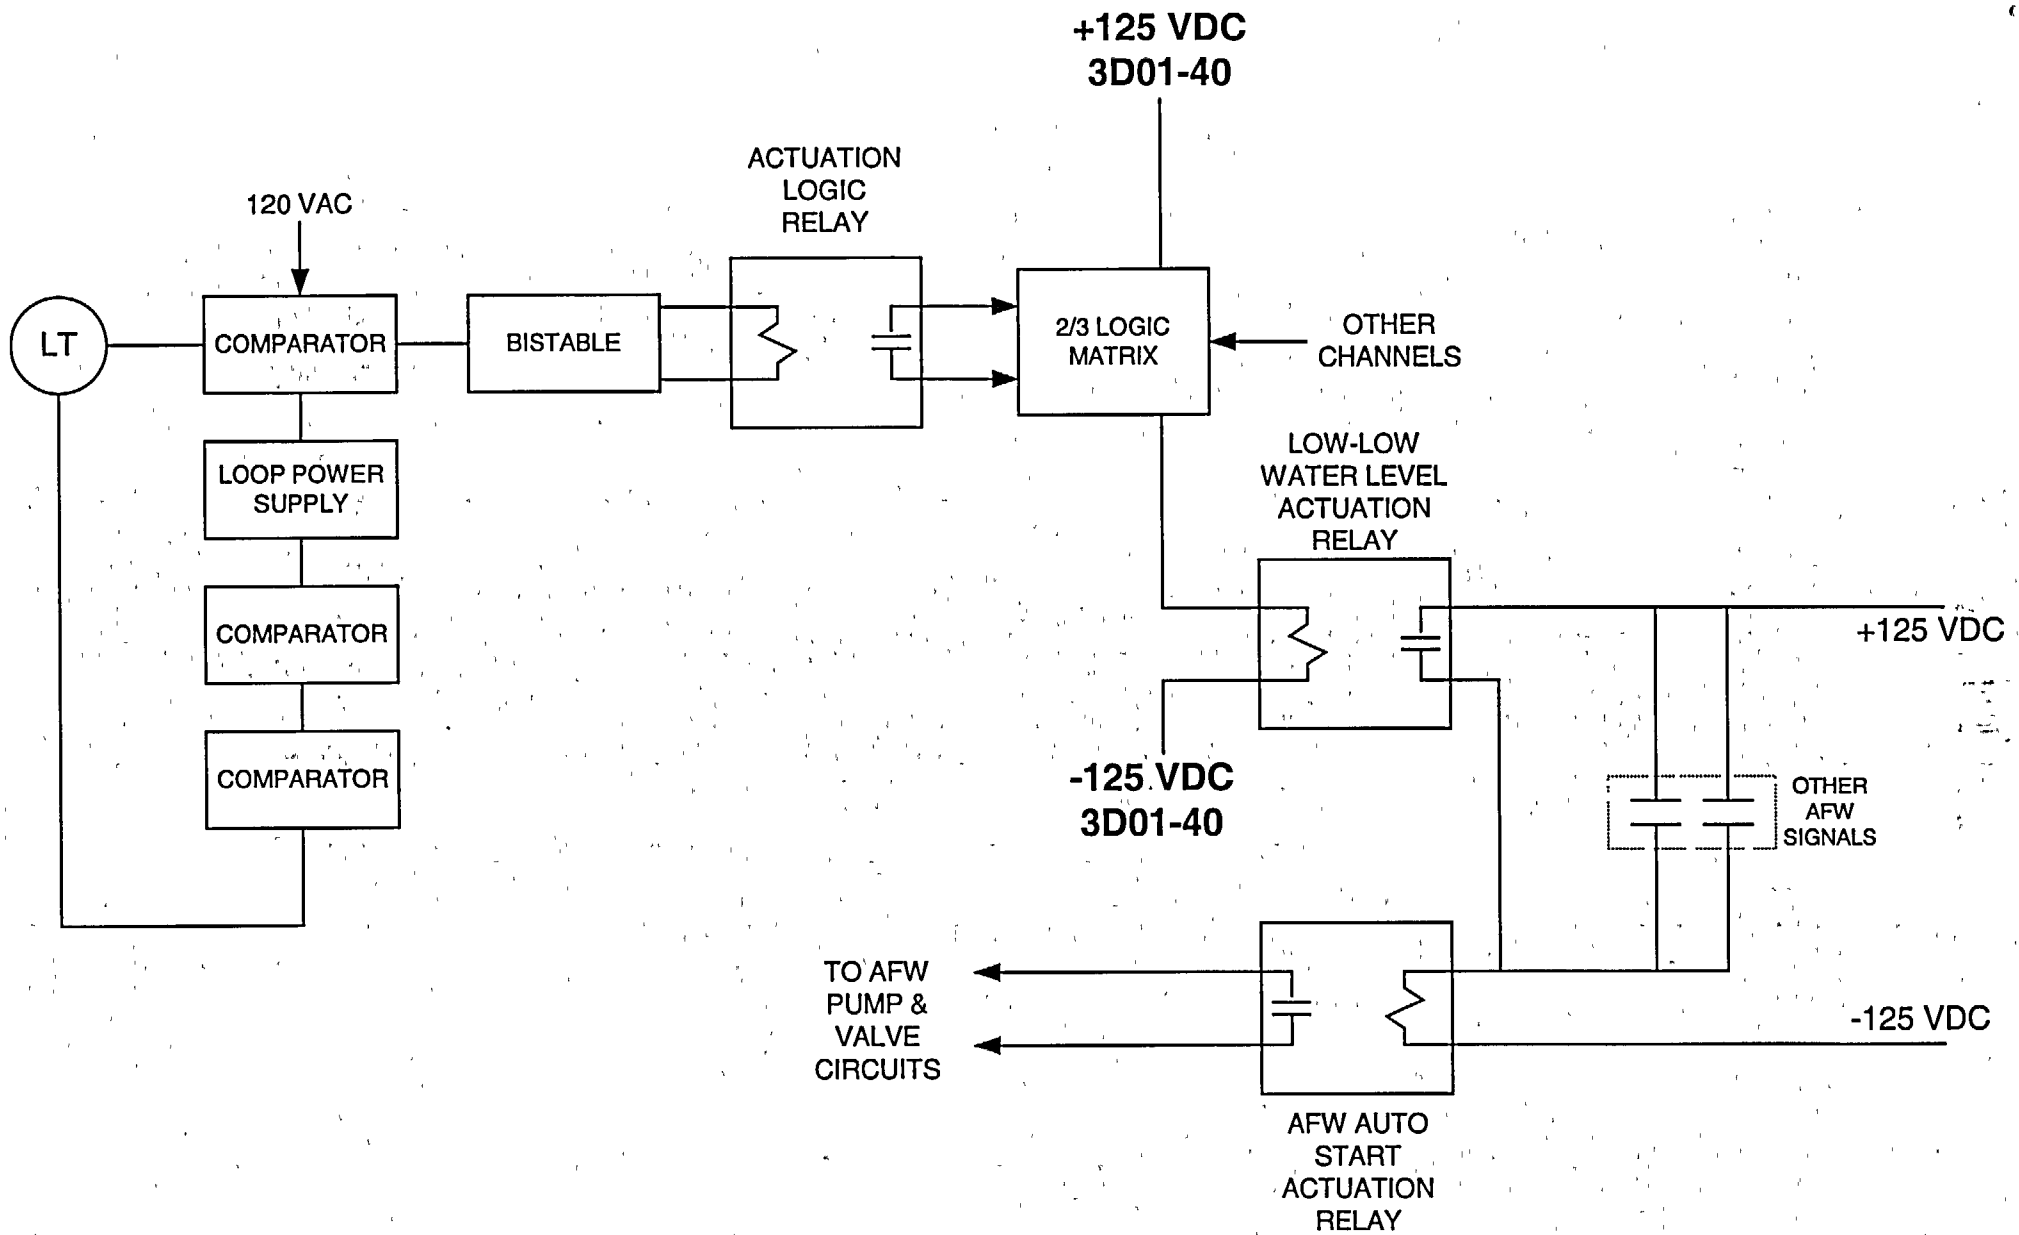
Figure 2
STEAM GENERATOR LOW-LOW WATER LEVEL AUXILIARY FEEDWATER ACTUATION
 LER 2003-005-00 Page 8 of 8

Furthermore, a simplified overview of the Steam Generator low-low water level AFW initiation circuit is provided in the attached sketch, Figure 2. The sketch reflects one transmitter on one Steam Generator and one train of actuation logic and actuation relays. Each of the three Steam Generators has three level transmitters. These nine transmitters are connected to two trains of logic and actuation relays such that the AFW is initiated if a low-low level is sensed on two out of three channels on any Steam Generator.

Technical Specification Table 3.3-2, Item 6 addresses operability requirements for the AFW ESFAS Instrumentation. Item 6.b of Table 3.3-2 is specific to the AFW low-low Steam Generator water level instrumentation. This is considered to encompass the level transmitter, level comparator and bistable. This instrumentation is powered from 120 VAC vital instrumentation power and was not part of the subject clearance. Item 6a of Table 3.3-2 is specific to AFW automatic actuation logic and actuation relays. This is considered to encompass the remainder of relays. As shown in the sketch, the actuation logic relay coil is powered from the 120 VAC vital instrumentation power, which was not part of the subject clearance. The opening of Breaker 3D01-40 removed power from the Train 3A low-low level actuation relays for all three Steam Generators. Breaker 3D23-08 removed power from the Train 3B low-low level actuation relays for all three Steam Generators. As shown in the attached sketch, the opening of the subject breakers only disabled the low-low level actuating relays. Power to

the AFW automatic start actuating relays was not affected by opening the subject breakers. Therefore, only the low-low Steam Generator water level AFW auto start was affected by the subject incident. All other AFW automatic start signals (safety injection, bus stripping, and trip of Last Running Main Feedwater pump, AMSAC) remained available.
