SEQUOYAH NUCLEAR PLANT - UNIT 2 CYCLE 11 (U2C11) 12-MONTH STEAM
GENERATOR (SG) INSPECTION REPORT AND METALLURGICAL EXAMINATION
REPORT ON TUBE REMOVED FROM SG

TENNESSEE VALLEY AUTHORITY
SEQUOYAH NUCLEAR PLANT (SQN) UNIT 2

TUBE EXAMINATIONS FOR THE SUPPORT OF SEQUOYAH UNIT 2 STEAM GENERATORS VOLTAGE-BASED REPAIR CRITERIA

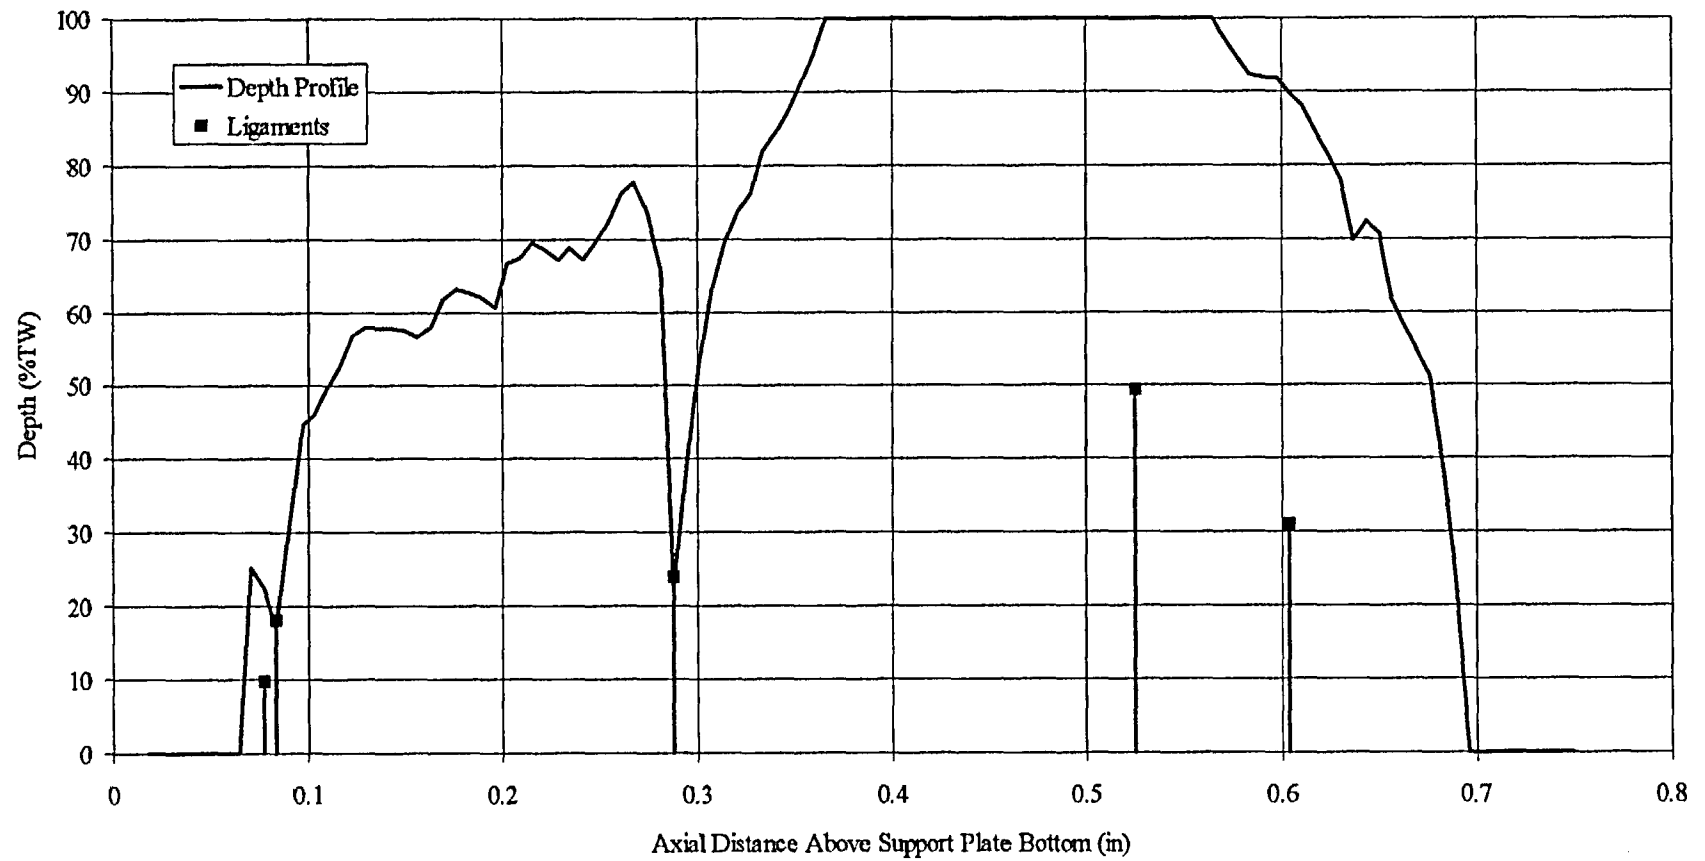
Figure 5-1. TSP1 Left Burst Opening Macrocrack Depth Profile.

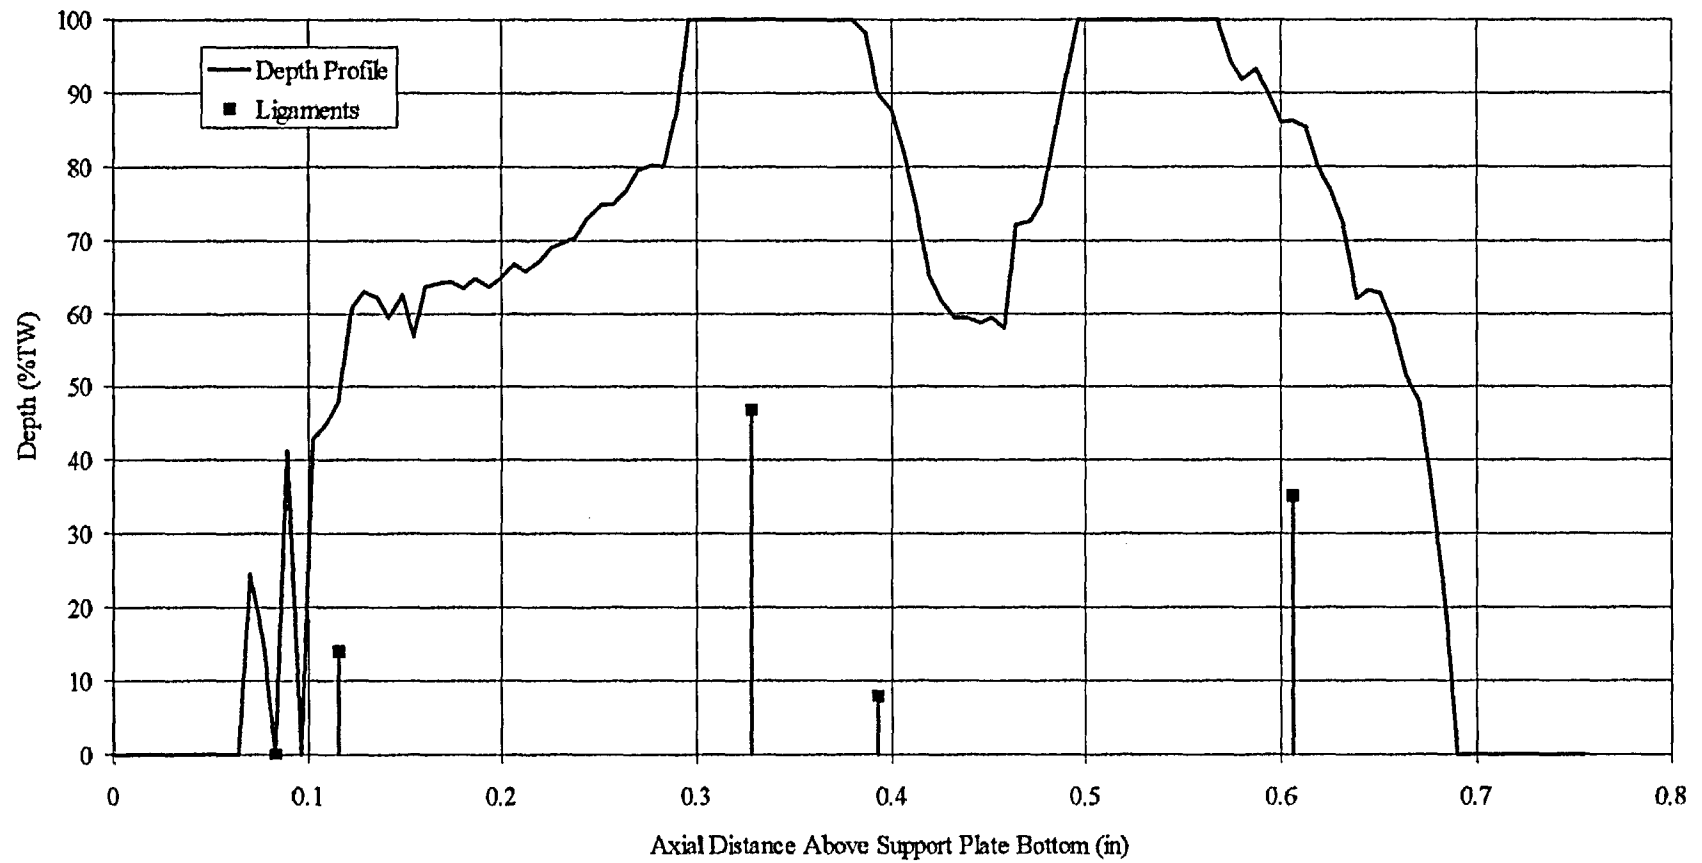
Figure 5-2. TSP1 Right Burst Opening Macrocrack Depth Profile.

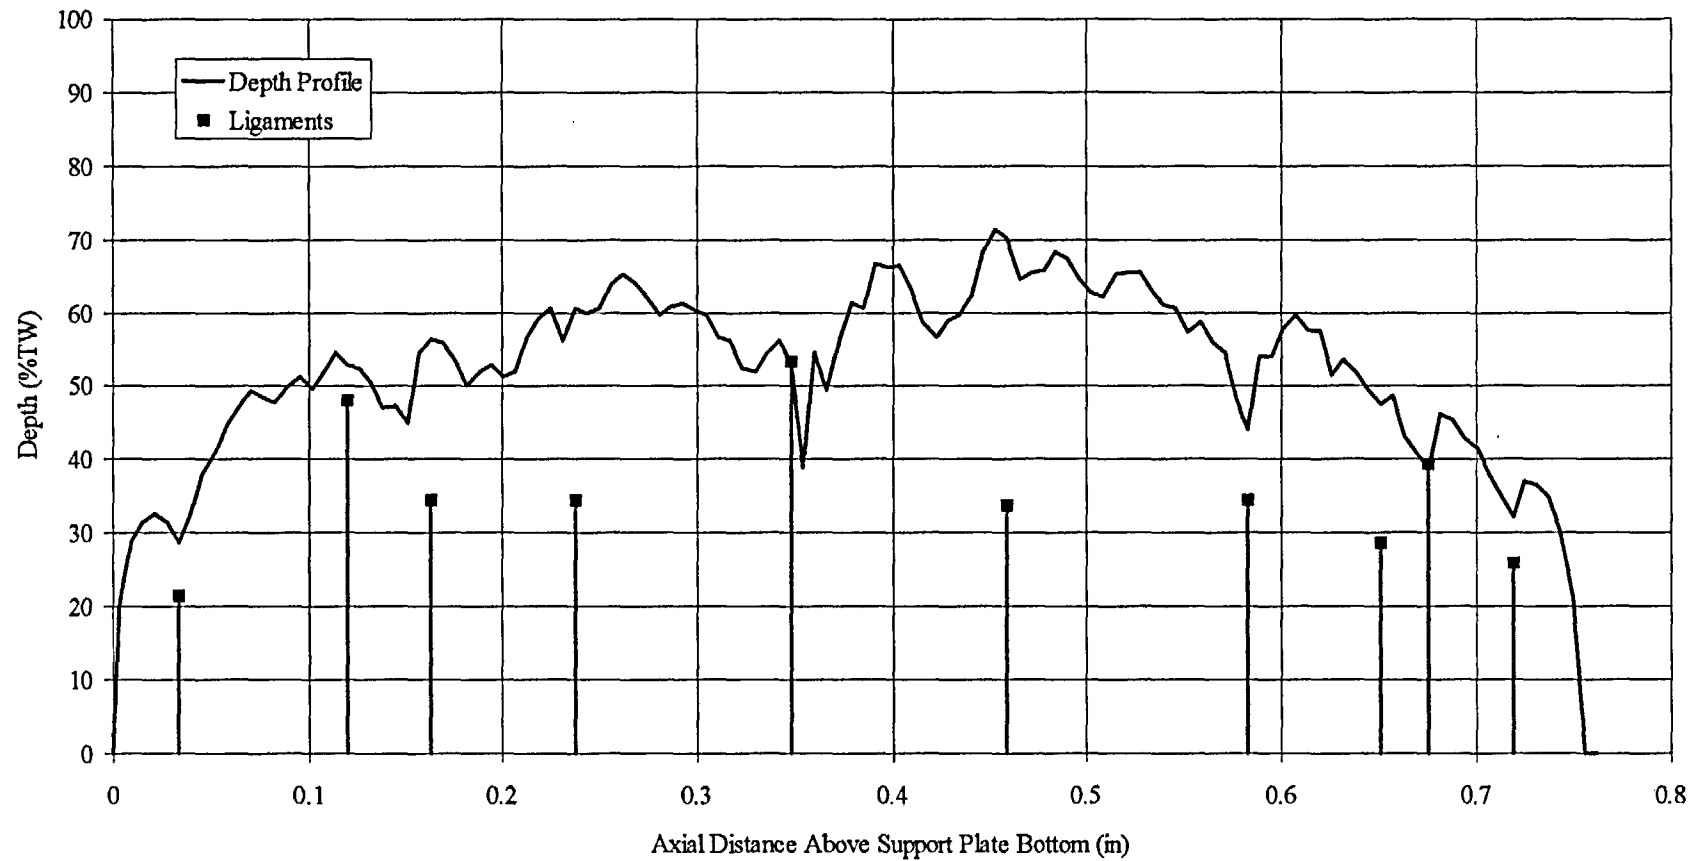
Figure 5-3. TSP2 Burst Opening Macrocrack Depth Profile.

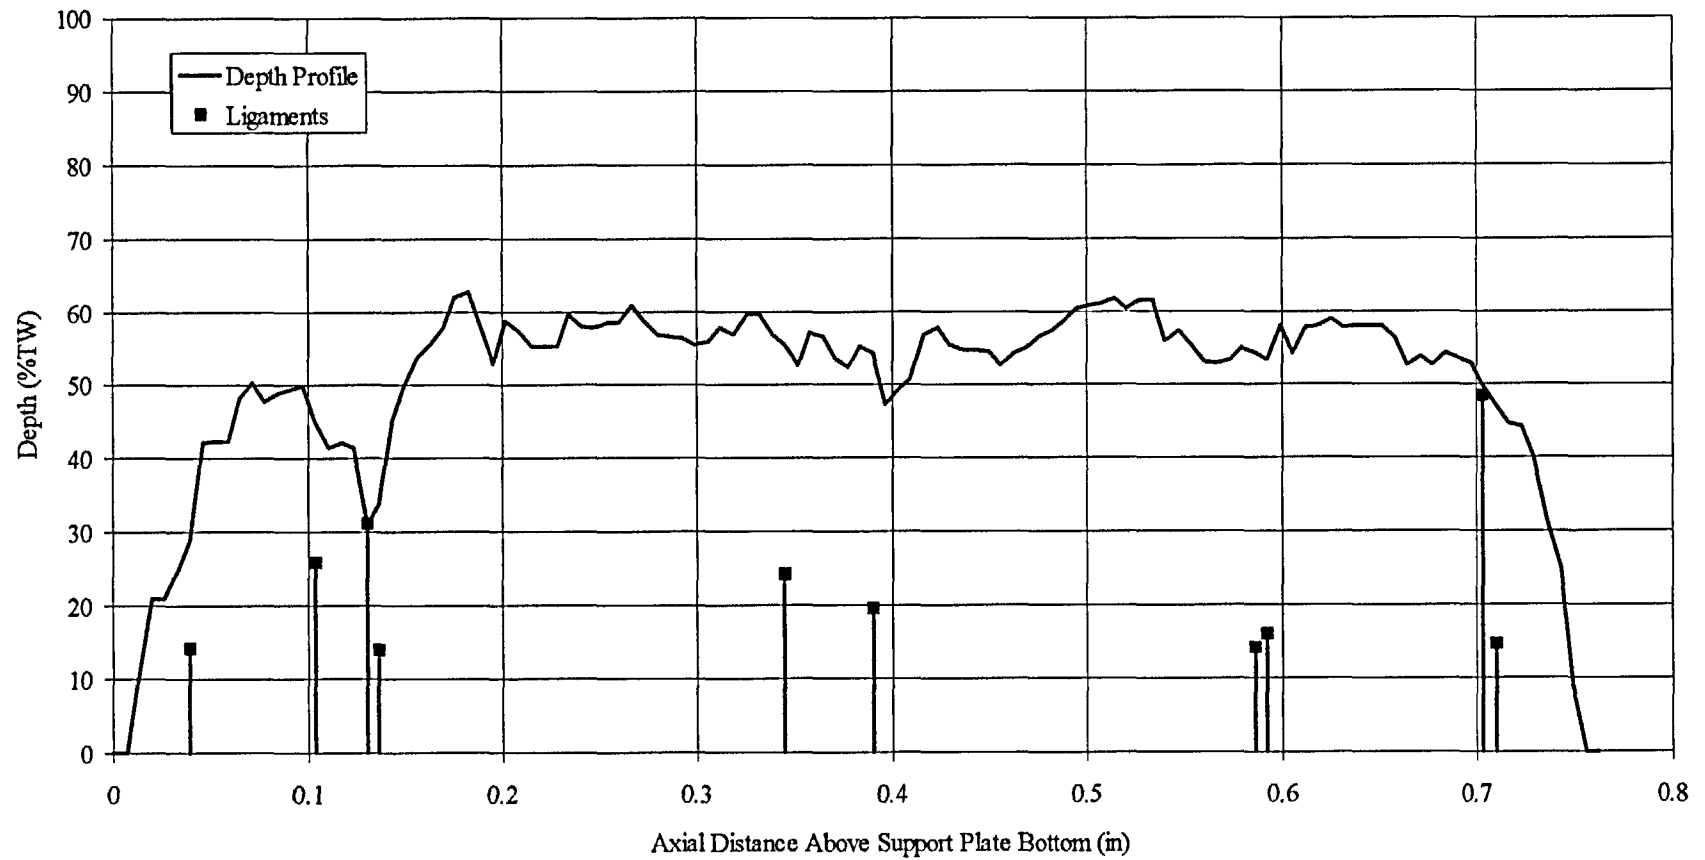
Figure 5-4. TSP3 Burst Opening Macrocrack Depth Profile.

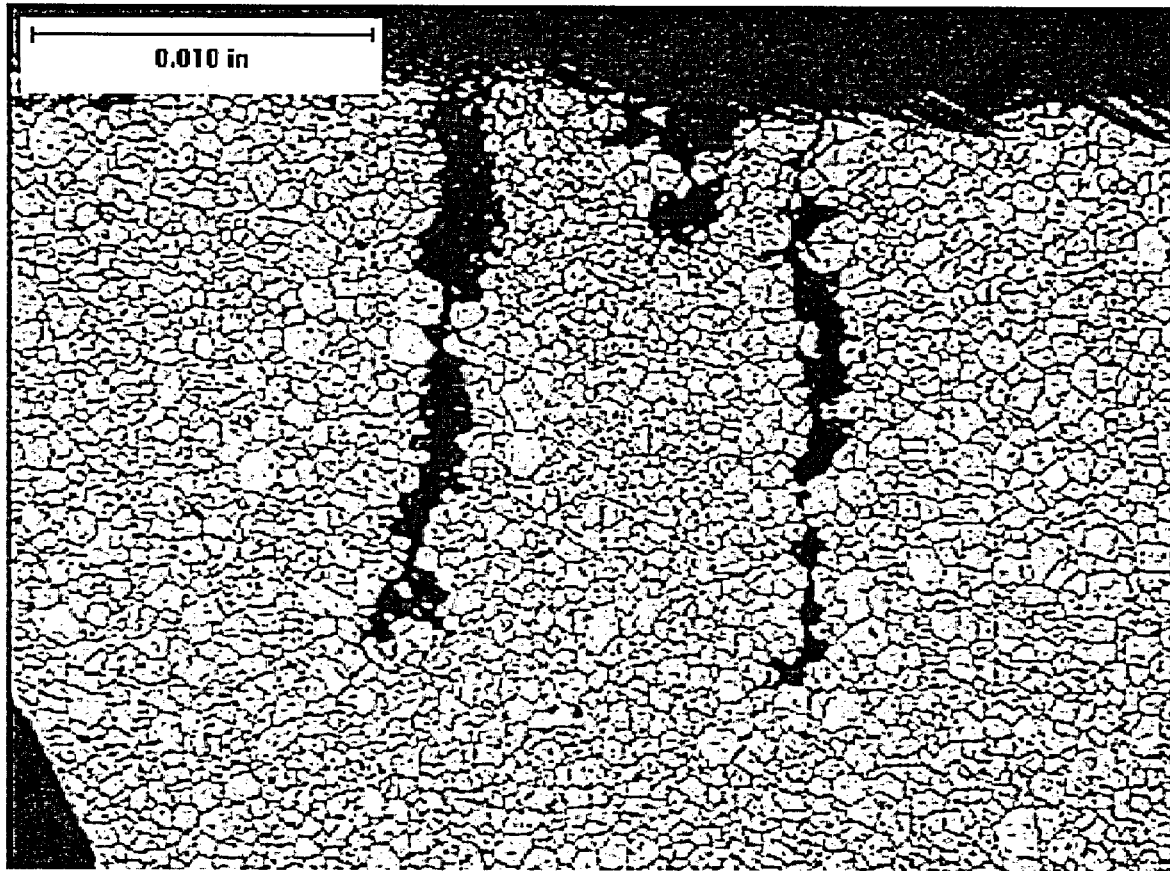
Figure 6-2. Deepest Crack on the TSP1 Transverse Section, Position 1 in Figure 6-1 (Nital Etch).

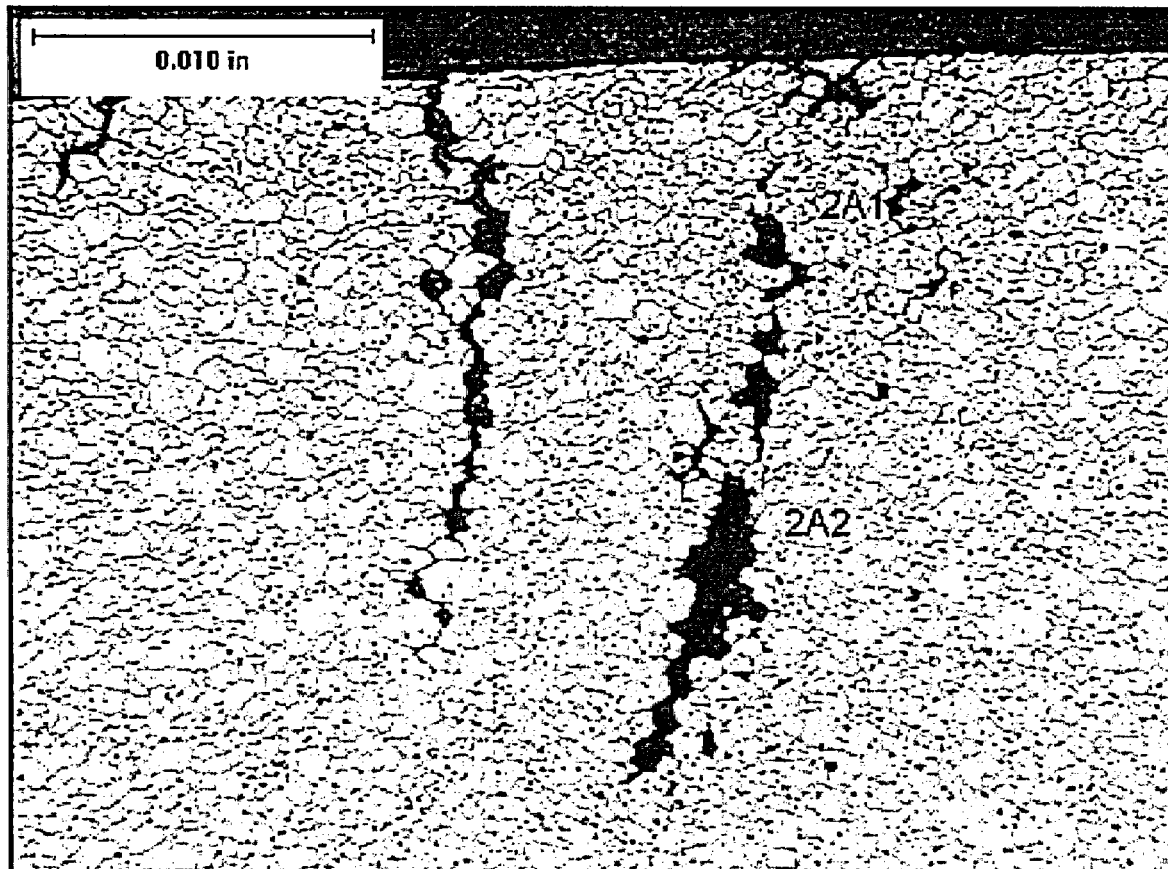
Figure 6-4. Deepest Crack on the TSP2 Transverse Section, Position 2 in Figure 6-3 (Nital Etch).

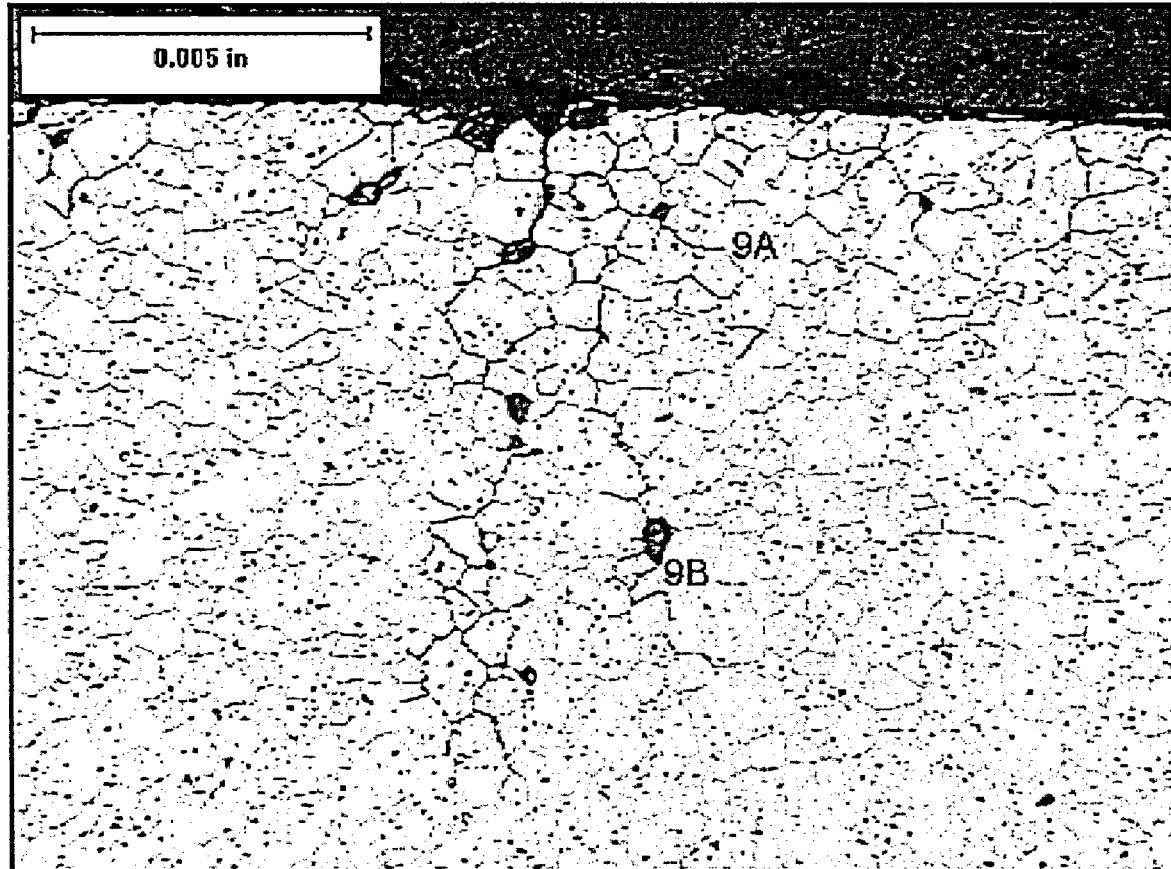
Figure 6-5. Deep IGA on the TSP2 Transverse Section, Position 9 in Figure 6-3 (Nital Etch).

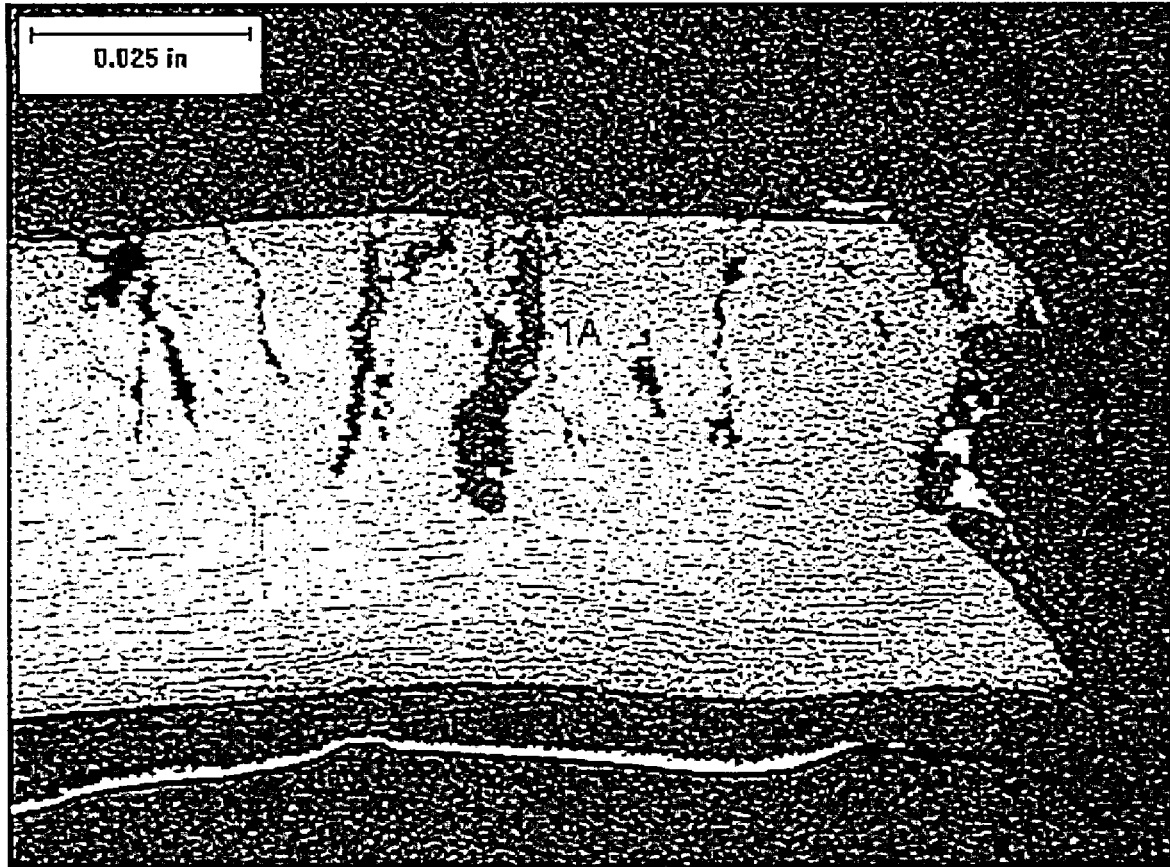
Figure 6-6 presents the unetched view of the entire sample. The OD initiated cracks were found at each of the seven positions examined. Figure 6-7 shows the deepest of the cracks that were found on this sample (taken from position 1, after etching). The deepest crack on this sample was 69%TW. This is deeper than the maximum depth measured from the SEM depth profile of the burst opening. Figure 6-7 shows that the IGSCC cracks had no or few branches at the deeper locations; however the region around the cracks were surrounded by shallow (~10%TW) IGA. The post-burst visual observations characterized this region as having some patches of cellular corrosion. It is likely that the cellular corrosion that was observed visually was actually the shallow IGA. The cracking at the TSP3 region can be characterized as relatively shallow IGA with deeper IGSCC penetrations.

Figure 6-7. Deepest Crack at TSP3, Position 1 in Figure 6-6 (Nital Etch).

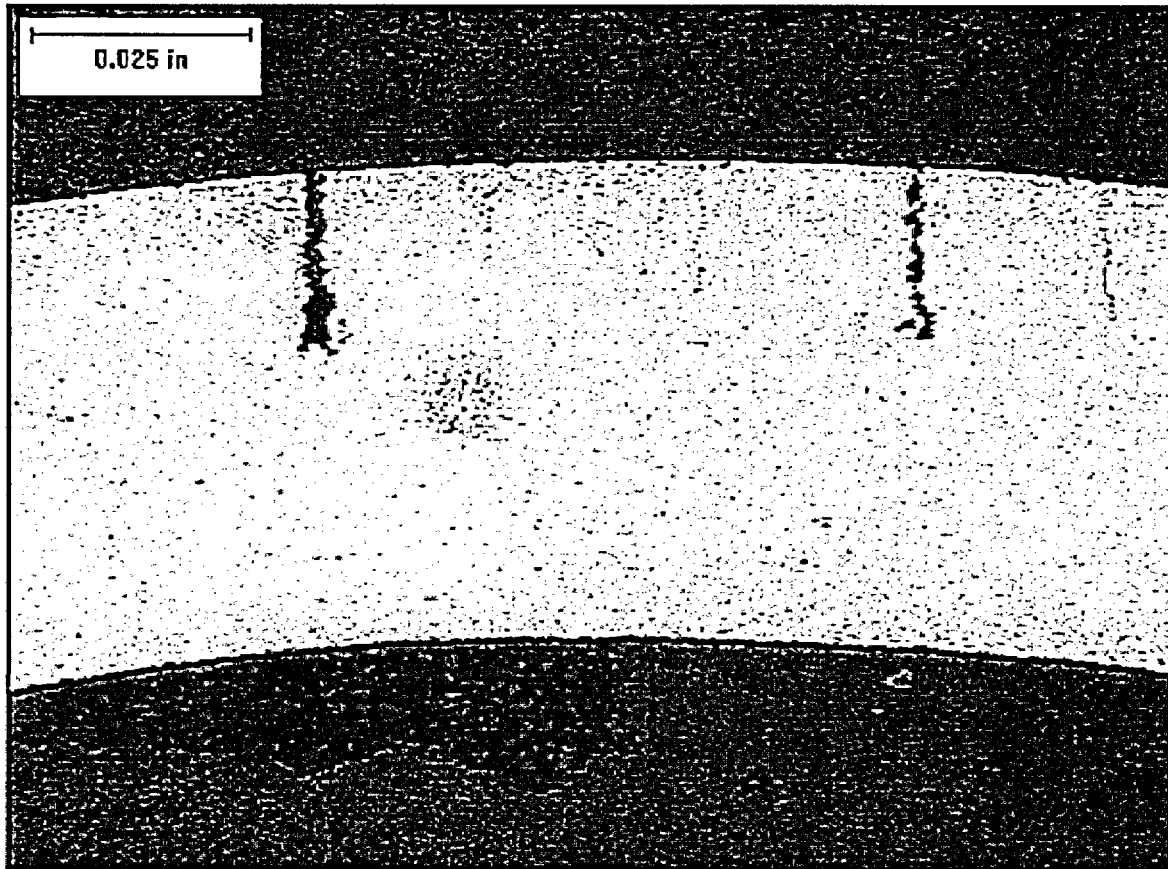
Figures 6-8 and 6-9 show the scratch cracks located at positions 6 and 7, respectively. The scratch crack at position 6 is 42%TW, the one at position 7 is 24%TW. Figure 6-10 presents a close-up of the position 6 scratch crack at the OD surface. At the OD surface grains, there is possible evidence of elongated grains; however these are less than a typical (non-elongated, Sequoyah-2 tube R12C45) grain deep. Elongated grains would result from an installation scratch and the cold working of the surface may serve as an initiation site for IGSCC.

Figure 6-8. Scratch Crack, Position 6 in Figure 6-6 (Nital Etch).

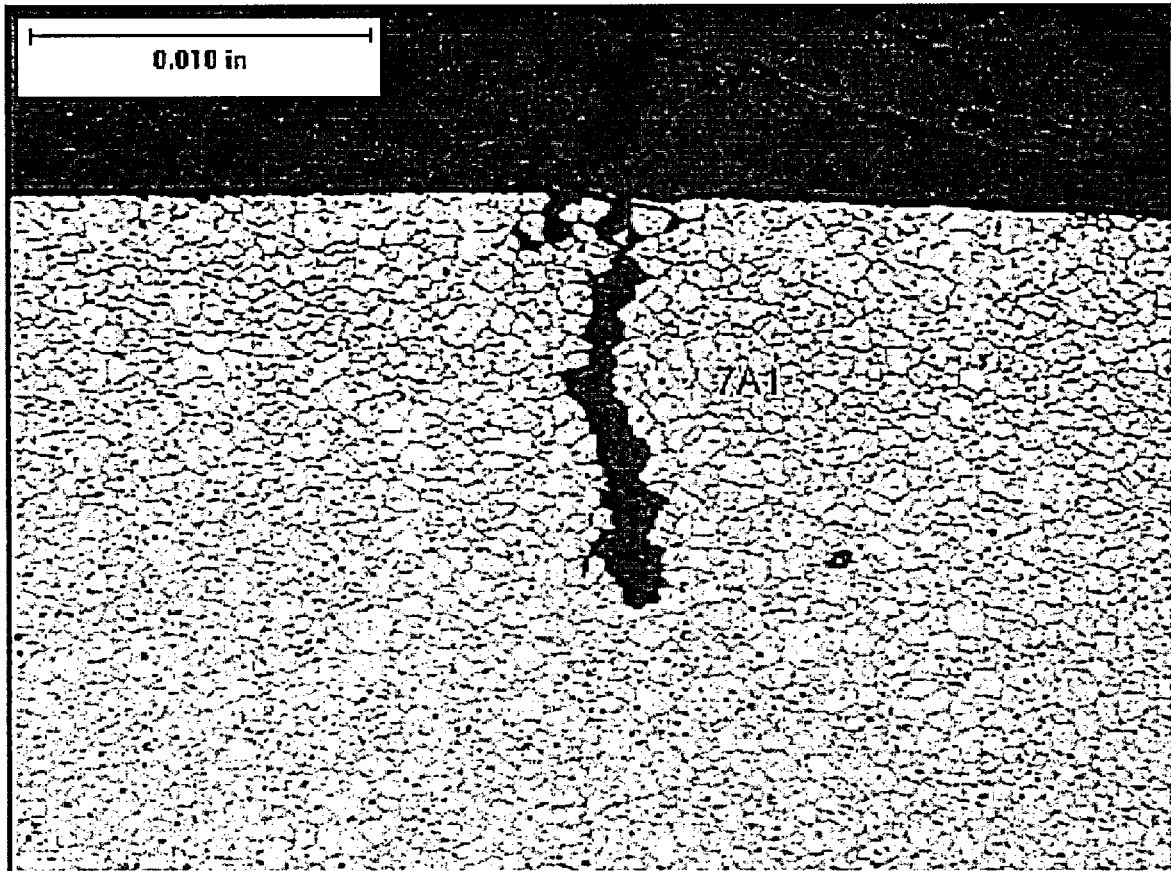
Figure 6-9. Scratch Crack, Position 7 in Figure 6-6 (Nital Etch).

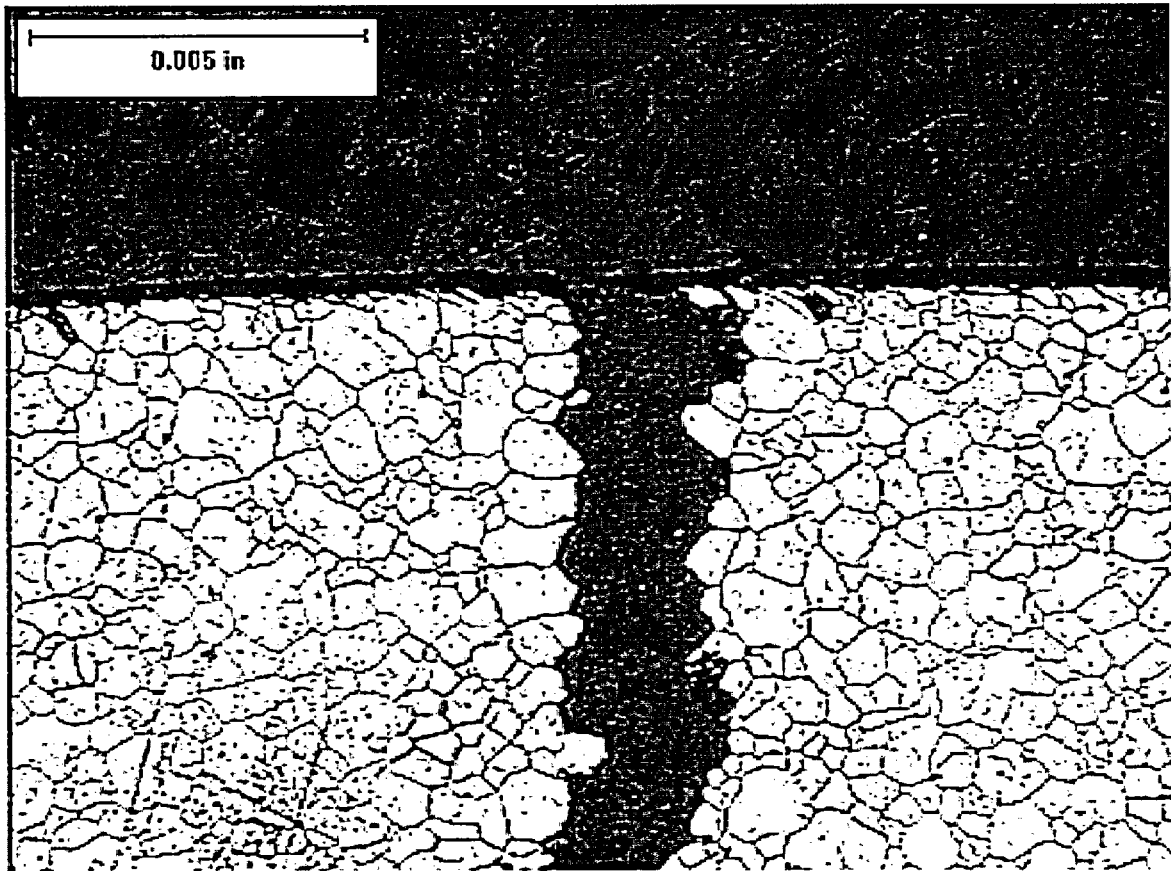
Figure 6-10. Close-Up of Position 6 Scratch Crack (Nital Etch).
