Analysis of Rail Car Components Exposed to a Tunnel Fire Environment

A.S. Garabedian, P.E.¹, D.S. Dunn² and A.H. Chowdhury²

Southwest Research Institute

May 8, 2003

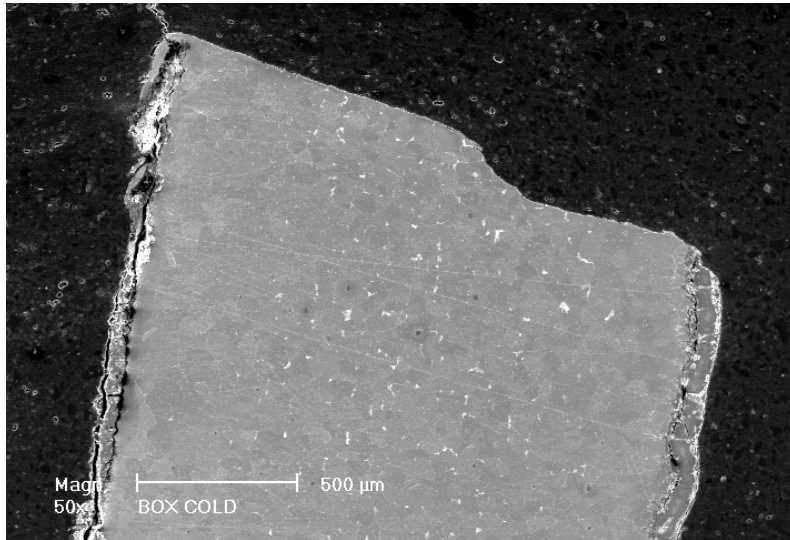
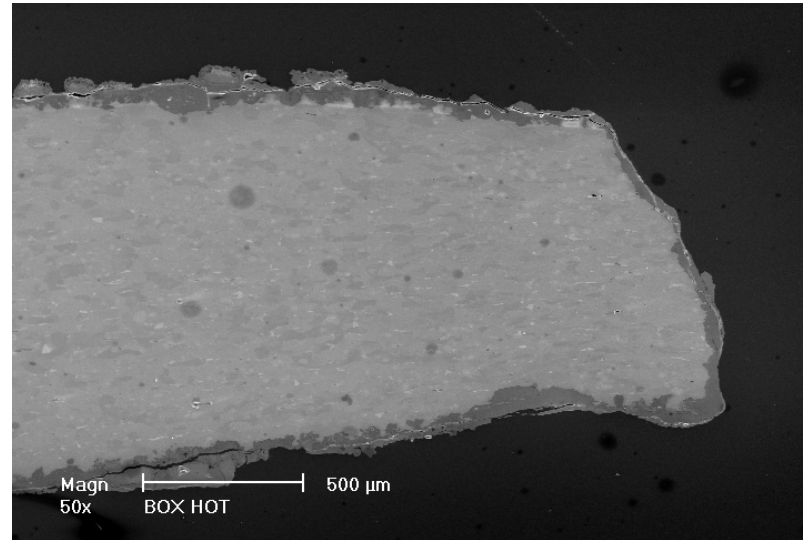
- Sections of Roof of Rail Car 50
- Thickest section: 1,761 micrometers [0.069 in]
- Thinnest section: 829 to 930 micrometers [0.033 to 0.037 in]
- Metal Loss: 148 to 466 micrometers [0.006 to 0.018 in]
4 hours at 750 to 850 °C [1,382 to 1,562 °F]
- Secondary Paper Fire

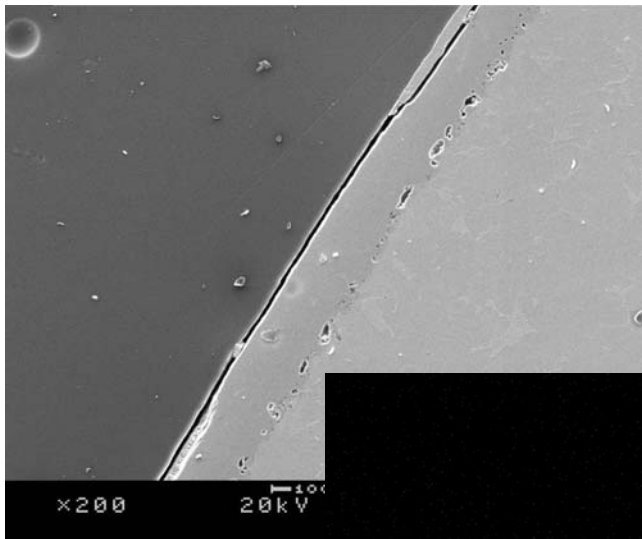
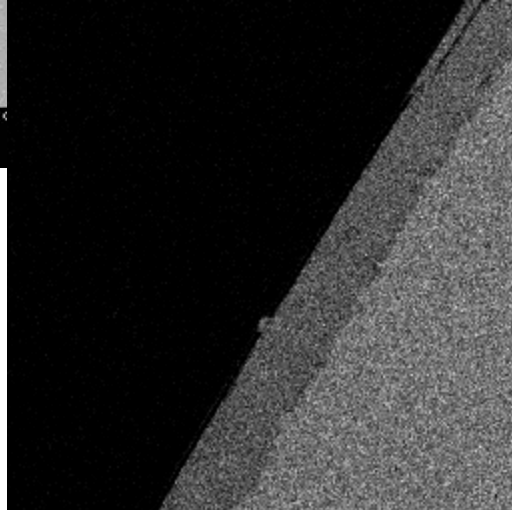
Secondary
Electron
Image

- Oxide layer on steel bolt found on air brake valve of Rail Car 52
- Aluminum Air Brake Valve Cover melted as a result of the fire
- Oxide layer thickness 53 micrometers [0.0021 in] with no evidence of spalling
- Oxide could be expected from an exposure at 627 °C [1,160 °F] for 4 hours

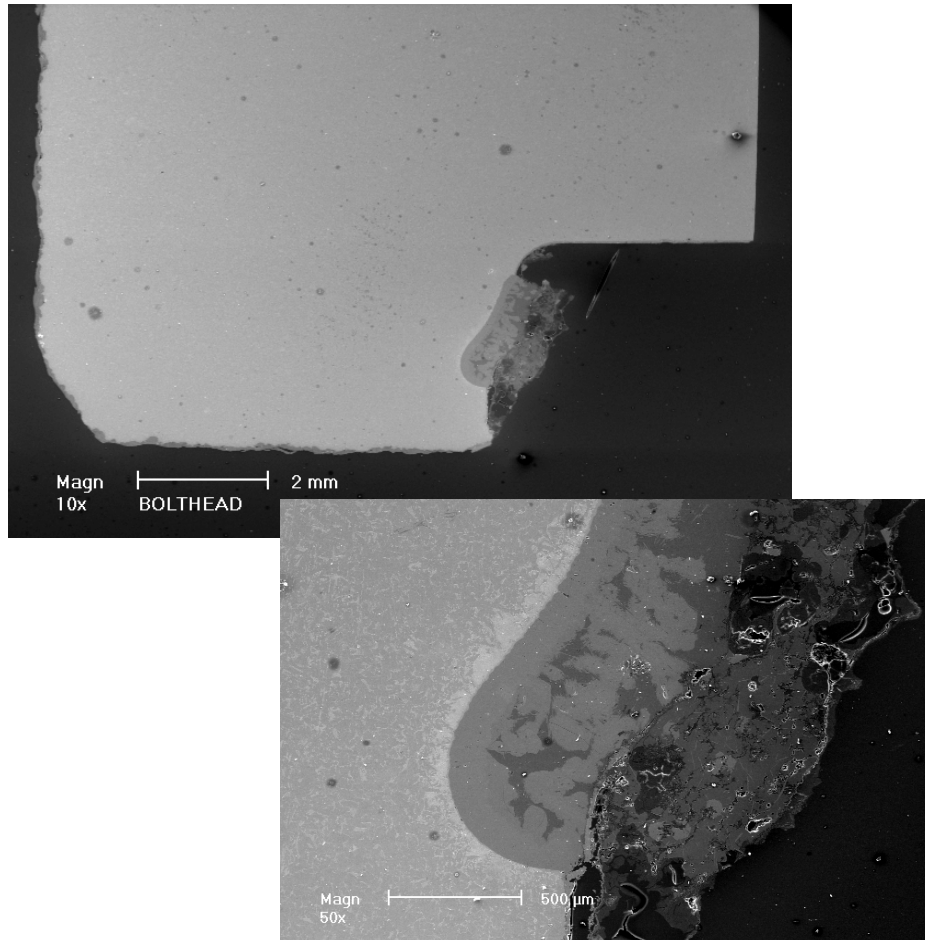
- Small Area of an observed phase on the underside of one ABDX Brake valve
66Al-4Si-30Fe (atomic percent)
- Composition not likely to have been formed by melting or diffusion

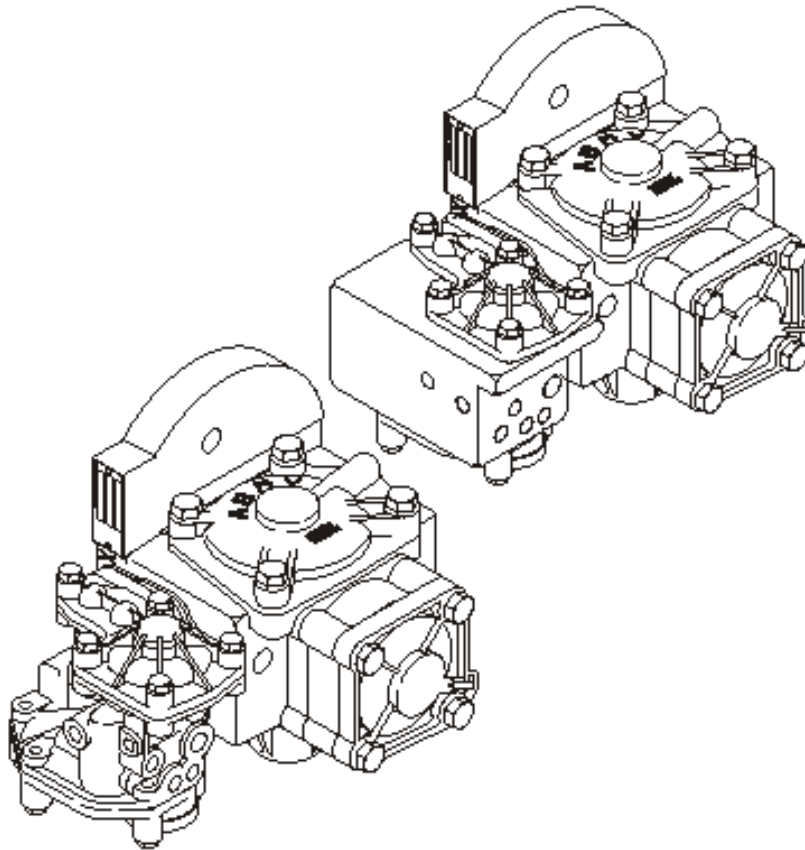
- Air brake valves used on rail cars
- Cast iron valve body with aluminum covers
- Aluminum covers located 10 m [33 ft] from fire source melted
- Aluminum melting temperature 600 °C [1,112 °F]

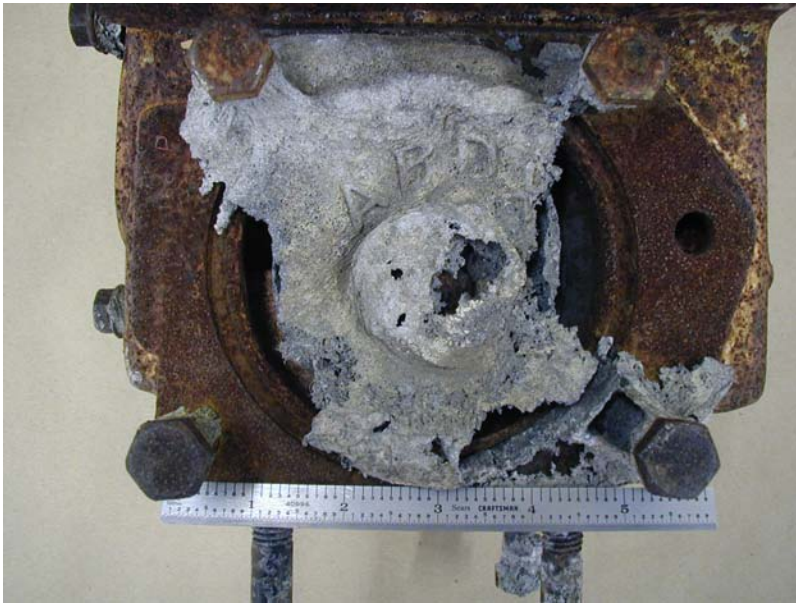
Aluminum covers from ABDX valve from Car 52

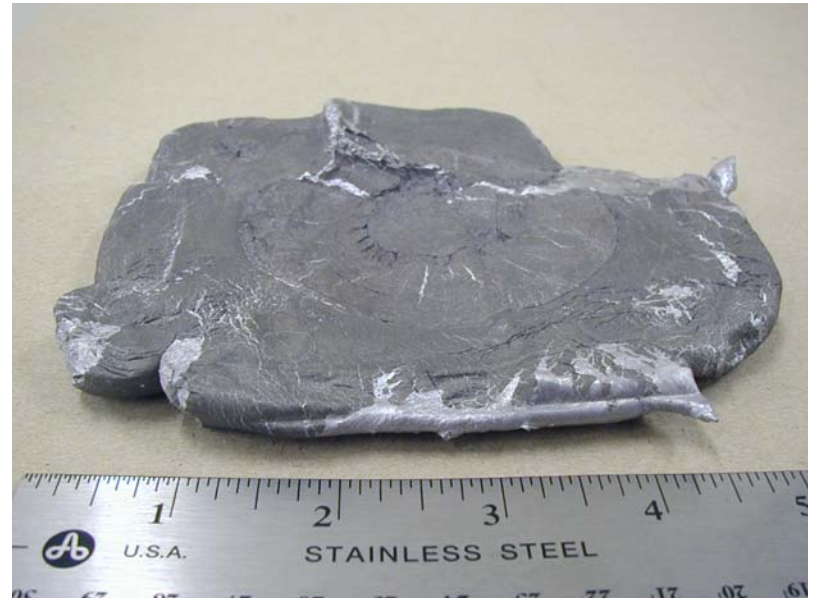
Melted in a little over 6 min

New aluminum cover for ABDX valve after testing

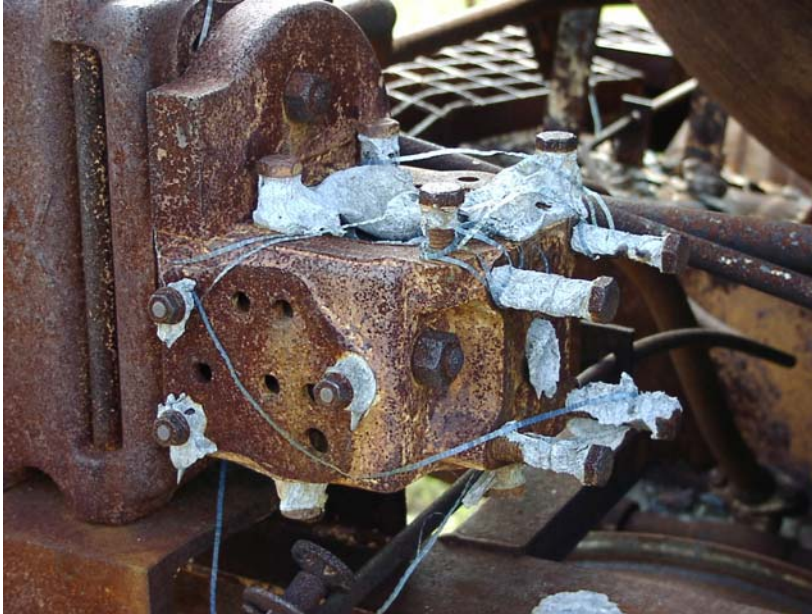
Air brake valve on Rail Car 52
located approximately 10 m [33 ft]
from fire source

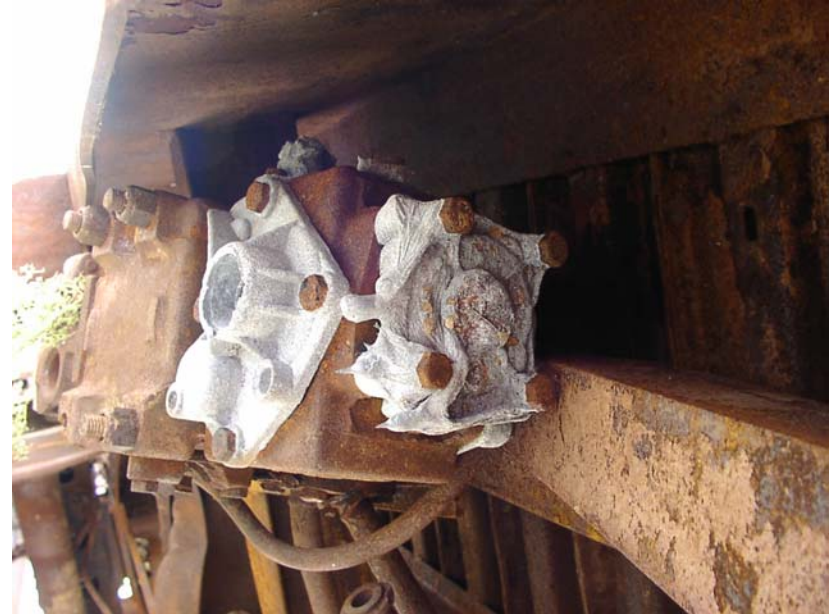
Air brake valve on Rail Car 51
located approximately 20 m [66 ft]
from fire source
