SUMMARY OF CONFERENCE CALL
WITH
EXELON NUCLEAR
REGARDING STEAM GENERATOR INSPECTION RESULTS
AT BRAIDWOOD UNIT 1

On April 25, 2003, the U.S. Nuclear Regulatory Commission (NRC) staff participated in a conference call with Exelon Nuclear (Exelon, the licensee) representatives regarding the steam generator (SG) tube inspection activities at Braidwood Unit 1 during the ongoing 10th refueling outage, 1R10.

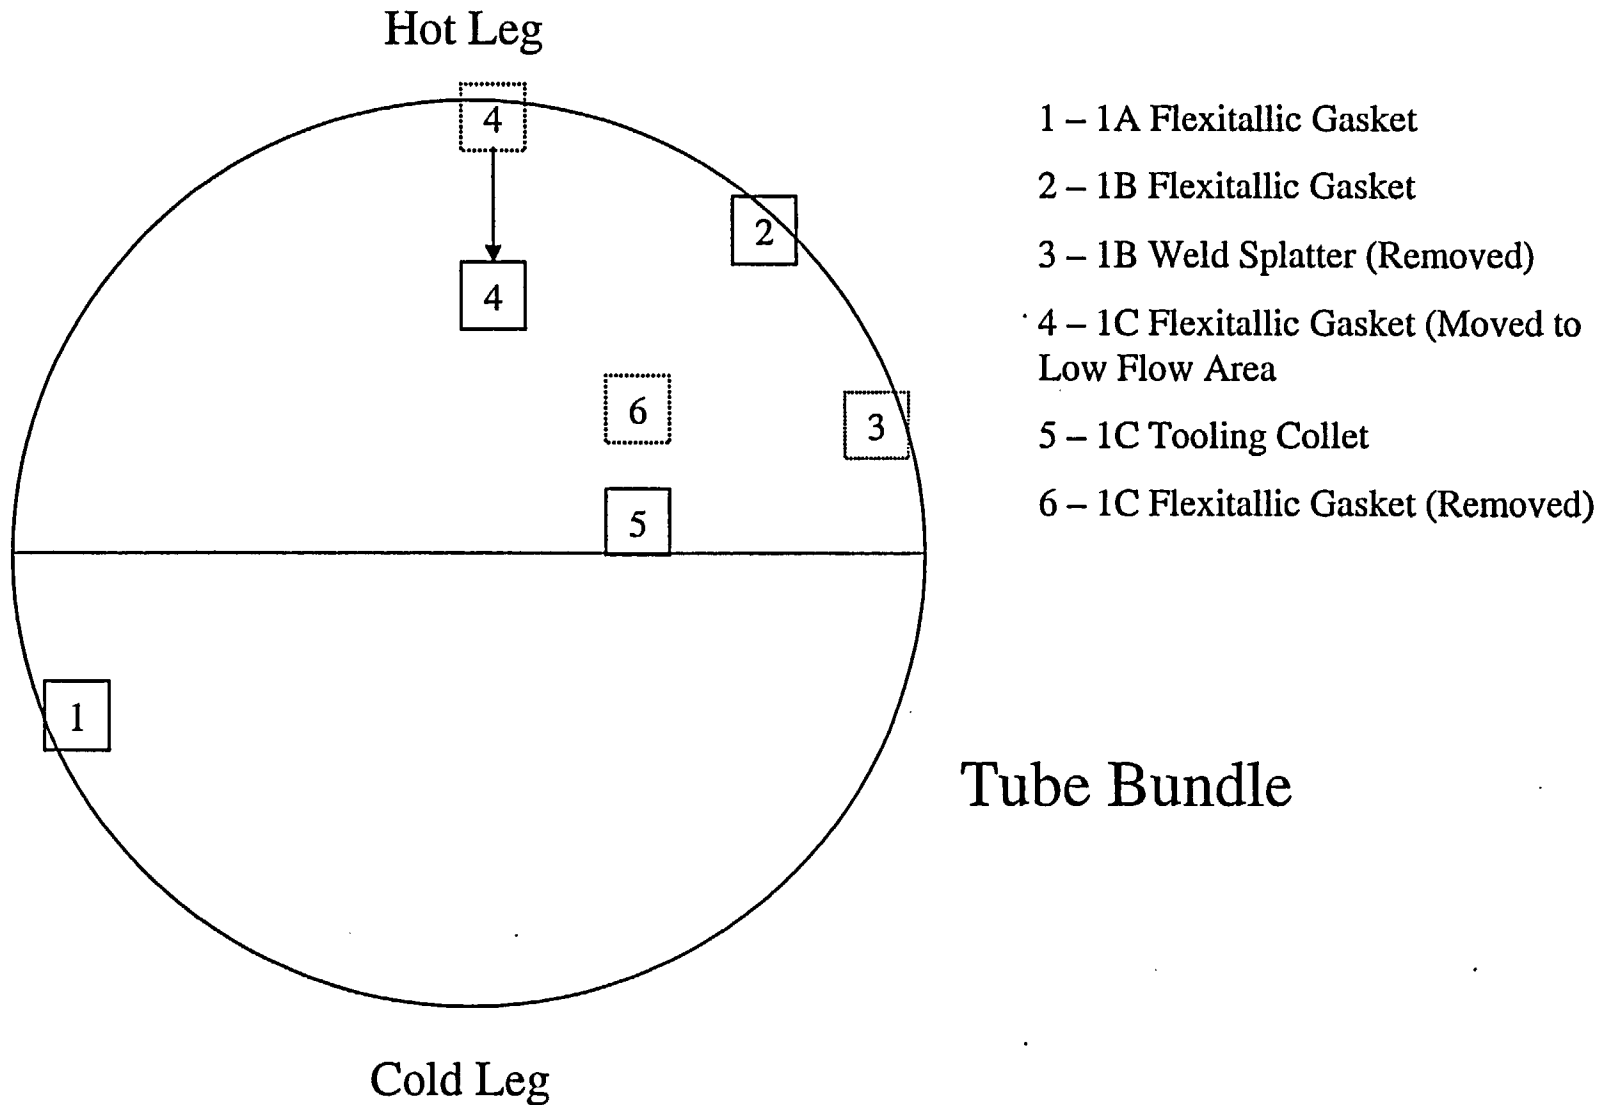
General Location of Objects

- One foreign object was identified near the top of the tubesheet on the periphery of the hot leg side. It was determined to be a piece of flexitallic gasket and could not be retrieved because it was fixed in-place. The gasket was 1.6 inches long, 0.12 inches wide and 0.12 inches deep. This object was not detected in the eddy current data from the bobbin probe inspection, which the licensee believes is because the flexitallic gasket is a small piece of stainless steel material which is not readily visible on eddy current.

- The second foreign object in SG B was identified near the top of the tubesheet on the periphery of the hot leg side. It was determined to be a piece of weld splatter and was removed. The object was oval and was 2.0 inches long, 1.25 inches wide and 0.062 inches deep.

- One foreign object was identified near the top of the tubesheet on the periphery of the hot leg side. It was determined to be a piece of flexitallic gasket which could not be retrieved. However, the licensee was able to move the foreign object in-bundle to a low flow area, and the licensee determined it would not be expected to cause wear in this location. The gasket was 0.75 inches long, 0.1 inches wide and 0.1 inches deep.

- A second foreign object was identified in-bundle near the top of the tubesheet on the hot leg side. It was determined to be a piece of flexitallic gasket which was retrieved. The gasket was 1.25 inches long and 0.063 inches deep.
- Another foreign object was introduced to the SG during the current refueling outage when a tooling collet fell off the loose part retrieval equipment and became lodged between three tubes in-bundle on the hot leg side of the SG. All three tubes surrounding the object were plugged and stabilized.
- Several indications of wear, all less than 10 percent throughwall, were identified at lattice grid and fan bar intersections. The tubes with these indications were left in service.

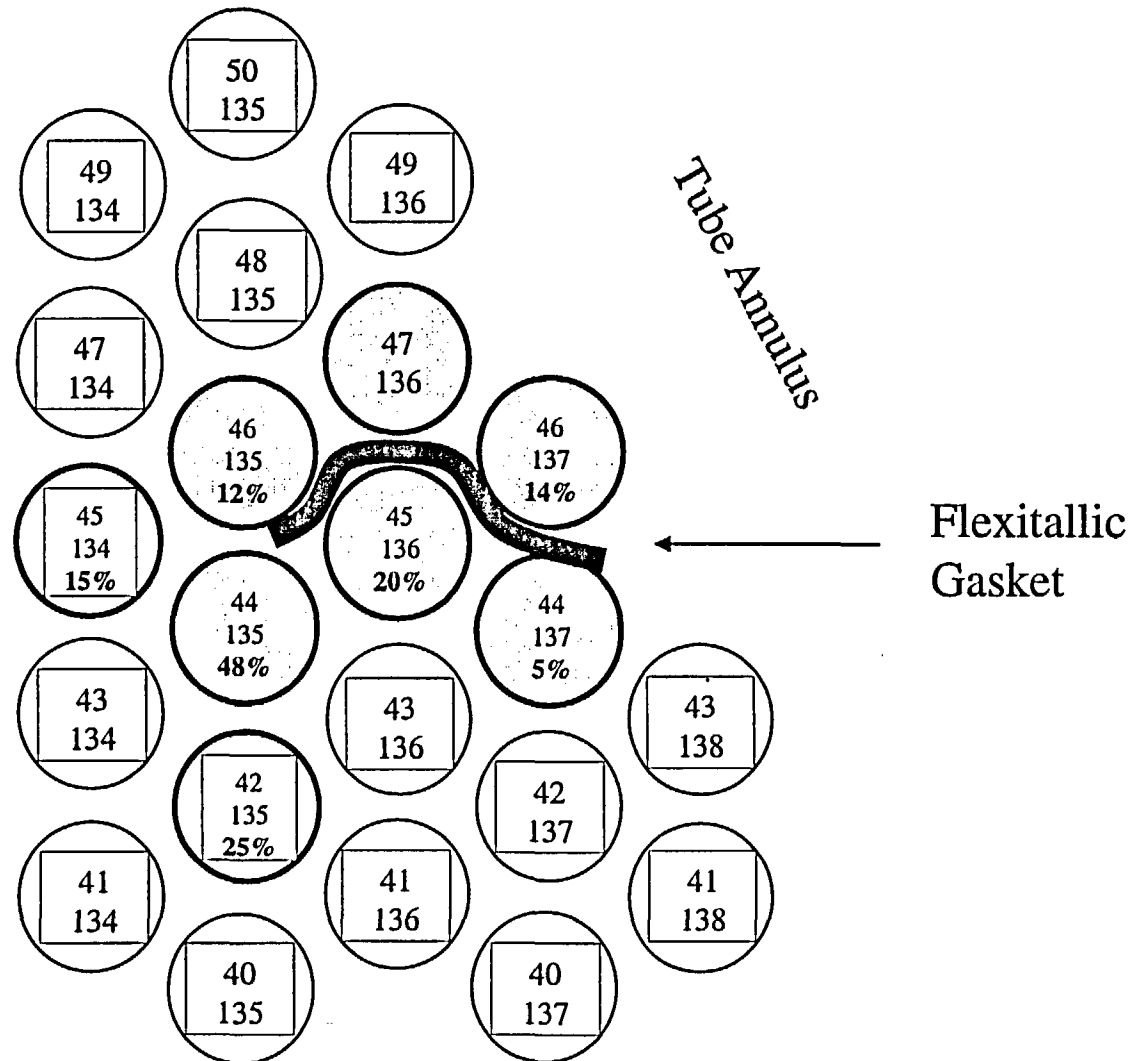
SG A Flexitallic Gasket Location

- One indication of wear, 12 percent throughwall, was identified at a lattice grid intersection. Two indications of wear, 5 percent and 7 percent throughwall, were identified at fan bar intersections. The tubes with these three indications were left in service.
- Based on the FOSAR examination, one foreign object was identified near the top of the tubesheet on the periphery of the cold leg side. It was determined to be a piece of flexitallic gasket and could not be retrieved because it was fixed in-place between 6 tubes. The gasket was 2.3 inches long, 0.08 inches wide and 0.031 inches deep. This object was not detected in the eddy current data from the bobbin probe inspection, which the licensee believes is because the flexitallic gasket is a small piece of stainless steel material which is not readily visible on eddy current.

Exelon performed an inspection with a rotating probe containing a +Point™ coil on 37 tubes surrounding the object. The tubes were inspected from 3 inches above to 3 inches below the top of the tubesheet. The licensee determined that seven tubes contained degradation due to wear, which ranged from 5 percent to 48 percent throughwall. Only the two deepest flaws (48 percent and 25 percent throughwall) were detected with the bobbin probe. A review of the prior inspection data (bobbin coil data) for the location with the 48 percent throughwall indication indicated that a flaw was not detected at that time. The licensee concluded that they would plug all tubes with wear (regardless of depth) and all tubes in contact with the object would be plugged and stabilized. A total of 8 tubes were plugged in SG A, of which 6 were stabilized.

Tubes Plugged and Stabilized

Tubes Plugged (Bold)
& Stabilized (Shaded)
& Shaded and are
listed below:

45-134

42-135

44-135

46-135

45-136

47-136

44-137

46-137

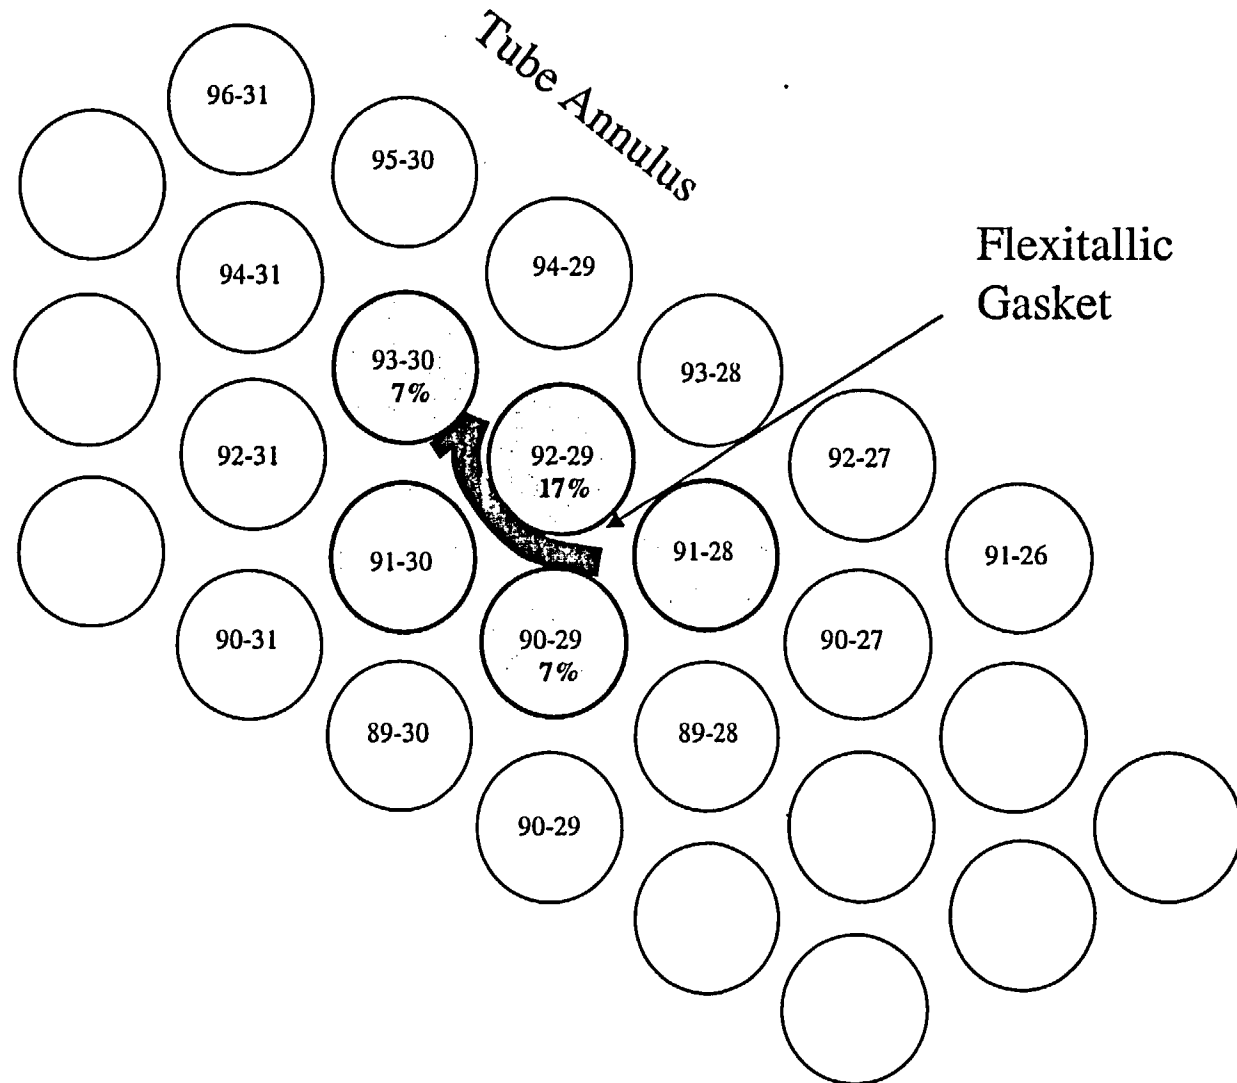
SG B Flexitallic Gasket Location

Exelon performed an inspection with a rotating probe containing a +Point™ coil on 37 tubes surrounding the object. The tubes were inspected from 3 inches above to 3 inches below the top of the tubesheet. The licensee determined that three tubes contained degradation due to wear, which ranged from 7 percent to 17 percent throughwall. None of these flaws were detected with the bobbin probe. The licensee concluded that they would plug all tubes with wear (regardless of depth) and all tubes in contact with the object would be plugged and stabilized. A total of 5 tubes were plugged in SG B due to this foreign object, all of which were stabilized.

Tubes Plugged & Stabilized

Tubes Plugged & Stabilized are shown as Bold & Shaded and are listed below:

91-30
93-30
90-29
92-29
91-28

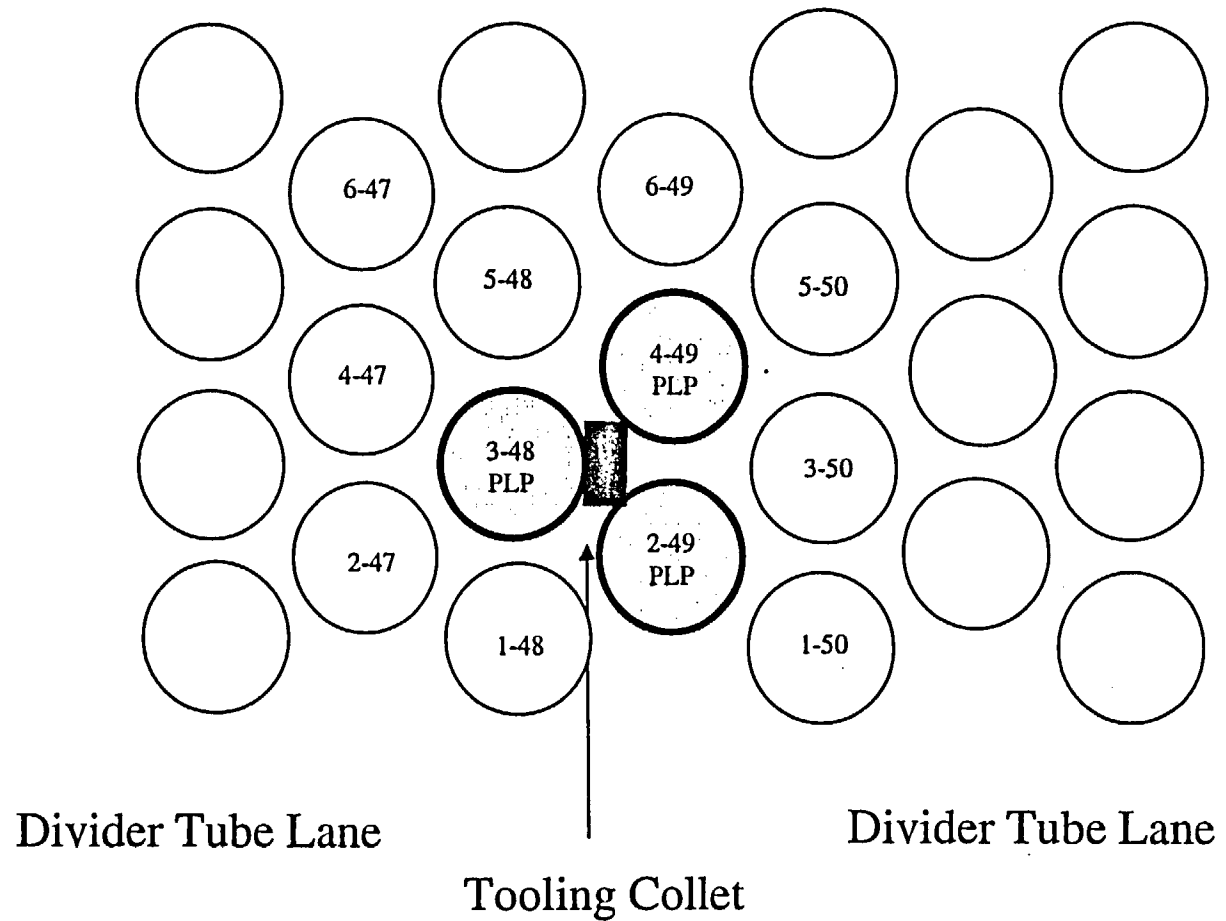
SG C Tooling Collet Location

Tubes Plugged & Stabilized

Tubes Plugged & Stabilized are shown as Bold & Shaded and are listed below:

3-48

2-49

4-49
