Research Reactor Center

University of Missouri-Columbia

Subject: Docket No. 50-186
The Curators of the University of Missouri
License No. R-103

Licensee Event Report No. 03-01 – May 18, 2003
University of Missouri Research Reactor

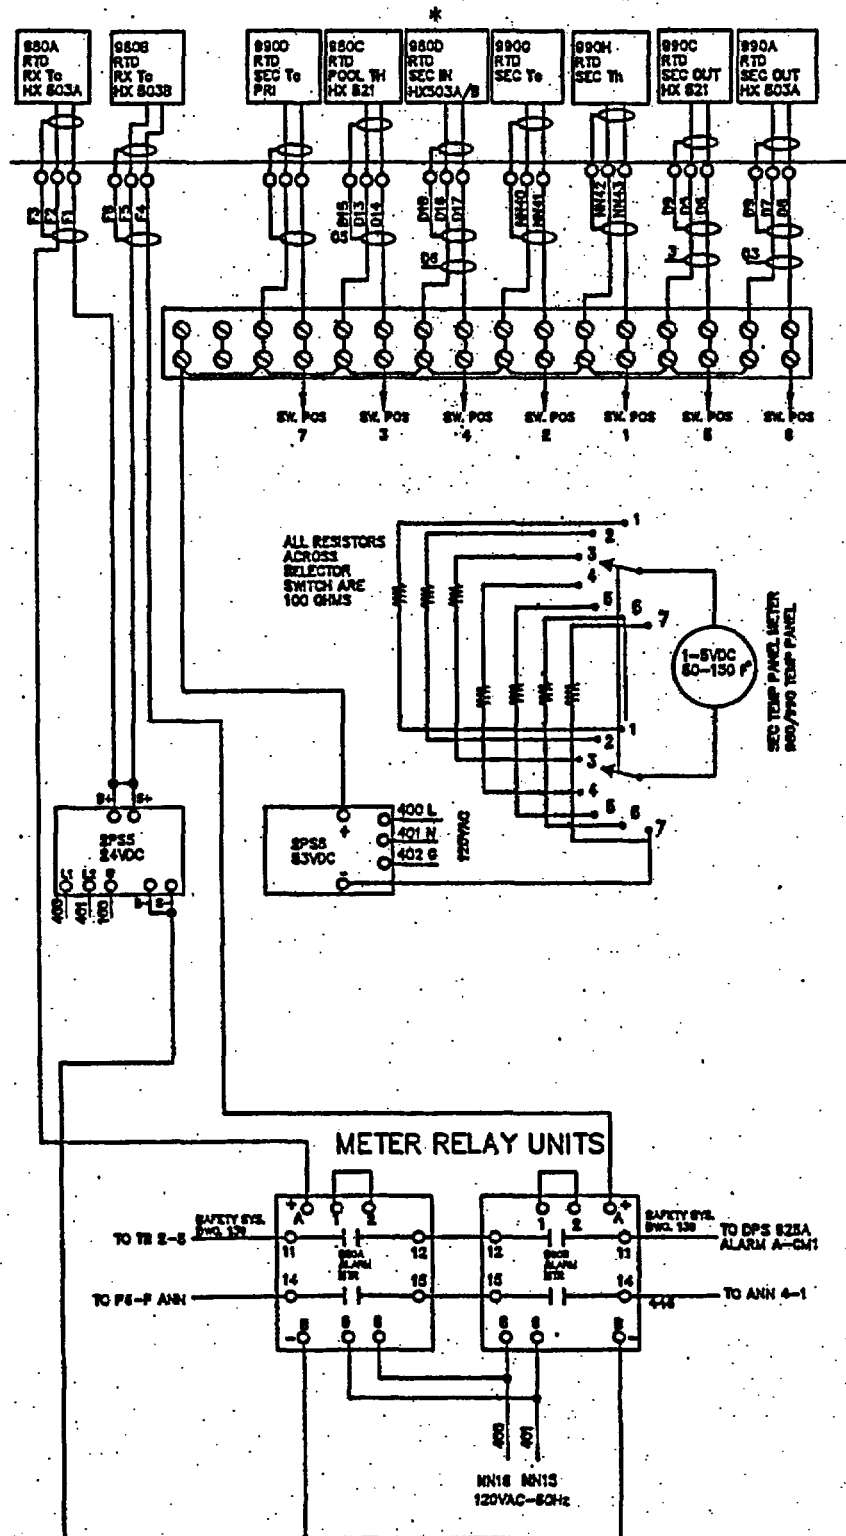
HEAT EXCHANGER OUTLET TEMPERATURE

On May 18, 2003, the duty operator initiated a manual reactor scram when primary coolant heat exchanger 503A outlet temperature instrument, TE-980A, meter indication failed downscale. The reactor was operating at 10 MW steady state at the time of the occurrence.

Extensive investigation and testing by an electronics technician could not reveal the exact cause of the problem, nor could the failure be duplicated. It was suspected that the Resistance Temperature Detector (RTD) and/or its Transmitter, which are an integral unit, were the cause of the instrument failure. Similar failures had occurred on January 20, 2002, and again on January 26, 2002, when temperature instrument TE-980B meter indication also failed downscale (MURR LER No. 02-01).

Temperature instrument channels TE-980A and TE-980B are shown as "Heat Exchanger Outlet Temperature" on the attached drawing. The sensor, an RTD, and Transmitter are Rosemount Model 444 Alphaline® units. Twenty-four volt power supply 2PS5 provides the operating voltage to both TE-980A and TE-980B. The output of the Transmitters is sent to corresponding Alarm Meter Relay Units mounted on the Instrument Panel in the Control Room.

The root cause of this instrument malfunction has not yet been fully determined. The downscale failure of the system could not be duplicated, nor were there any discrepancies noted during the bench tests. The RTD/Transmitter unit for TE-980B, which appeared to have failed in January 2002, was returned to Rosemount in February 2002 for failure analysis. Failure Analysis Report No. 3672, prepared by Rosemount Inc. Failure Analysis Lab, identified a failed operational amplifier on the Transmitter's Analog Output Board, which caused transmitter output drift and improper burnout mode. This report was included as an attachment to MURR LER No. 02-01. Rosemount Inc. stated that the component might have failed due to a transient voltage or a manufacturing defect in the component. Rosemount provided MURR with replacement Model 444 Alphaline® RTD/Transmitter units for the units installed in the reactor and for the ones used as spares.

The RTD/Transmitter unit for TE-980A was replaced and tested. All tests demonstrated that the instrument was operable. Compliance Procedure CP-8B was performed during May 19 maintenance day activities, once again demonstrating that the instrument was operable.
