Point Beach Nuclear Plant

Regulatory Conference Concerning Auxiliary
Feedwater Orifice Issue

June 6, 2003

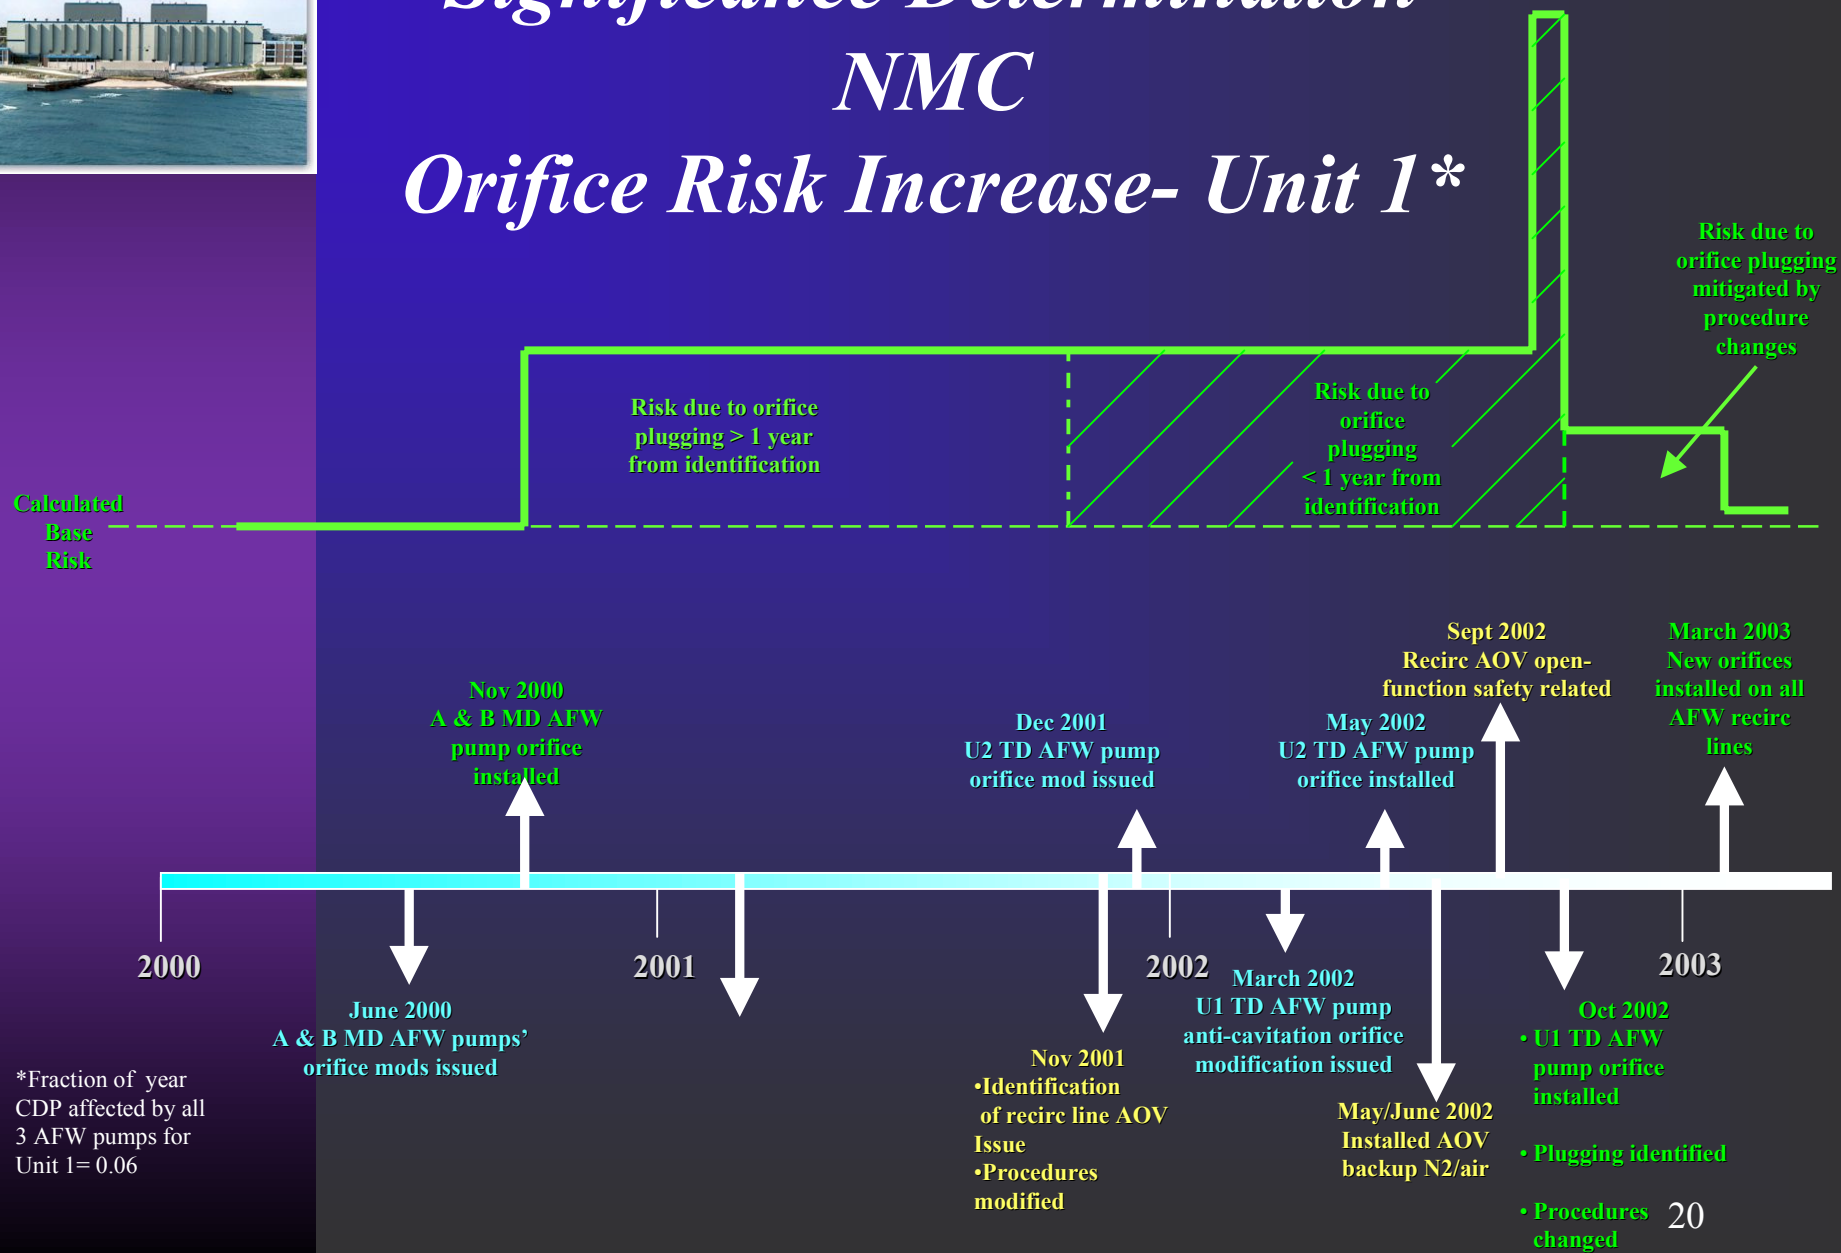
Significance Determination NMC Orifice Risk Increase- Unit 1*

- Increase in Internal Events Core Damage Probability
 - Unit 1: High White
 - Unit 2: Mid Yellow
