Subject: Submission of Intermediate Milestone 06003.04.041.340, Baltimore Tunnel Fire
Analysis Report—Final Letter Report

This report documents the analysis of rail car components for estimating temperature and duration of exposure during the Howard Street Tunnel Fire.

ANALYSIS OF RAIL CAR COMPONENTS EXPOSED TO A TUNNEL FIRE ENVIRONMENT

CNWRA 2003-04
Revision 1

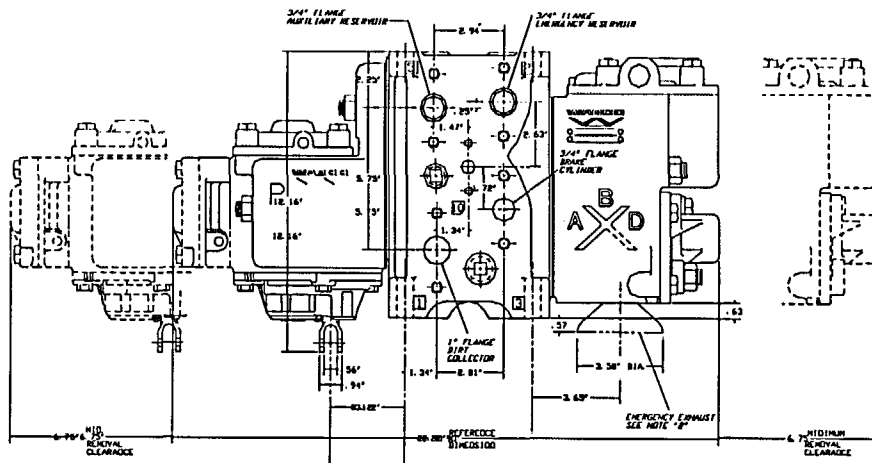
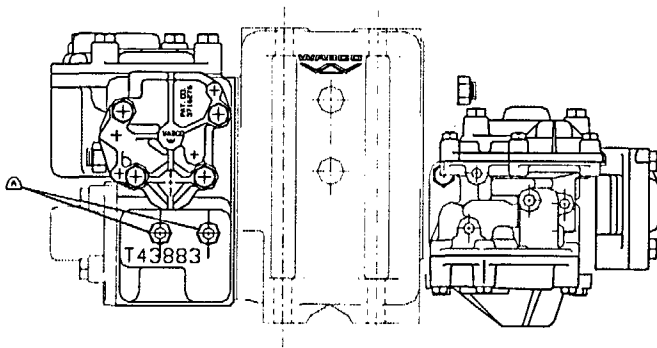
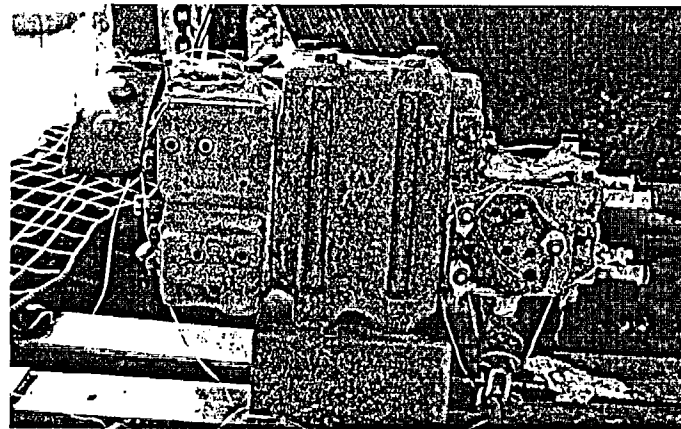
The valve assembly found on Car 52 was identified as an ABDX-L valve. The valve assembly located on Car 51 was also assumed to be an ABD valve assembly. A complete ABDX-L valve assembly is shown in Figure 3-1.

Figure 3-1. The ABDX-L Control Valve (Clockwise from Top: Valve Body Schematic, Photograph of Damaged Valve on Car 52, Corresponding Outline of the Valve Body)

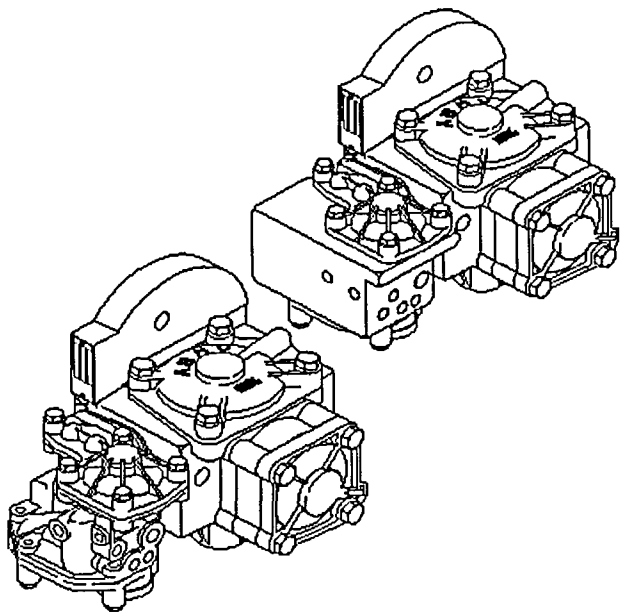
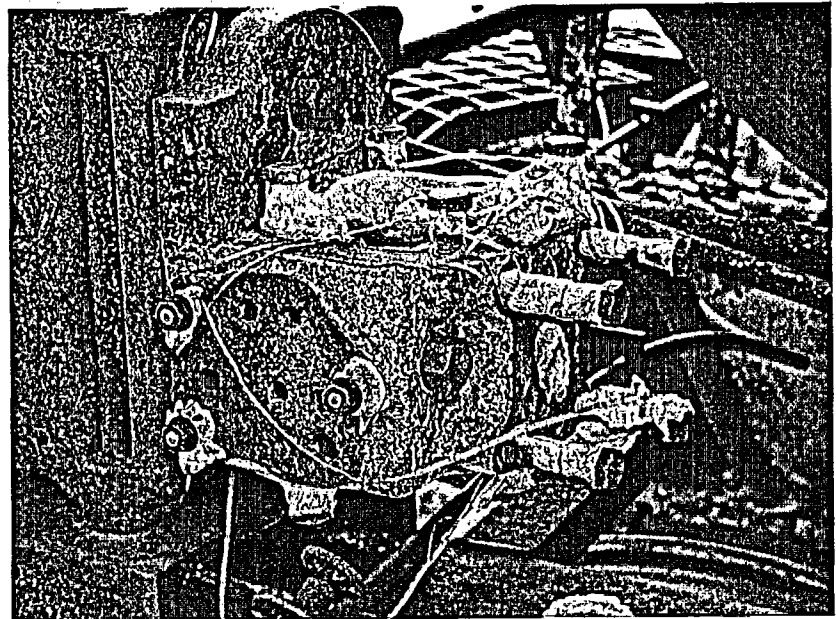
Figure 3-2. ABDX-L Service Portion Outline and Photograph

The standard ABDX-L-style valve consists of a normal service valve and an emergency valve. For this analysis, the damage observed on the service portion of the valve was analyzed (see Figure 3-2).

Complete Melting—The aluminum section reached its liquidus temperature. This is a good assumption considering the condition of the covers in Figure 3-2.

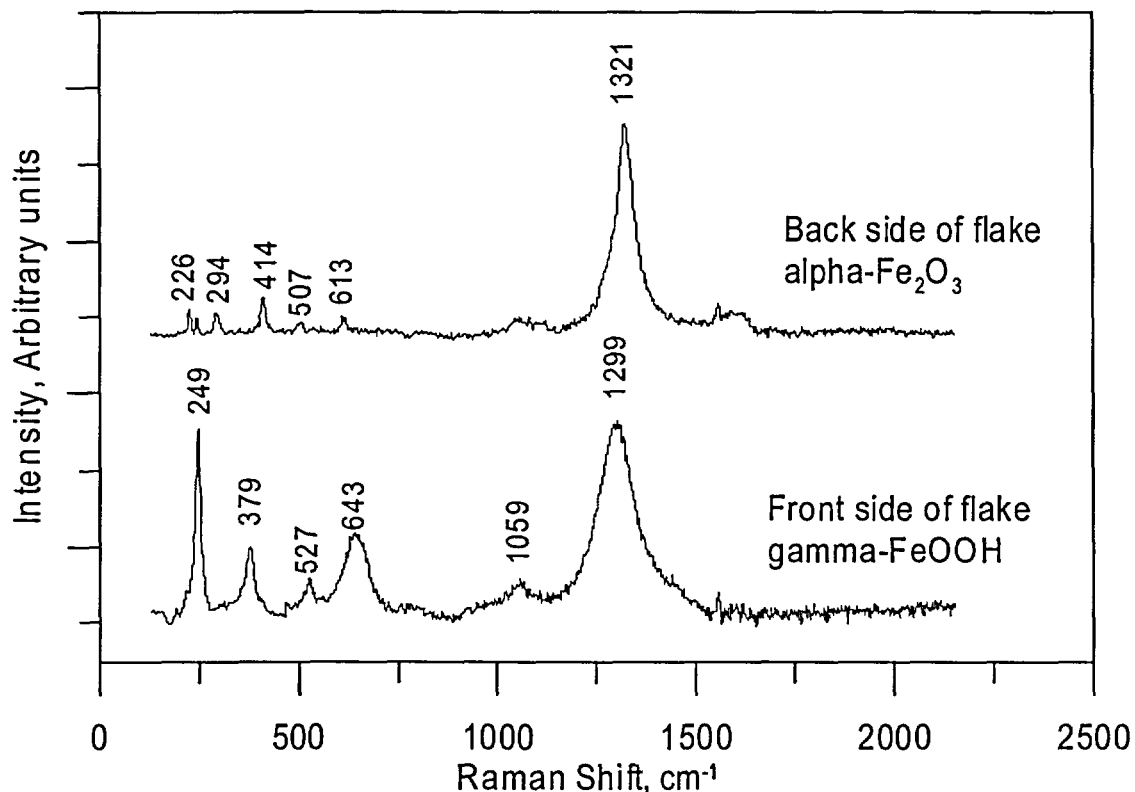
Both Raman spectroscopy (Figure 4-4) and x-ray diffraction (Figures 4-5 and 4-6) of the scale obtained from Car 51 indicate the presence of lepidocrocite (γ -FeOOH), hematite (α -Fe₂O₃) and possibly magnetite (Fe₃O₄). It should be noted that magnetite can easily be oxidized in air to hematite. The presence of γ -FeOOH, which covered large sections of the scales, indicates that the specimens were exposed to either a humid environment or water. Formation of γ -FeOOH may have occurred as a result of water contact after rupture of the water main, fire fighting efforts, or subsequent storage of the train cars involved in the derailment.

Figure 4-4. Raman Spectra for Scales Recovered from Car 51

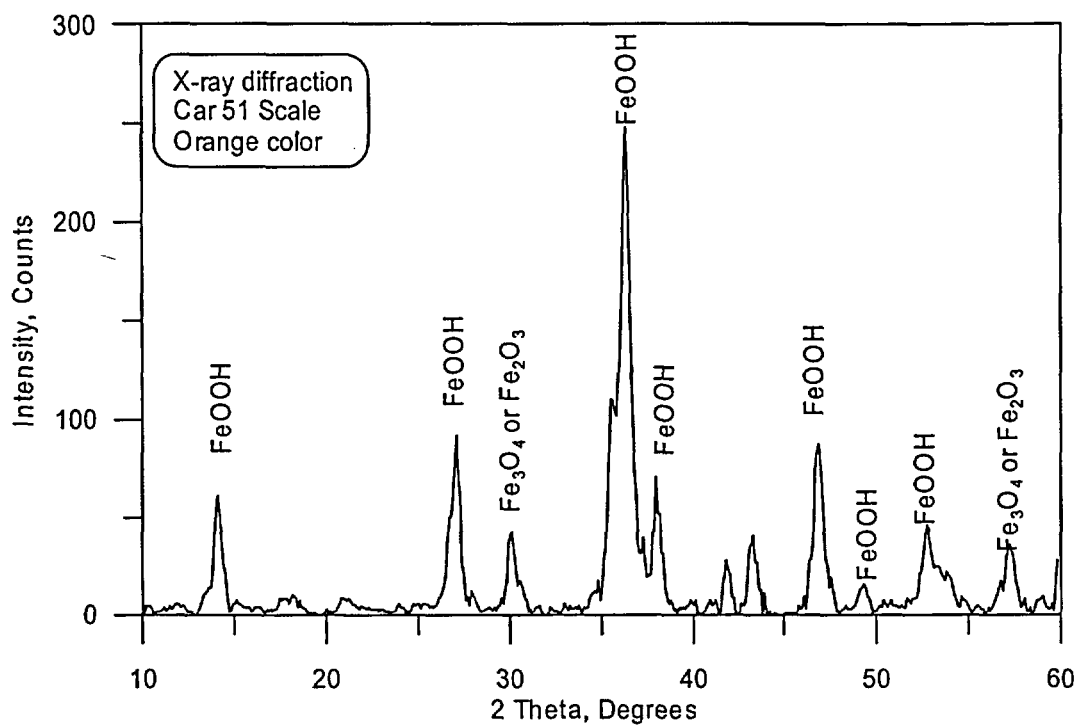
Figure 4-5. X-Ray Diffraction of Orange Colored Oxide Scales from Car 51

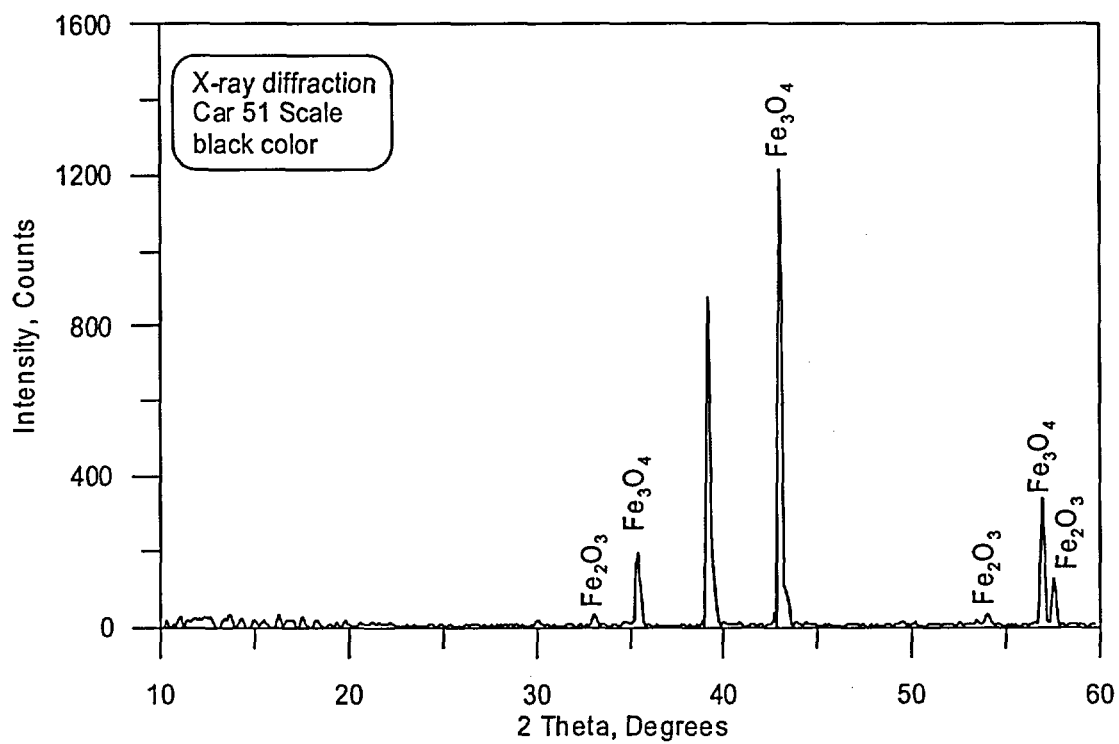
Figure 4-6. X-Ray Diffraction of Black Colored Oxide Scales from Car 51

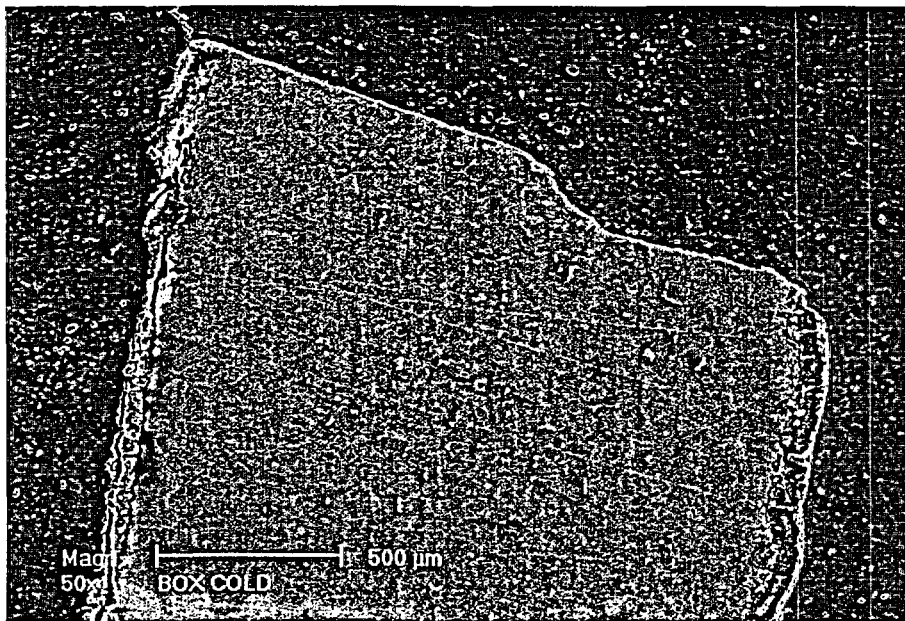
Specimens from the roof section of Car 50 were analyzed for oxide scale thickness as well as the thickness of the remaining steel section. The first specimen was cut from the opposite end of the roof panel section that may not have been directly exposed to the fire (Figure 4-7). The second specimen was cut from the edge of the roof panel section that was directly exposed to flames from the paper inside the box car (Figures 4-8 and 4-9). From the cross section of the roof shown in Figure 4-7, the remaining metal thickness was determined to be 1,761 μm [0.069 in]. Near the edge of the roof, the metal thickness varies from 829 μm [0.033 in] at the edge (Figure 4-9), to 1,464 μm [0.058 in] at a distance approximately 3 cm [1.2 in] from the exposed edge (Figure 4-8). Although it is apparent that the metal thickness of the roof section shown in Figure 4-7 has been reduced by oxidation, the metal thickness of this section was used as a basis to determine metal loss. Assuming that metal loss occurred at equal rates on both sides of the specimen shown in Figures 4-8 and 4-9, the metal loss from each side varied from 148 to 466 μm [0.006 to 0.018 in]. Based on the calculated reduction in metal thickness as a function of time and temperature shown in Figure 4-2, temperatures in the range of 750 to 850 $^{\circ}\text{C}$ [1,382 to 1,562 $^{\circ}\text{F}$] for approximately 4 hours would be required to achieve the reduced metal thickness.

Figure 4-7. Cross section of Car 50 Roof Approximately 40 cm [16 in] from the Opposite End of the Roof Panel Section that May Not Have Been Exposed to the Fire. Thickness of the Metal was Approximately 1,761 μm [0.069 in].

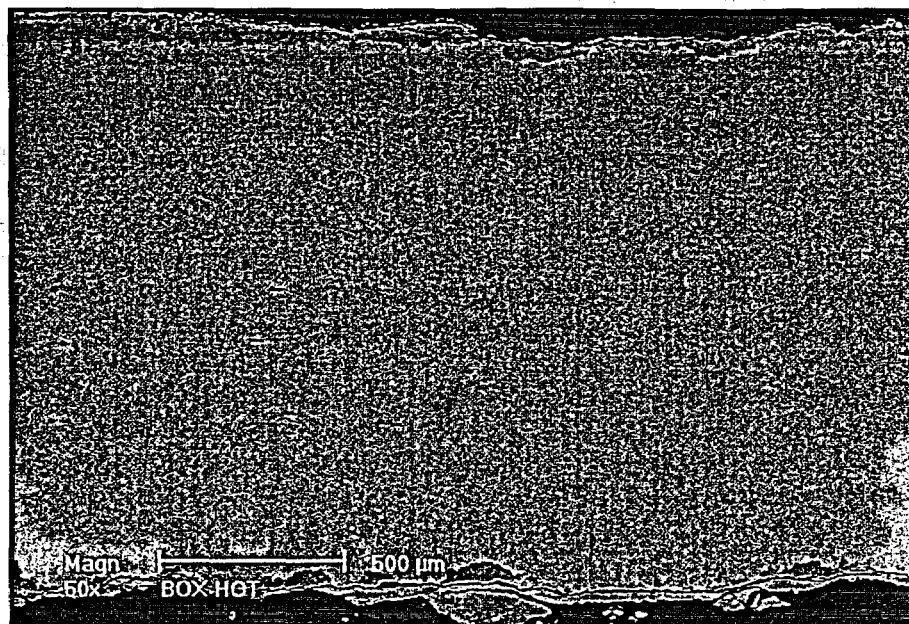
Figure 4-8. Cross Section of Car 50 Roof Approximately 3 cm [1.2 in] from the Edge Directly Exposed to the Fire. Thickness of the Metal was Approximately 1,464 μm [0.057 in].

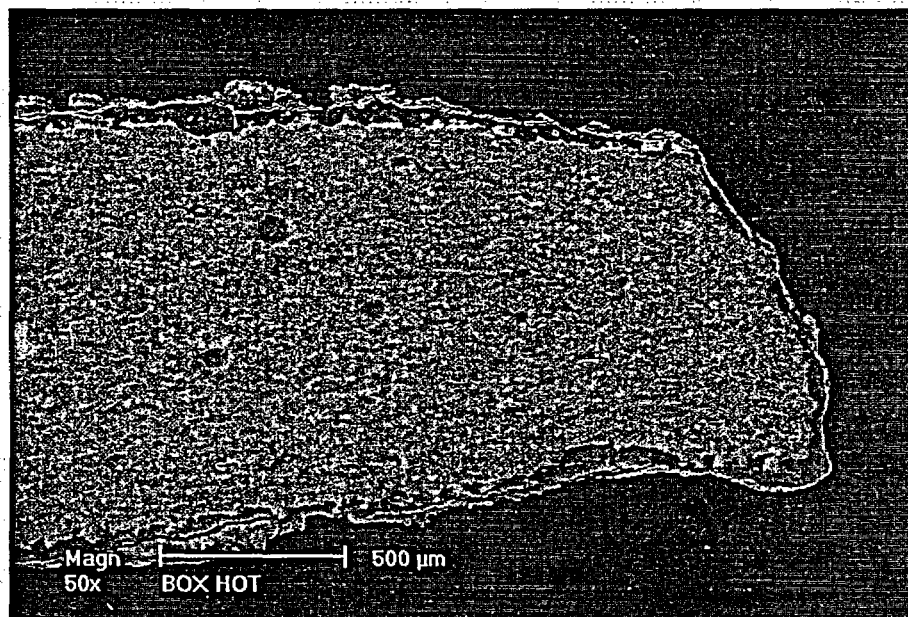
Figure 4-9. Cross Section of Car 50 Roof at Edge Directly Exposed to the Fire. Thickness of the Metal Ranged from 829 to 930 μm [0.033 to 0.037 in].

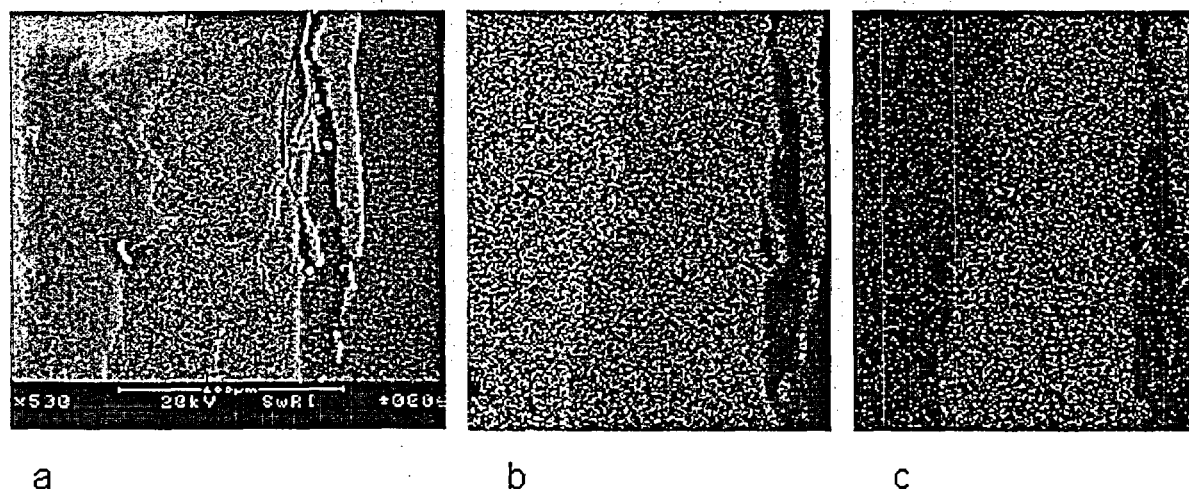
Figure 4-10(a) shows a closeup of the metal oxide scale of the Car 50 roof section near the edge exposed to the fire. Cracks and spalling of the oxide are apparent from the cross section. Figure 4-10(b) shows the scanning electron microscope-energy dispersive spectrometer element map for iron, and Figure 4-10(c) shows the element map for oxygen which confirms the scale is an iron oxide. Based on the analyses of the cross-sectioned specimen, the oxide scale on the roof section exposed to the fire ranged from 50 to 81 μm [0.0019 to 0.0032 in] in thickness. According to the calculations shown in Figure 4-3 scales of this thickness can be produced at temperatures below 700 °C [1,292 °F] for a period of 4 hours. However, the oxide scale shown in Figure 4-10(a) has clear signs of spalling which may have reduced the scale thickness that remained attached to the damaged roof section.

Figure 4-10. (a) Secondary Electron Image from Car 50 Roof at Edge Directly Exposed to the Fire, (b) Iron Image Map, (c) Oxygen Image Map

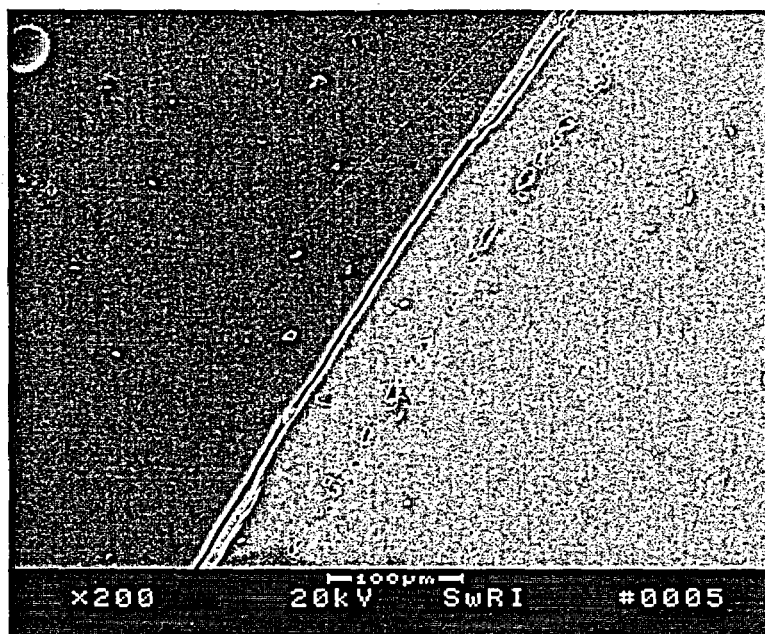
The cross section of the air brake bolt is shown in Figure 4-11. The oxide scale on the bolt shank was determined to be 53 μm [0.0021 in]. Little spalling or cracking of the oxide layer was observed, suggesting the temperature was less than that achieved by the roof panel of Car 50. Based on the predicted metal oxide thickness shown in Figure 4-3, a 53 μm [0.0021 in] oxide scale could be expected in 4 hours at 627 °C [1,160 °F]. At higher temperatures, spalling of the oxide would be expected.

**Figure 4-11. Scanning Electron Microscope
Secondary Electron Image of Car 52 Air Brake Valve
Bolt Showing Metal and Oxide Layer**

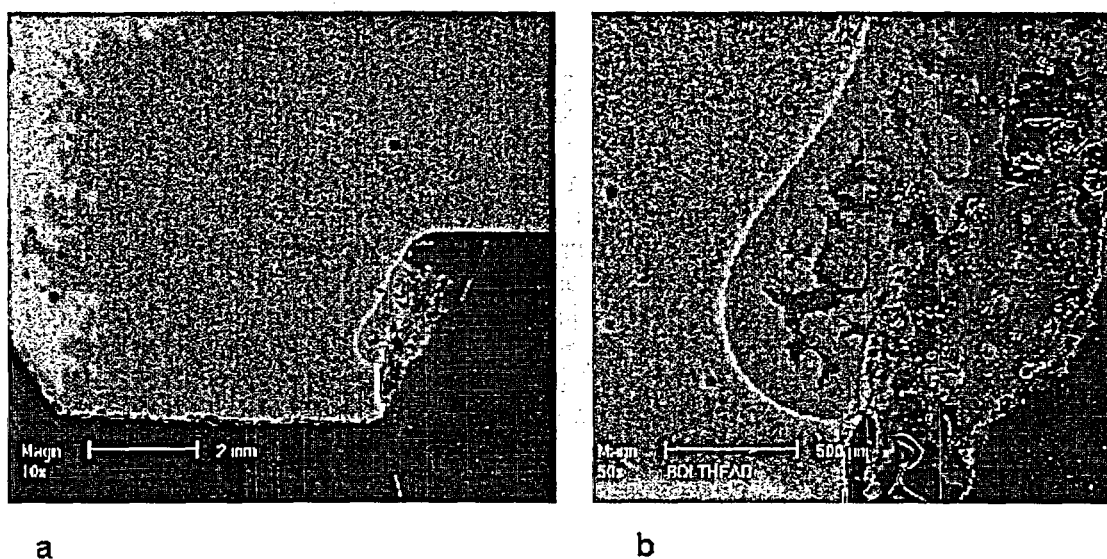
Figure 4-12(a) shows a cross section of one of the air brake assembly bolts. During the analysis of the specimen, several regions were found where an aluminum-iron phase had formed. A higher magnification of such a region is shown in Figure 4-12(b). Using an energy dispersive spectrometer, the composition of the bolt was determined to be 98.4 atomic percent iron with no measurable concentration of aluminum. In the mixed aluminum-iron region, the composition was found to be 66 atomic percent aluminum, 4 atomic percent silicon, and 30 atomic percent iron. The liquidus temperature for a 66 atomic percent Aluminum and 34 atomic percent iron binary is 1,180 °C [2,156 °F] and the solidus temperature is 1,165 °C [2,129 °F] (ASM International, 1992). The aluminum-iron binary phase diagram does not contain low melting point eutectic compositions. The addition of 4 atomic percent silicon is not expected to significantly alter the solidus or liquidus temperatures based on examination of the iron-silicon and aluminum-silicon binary systems.

Figure 4-12. (a) Scanning Electron Microscope Secondary Electron Image of Car 52 Air Brake Valve Bolt Head Showing Iron and Aluminum and (b) Closeup of Iron with Aluminum

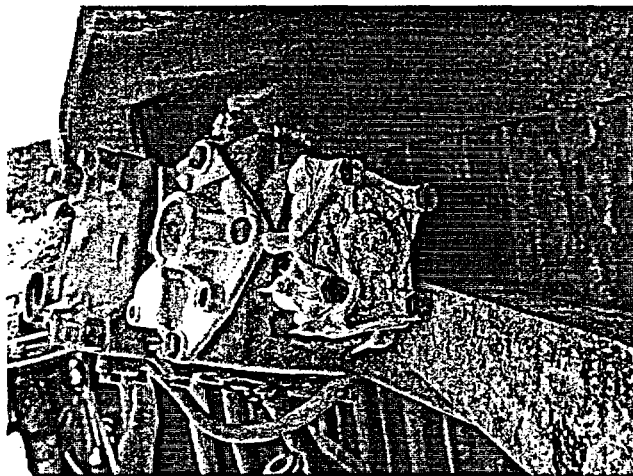
A second aluminum witness was found approximately 20 m [66 ft] uphill of the fire source. This piece is shown in Figure 6-1. It is interesting to note that this piece did not melt completely, which would indicate the very specific conditions required to melt the valve assembly on Car 52 were likely not encountered at approximately 20m [66 ft] away.

Figure 6-1. Air Brake Valve Found 20+ m [66 ft] from Fuel Spill Site (Note Only Partial Melting at This Location)

Closer analysis of the damage caused to the valve cover found at Car 52, indicates that a separation distance of approximately 20 m [66 ft] was sufficient to limit the exposure conditions

in this area, as evidenced by the level of damage to the valve cover. Considering only partial melting in this area, temperatures at the surface of the aluminum were only slightly above 600°C [1,112°F] (enough to initiate melting) but were not maintained for any appreciable duration.
