L. William Pearce
Site Vice President724-682-5234
Fax: 724-643-8069June 24, 2003
L-03-103U. S. Nuclear Regulatory Commission
Attention: Document Control Desk
Washington, DC 20555-0001**Subject: Beaver Valley Power Station, Unit No. 1
BV-1 Docket No. 50-334, License No. DPR-66
Reactor Head Inspection 60-Day Report**

**Evaluation Report for 1R15
Visual and Under-head Inspection
of
Beaver Valley Unit 1
Reactor Vessel Head Penetrations
(Ref: Order EA-03-009)**

June 2003

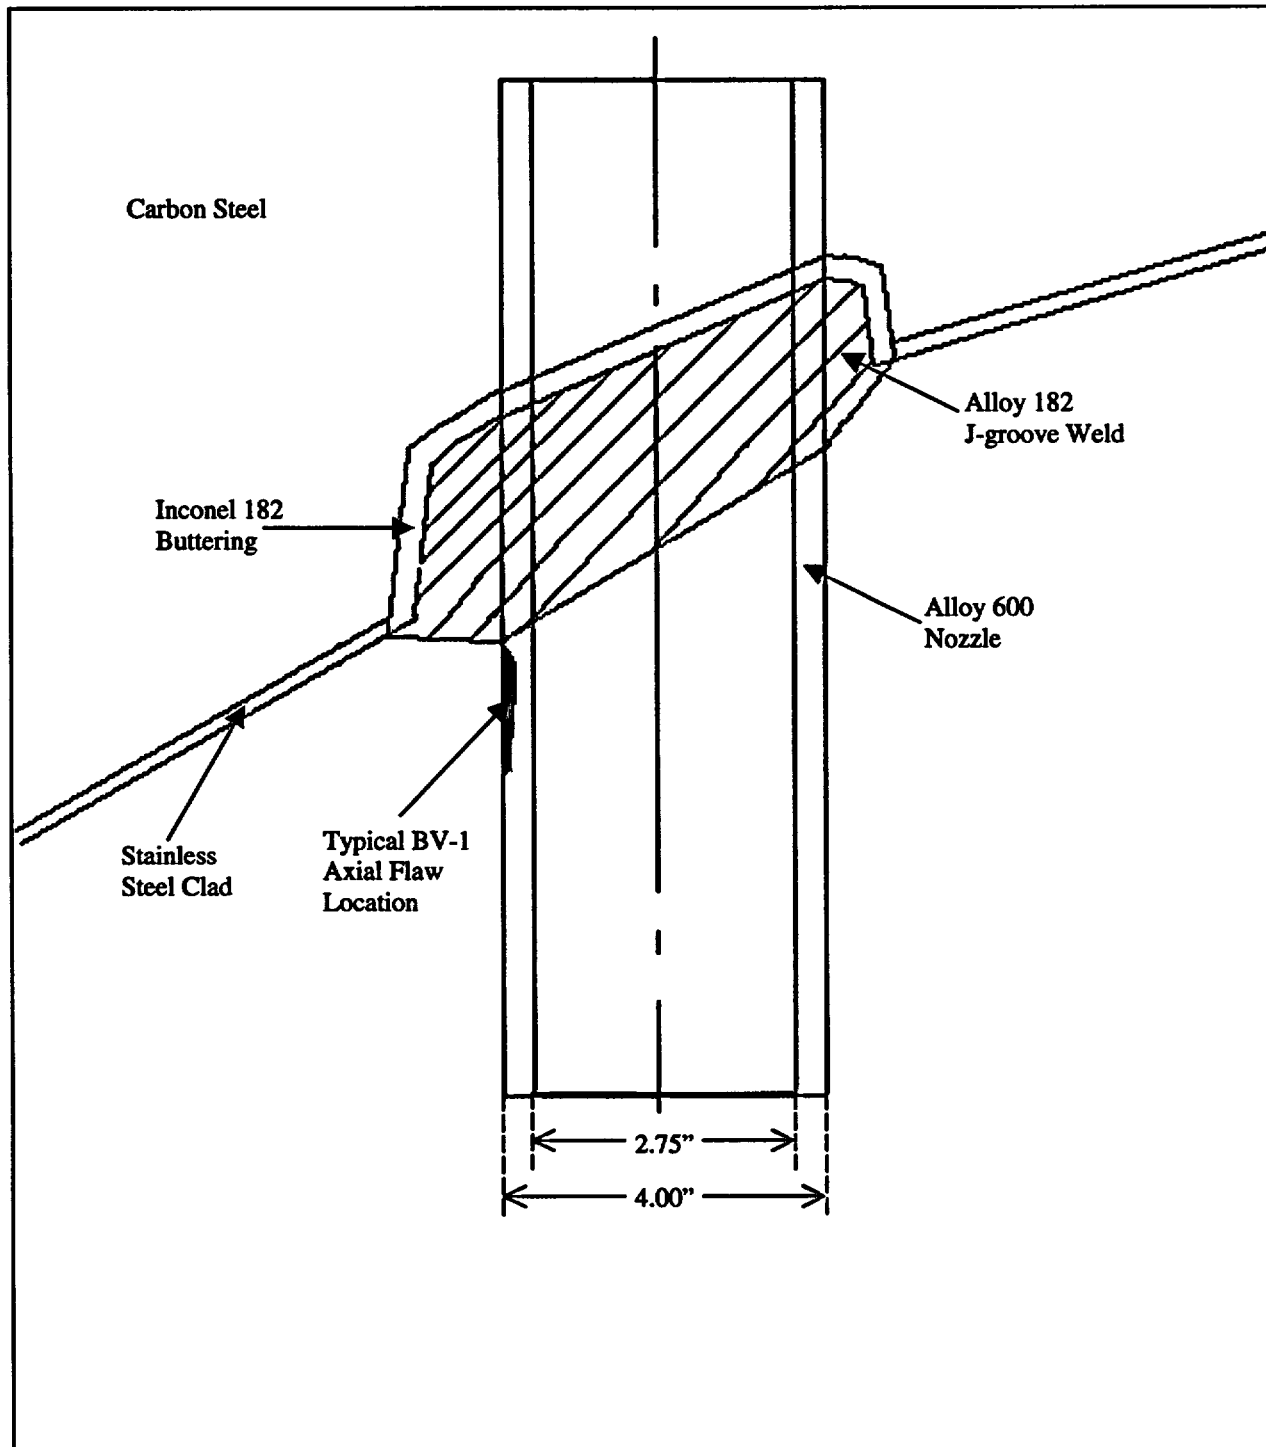
Figure 7: Typical Axial Flaw Location
Penetrations #50, 51, 52, and 53

Eddy current wetted surface examination was performed on the OD surface of all 65 CRDM penetrations. Reportable indications, with characteristics of Primary Water Stress Corrosion Cracking (PWSCC), were identified in the penetration tube scans of four CRDM locations. Penetrations #50, 51, 52, and 53 contained indications initially classified as having crack-like characteristics; single axial indications (SAI), single circumferential indications (SCI) and/or multiple circumferential indications (MCI). Following Time of Flight Diffraction (ToFD) Ultrasonic analysis of the four penetrations from the ID surface, all indications were ultimately

classified as axial in orientation. Neither eddy current nor ultrasonic test results identified any crack extension into the J-groove weld.

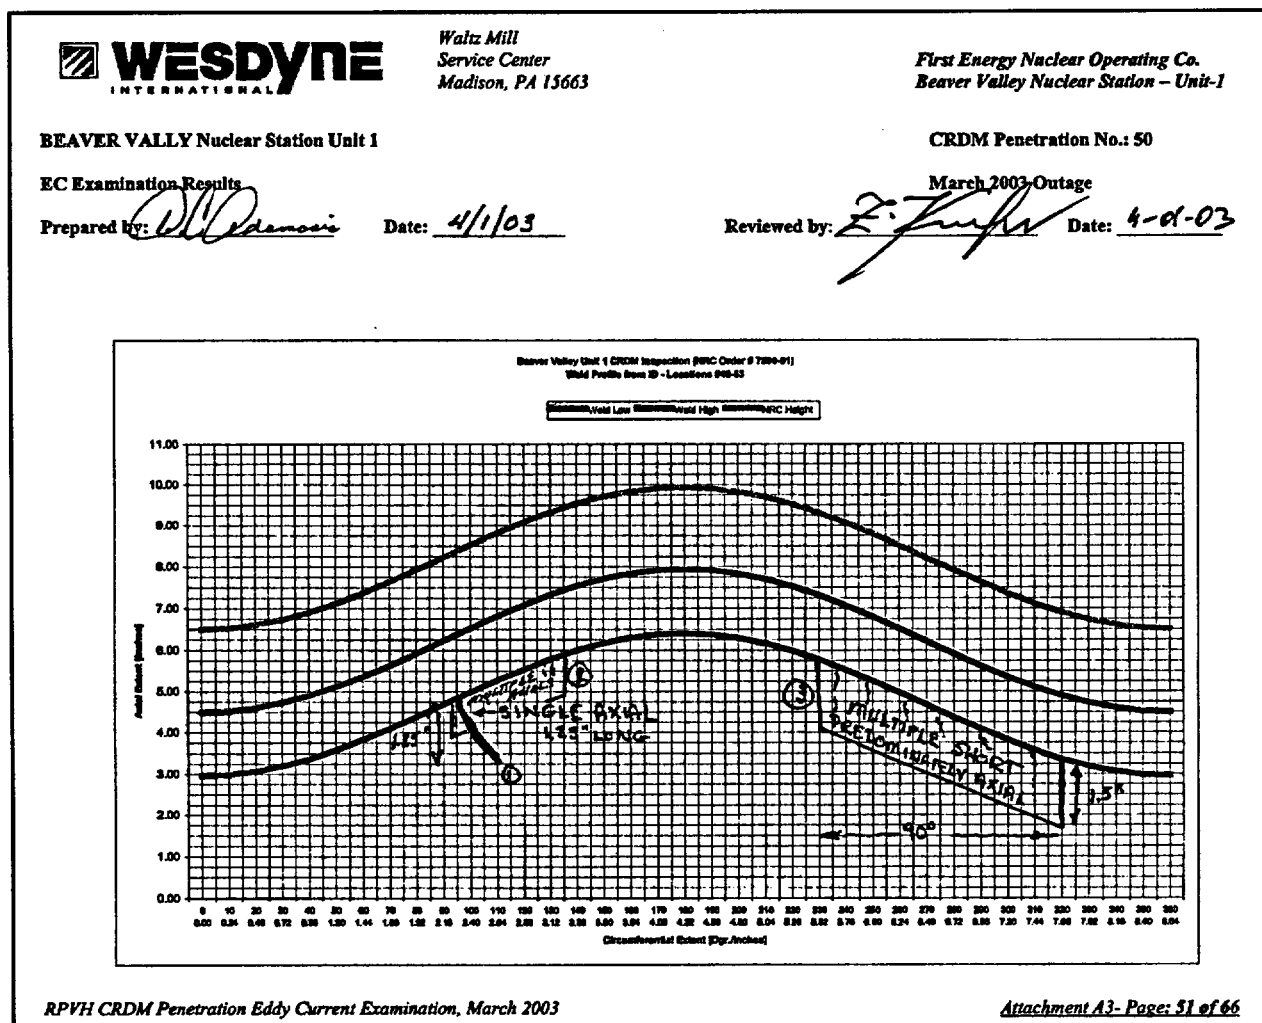
Figure 8: CRDM Penetration #50 Tube Profile

#	Length (Inches)	Depth (Inches)	Disposition	Circ. Location
1	1.25"	0.30"	Single Axial	97°
2*	~0.8"	<0.125"	Multiple Shallow Axial	90°-135°
3*	1.55"-1.80"	<0.125"	Multiple Shallow Axial	230°-320°

Repairs were performed on Penetrations 50 through 53 using the Embedded Flaw Repair Technique, consisting of a three-pass Alloy-52 weld overlay of the J-groove weld and a two-pass overlay of the penetration tube OD for each of the four penetrations. Verbal NRC approval of BVPS Relief Request BV3-RV-04 for the use of this technique was received on April 18, 2003, followed by written approval from the NRC on May 14, 2003. Post-repair dye penetrant examinations of all repaired regions were satisfactory.

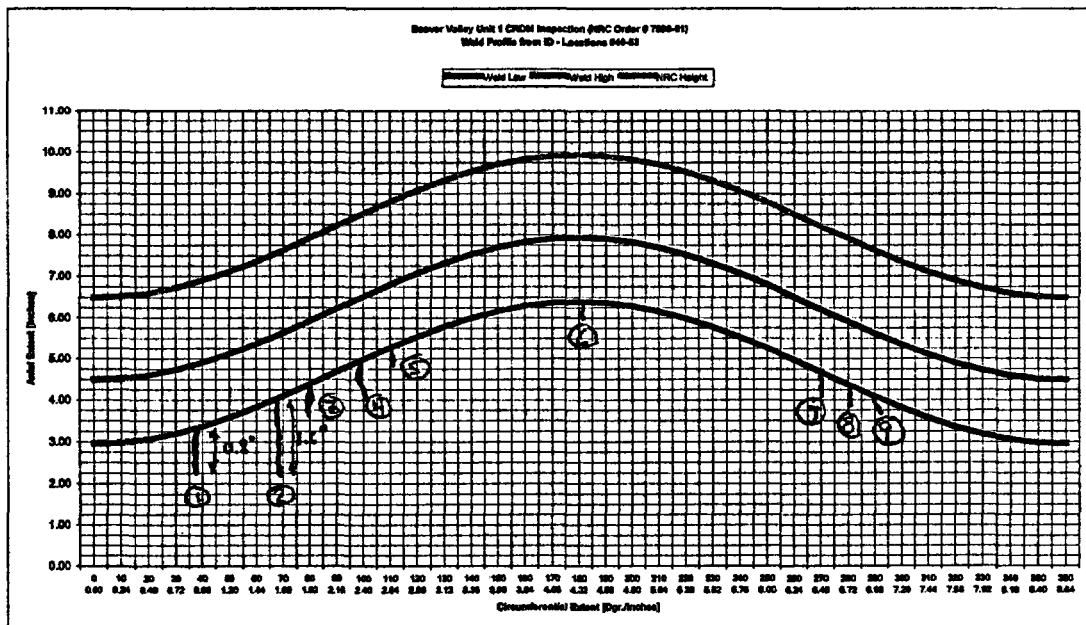
Figure 10: CRDM Penetration #51 Tube Profile

#	Length (Inches)	Depth (Inches)	Disposition	Circ. Location
1	1.0"	0.25"	Single Axial	37°
2	1.6"	0.25"	Single Axial	67°
3	0.6"	0.25"	Single Axial	80°
4	0.8"	0.25"	Single Axial	90°
5	0.85"	0.25"	Single Axial	110°
6	0.35"	0.25"	Single Axial	182°
7	0.25"	0.25"	Single Axial	270°
8	0.3"	0.20"	Single Axial	280°
9	0.3"	0.20"	Single Axial	290°

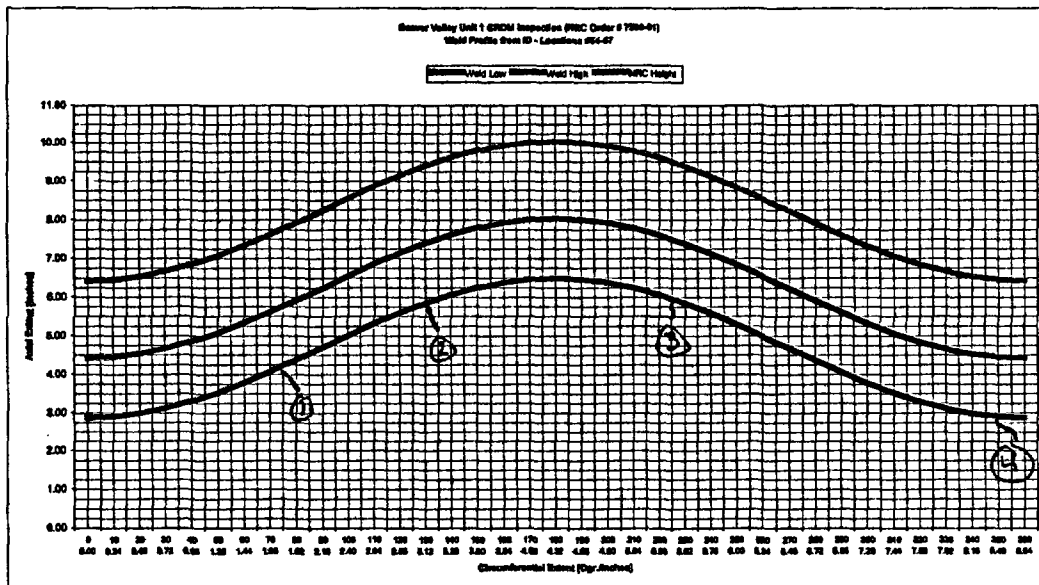
Figure 12: CRDM Penetration #52 Tube Profile

#	Length (Inches)	Depth (Inches)	Disposition	Circ. Location
1	0.3"	0.25"	Single Axial	75°
2	0.3"	0.20"	Single Axial	130°
3	0.3"	0.25"	Single Axial	225°
4	0.3"	0.20"	Single Axial	350°

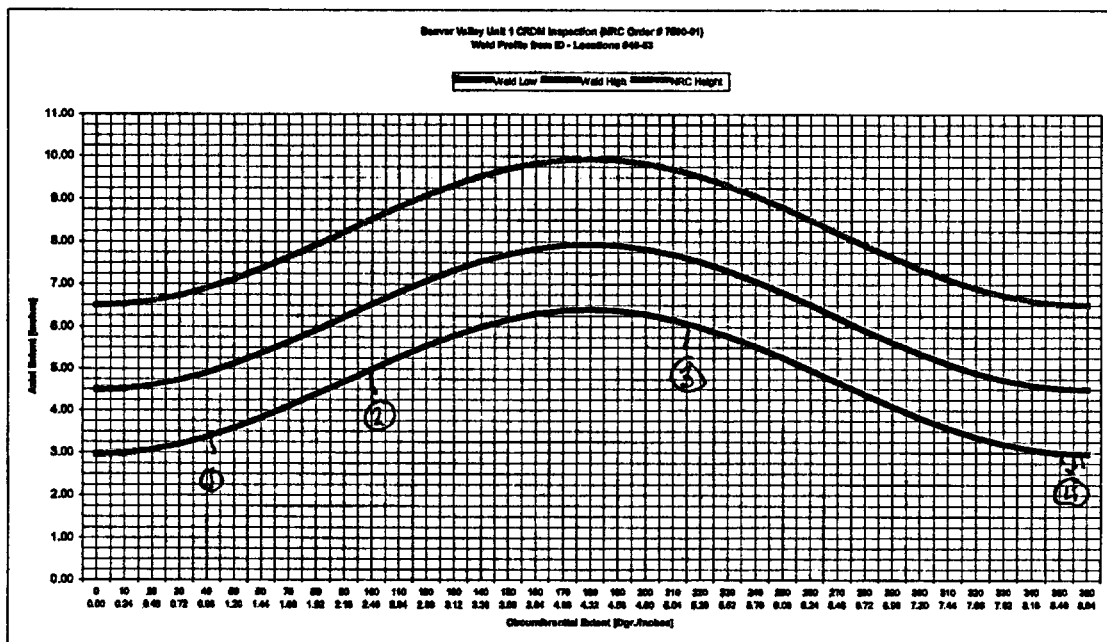
Figure 14: CRDM Penetration #53 Tube Profile

#	Length (Inches)	Depth (Inches)	Disposition	Circ. Location
1	0.3"	0.25"	Single Axial	42°
2	0.3"	0.20"	Single Axial	100°
3	0.3"	0.25"	Single Axial	215°
4	0.4"	0.15"	Multiple Shallow Axial	355°
