Subject: UCD/MNRC 2002 Annual Report

**2002**

**ANNUAL REPORT**

The University of California, Davis McClellan Nuclear Radiation Center (MNRC) consists of a research reactor and associated radiography and positioning equipment. This MNRC Annual Report is published each year in support of the license provided by the United States Nuclear Regulatory Commission (NRC). The aforementioned license is for the operation of a steady-state TRIGA™ reactor with pulsing capability.

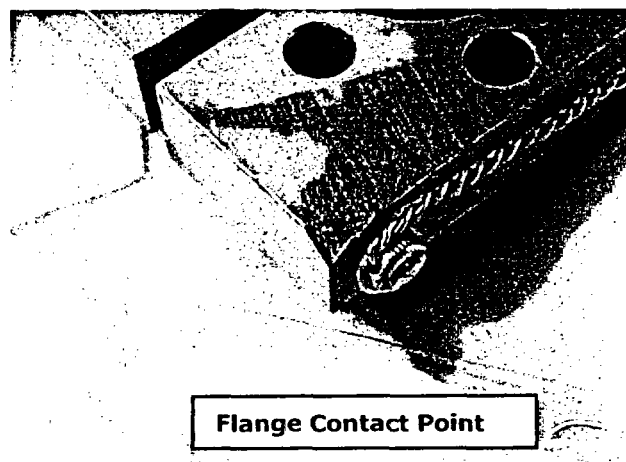
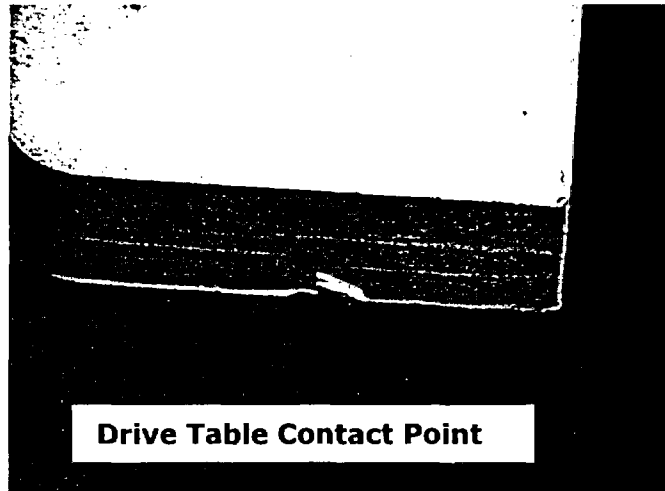
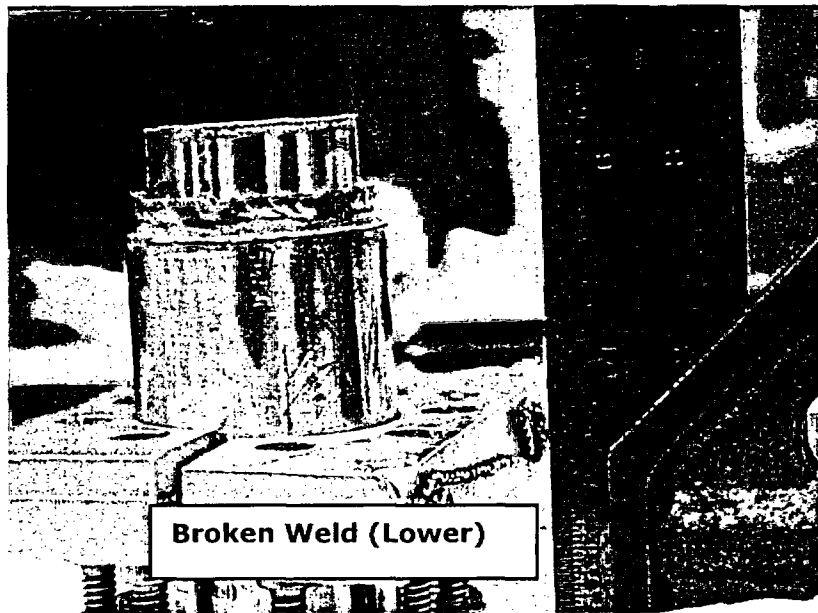
After removing the exposure vessel from the reactor tank, personnel attempted to reposition the  $^{16}\text{N}$  diffuser nozzle. When they pushed down on the nozzle to return it to its proper position; it separated from the supply piping. A locating pin on the bottom of the diffuser held it in a vertical plane, preventing it from falling over.

Personnel removed the  $^{16}\text{N}$  diffuser assembly from the reactor tank. The impact from irradiator had caused the  $^{16}\text{N}$  diffuser to rotate, but the direct cause of the of the  $^{16}\text{N}$  diffuser separating from the supply piping, was that it had become un-threaded itself at its lowest joint. The connecting elbow and the connecting pipe were rethreads and the  $\text{N}^{16}$  diffuser reinstalled.

1. The exposure vessel (one of two) has been removed from service. The attachment pole is bent preventing the irradiator from rotating in the irradiation well.
2. The connecting pole was re-welded.
3. Several stainless steel cables are now attached to each connecting pole and the crane during lifting and lowering operations to act as safety lanyards.

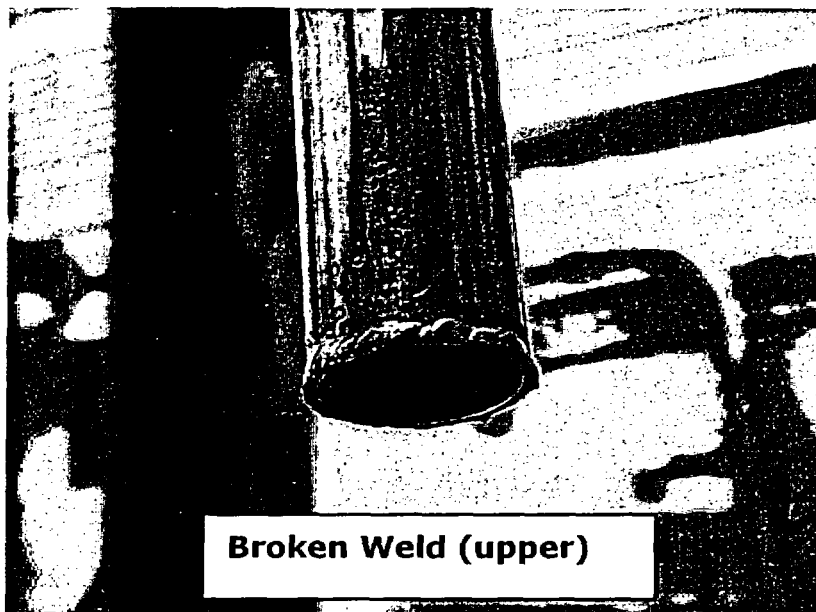
**Broken Weld (upper)**

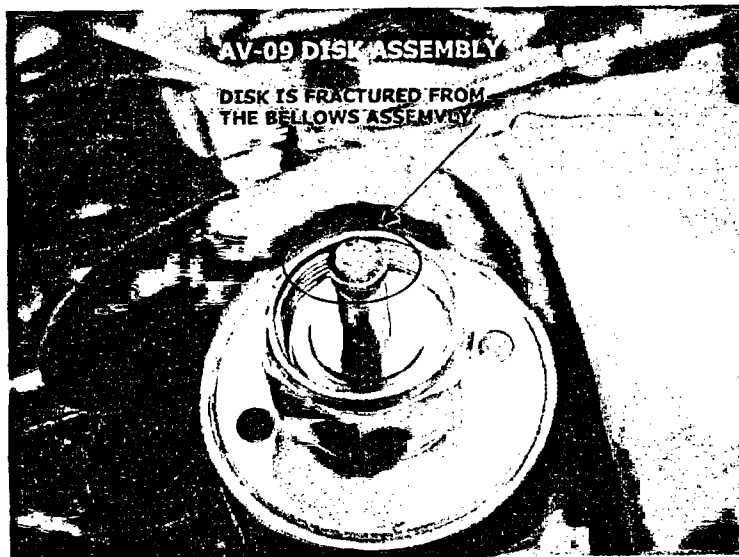
Figure 1

On July 27, 2002, operations personnel progressed to the point of removing the bonnet on AV-09 to see inside of the valve. Upon opening the valve (Figure 1), personnel discovered that the valve disk appeared melted and was blocking the exit port of the valve. The remains of the valve disk were charred and several pieces fell off the disk. These parts were highly radioactive and caused unexpected increase in the radiation levels. Personnel reassembled the valve and secured for the day.
