Braidwood Station, Unit 1
Facility Operating License No. NPF-72
NRC Docket No. STN 50-456

Subject: Braidwood Station Unit 1 60 Day Response to the Reporting Requirements of NRC Order EA-03-009, "Issuance of Order Establishing Interim Inspection Requirements for Reactor Pressure Vessel Heads"

Results of the Visual Inspections of the Braidwood Station Unit 1 Reactor Vessel Head

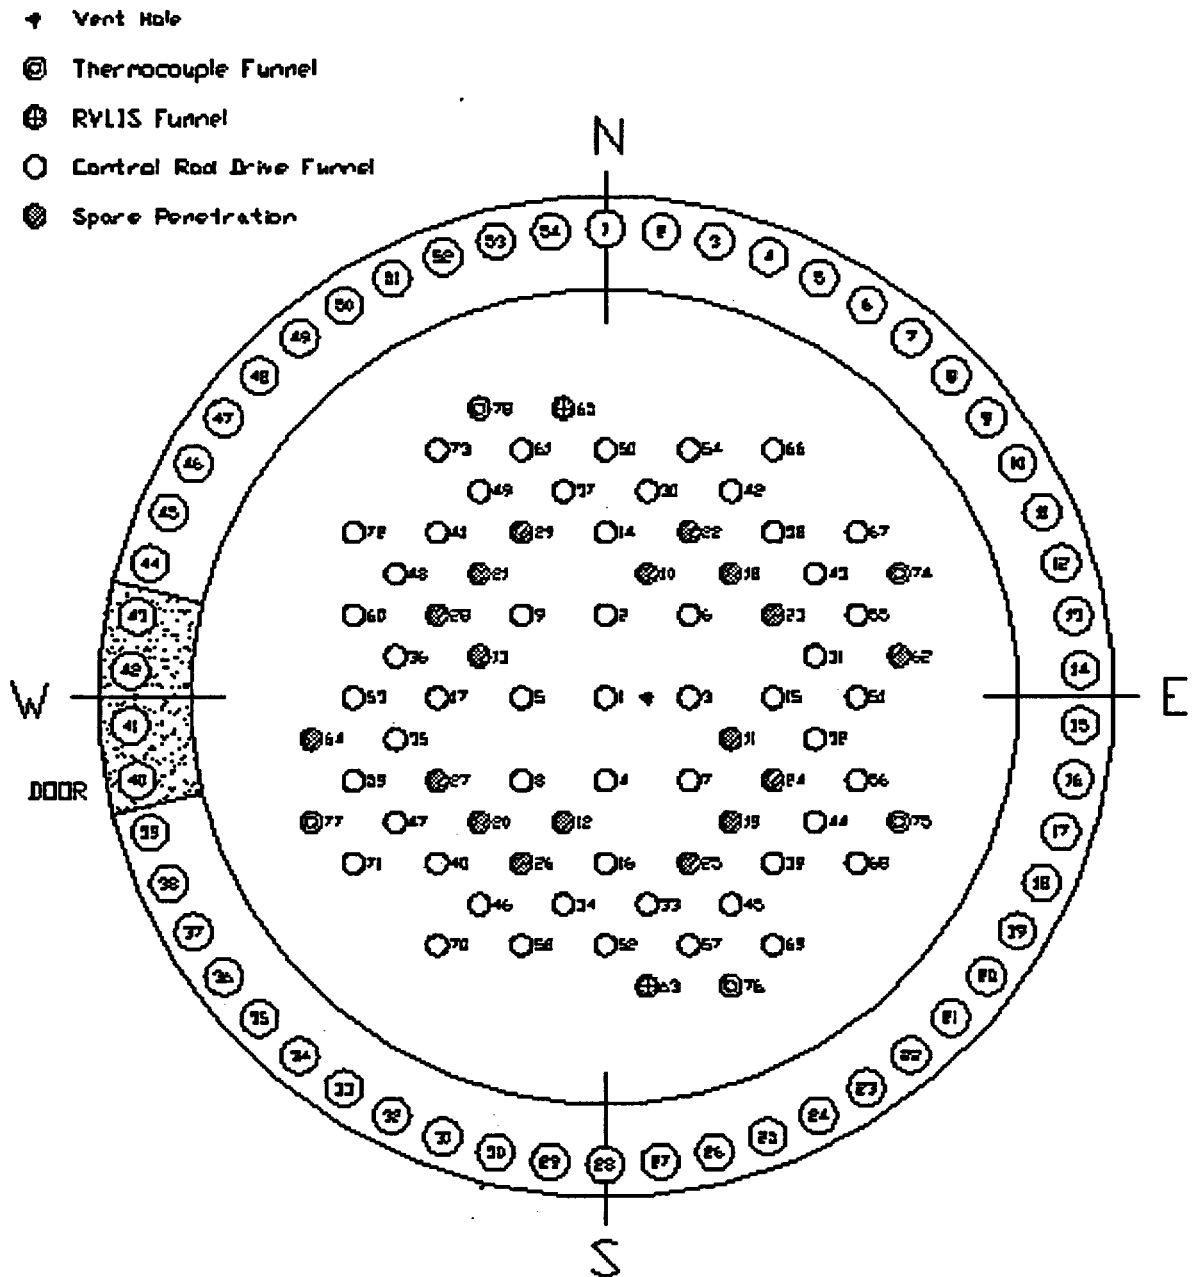
Figure 1
Braidwood Unit 1 VHP Map

The examination consisted of a qualified visual exam that covered 100% of the RPV surface including all 79 vessel head penetrations (VHPs). These VHPs include two Reactor Vessel Level Indication System (RVLIS) penetrations, 5 thermocouple penetrations, one vent pipe, 53 control rod drive mechanism penetrations, and 18 spare penetrations, (see Figure 1). The inspections were performed and the results evaluated by certified VT-1/VT-2/VT-3 examiners. The as-found and as-left examinations were performed using remote camera equipment with the inspections and results recorded on videotape.
