**FRAMATOME ANP REPORT 51-5027436-00**  
**"EXAMINATION OF DIABLO CANYON UNIT 2 SG TUBES – FINAL REPORT"**

## **Examination of Diablo Canyon Unit 2 Steam Generator Tubes**

**51-5027436-00**

**Final Report, May 2003**

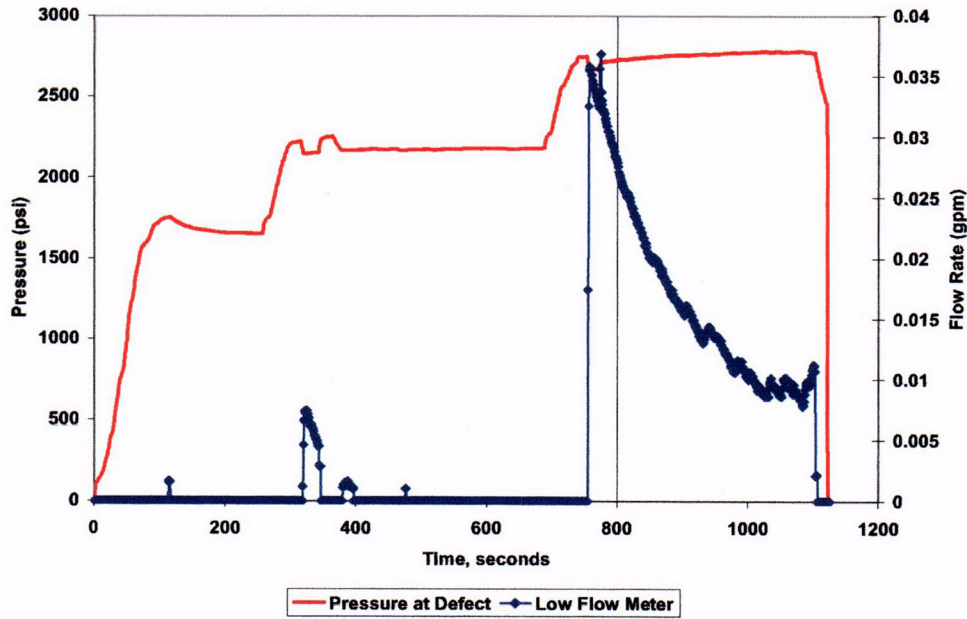
The test pressure and leak rate versus time (time in seconds) results for R35C57 are shown in Figure 4. Leakage initiated at approximately 2200 psi but decreased with time over the hold period and again increased with the increase in pressure to the MSLB condition. The maximum MSLB leak rate measured during this test was 0.0368 gpm at the start of the hold period at the MSLB pressure differential. Over the hold time at MSLB conditions with approximately constant pressure, the leak rate decreased by about a factor of three. Although deionized water was used in the tests to minimize the potential for particles in the water, it's possible that particulates in the pulled tube test specimen may have deposited within the crack.

Figure 4. Room temperature leak rate for SG 24 tube no. R35C57, section 8 (02H TSP)

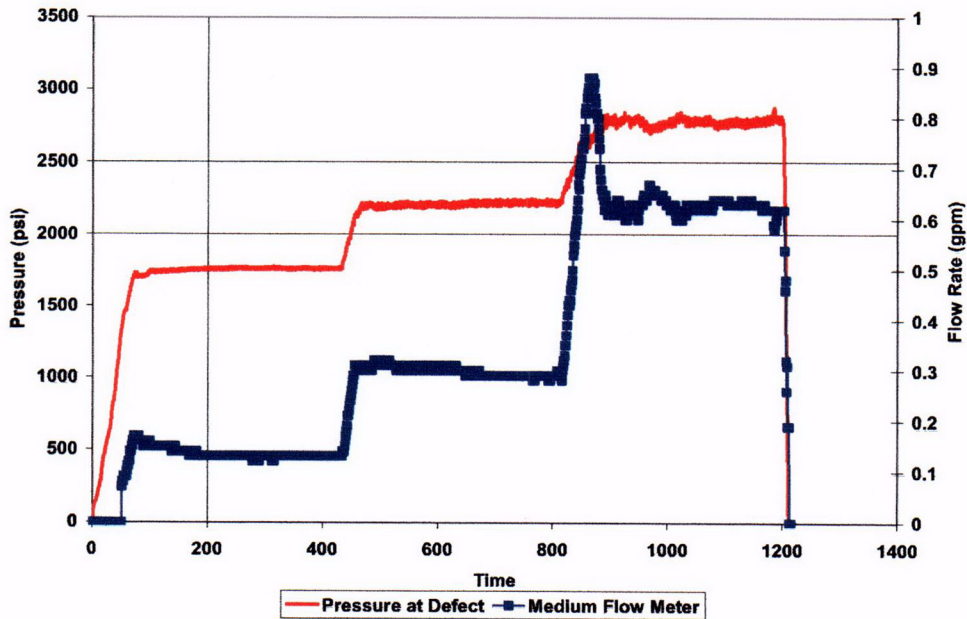
The test pressure and leak rate versus time (time in seconds) for R44C45 are shown in Figure 5. Upon reaching the MSLB pressure differential, the leak rate increased to a maximum of 0.88 gpm. This spike in leak rate might have been due to a transient in the flow meter following the rapid increase in leakage with increasing pressure. Following the spike, the leak rate remained essentially constant for the remainder of the 5 minute hold time.

Figure 5. Room temperature leak rate for SG 24 tube no. R44C45, section 13 (02H TSP)

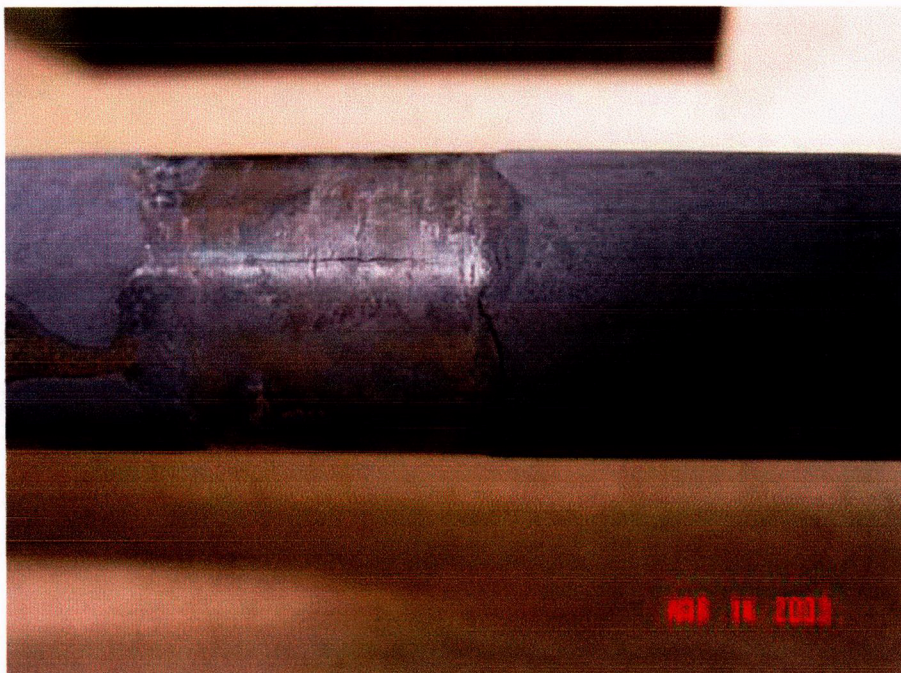
Following leak rate testing, the tube sections were reexamined and subjected to repeat eddy current inspection with the 3-coil rotating probe. Figure 6 is a photograph of the 2H intersection of tube no. R44C45 at ~75°, showing the axial crack that was not visible before leak rate testing. The visible portion of the crack was ~0.55 inches long.

**Figure 6. Post leak rate test photograph of axial crack at  $\sim 75^\circ$  in 02H TSP intersection of tube no. R44C45. The top (in SG) of the tube section is to the right.**

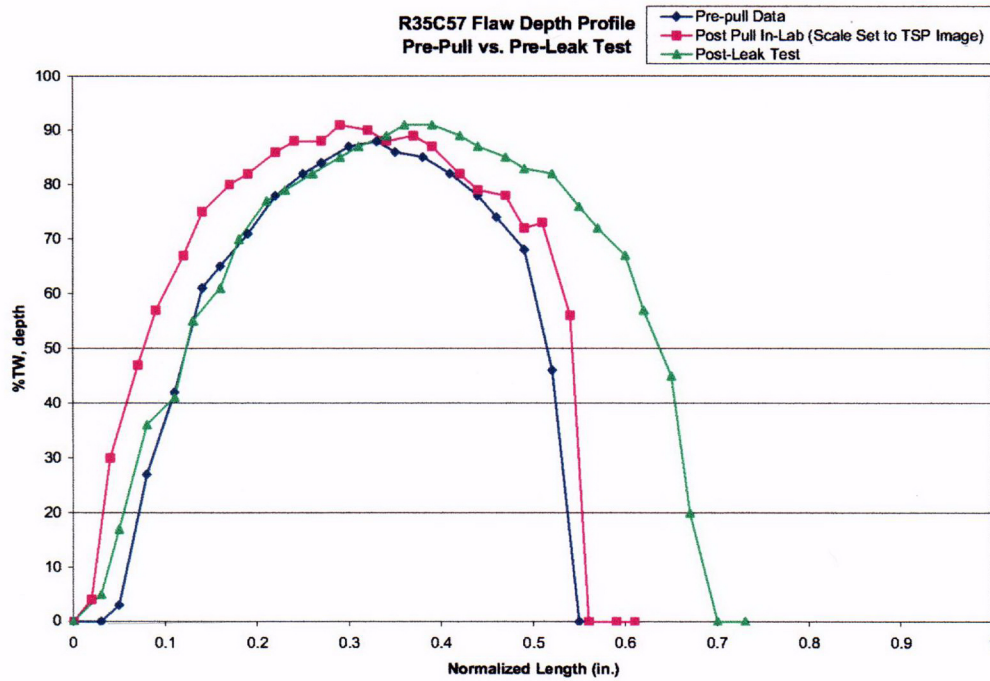
The field bobbin coil inspection identified a 5.09 volt (V) DOS<sup>2</sup> indication approximately in the middle of the 2H TSP. The +Point coil identified the indication as a 4.01V single axial indication (SAI). Following tube pull, the voltages increased to 7.18V and 5.08V for the bobbin and +Point coils, respectively. These increases in voltage may have occurred as a result of ligament tearing between micro cracks and/or a change in the width of the crack following removal of the tube from the steam generator; i.e., the primary crack may have opened up slightly when no longer constrained by the TSP or deposits within the TSP. The SAI was estimated to be near through wall and positioned 202° from the reference notch.

**Figure 7. Axial crack NDE profile at 02H TSP location for tube no. R35C57**

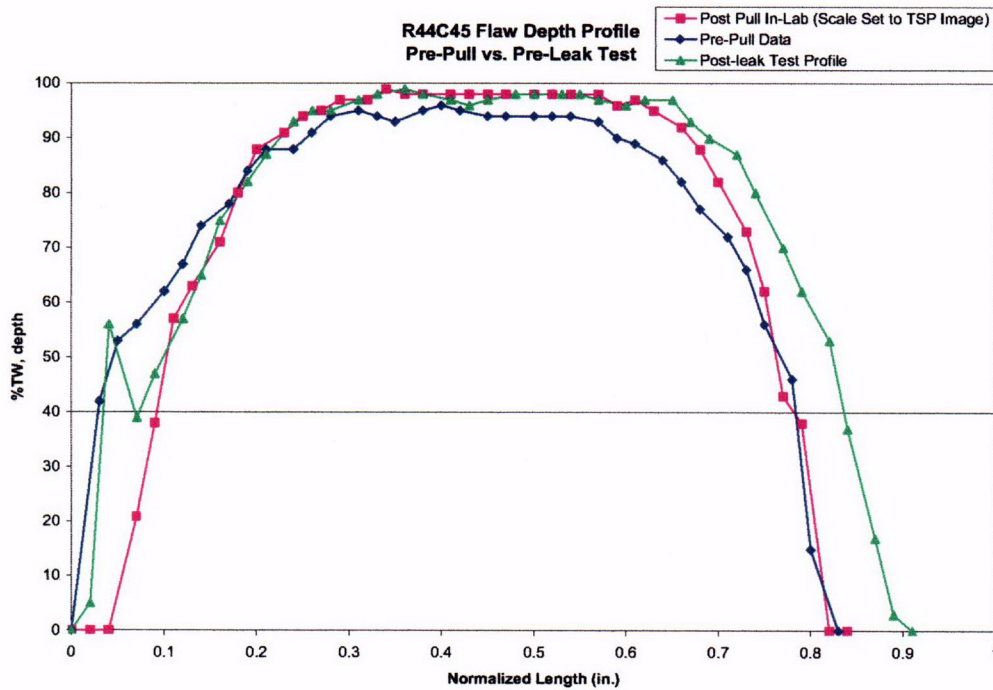
The field bobbin coil inspection identified a 21.5V DOS indication at 0.14" above the middle of the 2H TSP. The +Point coil identified two axial indications (SAI) at the 2H TSP. Following tube pull, the bobbin coil voltage increased by ~50% to 32.31V (on platform) and to 35.73V (in lab). No dent signal was observed either before or after the tube pull for this tube. The larger of the two axial indications also exhibited an increase in voltage from 12.12V (field) to 17.37V (on platform) and to 15.58V (in lab). The larger of the two indications was estimated to be 98% through wall and positioned 73° from the reference notch. The smaller indication was estimated to be 57% through wall and positioned 25° from the reference notch.

**Figure 8. Axial crack NDE profile at 73° at 02H TSP location for tube no. R44C45**

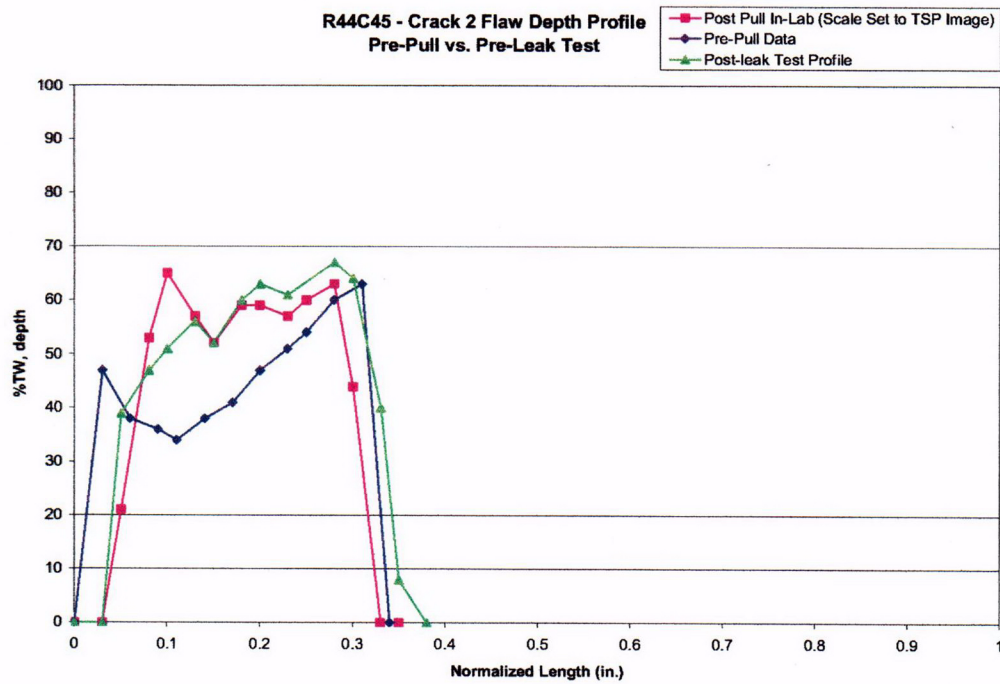
**Figure 9. Axial crack NDE profile at 25° at 02H TSP location for tube no. R44C45**

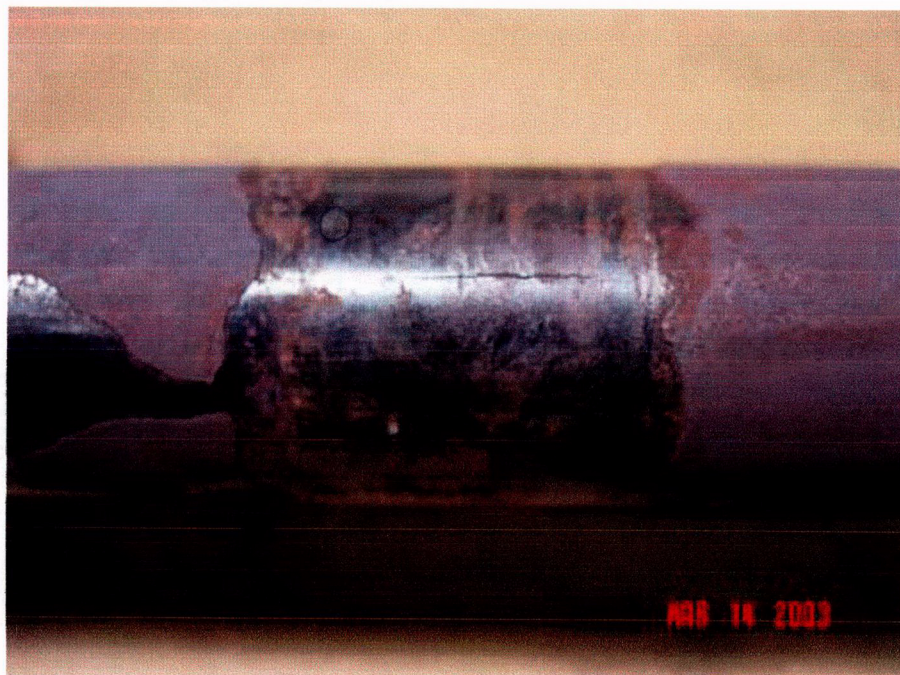
**Figure 10. Post oxidation view of axial crack at ~75° in tube no. R44C45 at 02H TSP intersection.**

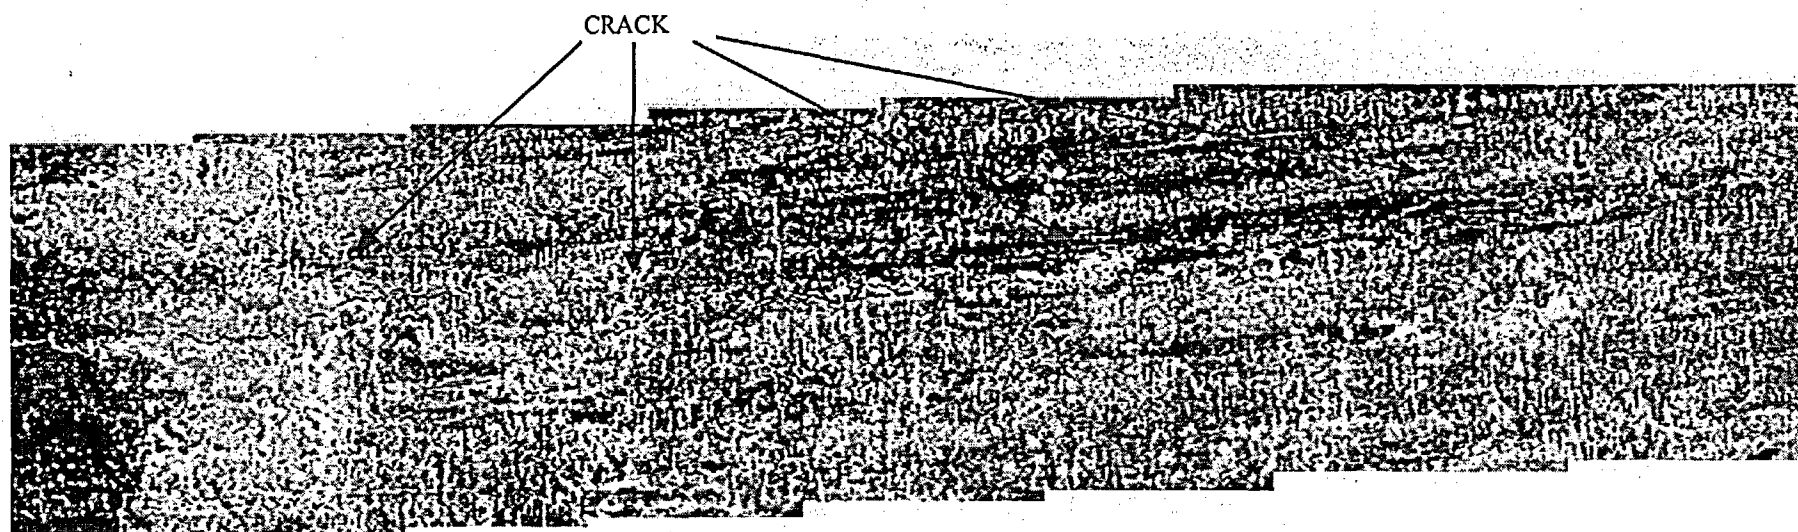
Stereovisual examinations detected an axial crack on R35C57-8B at ~170°, starting about 0.2" above the bottom of the 2H TSP region. A photo mosaic of this crack is provided in Figure 27. A large axial crack was located on R44C45-13A at ~90°, which was ~0.6" long and ended just below the top of the 2H TSP region. A photograph of this crack is provided in Figure 28. Another small area of secondary cracking was also noted on R44C45-13A at ~25° within the TSP region.

Figure 27. Axial crack in O2H TSP region of R35C57-8B at 170°. 24X

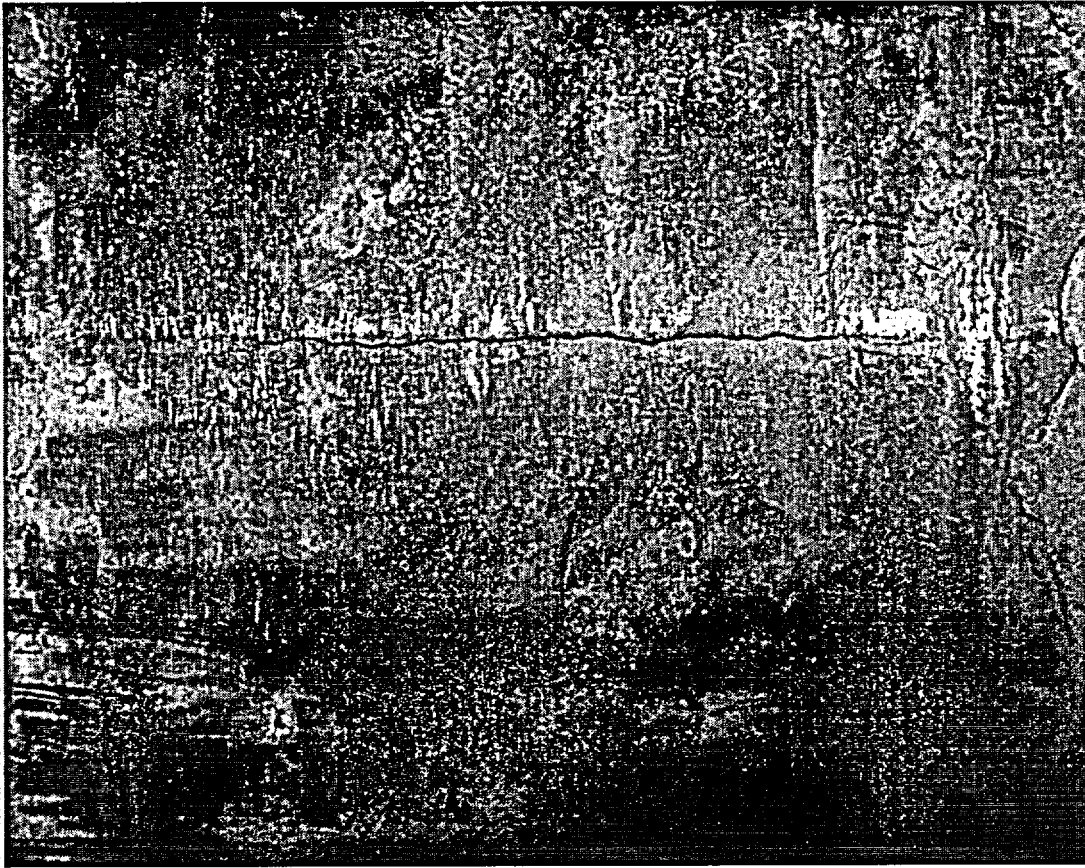
Figure 28. Axial crack in 02H TSP region of R44C45-13A at 90°. 6X

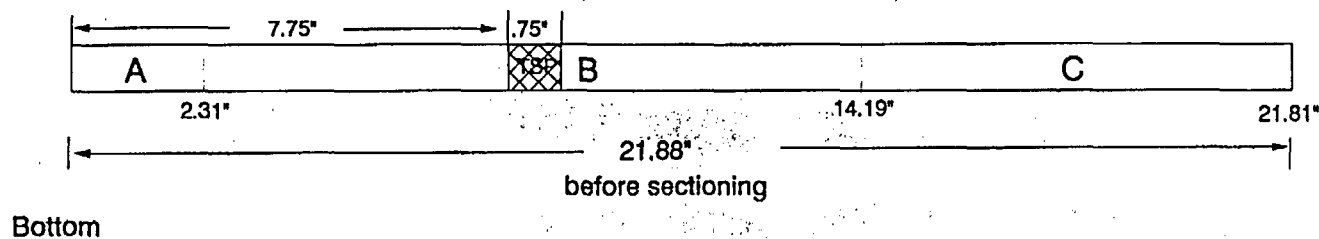
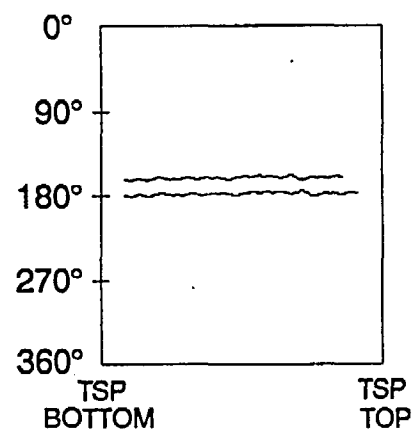
Figure 29. 2H TSP crack locations and initial sectioning of R35C57-8

Main crack at 170° from 0.2" to 0.7"

Secondary crack at 180° from 0.2" to 0.75"

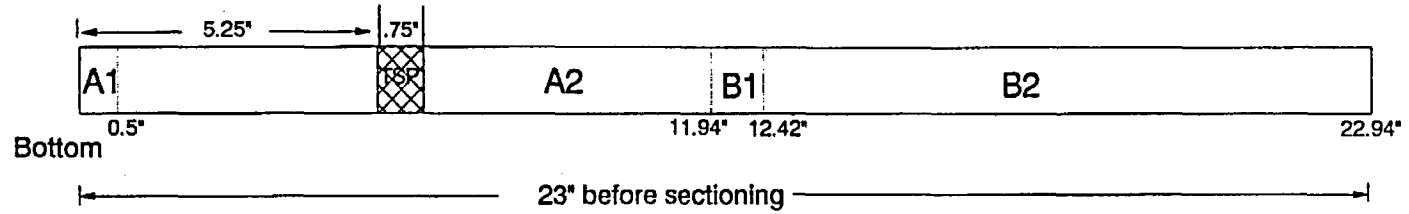
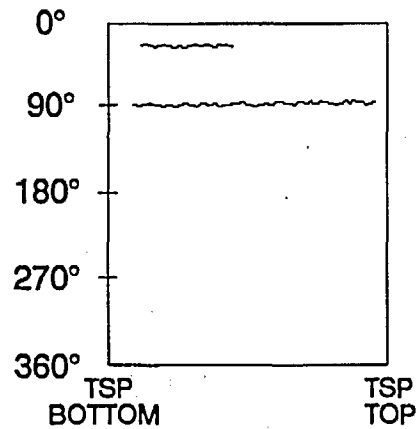
Secondary crack at 25° from 0.05" to 0.4"

Main crack at 90° from 0.04" to 0.74"

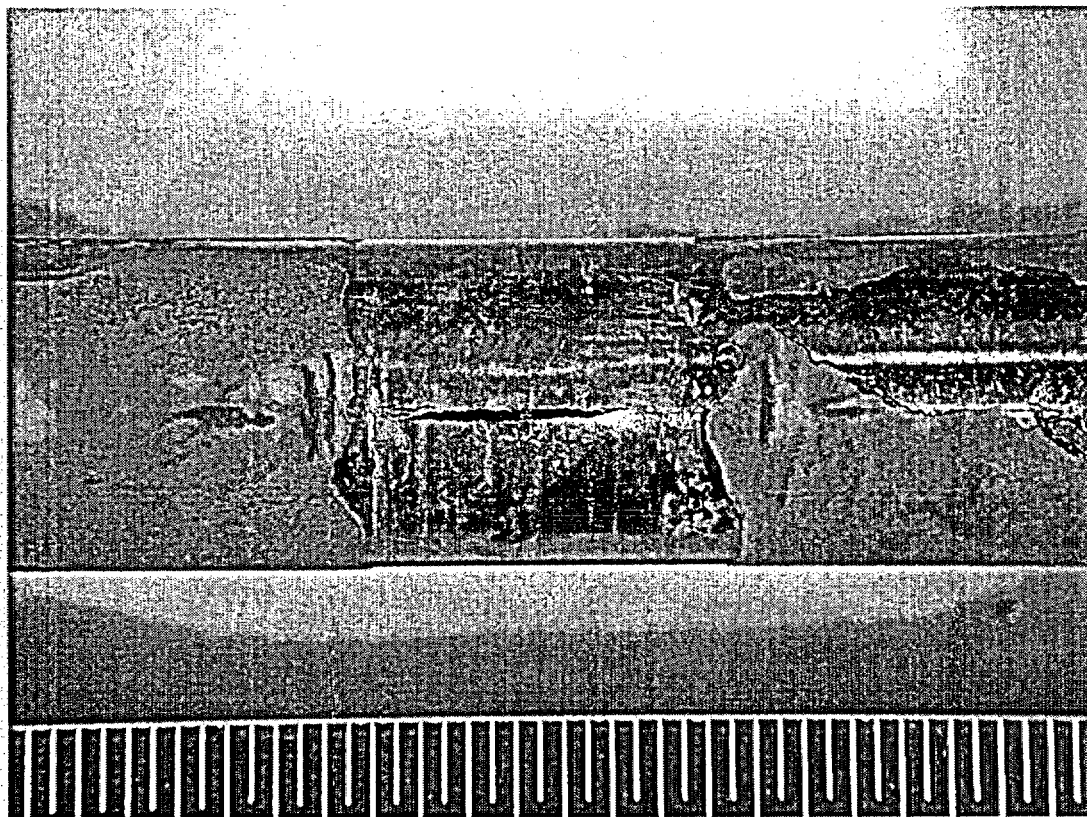
Figure 37. Crack opening on R44C45-13A2 after initial pressurization to 3,403 psi (shim slipped). Later burst tested to 4,226 psi. 2.1X

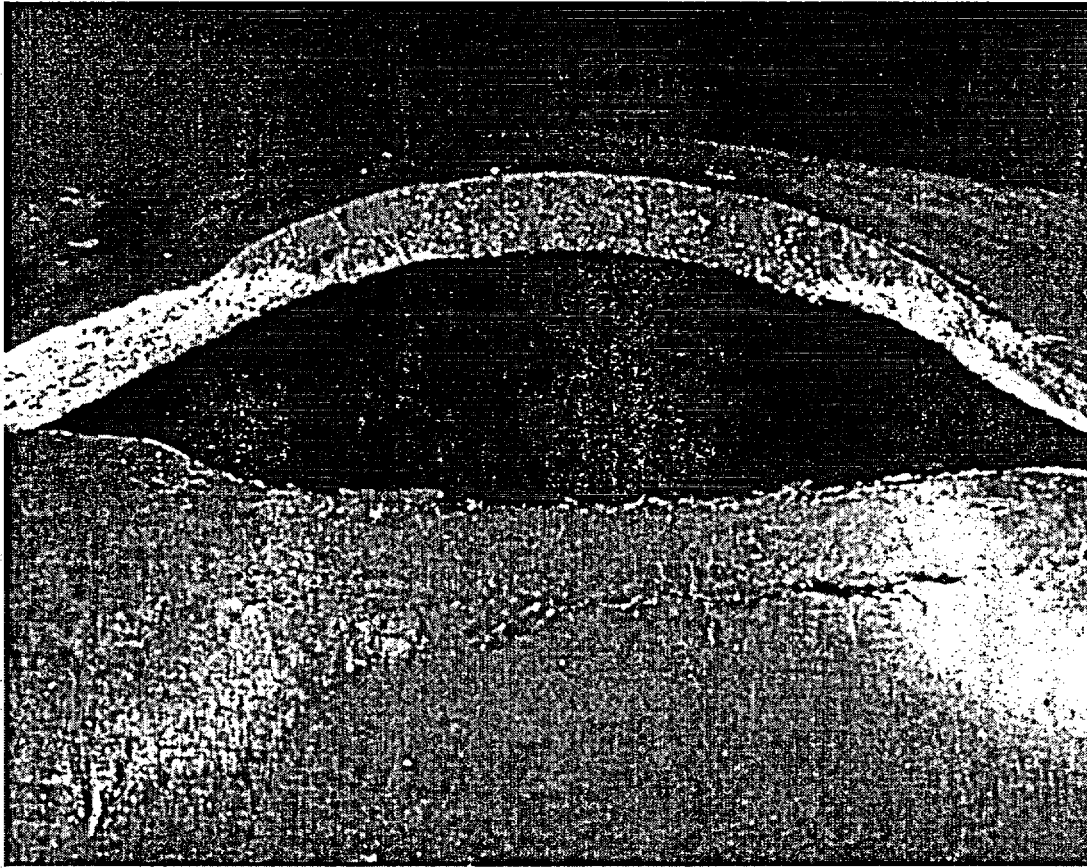
Figure 47. Oxidized CCW rupture surface on R35C57-8B along with secondary fissure. 8X

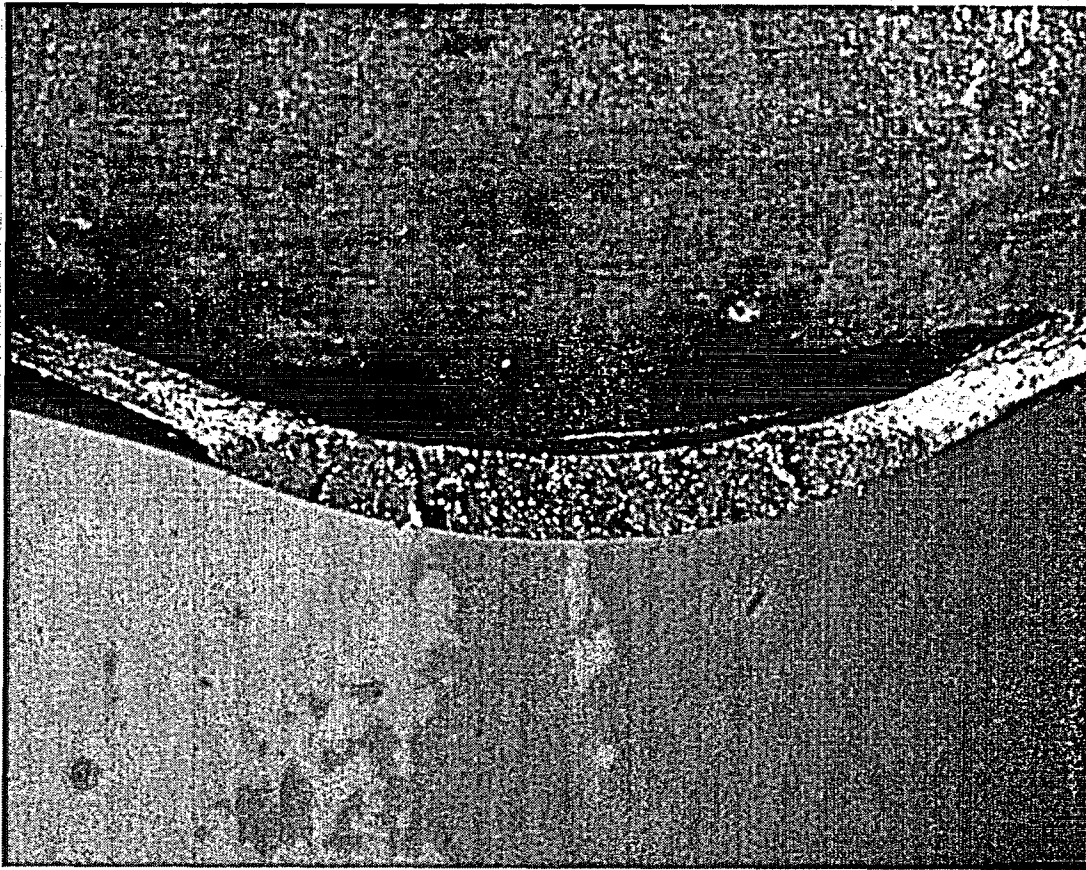
**Figure 48. Oxidized CW rupture surface on R35C57-8B. 8X**

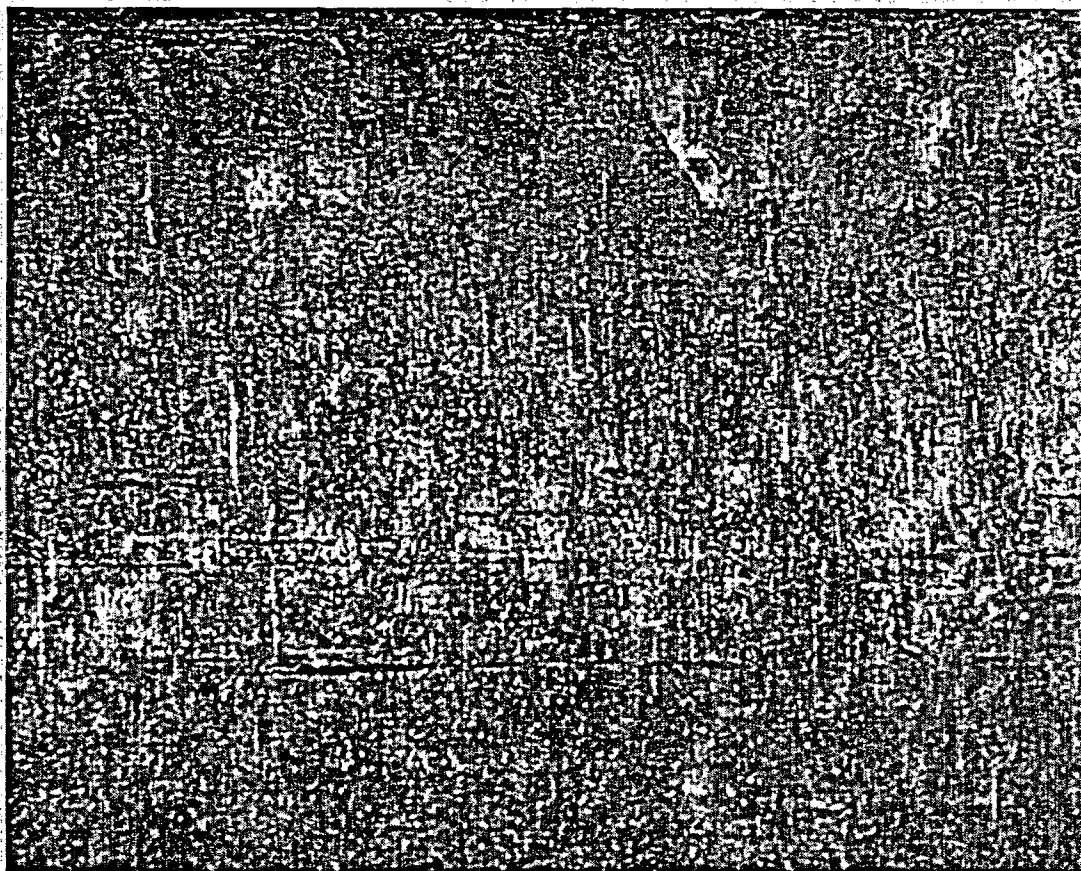
**Figure 50. Typical mottled deposits on R35C57-9B after burst testing. 12X**

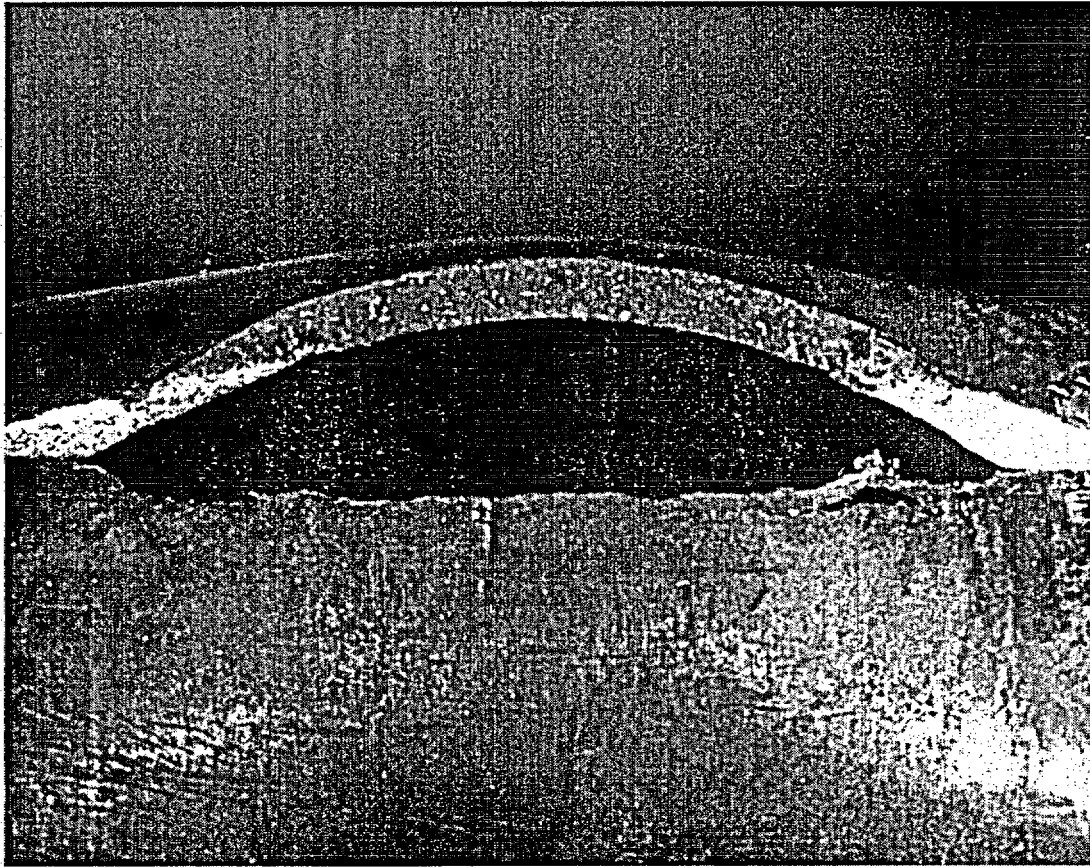
Figure 60. Oxidized CCW rupture surface on R44C45-13A2B1. 6X

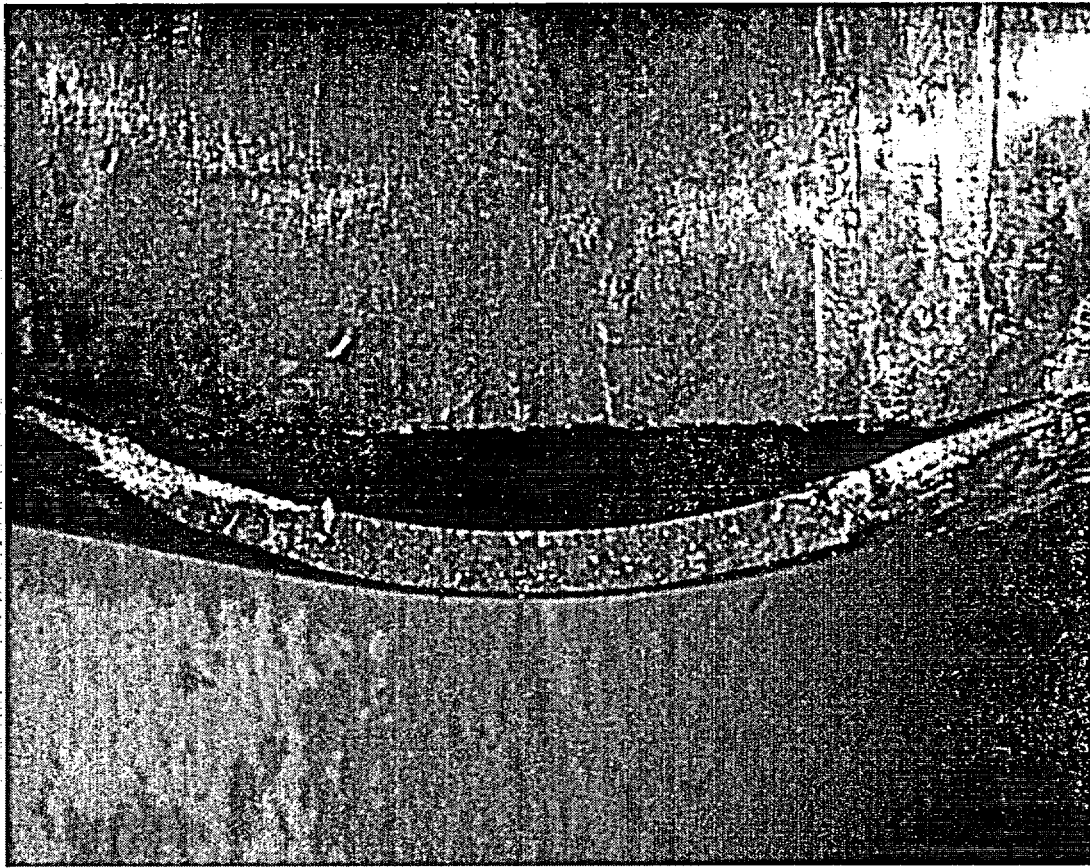
**Figure 61. Oxidized CW rupture surface on R44C45-13A2B1. 6X**

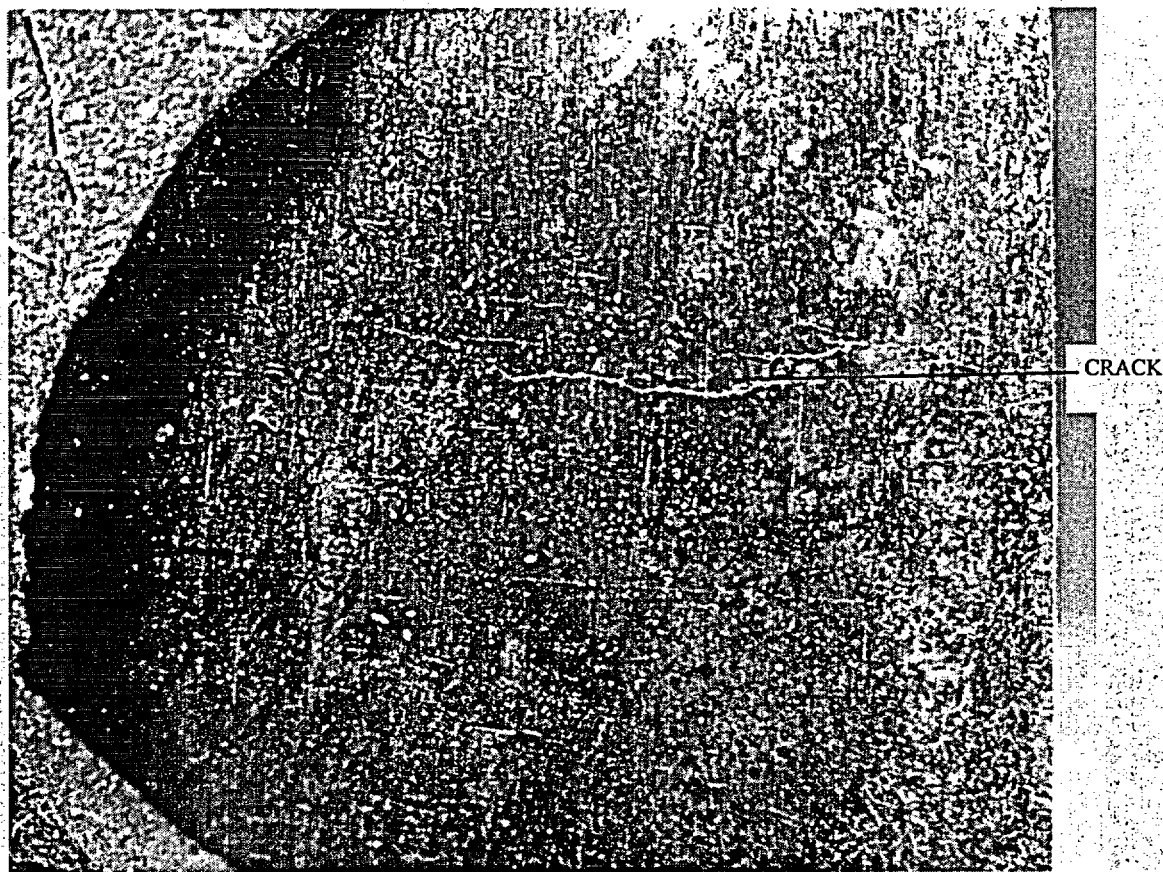
**Figure 62. Secondary crack near 25° on R44C45-13A2B2 (broken out of metallographic mount). 15X**

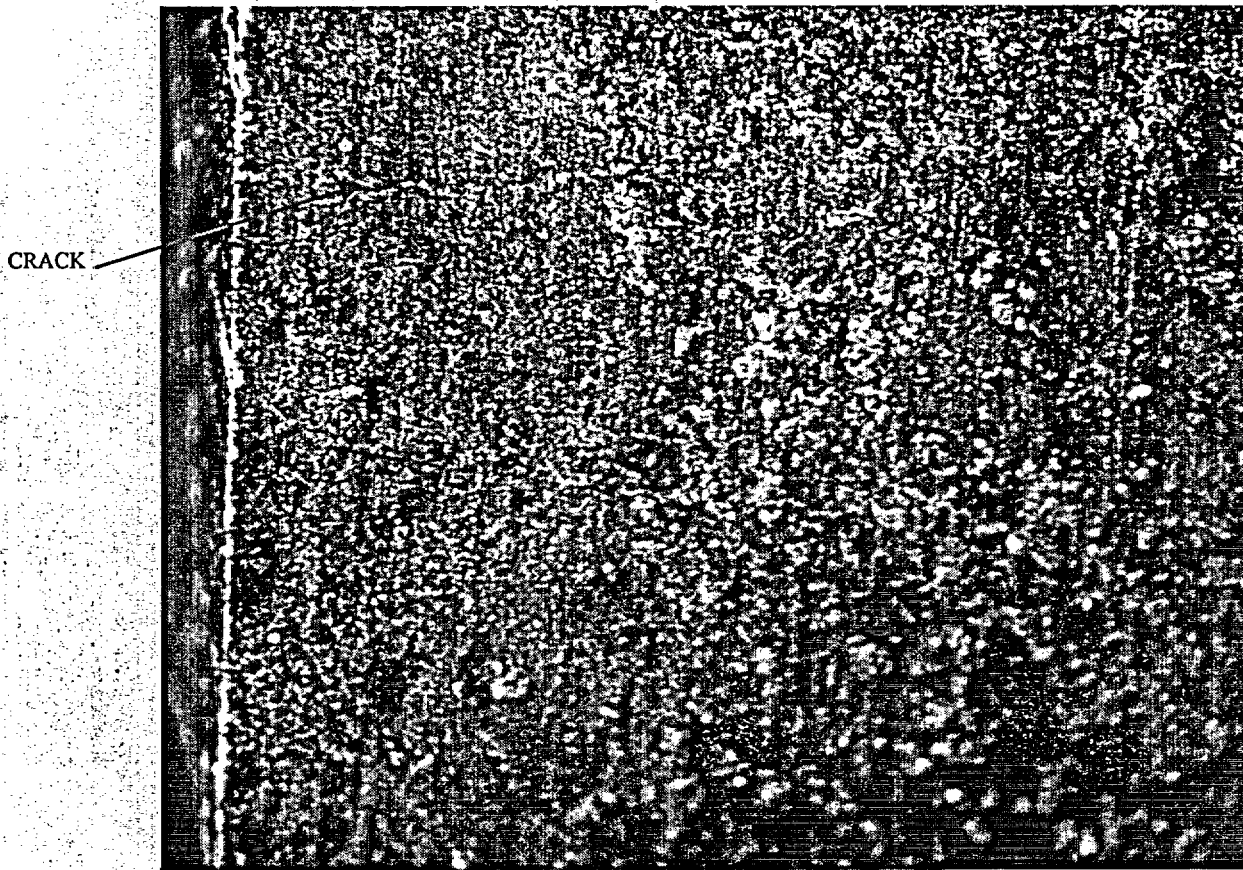
**Figure 63. Other half of secondary crack near 25° on R44C45-13A2B3. 83X**

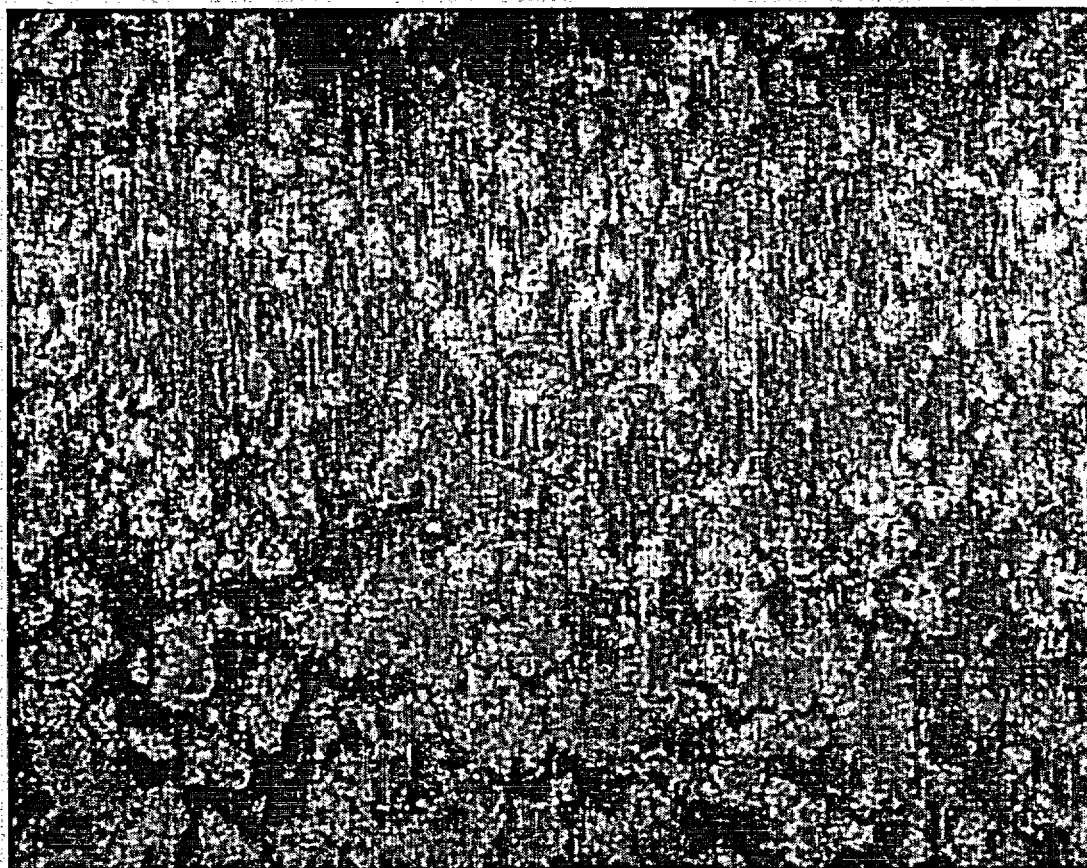
**Figure 69. Typical mottled deposits on R44C45-13B2 after burst testing. 12X**

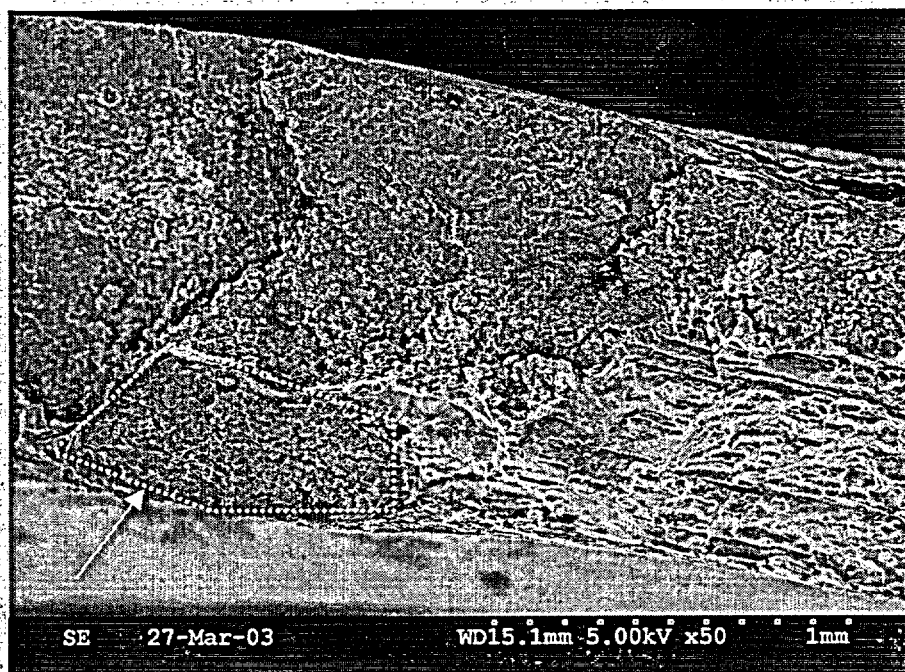
Figure 82. Near top edge of IGSCC region on R44C45-13A2B1. An out-of-plane small crack is indicated by the white arrow and boxed-in region.

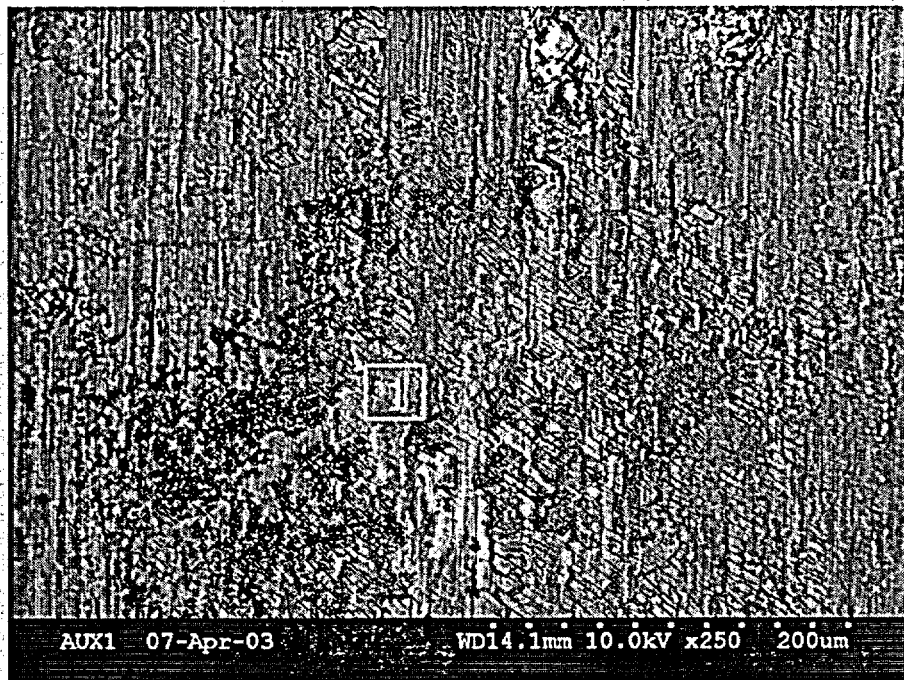
Figure 89. Typical OD wall near burst rupture on R35C57-8B2B.  
WDS performed on Area 1. BSE 250X

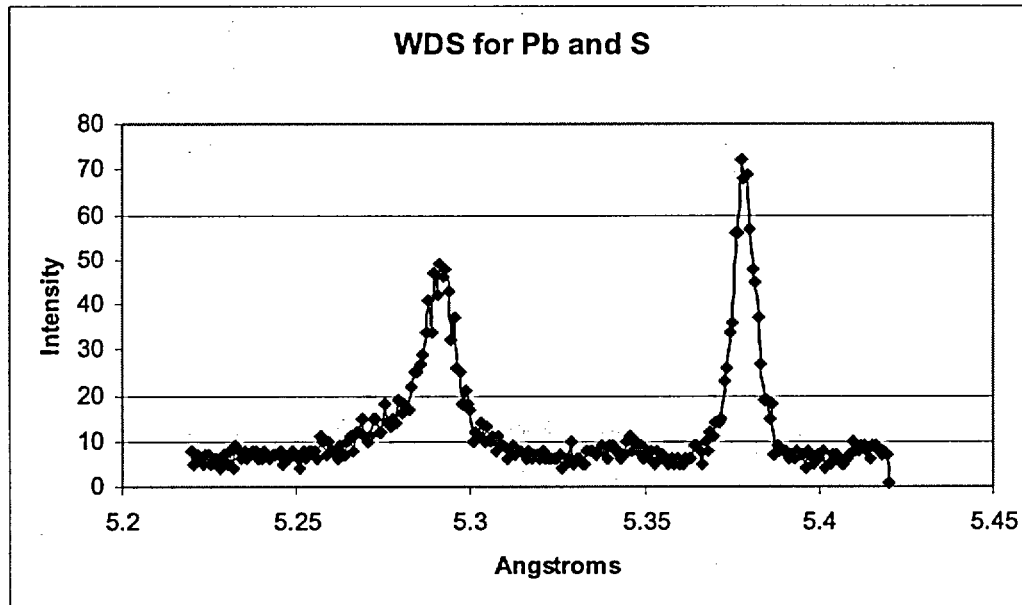
SEM/EDS/WDS analysis revealed the presence of sulfur and lead in spalled areas on the OD surface near the defect location of R35C57, as well as on the burst rupture surface itself. This is consistent with results from the 2R8 tube pull examination conducted in 1998.<sup>[3]</sup> Sulfur and lead are known to be detrimental to Alloy 600 and have been previously implicated in ODSCC.

Figure 90. WDS of Area 1 in Figure 89. Main peak is sulphur (5.3722 Å°) and secondary peak is lead (5.286 Å°).

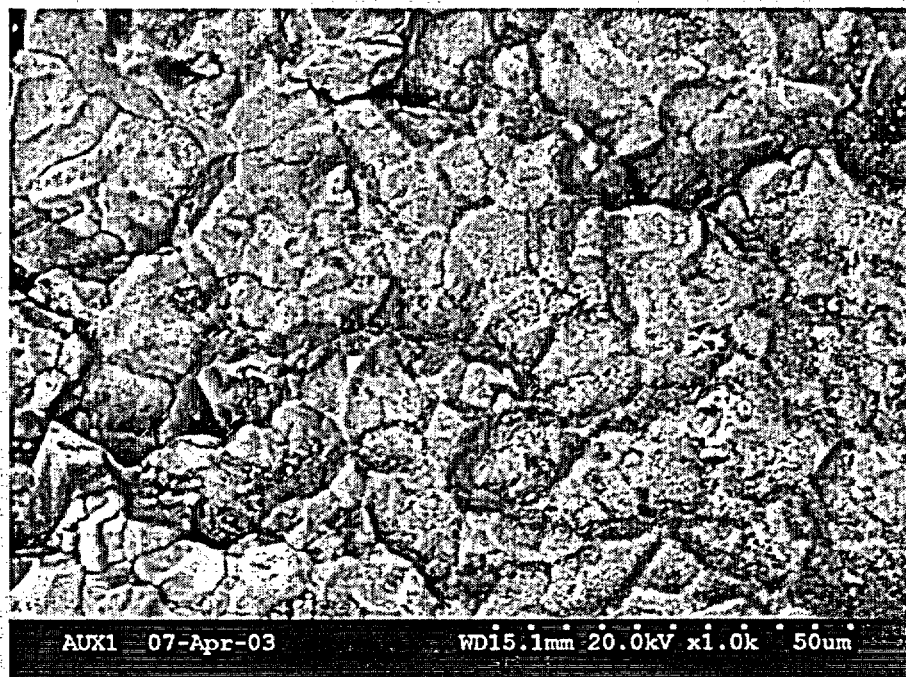
Figure 91. Typical IGSCC on R35C57-8B2B rupture surface.  
BSE 1000X

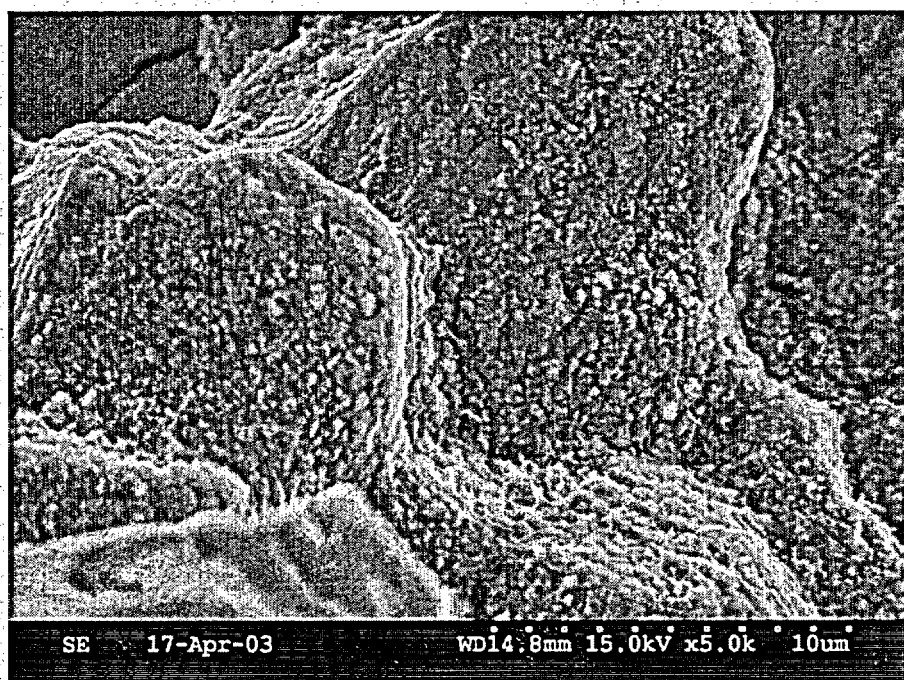
**Figure 93. Area on rupture surface of R35C57-8B2B used for WDS analysis for lead and sulphur. SE 1000X**

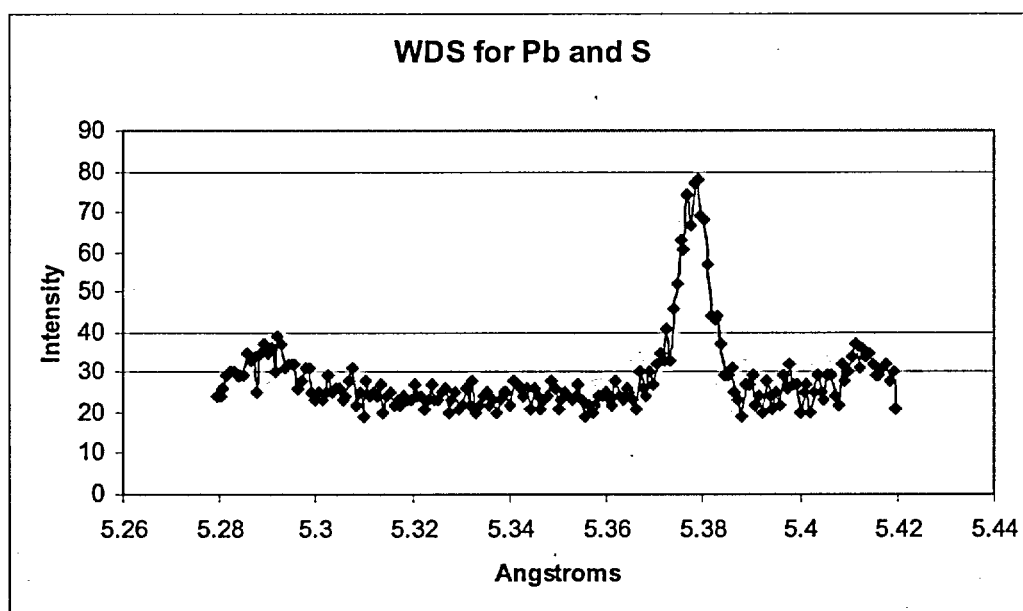
**Figure 94. WDS of area in Figure 93. Main peak is sulphur (5.3722 Å) and secondary peak is lead (5.286 Å).**

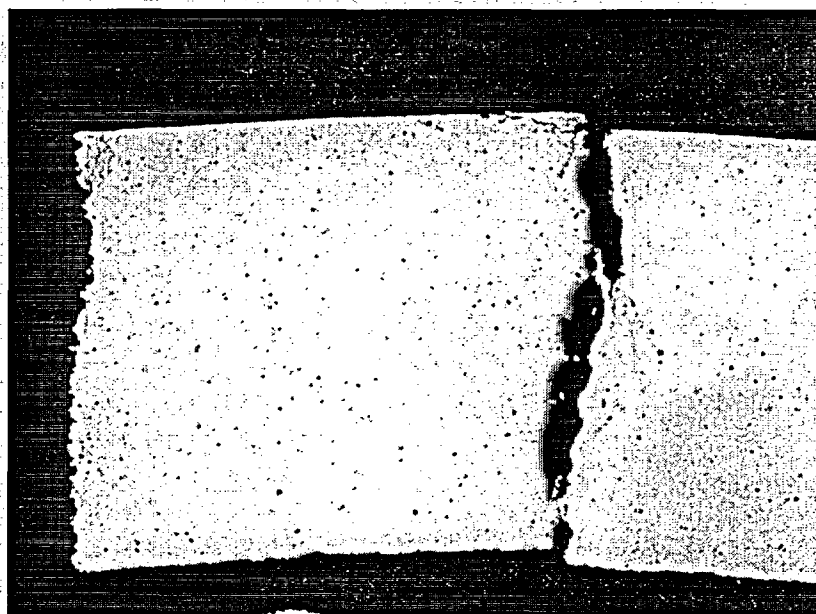
**Figure 95. Rupture surface (170°) and secondary through wall crack (180°) on R35C57-8B2B. 46X**

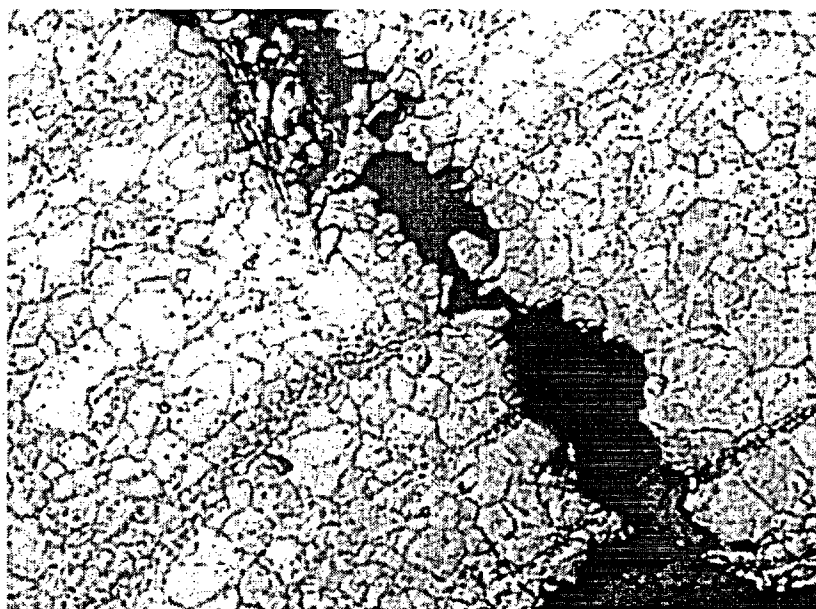
**Figure 96. Etched microstructure of secondary crack on ID surface of R35C57-8B2B. 480X**

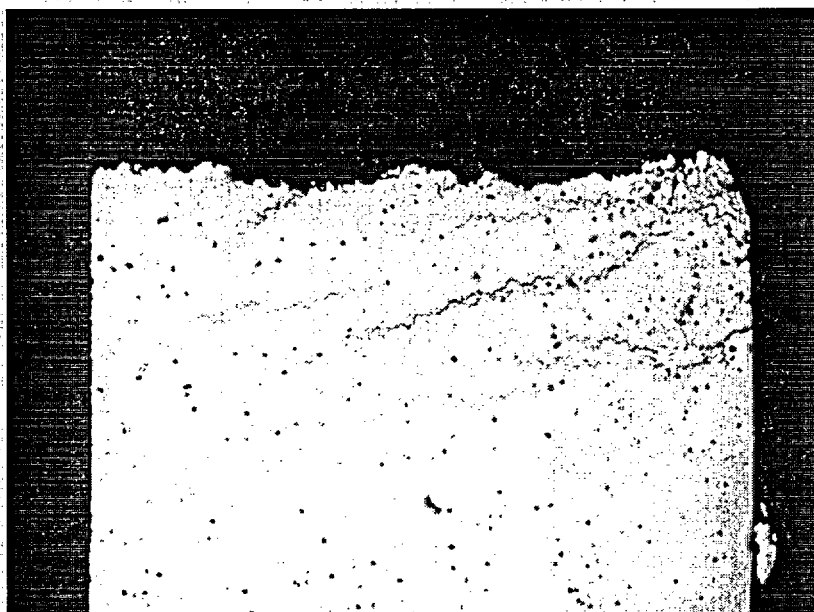
Figure 97. Secondary cracking near rupture surface of R44C45-13A2B2. 75X
