**FRAMATOME ANP REPORT 51-5027436-00**  
**"EXAMINATION OF DIABLO CANYON UNIT 2 SG TUBES – FINAL REPORT"**

## **Examination of Diablo Canyon Unit 2 Steam Generator Tubes**

**51-5027436-00**

**Final Report, May 2003**

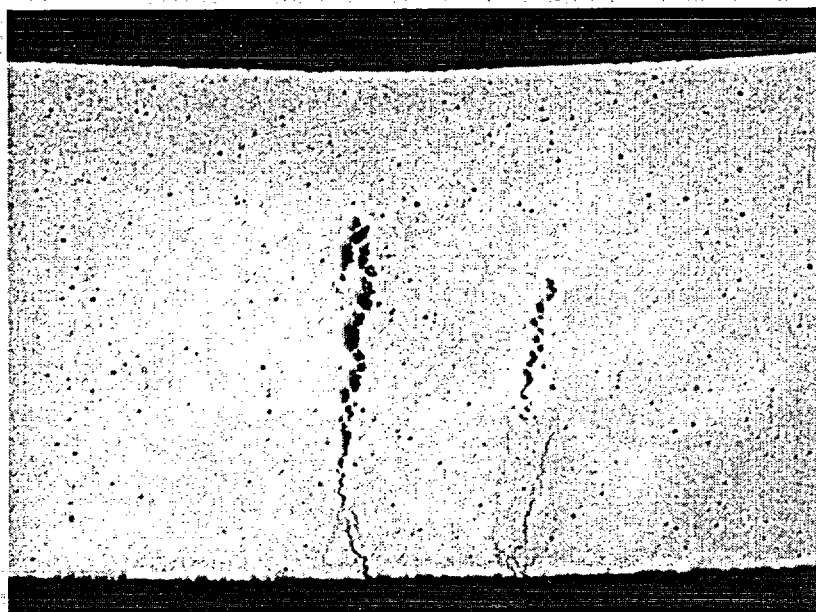
Figure 99. Secondary cracks on R44C45-13A2B2 near 25°. 58X

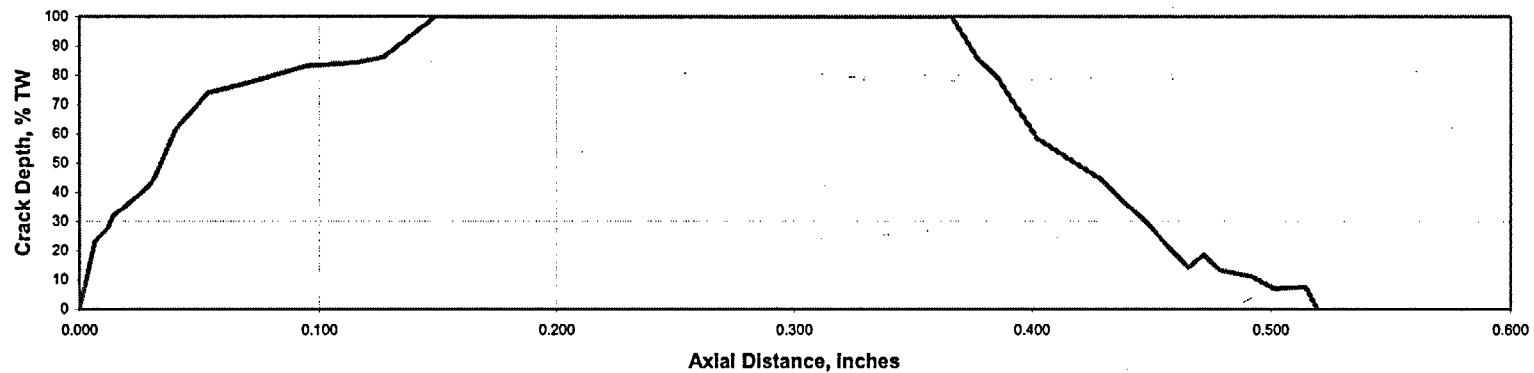
**Figure 1**

SG 24 Tube 35-57, No Ductile Tearing Observed at SLB

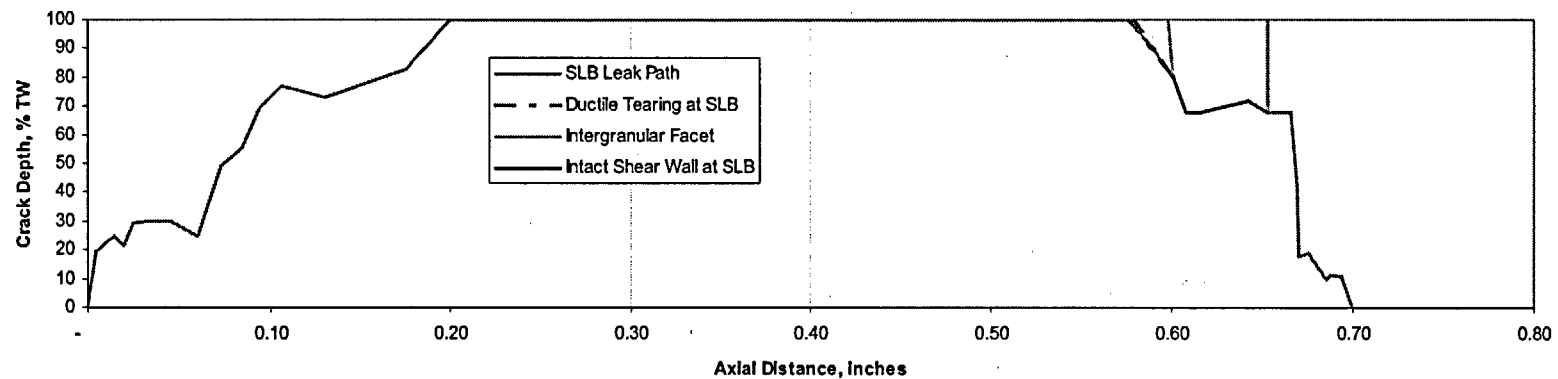
**Figure 2**

SG 24 Tube 44-45

Notes for Figure 2: (1) The ductile tearing at SLB is essentially negligible
