## **Bottom Mounted Instrument Penetration Tube Condition Update**

## **PROGRESS SUMMARY**

## Summary

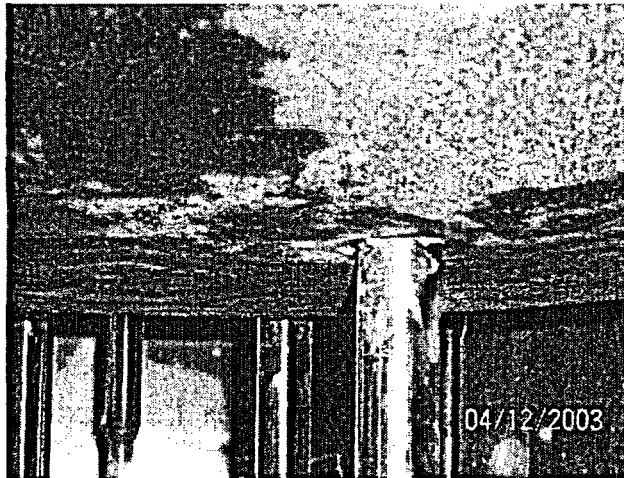
## Penetration #1

~150 mg of residue on Penetration #1

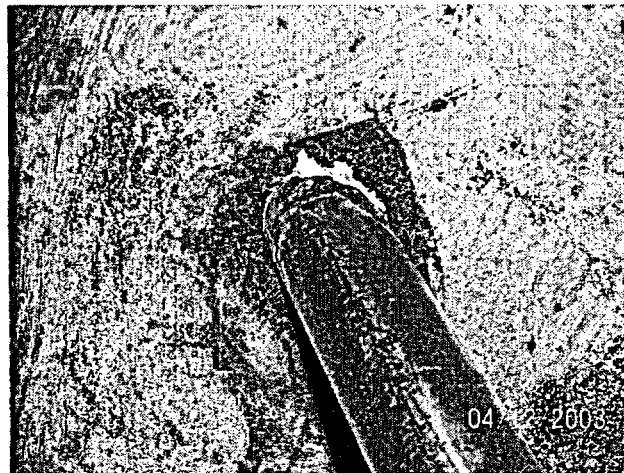
## Penetration #46

~ 3 mg of residue on Penetration #46

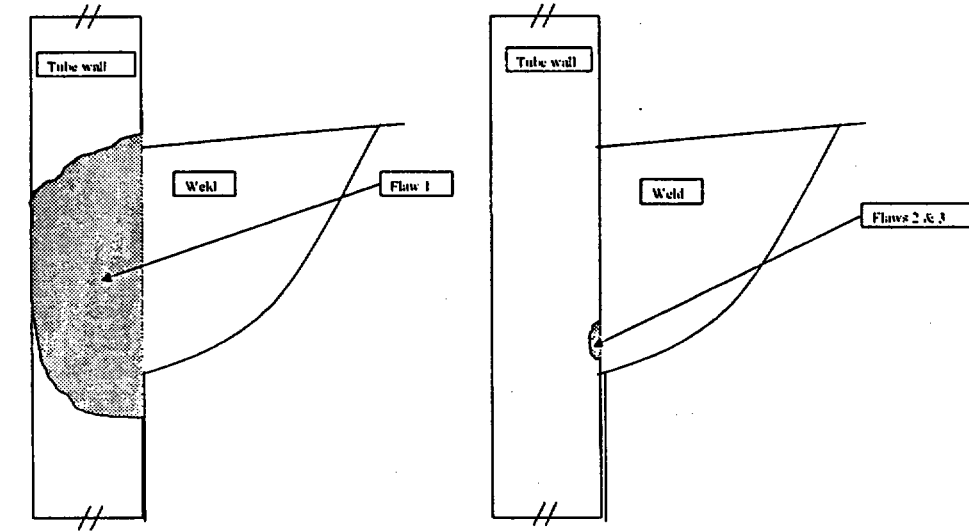
## Penetration #1

- Penetration #1
  - Three axial indications, one leak path
  - No crack-like indications on J-Groove weld
  - Visual grinding marks in side of tube
- Penetration #46
  - Two axial indications, one leak path
  - No crack-like indications on J-Groove weld

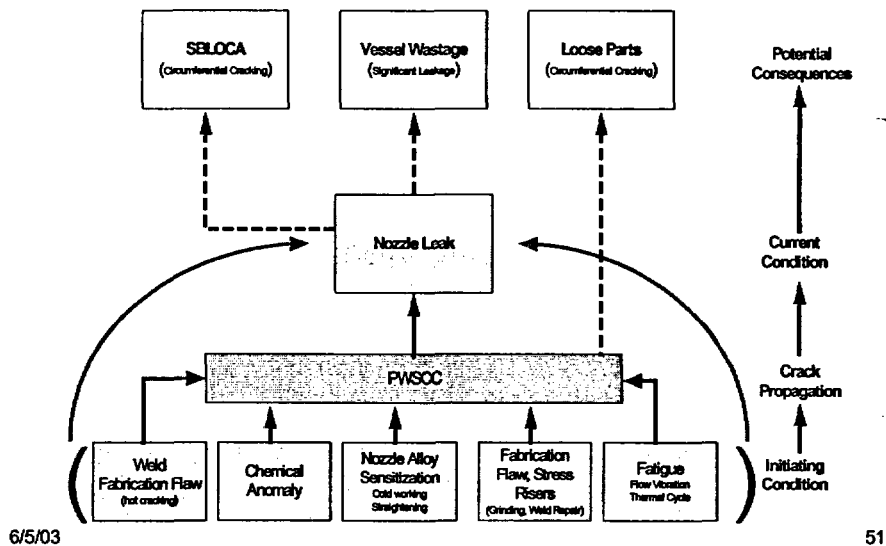
## PWSCC May Not Be the Cause

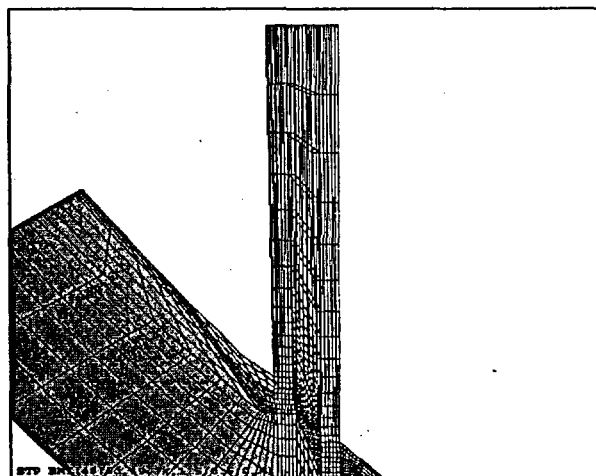
## Analysis Shows Minimal Displacement During Welding

Coldworking is not a significant contributing factor

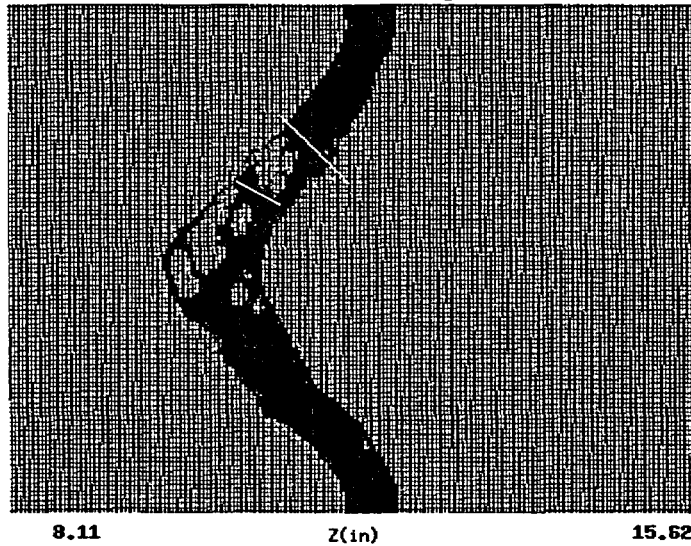
## Axial Scan of Penetration 46 with Flaws Overlayed

- Residual fabrication stresses
  - J-groove weld grinding, welding, welding rework
- Lack of J-groove weld fusion to nozzle OD
- Weld cracking; fabrication defects / contaminants
- Combination of one or more with PWSCC
