**SOUTH TEXAS PROJECT UNIT 1
BOTTOM MOUNTED INSTRUMENTATION NOZZLE
LEAKAGE ISSUE**

**Matthew A. Mitchell, Senior Materials Engineer
Materials and Chemical Engineering Branch
Office of Nuclear Reactor Regulation**

**Advisory Committee on Reactor Safeguards Full Committee Meeting
July 11, 2003**

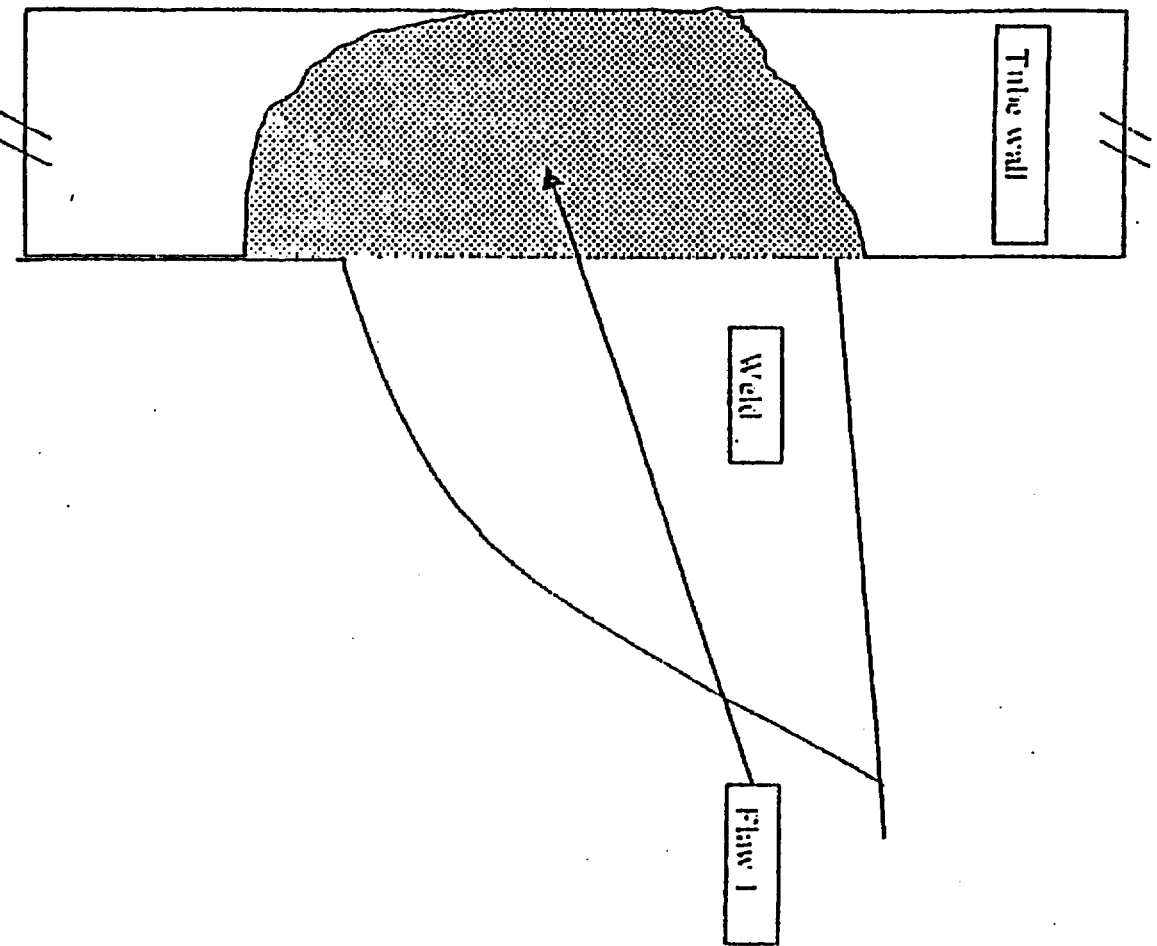
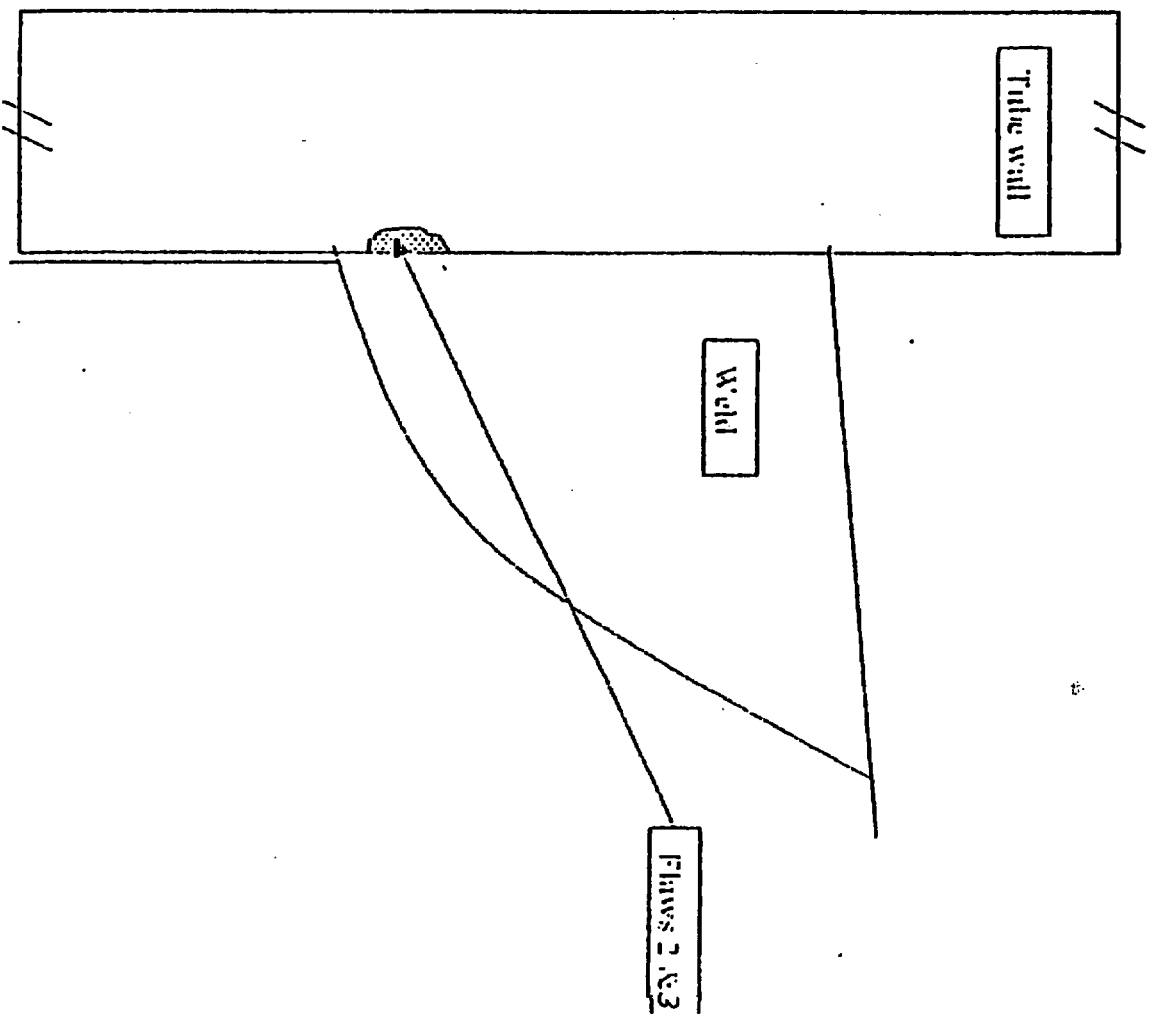
Penetration #1

- In April 2003, the licensee discovered deposits characterized as, in total, “about the size of one half of an aspirin tablet” around bottom mounted instrumentation (BMI) penetrations #1 and #46.
- Chemical analysis showed evidence of boron and lithium, indicating the reactor coolant system (RCS) to be the most likely source of the deposits.
- Radiochemical analysis based on cesium isotope dating indicated that the deposits were approximately four years old.

- The licensee's NDE results showed:
 - Three axially-oriented indications in nozzle #1. One indication characterized as having a length of ~1.38 inches, extending from above to below the J-groove weld and penetrating the ID of the tube. The other two indications were much smaller and near the root of the weld.
 - Two axially-oriented indications in nozzle #46. One indication characterized as having a length of ~0.98 inches and extending from above to below the J-groove weld. The other indication characterized as having a length of ~0.95 inches and not surface connected.
 - EVT-1 examinations showed signs of extensive grinding on the nozzle and J-groove weld surfaces of many penetrations.

- The licensee has repaired STP Unit 1 nozzles #1 and #46 using a “half nozzle repair” similar in design to those used to repair other Alloy 600 penetrations.
- The repair was made using Alloy 690 nozzle material and Alloy 52/152 weld material, including the installation of a temper bead weld pad on the outside of the RPV lower head. The RCS pressure boundary weld was moved to the outside surface of the RPV.
- Questions regarding future inspections of the repair, along with inspections of the ferritic base material which will be left exposed to the reactor coolant, are being addressed by the licensee in support of NRC staff review and approval of the repair.
