South Texas Project Electric Generating Station P.O. Box 289 Wadsworth, Texas 77483

South Texas Project
Units 1 & 2
Docket Nos. STN 50-498, STN 50-499
Additional Information Regarding STP's Commitment to Investigate and Repair
Bottom Mounted Instrumentation Penetration Indications

South Texas Project Status Report on Resolving the Unit 1 BMI Issue

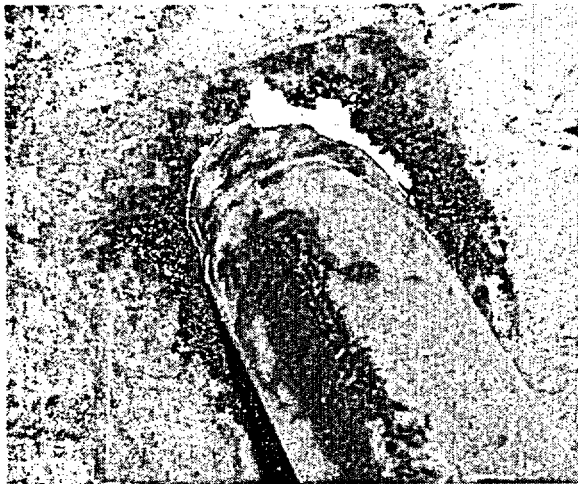
Figure 1 (Nozzle 46)

Nozzle 46 had two cracks and each crack was axially oriented to the J-groove weld. One crack extended above and below the J-groove weld but did not penetrate the inside diameter of the nozzle. The second crack extended for most of the length of the J-groove weld from the outside diameter, did not extend either above or below the J-groove weld, and did not penetrate through to the inside diameter of the nozzle.

The bottom head of the reactor was inspected on April 12, 2003 as a routine part of the station's regular bare metal inspection of the reactor vessel bottom penetrations. The inspection is part of the RCS Pressure Boundary Inspection for Boric Acid Leaks program, OPGP03-ZE-0033. The bottom head of the reactor is contained in an insulating box structure with no insulation directly in contact with the bottom head. The inspection is accomplished by removing some of the insulation panels forming the box. Three different vantage points are used to inspect all 58 BMI nozzles. The inspection found small amounts (150 milligrams on nozzle 1 and 3 milligrams on nozzle 46) of white residue around Bottom Mounted Instrument (BMI) nozzles number 1 and 46 at the annulus between the nozzle and the bottom head, (Figure 1 and Figure 2).

Nozzle 46 had two cracks. Each crack was axially oriented to the J-groove weld. One crack extended above and below the J-groove weld but did not penetrate the inside diameter of the nozzle. The second crack was smaller, did not extend above or below the J-groove weld, and did not penetrate the inside diameter of the weld.

South Texas Project performed half-nozzle repairs on both Bottom Mounted Instrument nozzles number 1 and 46, using an Alloy 690 material with demonstrated superior corrosion resistance compared to the original Alloy 600 nozzle. The repair relocated the pressure boundary to the outside of the reactor pressure vessel surface where future visual and non-destructive examinations can be readily performed. The upper section of the original Alloy 600 nozzle remains in service as a non-pressure boundary component.

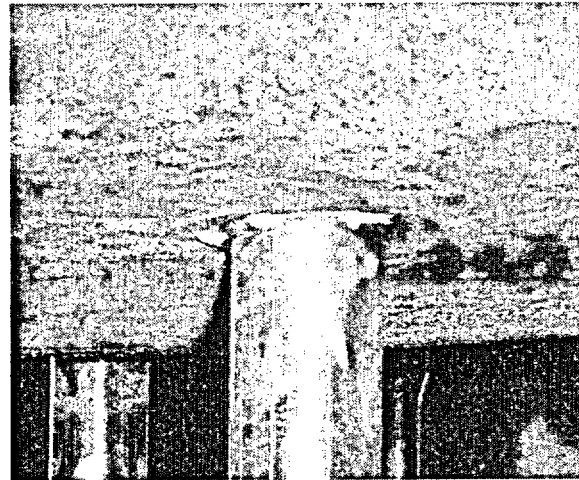
Figure 2 (Nozzle 1)

Nozzle 1 had three cracks and each crack was axially oriented to the J-groove weld. One crack extended above and below the J-groove weld and penetrated the inside diameter of the nozzle. The second and third cracks were much smaller and were located on the outside diameter of the nozzle close to the initial root weld passes. The second and third cracks did not extend either above or below the J-groove weld and did not penetrate the inside diameter of the nozzle.

Nozzle 1 had three cracks. Each crack was axially oriented to the J-groove weld. One crack extended above and below the J-groove weld and penetrated the inside diameter of the nozzle. The second and third cracks were much smaller and on the outside diameter of the nozzle close to the initial weld passes. The second and third cracks did not extend above or below the J-groove weld and did not penetrate the inside diameter of the weld.

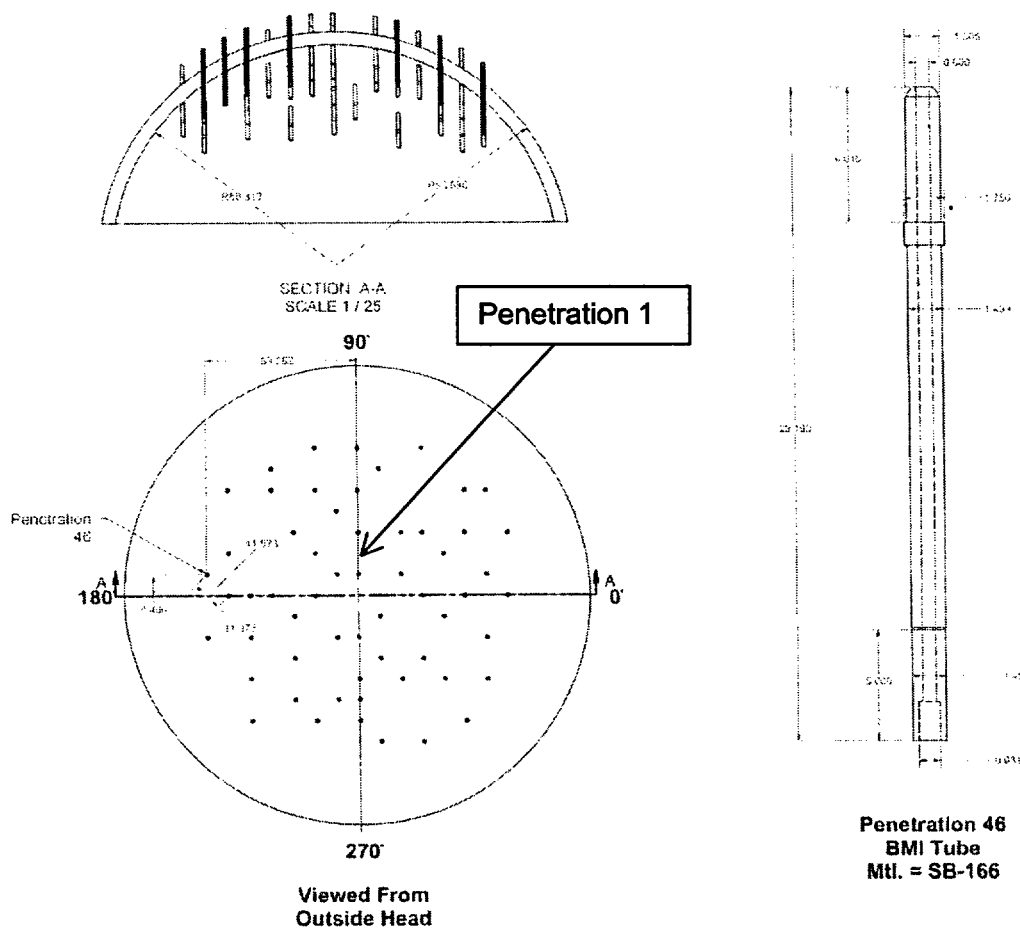
Nozzle number 1 is located about 8.5 inches due north of the center of the bottom head. The nozzle is nearly perpendicular to the reactor bottom head. Penetration number 46 is about 8.5 inches north of the east-west center line and just over 59 inches west of the bottom head center (Figure 3). Nozzle number 46 penetrates the head at 42.6 degrees.

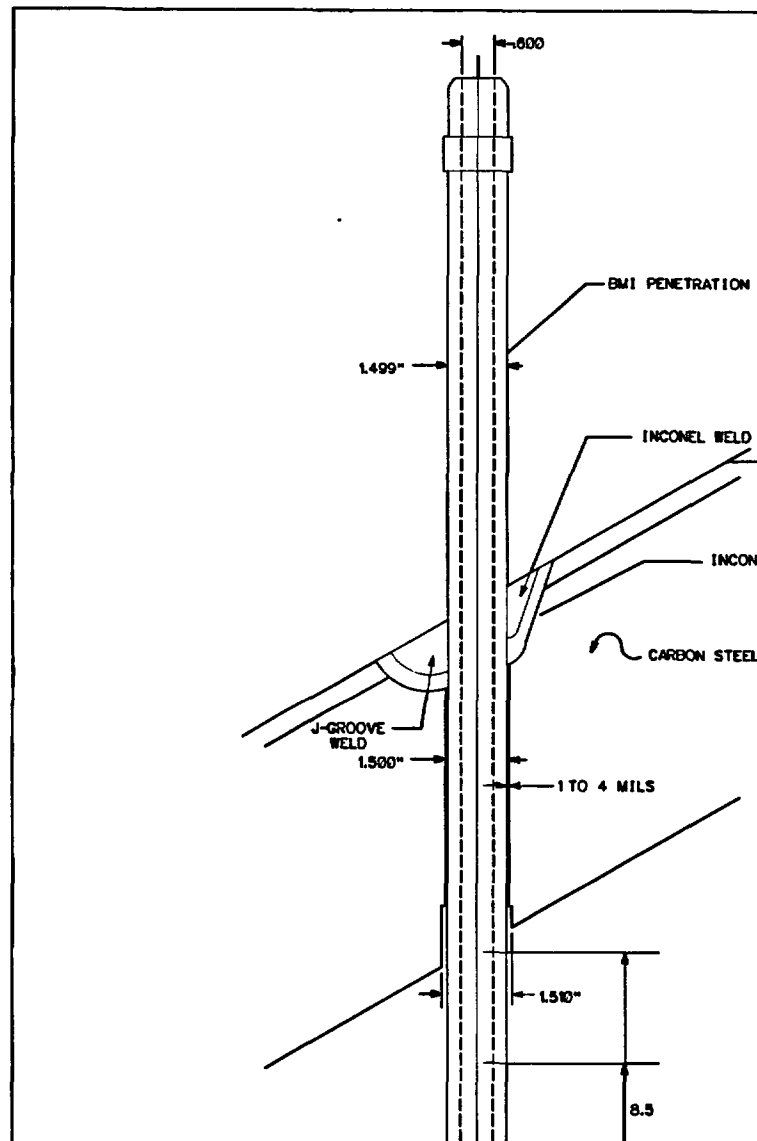
The BMI nozzles are machined from 1.75-inch diameter Alloy 600 bar stock. The nozzles have an outside diameter of 1.499 inches and an inside diameter of 0.60 inches. The BMI nozzles are structurally secured by an interior J-groove weld consisting of Alloy 600 base weld materials designated as 182 with fabrication

weld repairs being made with either 182 or 82 weld material. The vessel itself is 5.38-inch thick low alloy carbon steel with 0.22 inches of stainless steel cladding on the interior surface. Each penetration bore in the reactor bottom head is nominally 1.5 inches in diameter. There is an open annulus between the nozzle and the reactor head below the J-groove weld. Figure 4 provides a simplified view of a typical nozzle configuration

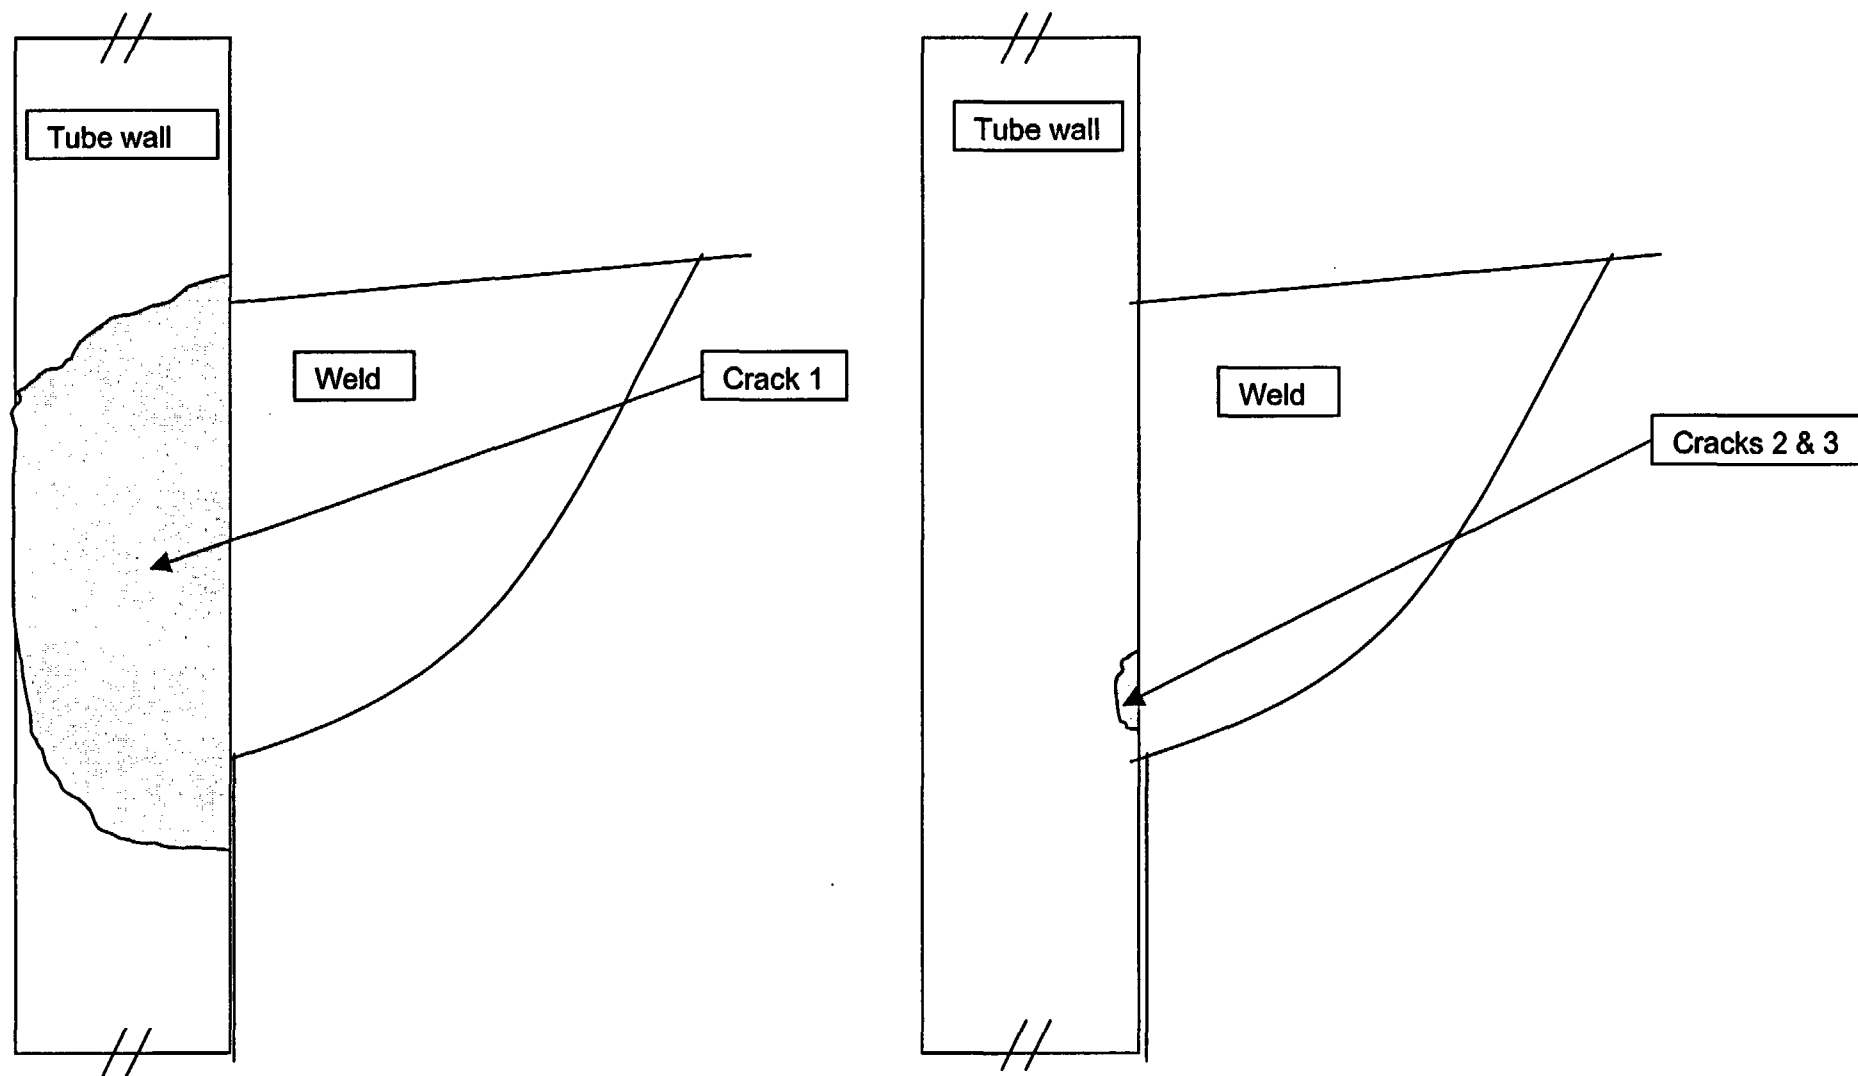
South Texas Project Status Report on Resolving the Unit 1 BMI Issue – Attachment 5 Two Dimensional Representation of Cracks in Nozzle 1

All three probes confirmed the presence of five cracks, three in nozzle 1 and two in nozzle 46. Attachments 5 and 6 are two-dimensional representations of the cracks. There were no cracks indicated in any of the remaining nozzles, and no circumferential cracks were found. In addition, the UT probes indicated anomalous conditions at the nozzle weld interface in all of the nozzles, possibly indicating lack of weld fusion or some other anomalous weld condition. The possible significance of lack of fusion in the BMI nozzle welds is discussed later in Section V. E. 4. The extensive data derived from the primary UT inspection are electronically recorded for detailed analysis and preserved as a baseline for future UT inspections.
