**Millstone Power Station, Unit No. 3**  
**Relief Request From ASME Code Section XI Repair and Replacement Requirements**  
**For a Flaw in a Service Water System Brazed Joint**

**Millstone Power Station, Unit No. 3  
Summary of Flaw Evaluation and Relief Request From ASME Code Section XI  
Repair and Replacement Requirements for a Flaw in a Service Water System Brazed Joint**

**Technical Evaluation M3-EV-03-0014**  
**Structural Evaluation of Line 3-SWP-003-67-3 with Leak on Brazed Joint FW-74-1**

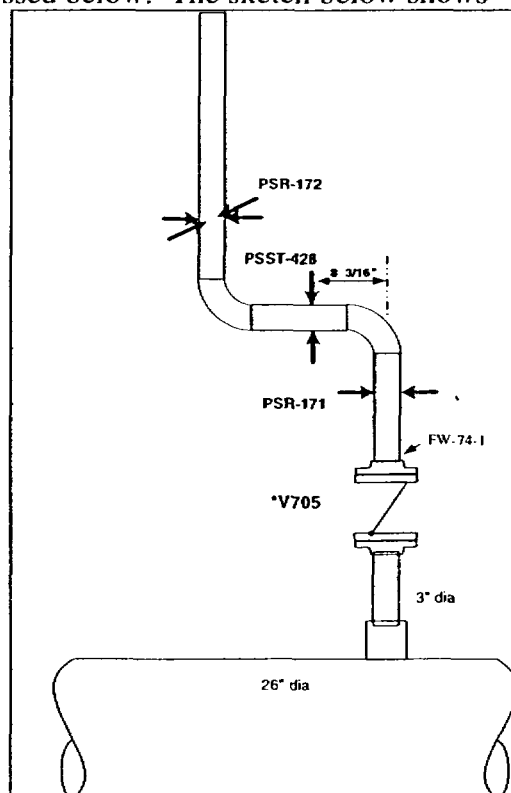
For the purpose of analyzing structural capacity of the associated components, this evaluation assumes the total loss of the leaking brazed joint. In this case, the configuration of piping and supports is such that the piping is constrained to stay within the fitting socket, and the leakage flow is limited by the small annular area between the pipe and fitting socket. At full design pressure of 100 psig the pressure thrust attempting to separate the joint would be approximately 740 lbs. Seismic and other design loads are also considered as discussed below. The sketch below shows the basic configuration under consideration.

The piping is restrained in the vertical direction by hanger strut PSST428 that is offset only 8.2 inches from the brazed joint. The strut has essentially a zero gap. Therefore, vertical deflection of the pipe out of the braze socket is minimal compared to the approximately ½" engagement. Per Reference 14, vertical load capacity of PSST 428 is well in excess of the 2338 lb. original design value and provides sufficient margin for the maximum calculated load of 2011 lb per Reference 14. This design load includes seismic, thermal and deadloads. With the brazed joint disrupted, the thermal expansion load is minimal. Therefore the additional thrust load is within the capability of the support. Similarly, N-S pipe support PSR171, located 14 inches above FW-74-1, has a design capacity of 1988 lb. and a maximum calculated load of 430 lb per Reference 12. Downstream a two way lateral support, located approximately 4 feet away from FW-74-1, has significant design capacity in the pipe strap

(Reference 13) and tube steel frame (Reference 15) to accommodate increased load postulated from the failure of FW-74-1. Valve 3SWP\*V705 is anchored by the 26" header pipe line 3-SWP-026-66-3 that is also well restrained. The remaining stub of pipe to the header pipe is short so no excessive bending moments will be generated even in a seismic event. Thus, because the line and valve are rigidly supported, the pipe can not disengage from the flange socket, even with full pressure and seismic loads applied under accident conditions. The monel pipe retains its integrity with no degradation (Reference 16), and the flange socket hub retains integrity and can be credited for side loading at the piping interface. There is only a thin annular area (associated with initial fit-up clearances) between the pipe and flange socket so leakage flow would be minimal. The predicted leakage flow has been determined to be acceptable with regard to system performance, Reference 5. Therefore it is concluded the piping will maintain its structural contiguity and flow capability even though the brazed joint is assumed totally failed and leakage will occur.
