**Subject: Beaver Valley Power Station, Unit No. 1 and No. 2  
BV-1 Docket No. 50-334, License No. DPR-66  
BV-2 Docket No. 50-412, License No. NPF-73  
Supplemental Information in Support of 2001-2002 Steam Generator  
Tube Outages Inspection Reports**

**Letter L-03-110 - ATTACHMENT A**

**Information in Response to a Request for Additional Information  
for Beaver Valley Power Station, Unit No. 2**

**Letter L-03-110 - ATTACHMENT B**

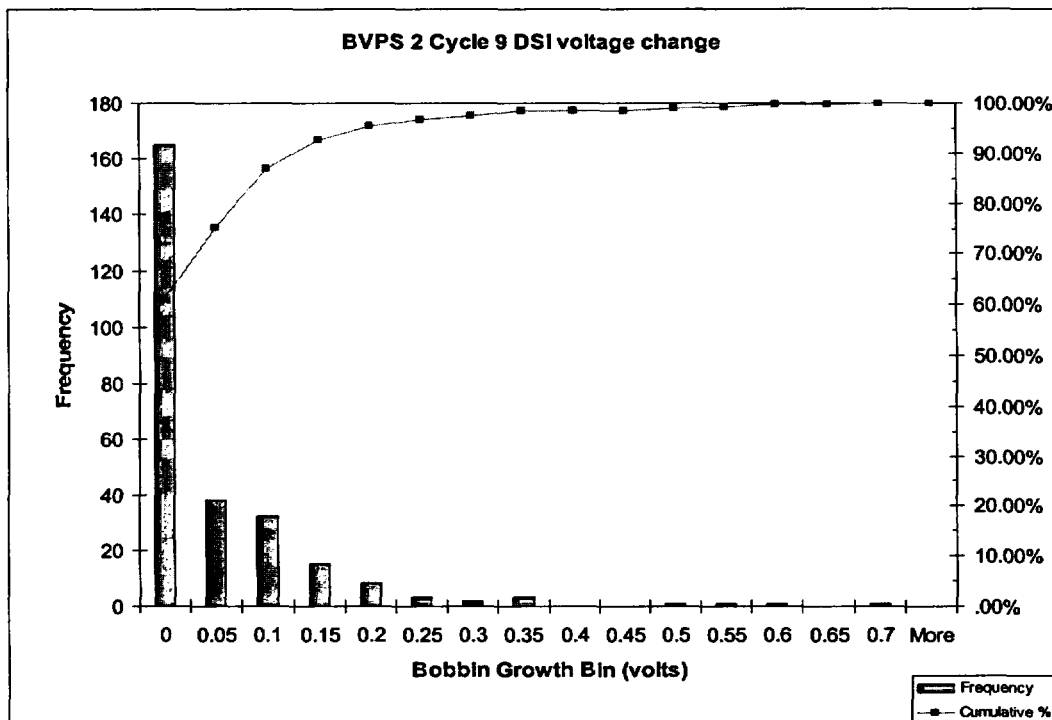
FIGURE 1

Additionally, the overall DSI amplitude growth for BVPS 2 Cycle 9 is negligible. The largest singular bobbin amplitude growth in any SG was 0.70 volts, with an average growth of -0.03 volts. Figure 1 provides a cumulative probability distribution function of DSI growth for Cycle 9. An overwhelming majority of the growth values are within the typical repeatability bounds for the bobbin coil.
