Appendix G: Posttest Data Correction

G.2 Post Test Data Conversion and Correction

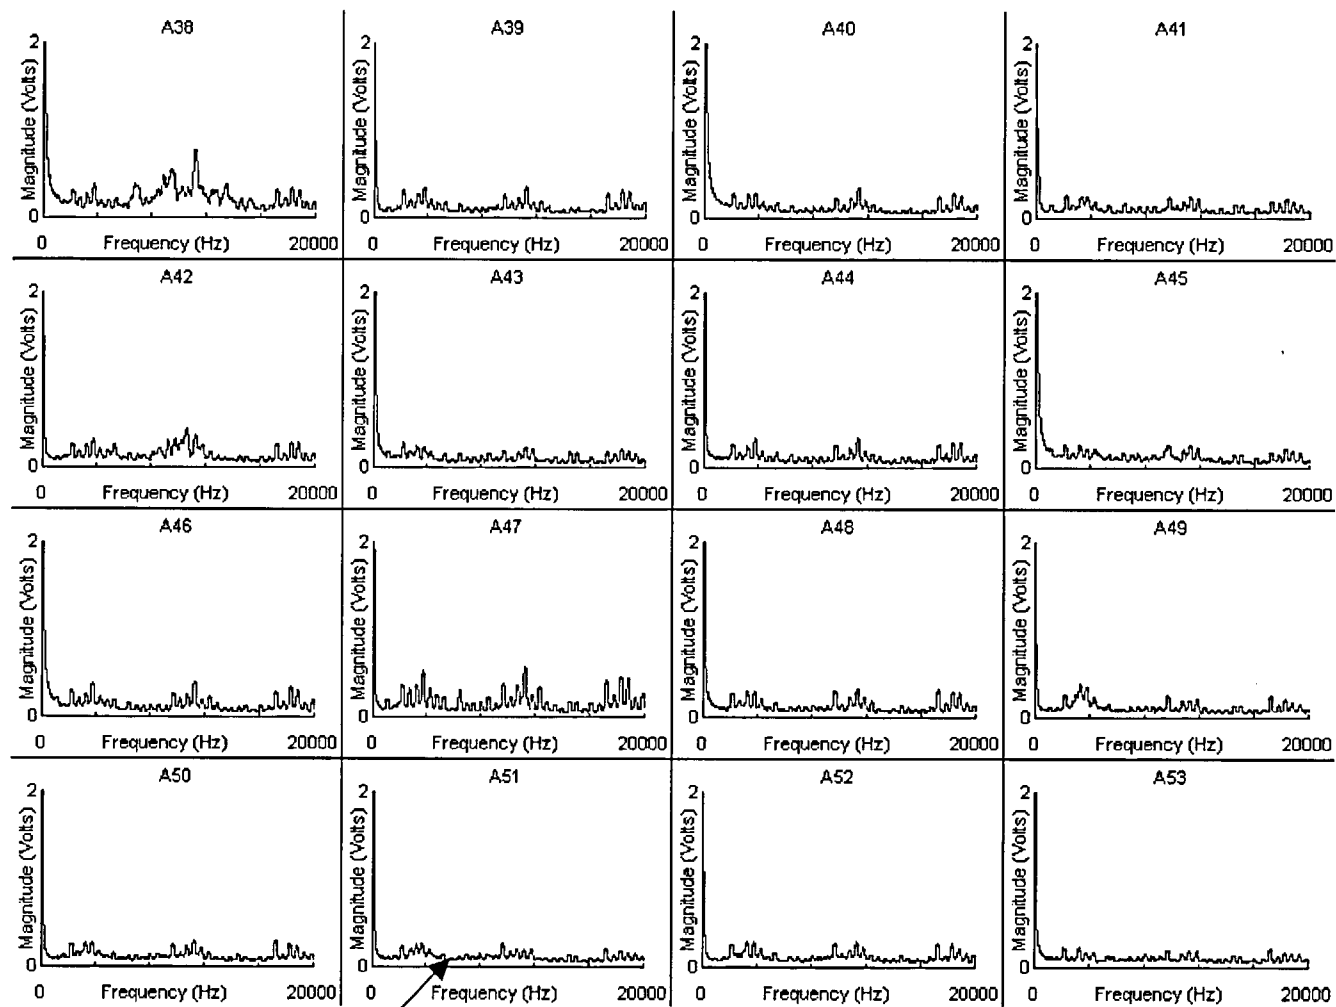
Analysis of the output of the sensors during the pressurization of the LST was done in an attempt to determine the development of leaks, and to determine the location of the first leaks as they appeared. In observing the FFT of all of the internal sensors, anomalies started to appear at 2.4 Pd in the area around the equipment hatch. This appearance is illustrated below in Figures 1 to 3.

Figure 1: Internal Sensors (FFT) at 2.3 Pd

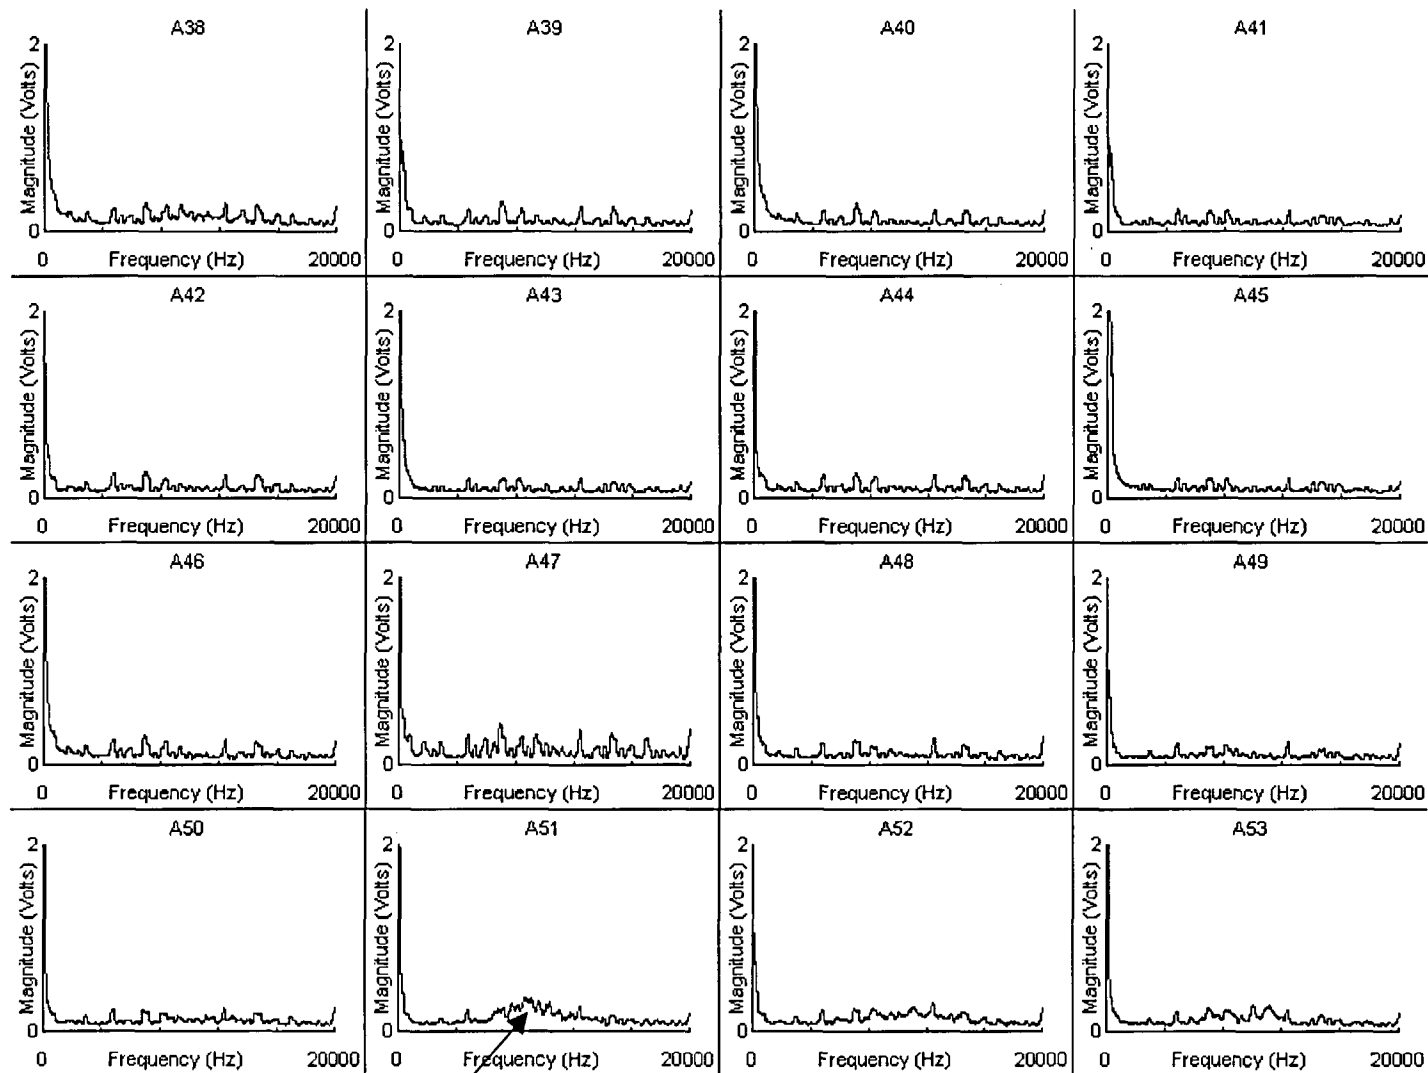
Figure 2: Internal Sensors (FFT) at 2.4 Pd

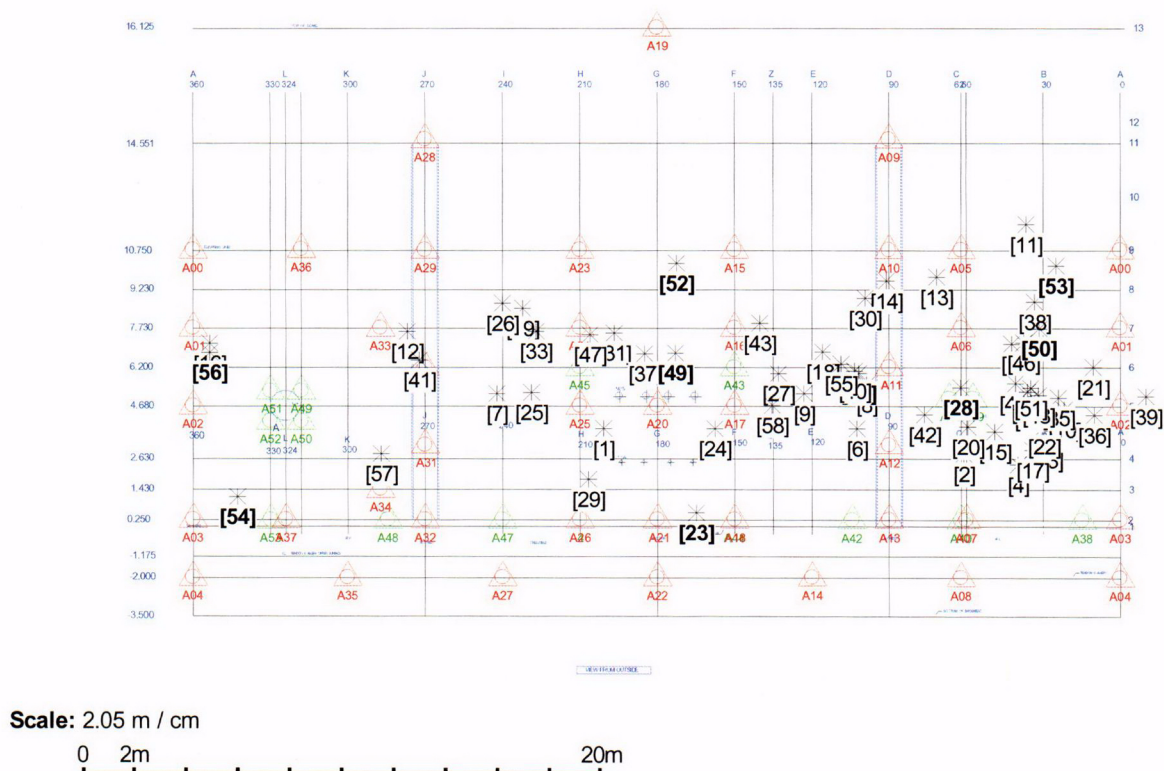
No wire break events were detected during the LST. The first wire break occurred at 10:39:47 Nov 14, during the SFMT. Wire breaks are expected to have at least as much energy as a Schmidt hammer impact, and are expected to show preferential propagation of acoustic energy along the tendon. However, as the concrete of the vessel became increasingly cracked, it became a poorer medium for the transmission of the sound. As a consequence, only the magnitude and frequency content of the output of sensors near each event could be used to assess whether or not a given event was likely the result of a wire break. Fifty-eight events were detected that matched these criteria. Three of these events detected double wire breaks, and Six events detected multiple wire breaks, excluding the final rupture of the vessel.

Figure 7: Flattened elevation view (from outside) of location of wire breaks during SFMT

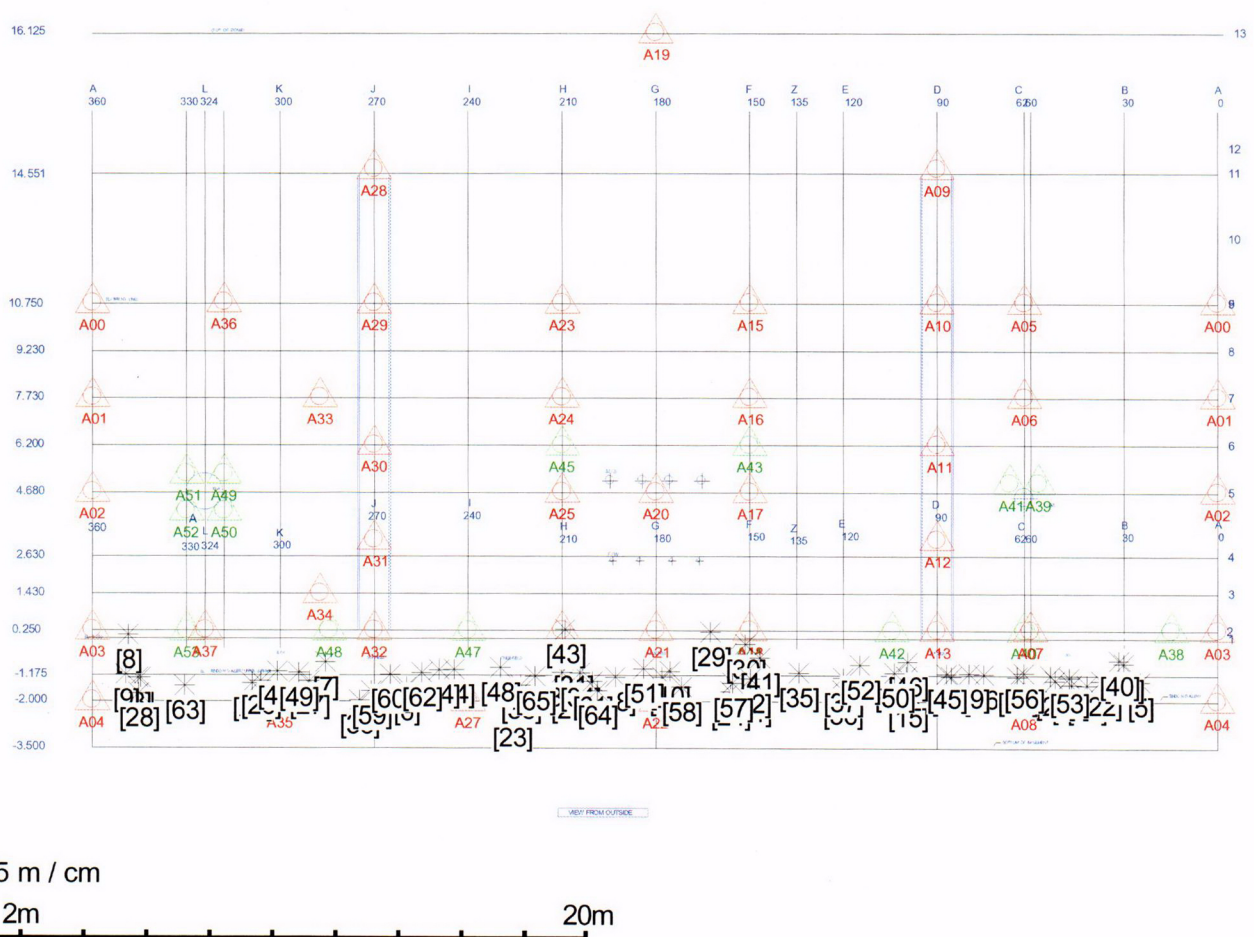
Figure 9: Location of Events in Basemat during SFMT

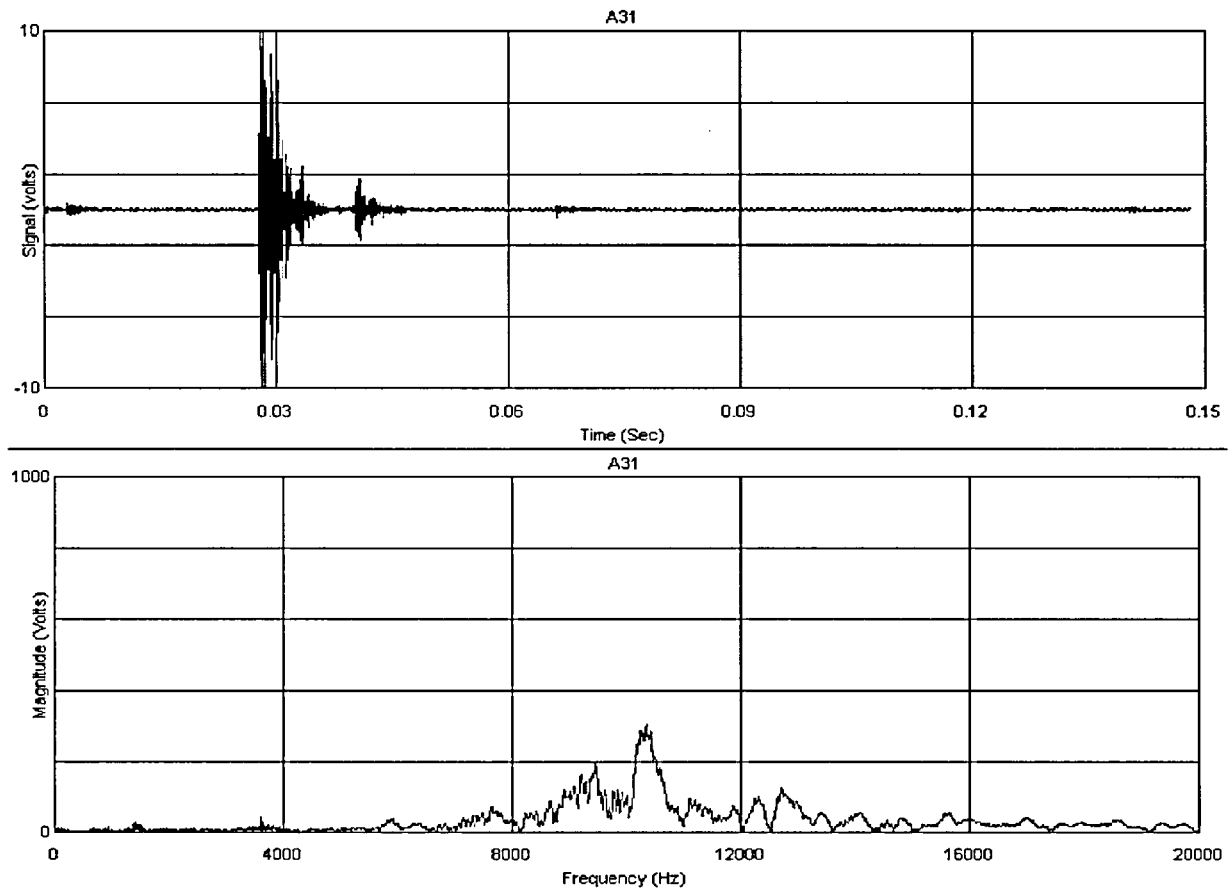
Throughout the SIT, LST and SFMT, events were detected that had properties consistent with concrete cracking. Most of these events occurred during the LST. Many thousands of these events were heard. Events sufficiently large to be detected at >5dB were located. During the SIT, there were 20 events located, and during the LST, there were 264 events located. Typical cracking behaviour has a time domain graph with multiple events, and a frequency domain that has anomalies from 6 KHz to 12 KHz.

Figure 11 Typical Concrete Cracking Event Large Enough to Locate

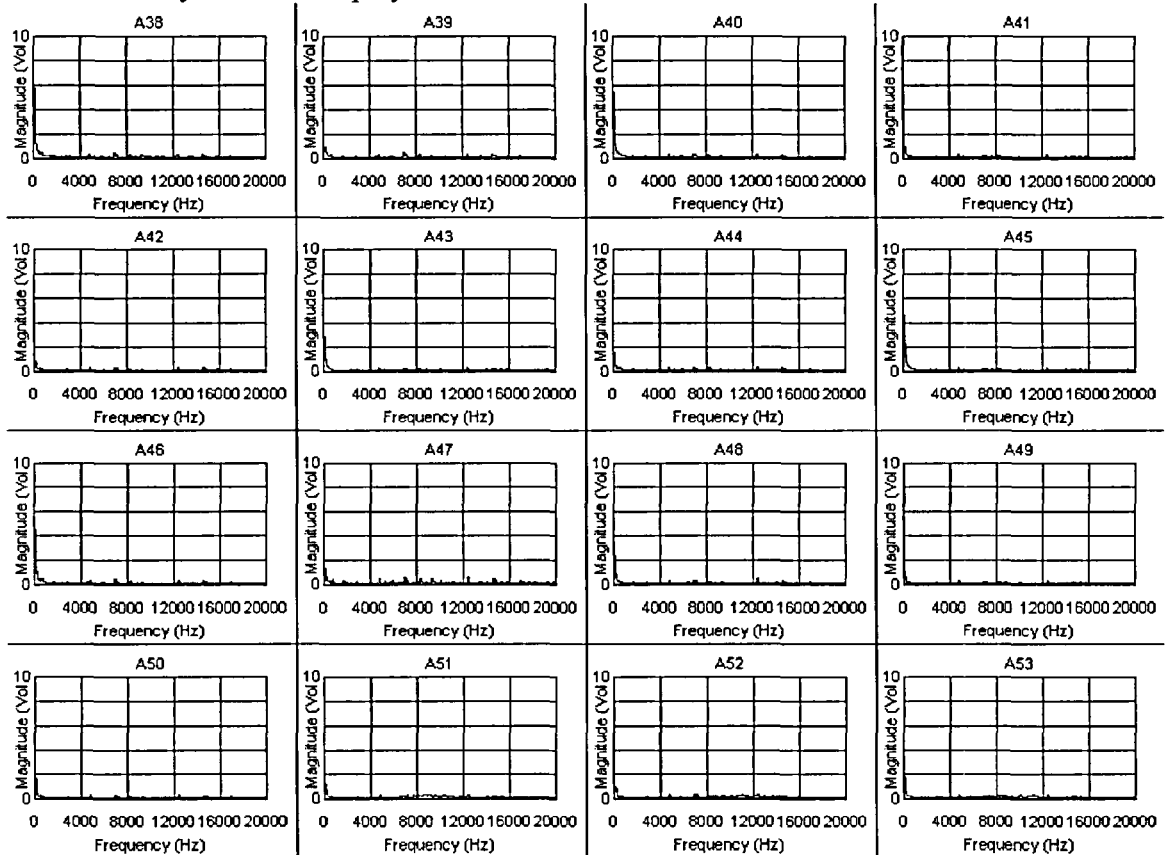
FIG. 1 FFT of internal sensors before liner tearing
Time: 09:27:52 Wed Sept 27, 2000

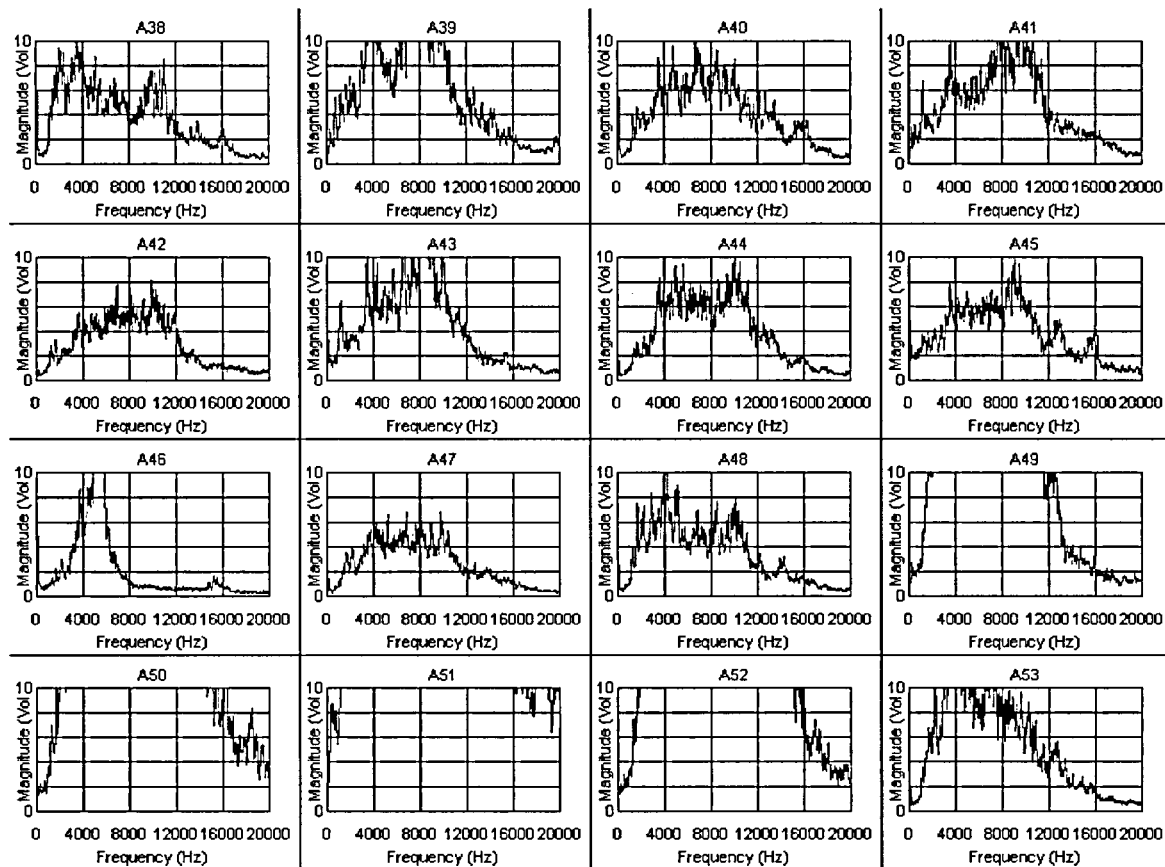
Figure 4. FFT of internal sensors with increased flow
noise from many suspected liner tears
Time: 15:45:49 Wed Sept 27, 2000

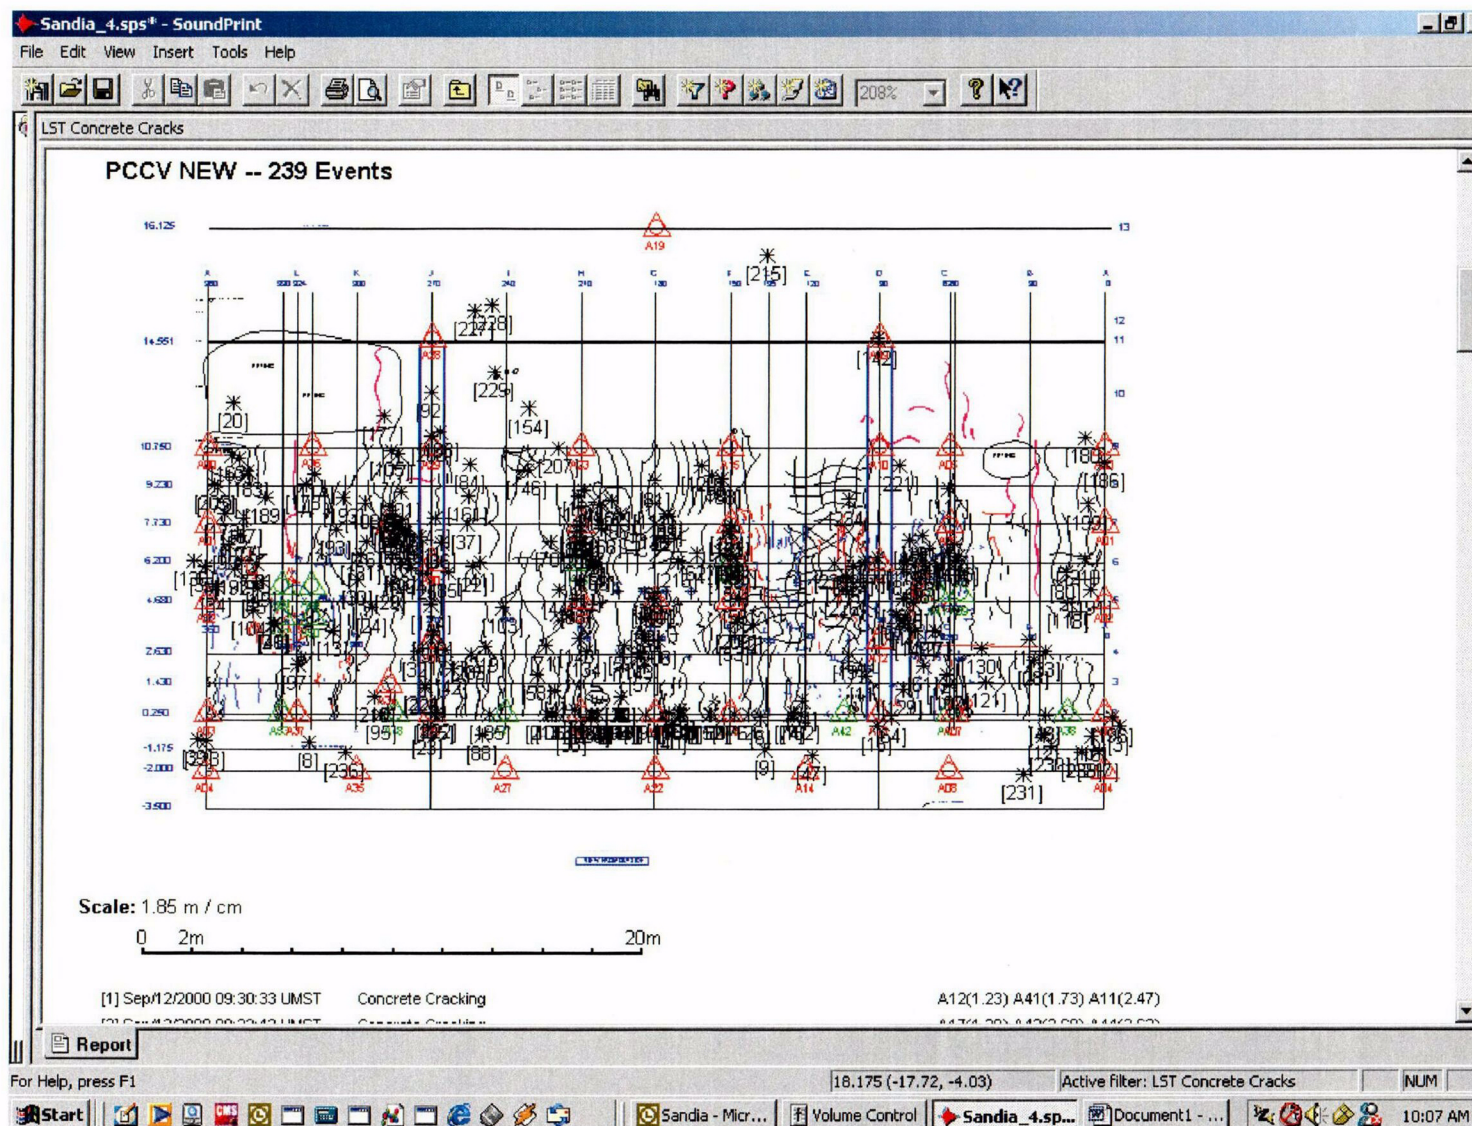
Concrete cracking was detected throughout the construction and testing of the PCCV. Large cracking sounds were located on the elevation view of the vessel. For this summary, only three figures are shown.. Figure 4 shows the position of cracks during the LST. Other views of cracks are available in the attached reports.

Figure 4 Position of cracking during LST overlay onto map of visual cracking

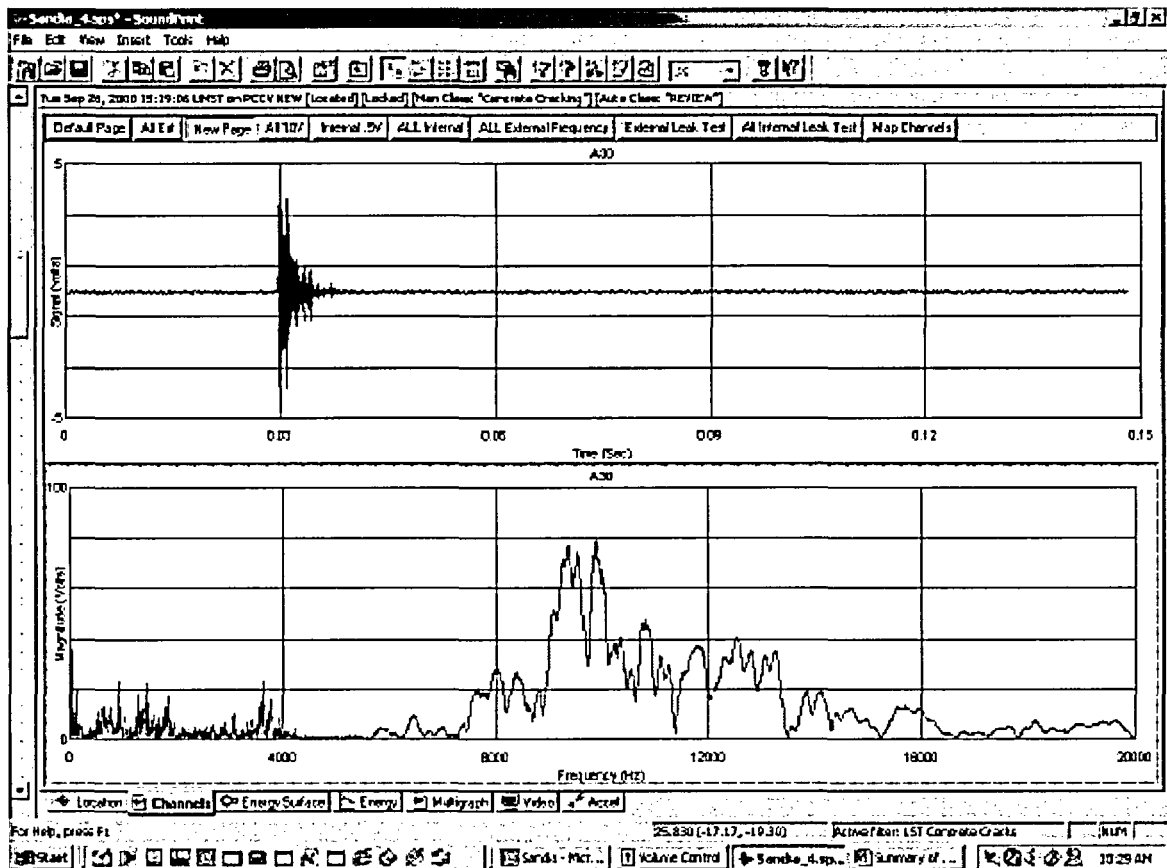
Events identified as concrete cracking have a sharp time domain signature and a FFT signature with anomalies from 8 KHz to about 12 KHz in the frequency domain. Figure 5 below shows a typical event from cracking of the concrete. The top chart is the time domain representation of the event, while the bottom chart is the frequency domain representation of the same event on the same sensor.

Figure 5 Typical event resulting from concrete cracking during LST

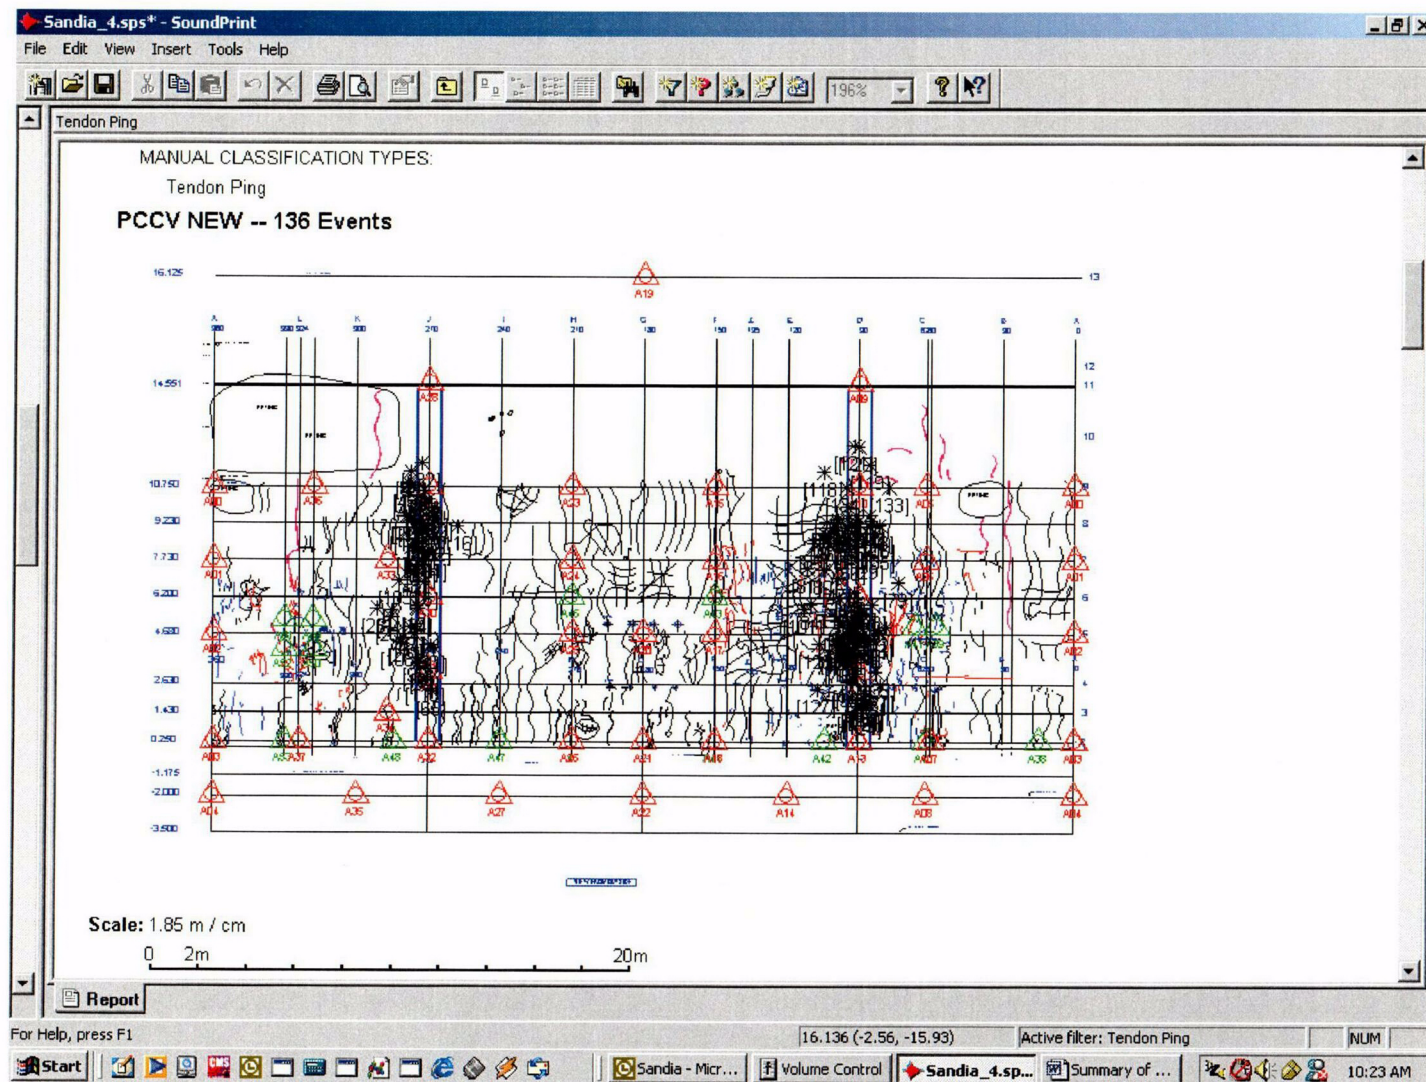
During the LST, 136 large events emanating from the buttresses were detected and identified as “tendon pings” meaning a readjustment of position of the tendon near the anchorage, but these were not wire or tendon failures.

Figure 6 Locations of events identified as tendon pings during the LST

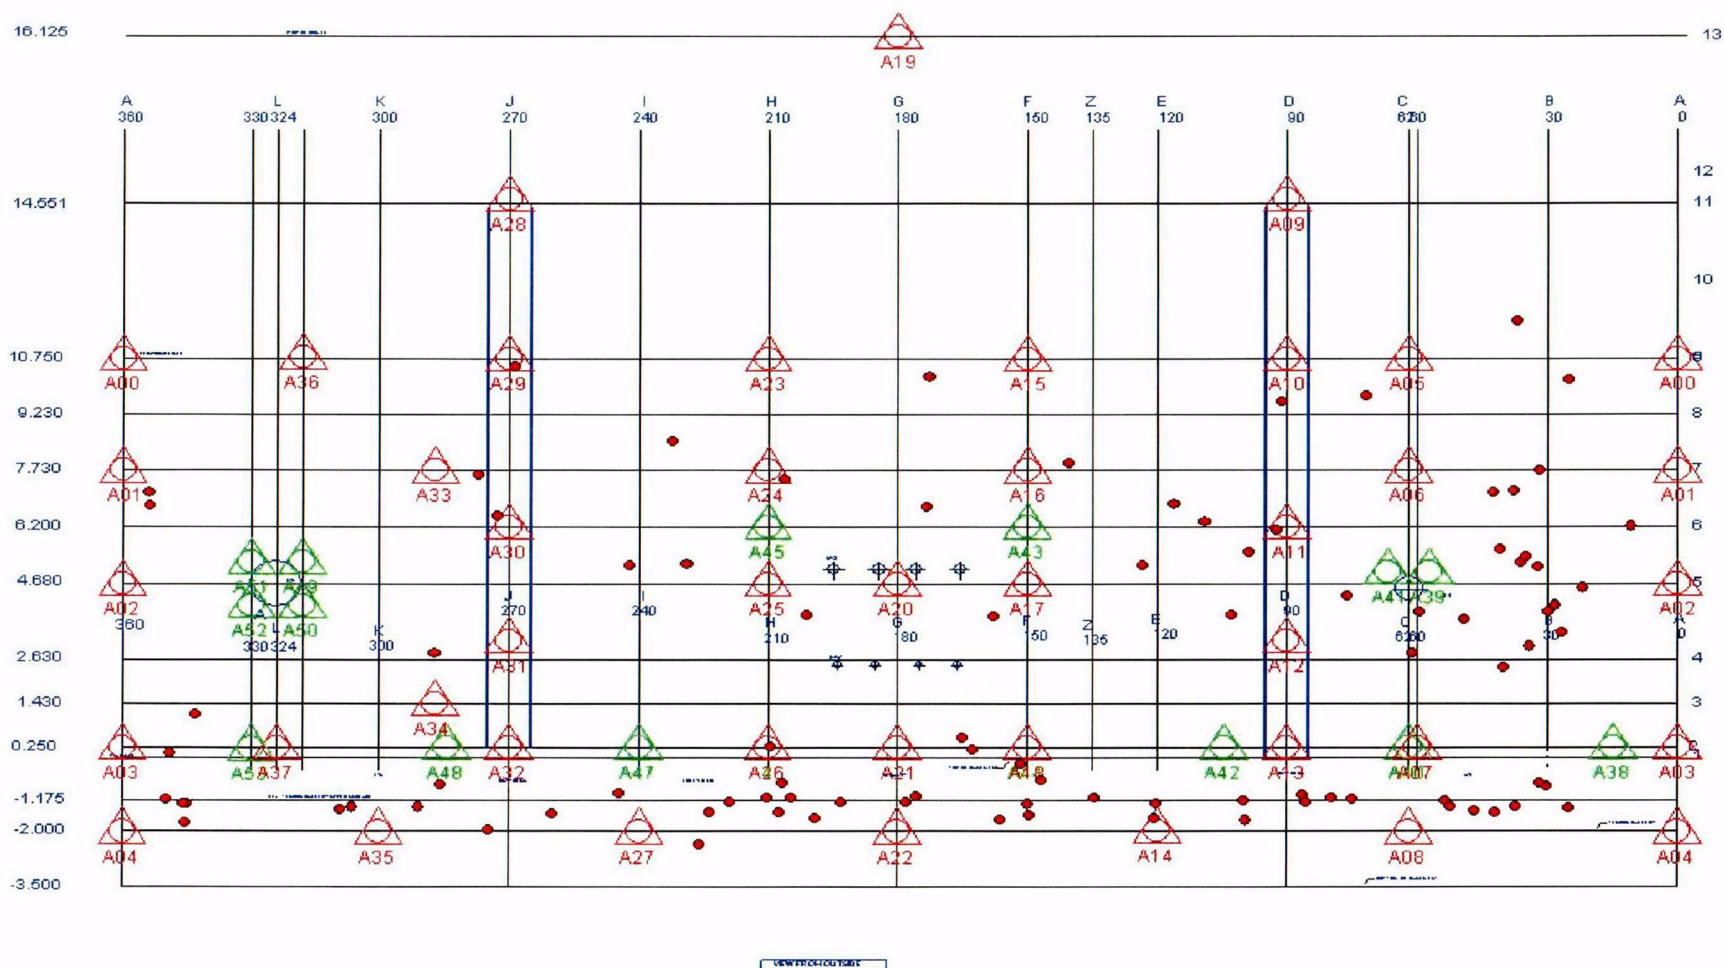
**All 92 wire breaks before failure during test Nov. 14, 2001
(Many contain multiple wire failures at one location)**

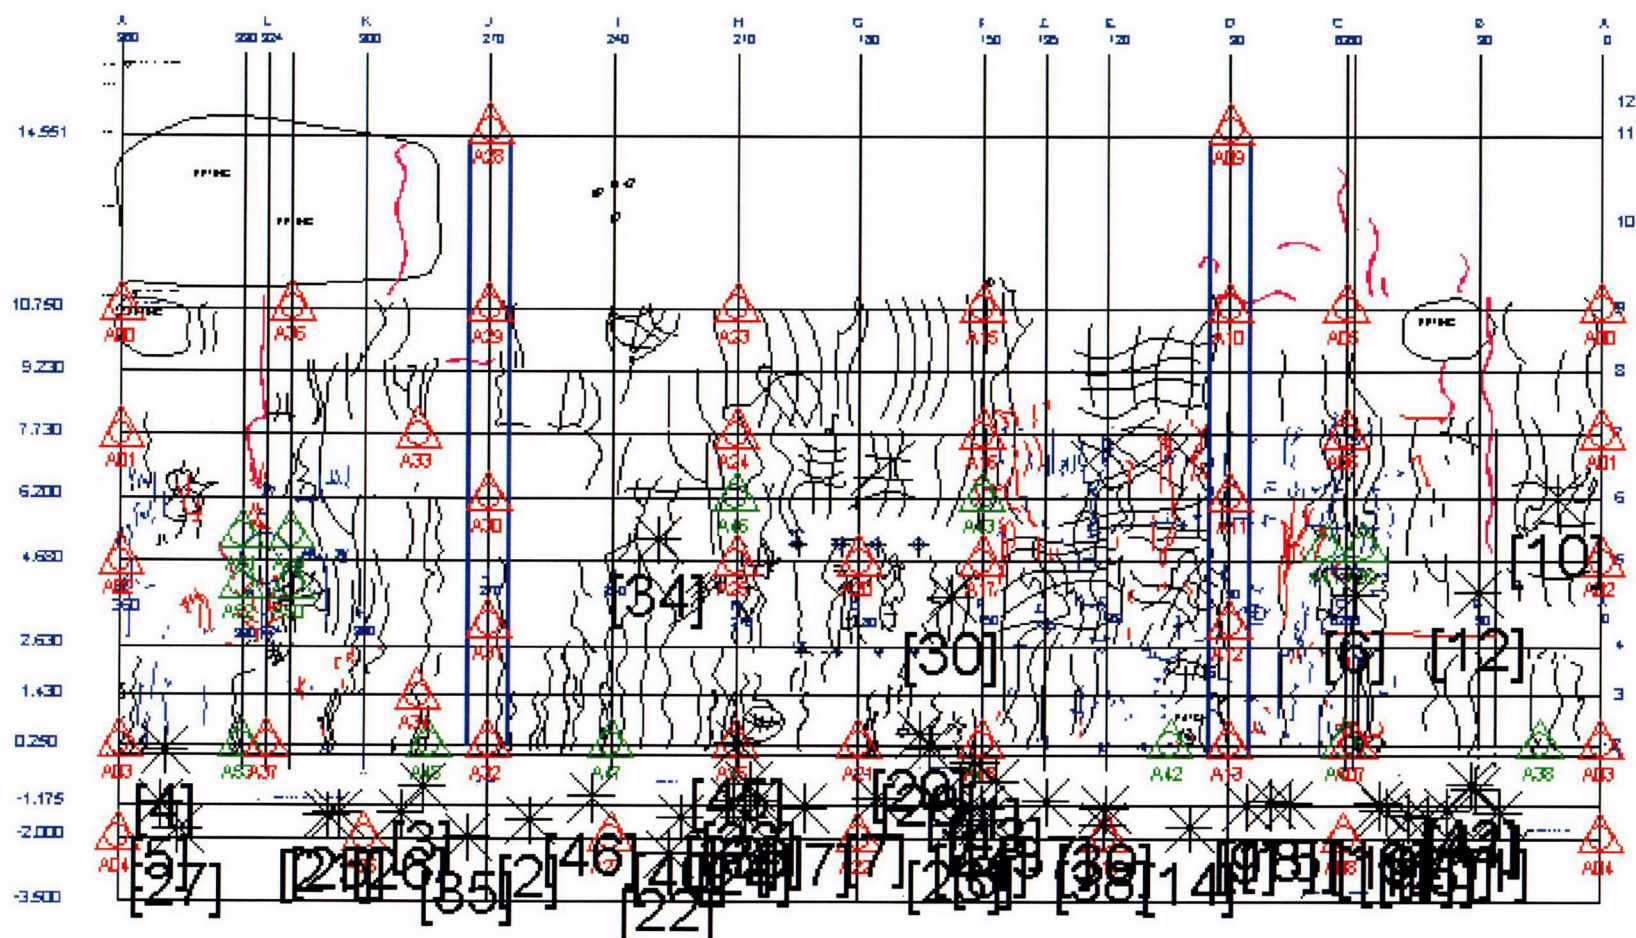
Wire breaks during the minute of 10:44 AM to 10:45 AM
193 psi to 197 psi

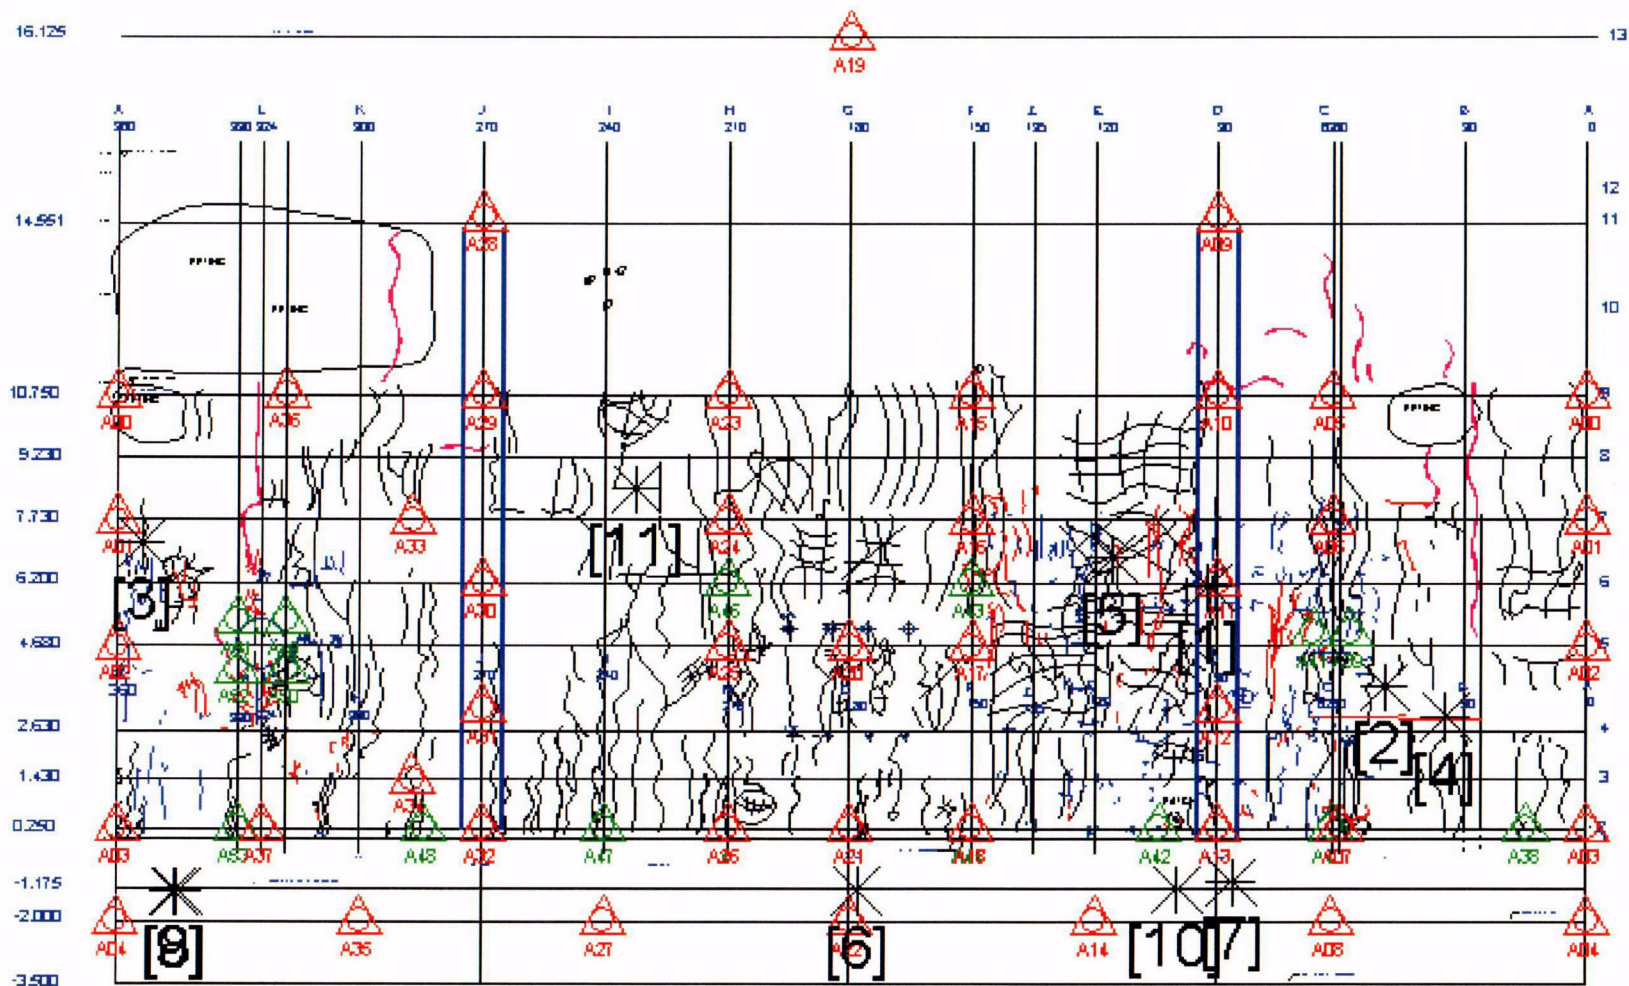
Wire breaks during the minute of 10:43 AM to 10:44 AM
192 PSI to 193 PSI

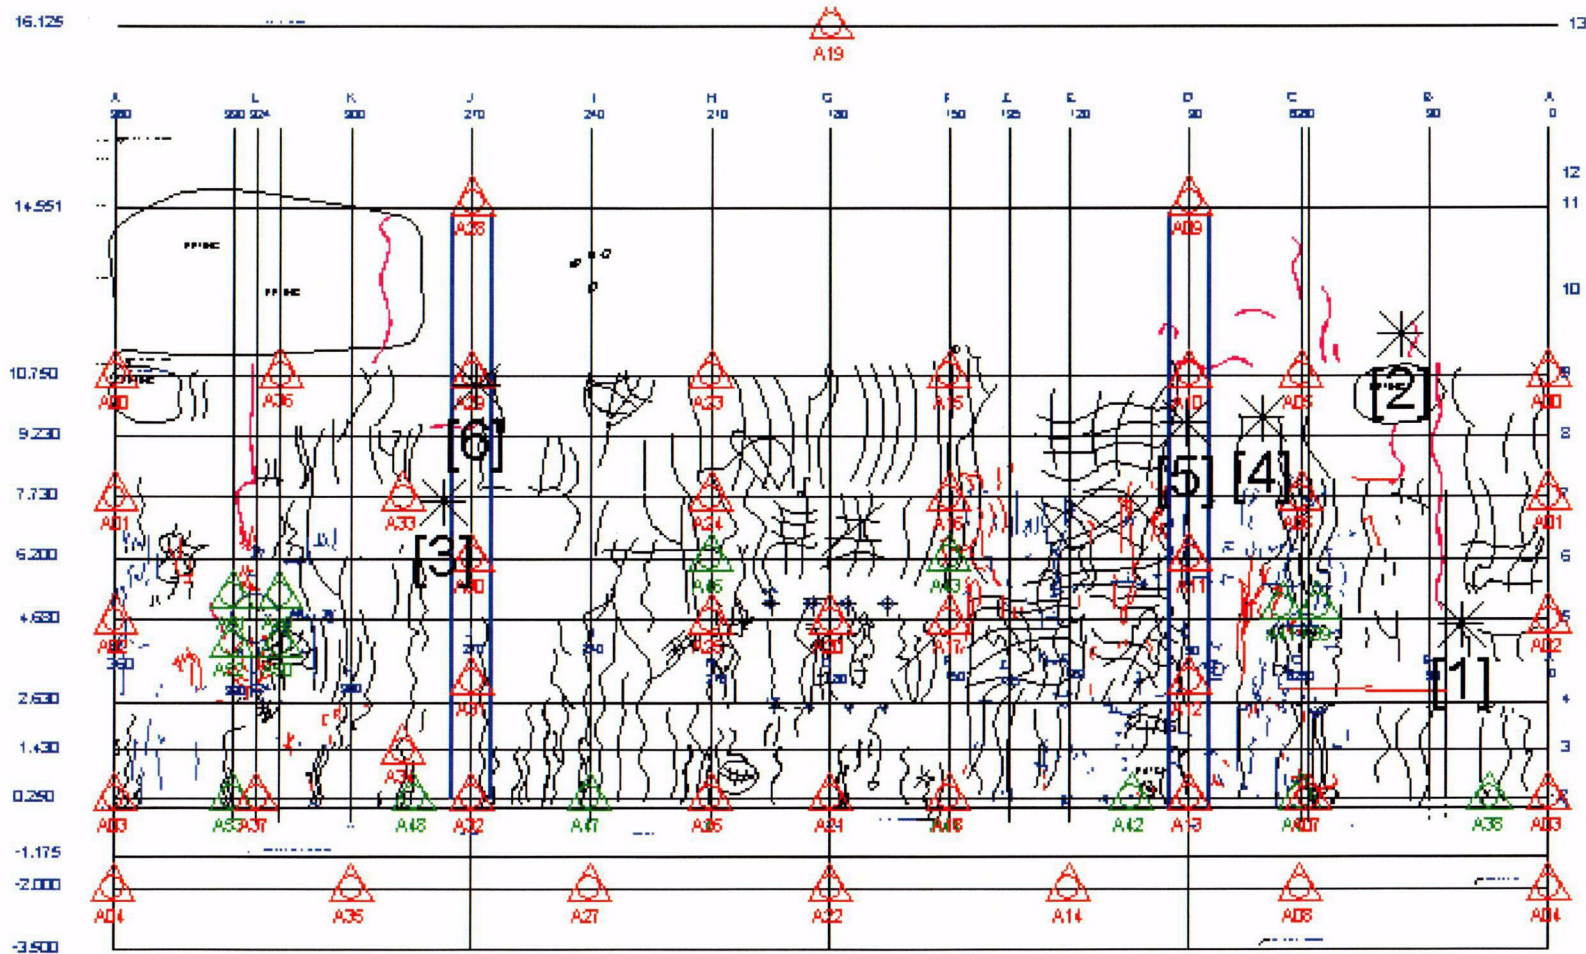
**Wire breaks during the minute of 10:42 AM to 10:43 AM
188 PSI to 192 PSI**

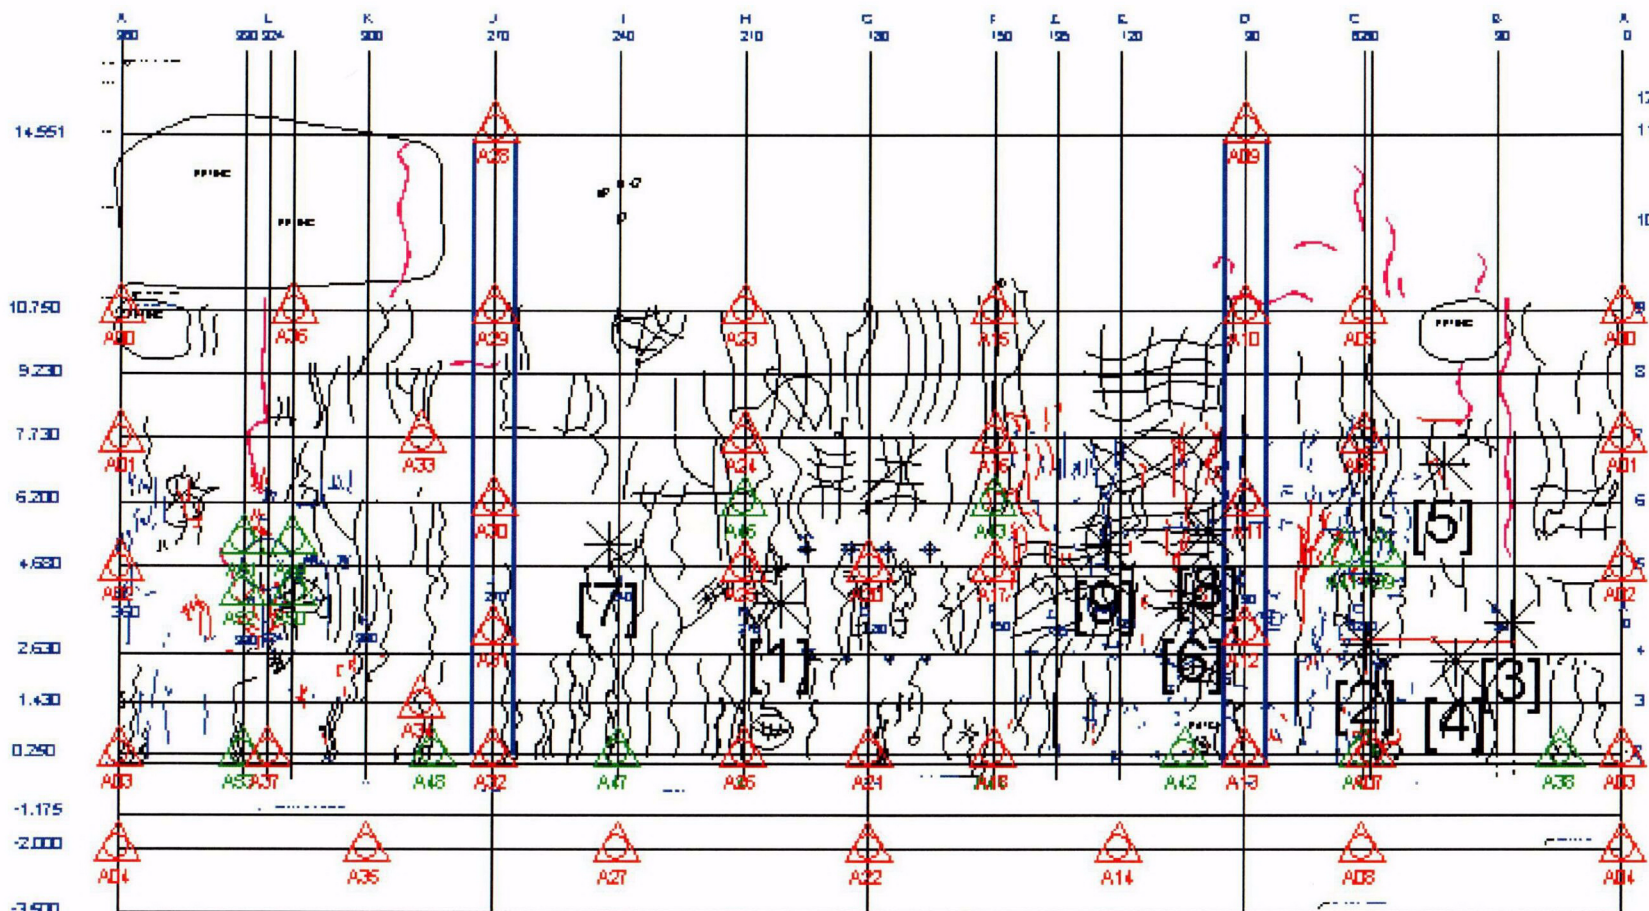
Wire breaks during the period 10:39 AM to 10:42 AM (First Breaks)
Approximately 188 PSI

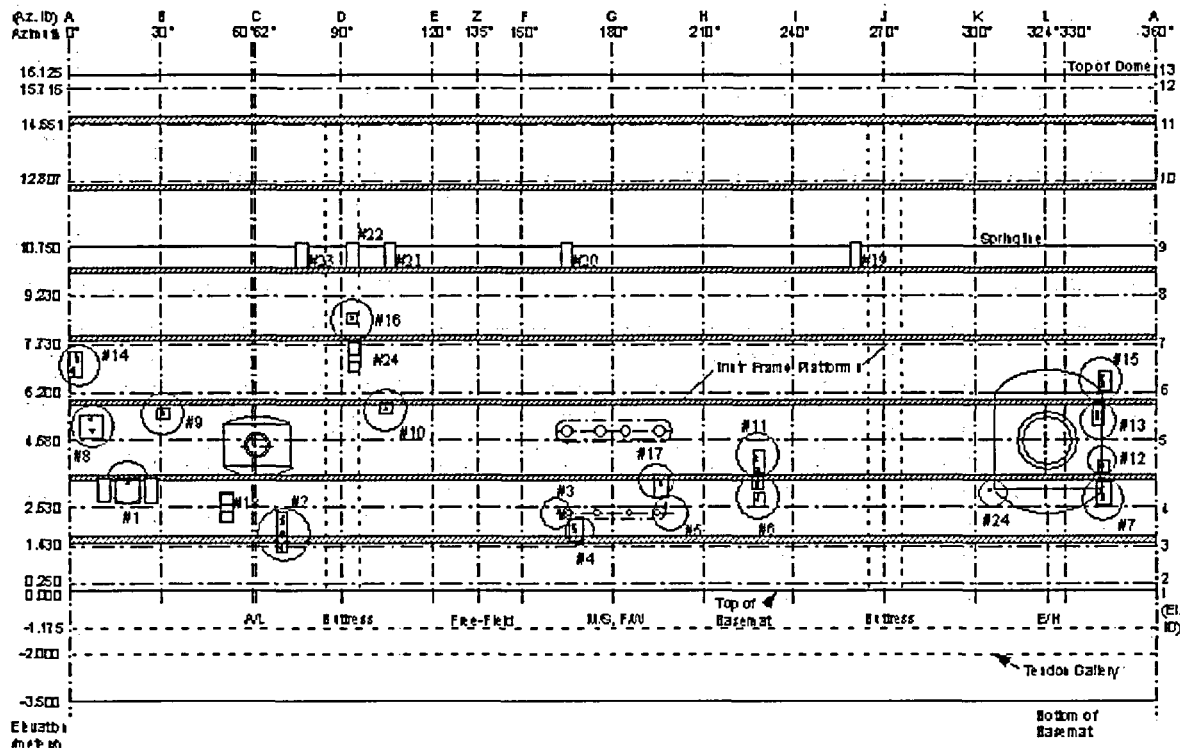
Figure 1. Map showing approximate locations of tears.

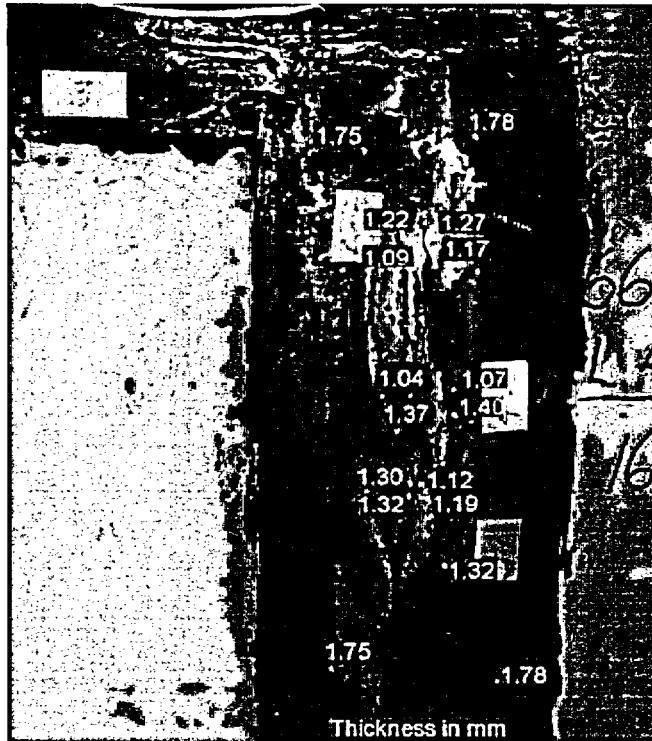
Figure 21. Liner thicknesses (in millimeters) measured ultrasonically in the vicinity of tear #4 (4-1, 4-2, and 4-3).

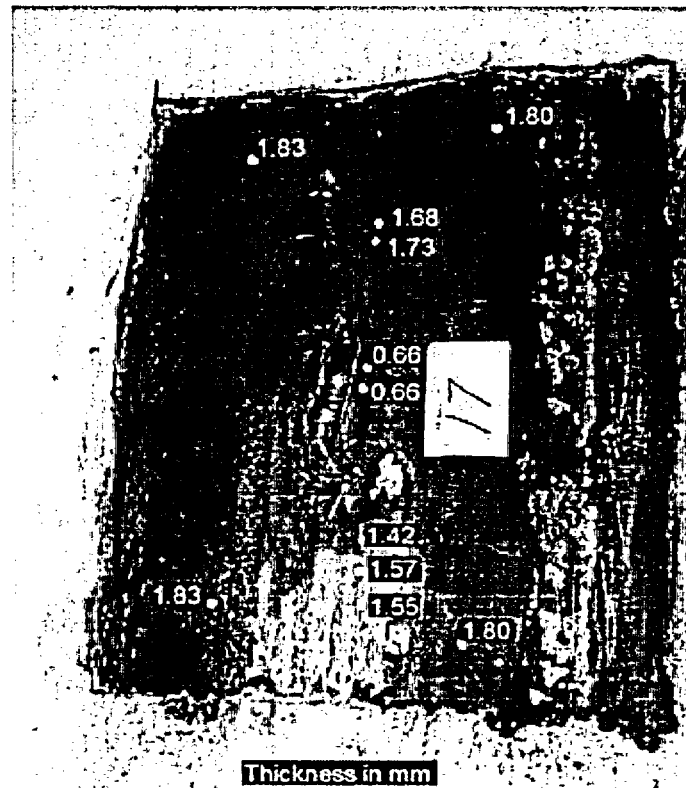
Figure 31. Liner thicknesses (in millimeters) measured ultrasonically in the vicinity of tear #17. Note exceptionally thin areas adjacent to repair weld and tear.
