Appendix G: Posttest Data Correction

G.2 Post Test Data Conversion and Correction

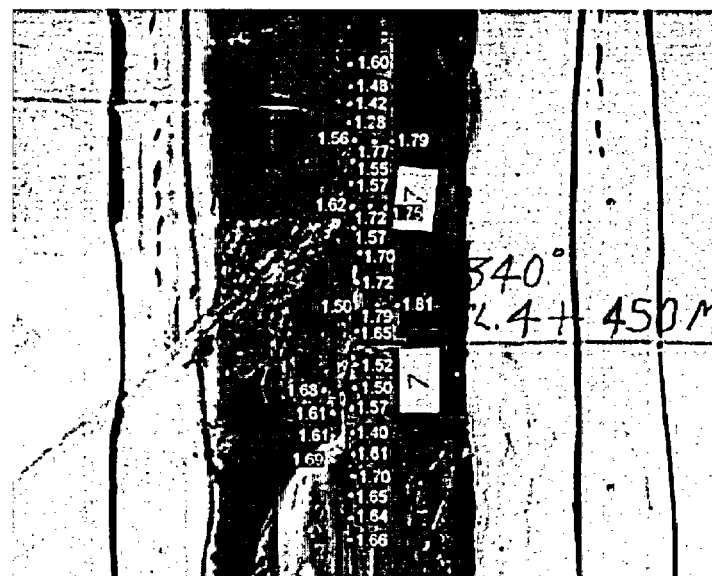
Figure 32. Liner thicknesses (in millimeters) measured ultrasonically in the vicinity of tear #7.

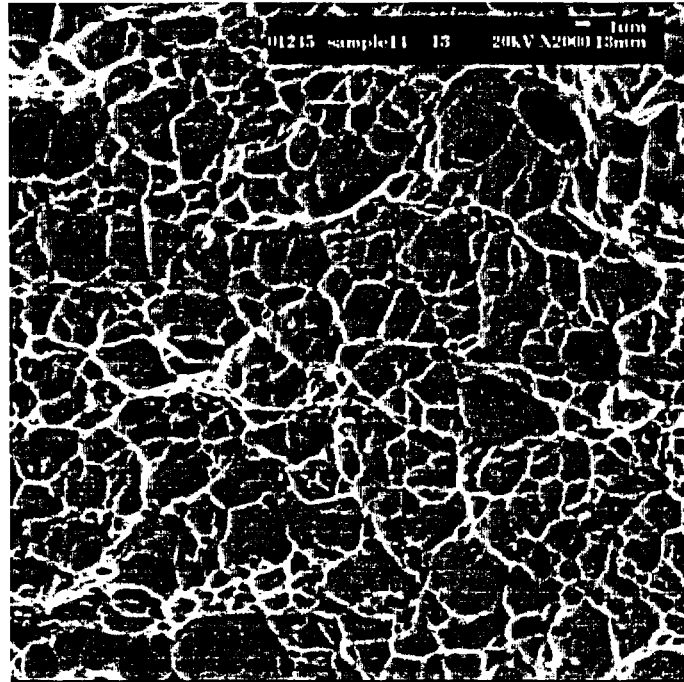
Figure 64. Scanning electron micrograph of fracture surface from tear #14-2. Failure occurred by ductile rupture, as was seen on fracture surfaces from tensile samples shown in Figures 42-44.

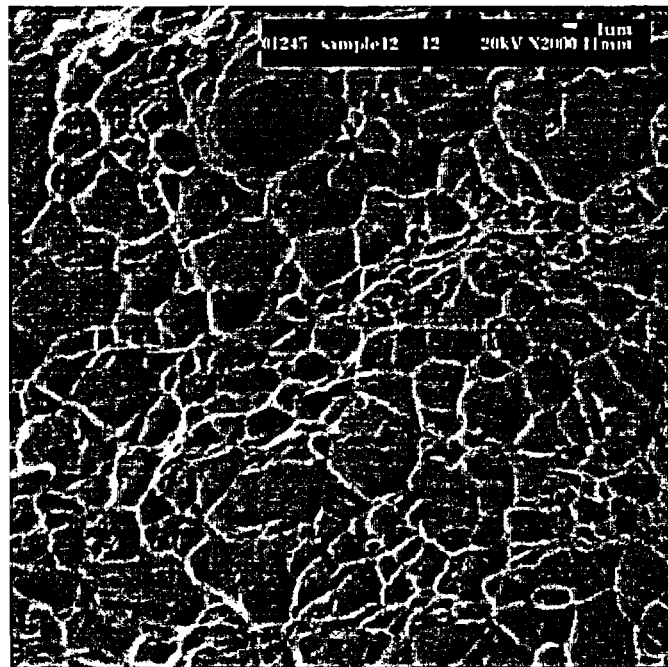
Figure 65. Scanning electron micrograph of fracture surface from tear #12. Failure occurred by ductile rupture, as was seen on fracture surfaces from tensile samples shown in Figures 42-44.

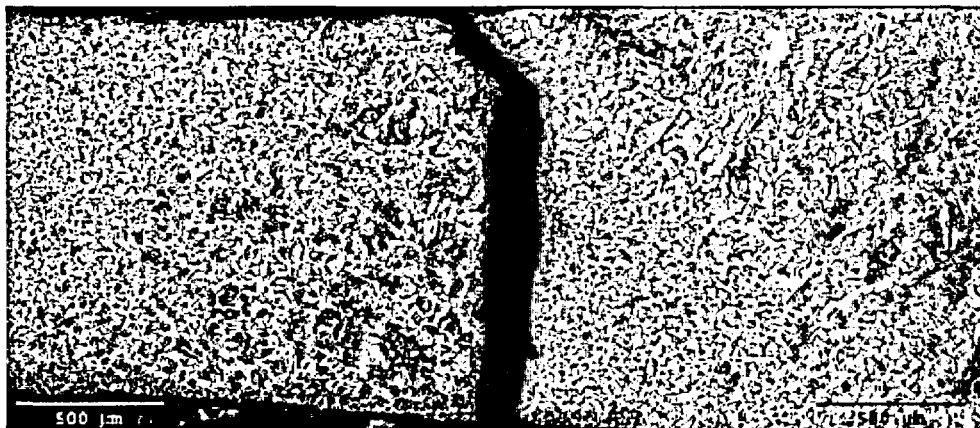
Figure 66. Metallographic cross section of tear #1. This cross section was taken at the location of widest crack opening, corresponding to where the tear apparently initiated. Note that the opening is flat and perpendicular to the liner circumference, and that the microstructure is not continuous across the separation. The “fracture” surfaces were also covered with a layer of foreign material (too dark to be seen here). These features indicate that this area represents a lack of fusion defect, i.e., a region in which the repair weld failed to bridge the gap being welded.

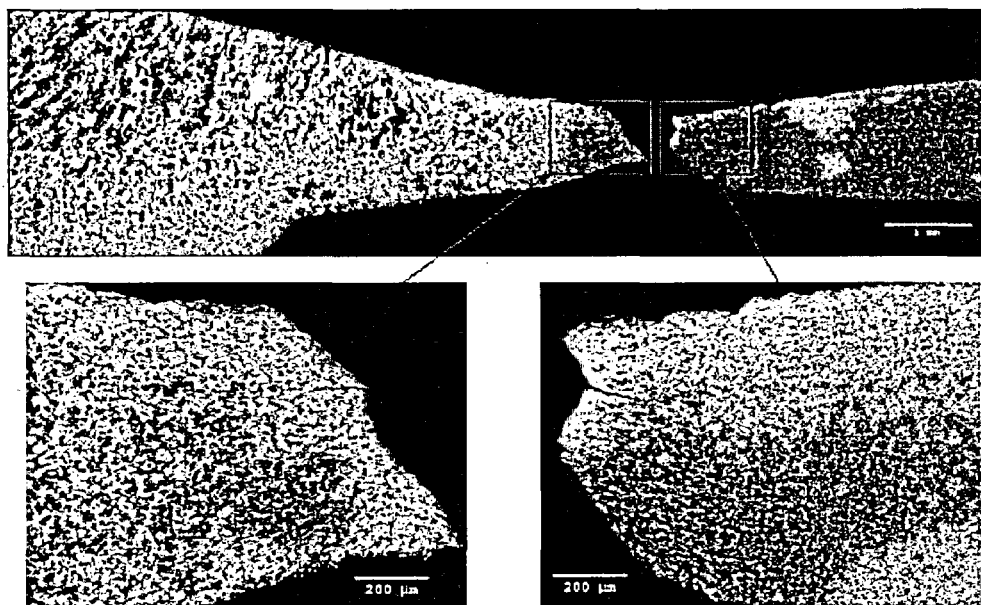
Figure 67. Metallographic cross section of tear #1 approximately 2 cm distant from the cross section shown in Figure 66. Note that failure occurred by more typical shear, and that microstructure shows evidence of substantial localized deformation having occurred prior to final separation. This represents an area removed from the lack of fusion defect where liner tearing occurred as the tear grew in length during testing of the structure. Tearing occurred through the fine grained portion of the heat affected zone.

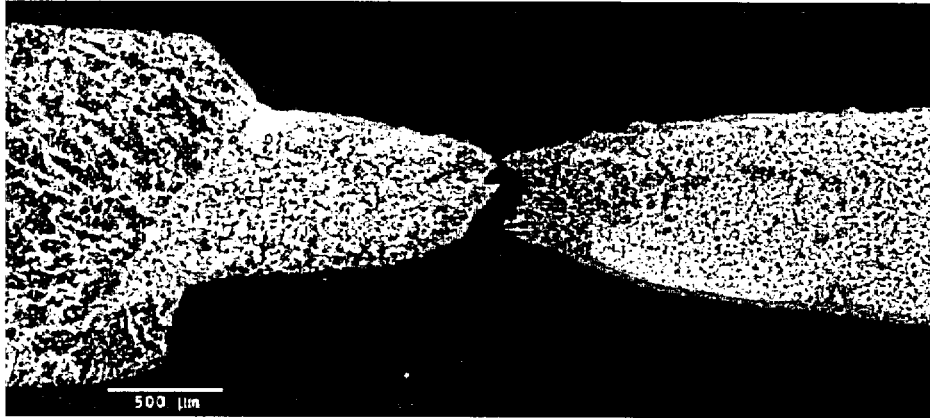
Figure 68. Metallographic cross section of tear #2-1. Tearing occurred in heat affected zone adjacent to repair weld. Note how grinding ends abruptly at edge of fusion zone, providing for measurement of as-ground liner thickness at edge of weld and close to location of tear. Tearing occurred in the adjacent heat affected zone.

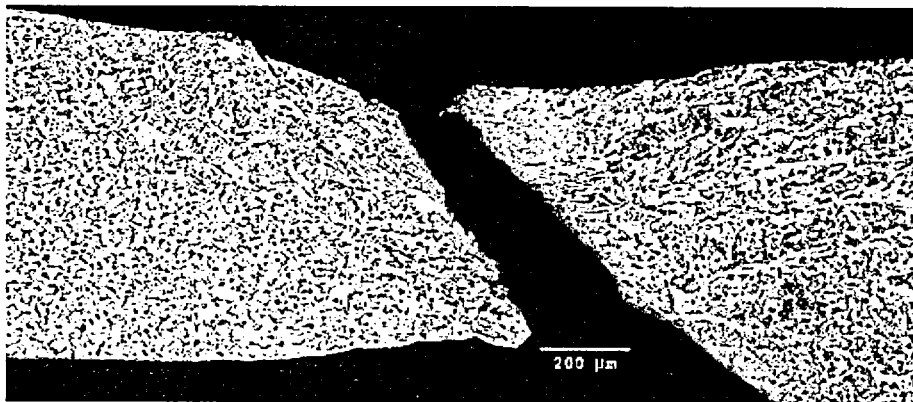
Figure 69. Metallographic cross section of tear #2-2. A very wide region (~29 mm) representing many sequential side-by-side welds was observed in this sample. The fusion zones of many of the early welds had been recrystallized by the heat input from subsequent welds, whereas many of the later welds retained the coarse columnar grain structures characteristic of single pass welds. Tearing occurred in by shear following substantial plastic deformation near the boundary between recrystallized weld metal and a region that could be either unrecrystallized weld metal or coarse grained heat affected zone.

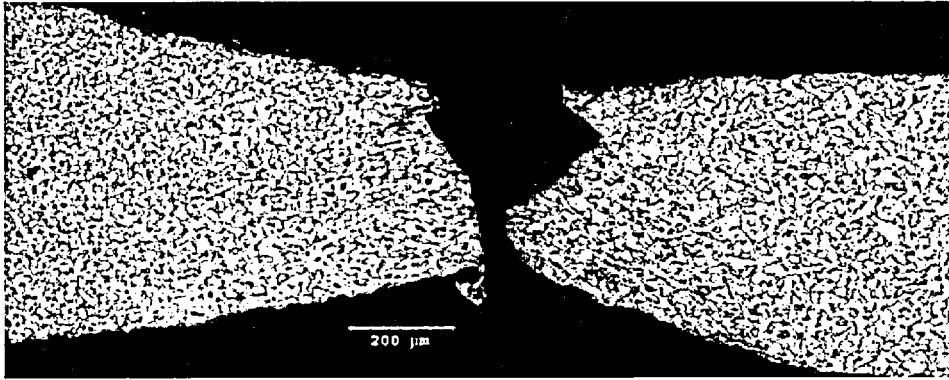
Figure 70. Metallographic cross section of tear #2-3. This sample was similar to #2-2, except that tearing occurred in a completely recrystallized fusion zone of an earlier weld. A portion of the fracture appears to have been mashed flat; this represents an artifact which occurred during unloading or when samples were being removed from the liner.

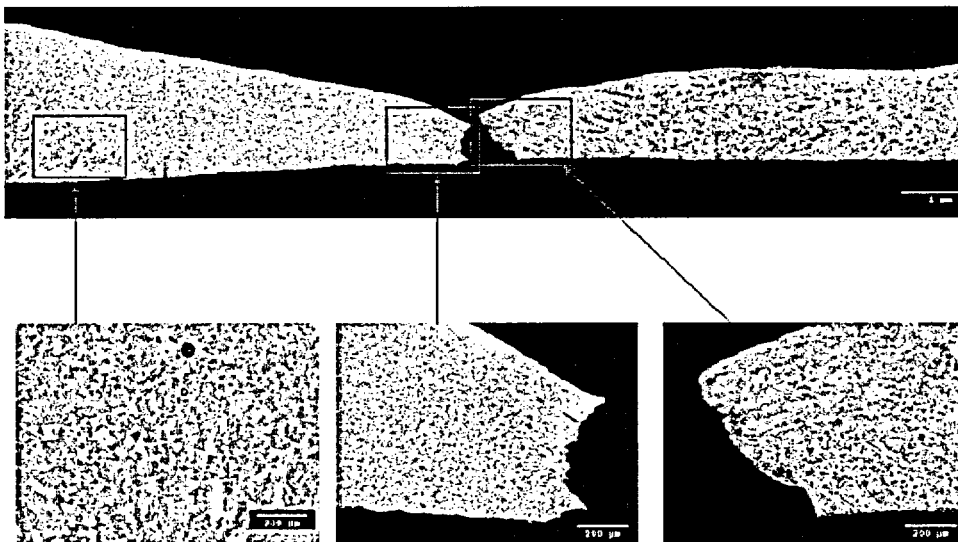
Figure 71. Metallographic cross section of tear #4-1. This sample was similar to #2-2, except that the region of sequential side-by-side welds was even wider, approximately 51 mm. Tearing occurred in an area of mixed recrystallized and unrecrystallized weld metal, and was accompanied by substantial localized plastic deformation.

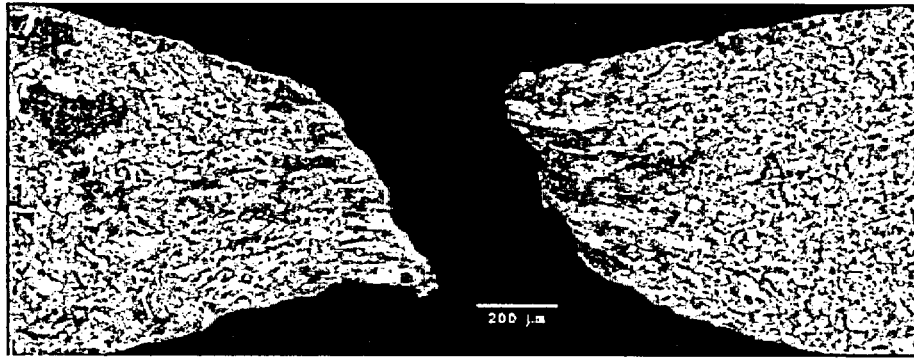
Figure 72. Metallographic cross section of tear #4-3. This sample contained the primary weld and several associated repair welds, plus a second weld approximately 25 mm in from the primary weld. This secondary weld was apparently made to repair the liner where it had been ground through when repairs were being made to the primary weld. Tearing occurred in a coarse grained region of heat affected zone between these two welds, and was preceded by extensive plastic deformation.

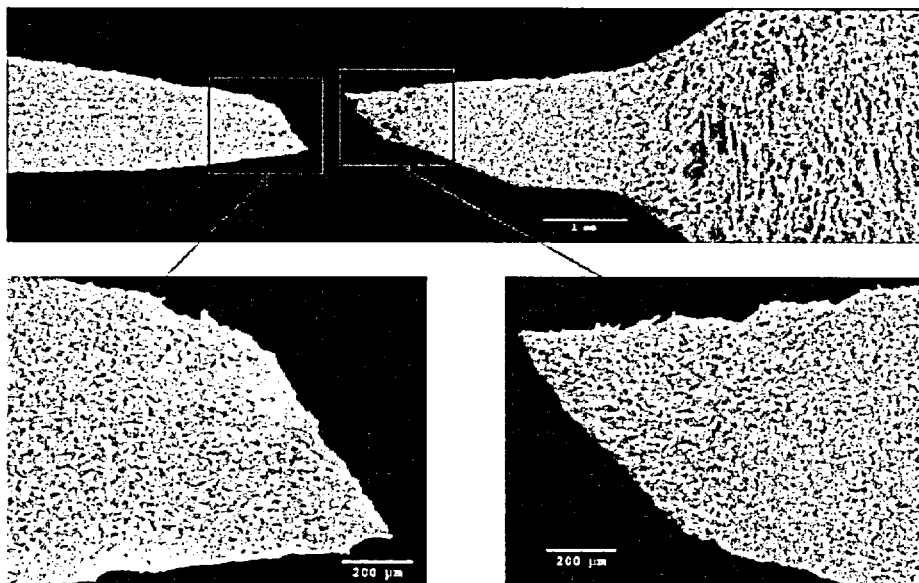
Figure 73. Metallographic cross section of tear #6-2. This sample contained a single repair weld. Grinding on the outside surface ended fairly abruptly at the edge of the back-up bar, resulting in a fairly deep but narrow region of liner thinning. Tearing occurred in the heat affected zone adjacent to the weld, and was accompanied by substantial localized plastic deformation.

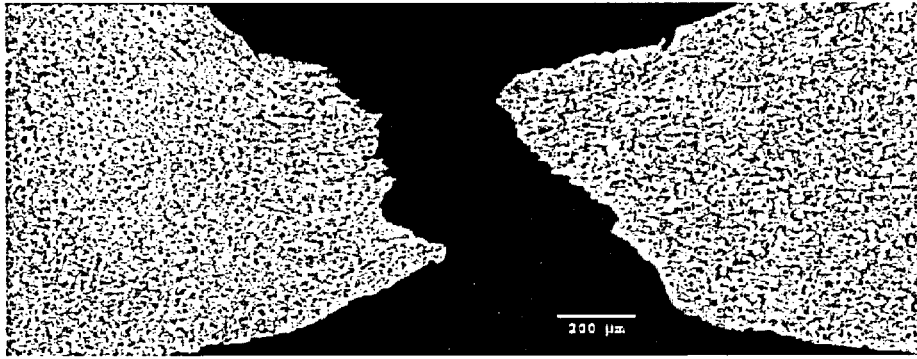
Figure 74. Metallographic cross section of tear #8-1. This sample contained a single repair weld surrounded by a region of recrystallized weld metal representing the original weld. Tearing occurred in either the recrystallized weld metal or the heat affected zone adjacent to the weld, and was accompanied by substantial localized plastic deformation.

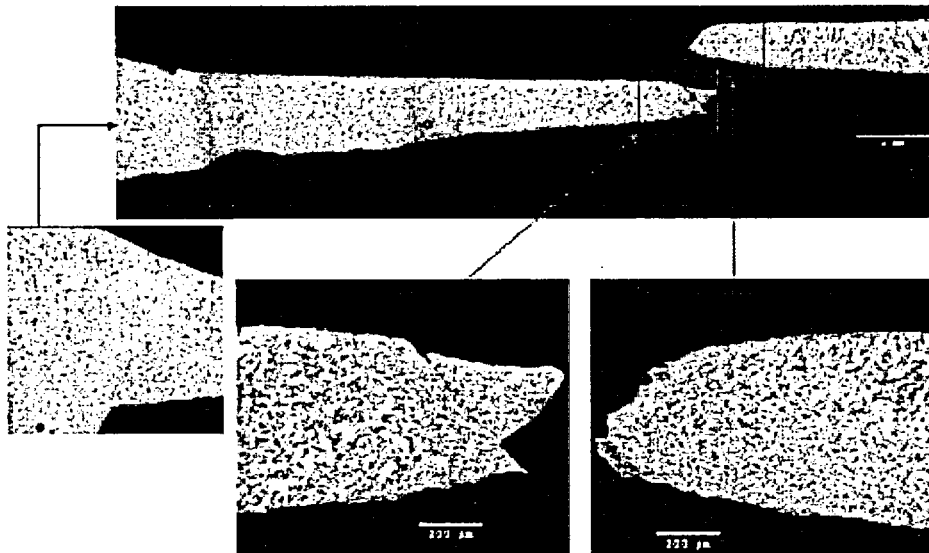
Figure 75. Metallographic cross section of tear #8-2. This sample contained the primary weld, plus a second weld approximately 13 mm in from the primary weld. This secondary weld was apparently made to repair the liner where it had been ground through when repairs were being made to the primary weld, similar to sample #4-3. Tearing occurred adjacent to the secondary weld in what appears to be recrystallized weld metal. Substantial localized plastic deformation accompanied tearing.

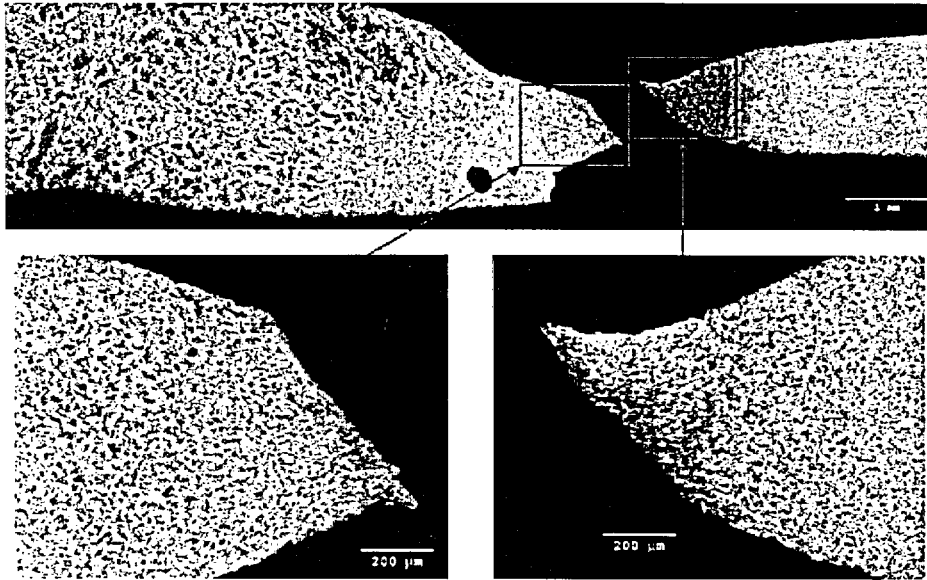
Figure 76. Metallographic cross section of tear #9. This sample contained a single repair weld. Grinding on the outside surface ended abruptly at the edge of the back-up bar, resulting in a deep but narrow region of liner thinning. Tearing occurred in the heat affected zone adjacent to the weld, and was accompanied by substantial localized plastic deformation.

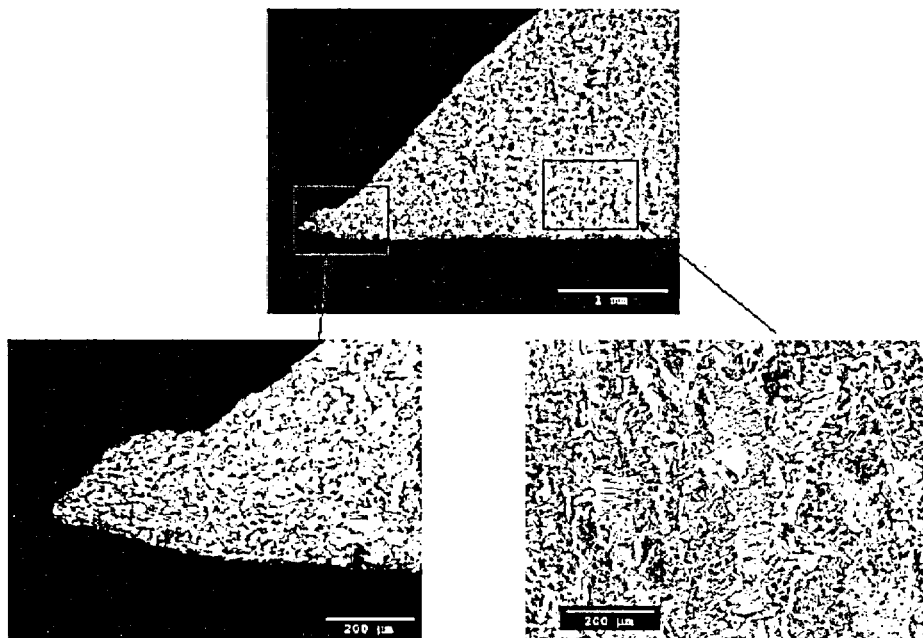
Figure 77. Metallographic cross section of tear #17. This shows the fusion zone of the primary weld, plus the tear adjacent to it. The tear appears to have occurred in a region of recrystallized weld metal from a previous weld. Tearing was accompanied by substantial localized plastic deformation.

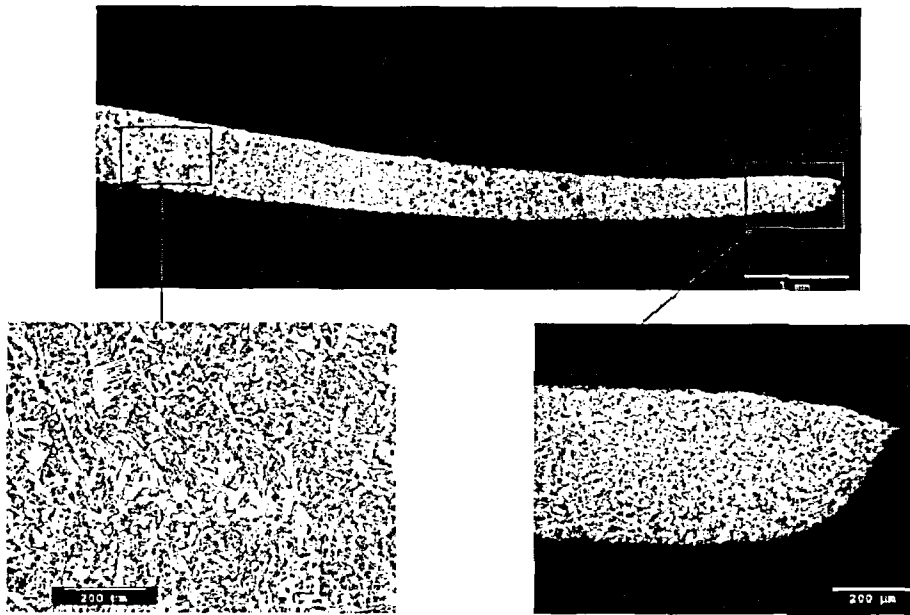
Figure 78. Region of tear #17 adjacent to that shown in Figure 77. Note columnar fusion zone at left; this corresponds to a secondary weld made to repair the liner where it had been ground through when repairs were being made to the primary weld, similar to samples #4-3 and #8-2. Note that the liner thickness was greatly reduced by grinding over the entire region pictured here.

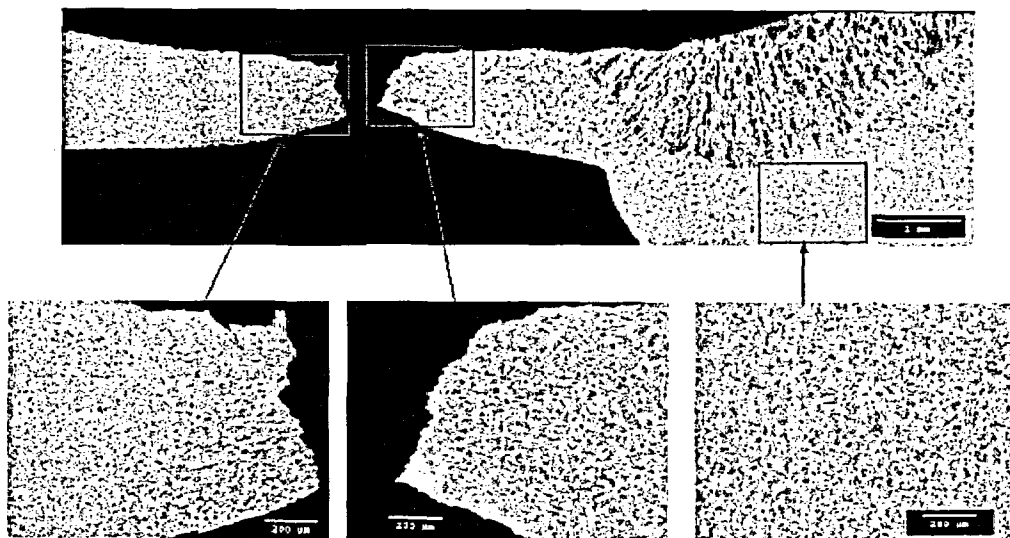
Figure 79. Metallographic cross section of tear #7. Columnar grained region represents repair weld; underlying recrystallized region represents earlier weld. Tearing occurred in heat affected zone adjacent to weld. Less shear and localized deformation appears characteristic of this tear, suggesting that it may have occurred due to more complex stresses.

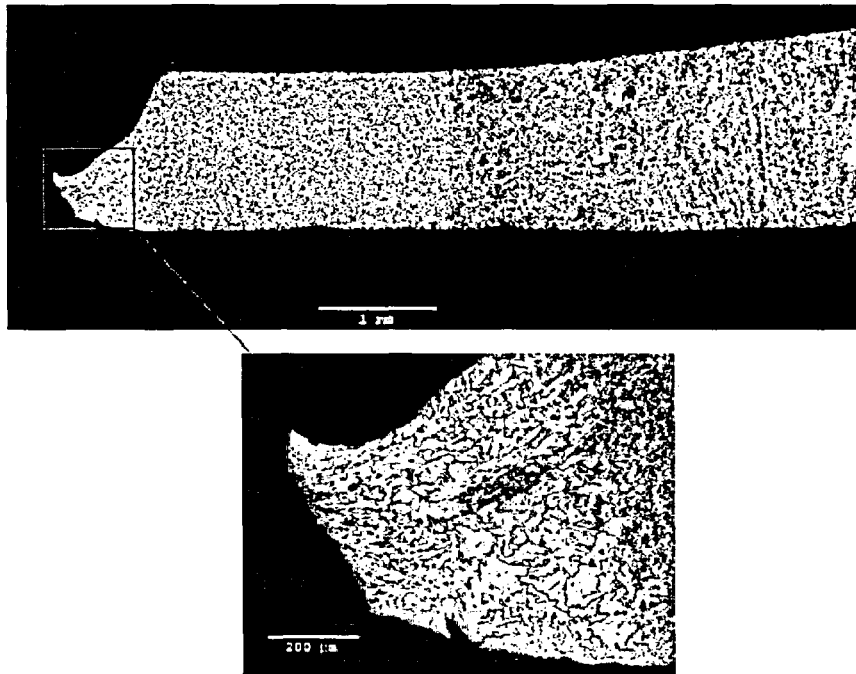
Figure 80. Metallographic cross section of tear #15. Region at right is columnar fusion zone of repair weld. Region at left is recrystallized fusion zone of former weld. Tear (at far left) occurred just left of where recrystallization stopped, either in unrecrystallized weld metal or coarse grained heat affected zone.

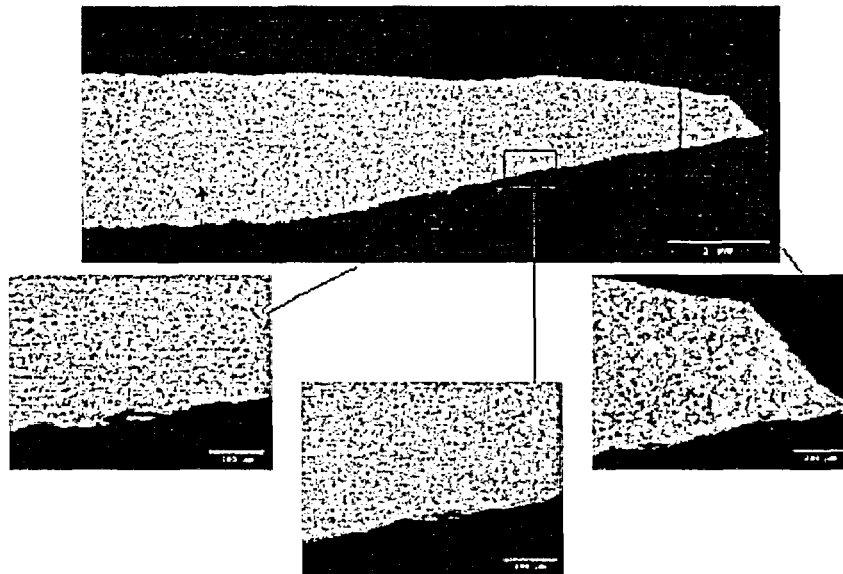
Figure 81. Region of tear #15 adjacent to that shown in Figure 80. Tear (at far right) occurred in coarse grained portion of heat affected zone. Note substantial angle between surface and segregation bands in metal, indicative of grinding in tapered area.

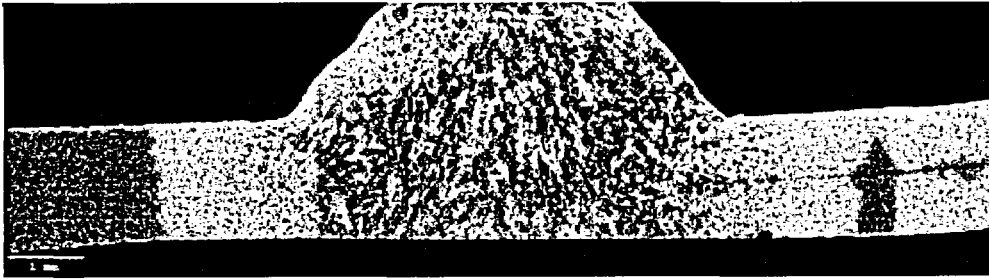
Figure 89. Metallographic cross section of region #18-1. Plastic deformation, but no tearing, occurred in this region. No evidence of repair welding or substantial grinding was found in this area.

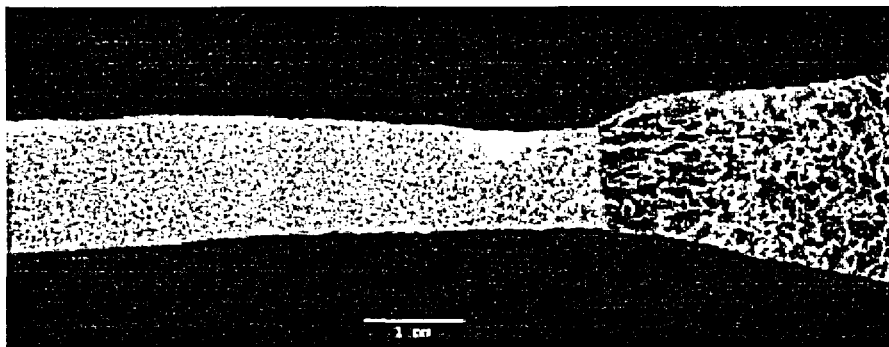
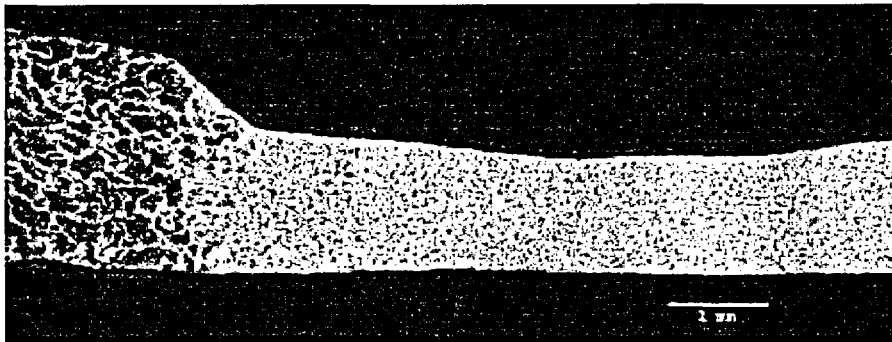
Figure 90. Metallographic cross section of region #18-2. Plastic deformation, but no tearing, occurred in this region. Evidence of repair welding and an undetermined amount of grinding was found in this area.

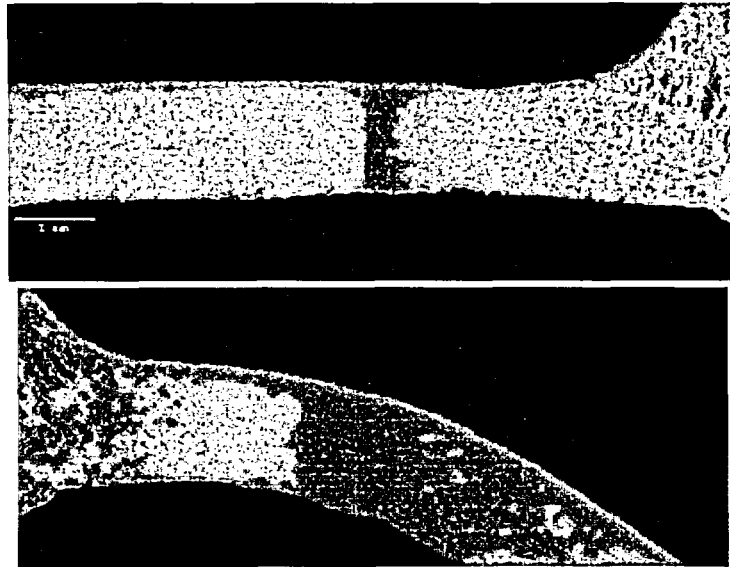
Figure 91. Metallographic cross section of region #24-2, where strain gauges recorded local strain of approximately 7%. No evidence of repair welding or substantial grinding was found in this area. Detailed observation of the surface “depressions” to the left of the weld suggested that they may correspond to surface defects in the plate. In particular, the bottom depression was filled with non-metallic particles, perhaps rolled-in oxide (too dark to be visible on this photo). These depressions may also correspond to the early stages of necking.

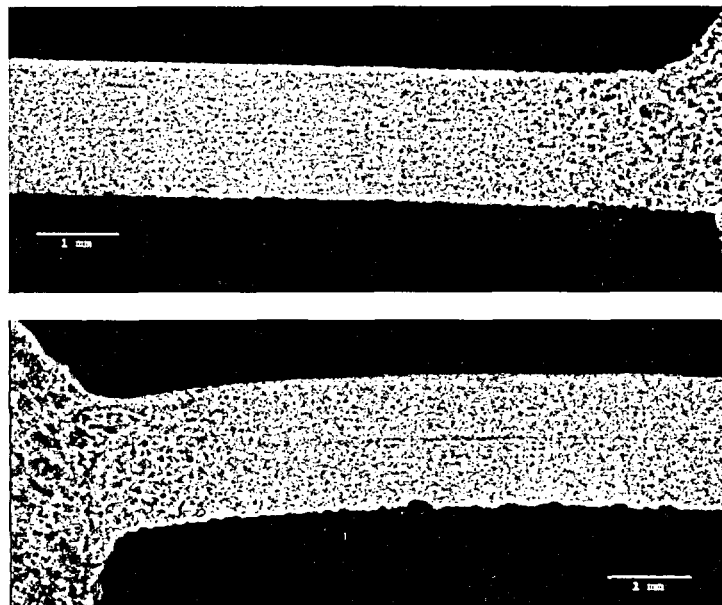
Figure 92. Metallographic cross section of region #24-1. Plastic deformation, but no tearing, occurred in this region. No evidence of repair welding or substantial grinding was found in this area.
