QUAD CITIES UNIT 2

Discuss the Root Cause and Corrective
Actions for Steam Dryer Damage at
Quad Cities Unit 2

**Quad Cities Nuclear Power Station
Unit 2
Steam Dryer Performance
Exelon/GENE**

July 25, 2003

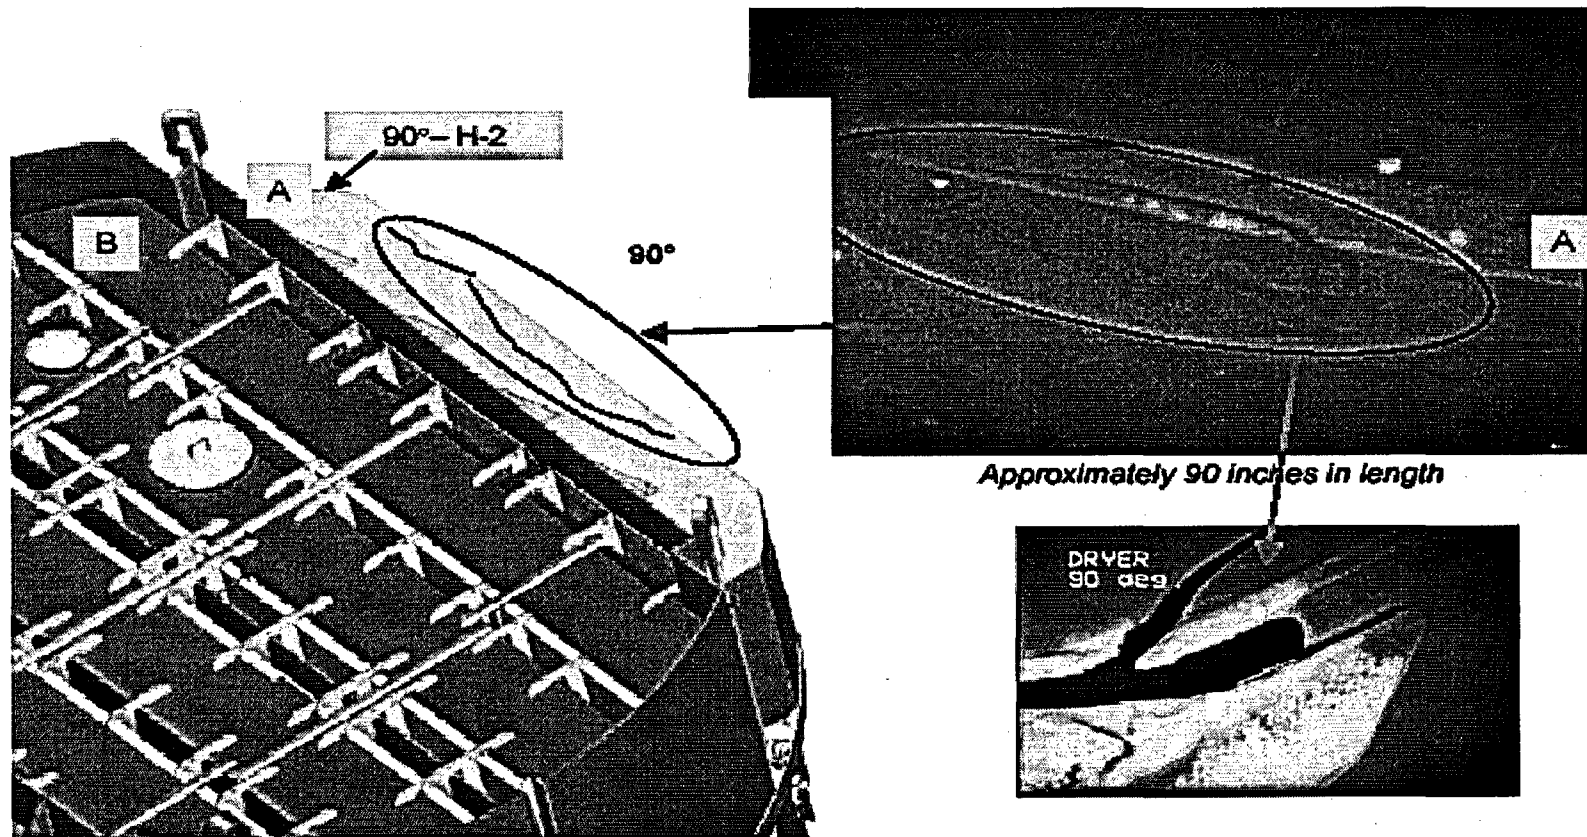
90° Top of Bank A

- Damage assessment
 - Top of outer hood cover plates
 - Through-wall crack (90° side)
 - Incipient cracking (270° side)
 - Internal bracing
 - Three braces detached in outer 90° hood
 - One severed vertical brace in outer 270° hood
 - Three tie bars connecting dryer banks cracked
 - Industry experience shows tie bar failures at both EPU and pre-EPU conditions
- Inspected for collateral damage
 - None identified
- All loose parts retained within the dryer envelope
 - All parts retrieved

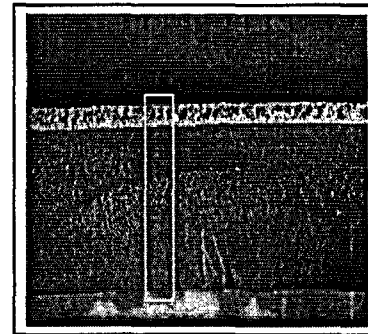
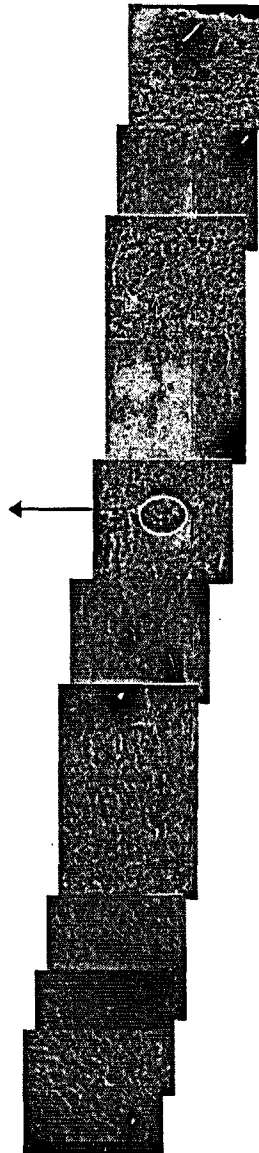
270° Hood Top Plate

- The cause of the steam dryer hood cracking was high cycle fatigue; final fracture resulted from decompression wave (PORV actuation)
- The fractures initiated at the stress concentrations at the bracket joint to the interior surface of the hood
 - No weld flaws were identified
 - Crack propagated lengthwise at a higher rate
 - Remaining ligament on 90° side is 0.03 inch through-wall
 - Remaining ligament on 270° side is 0.1 inch through-wall
- No chemistry, material, welding, or manufacturing deficiencies were identified
- No evidence of IGSCC was observed
