## 5. TESTING

The basic objectives of the PCCV test were specified by NUPEC in the Master Project Plan [34]. The stated objective of this plan was to... “investigate the ultimate behavior of PCCV under pressure beyond the design basis accident and to prove the pressure retaining capacity of PCCV.” NUPEC originally specified a series of five tests, illustrated in Figure 5.1: 1) trial pressurization to 0.4 kg/cm<sup>2</sup> (5.7 psig or 0.1 P<sub>d</sub>), 2) structural integrity and integrated leak rate tests to 4.5 and 3.6 kg/cm<sup>2</sup> (64.1 and 51.2 psig or 1.125 and 0.9 P<sub>d</sub>), respectively, 3) two design pressure tests to 4.0 kg/cm<sup>2</sup> (57 psig or 1.0 P<sub>d</sub>), and 4) a Limit State Test (LST) terminating with excessive leakage or structural failure.

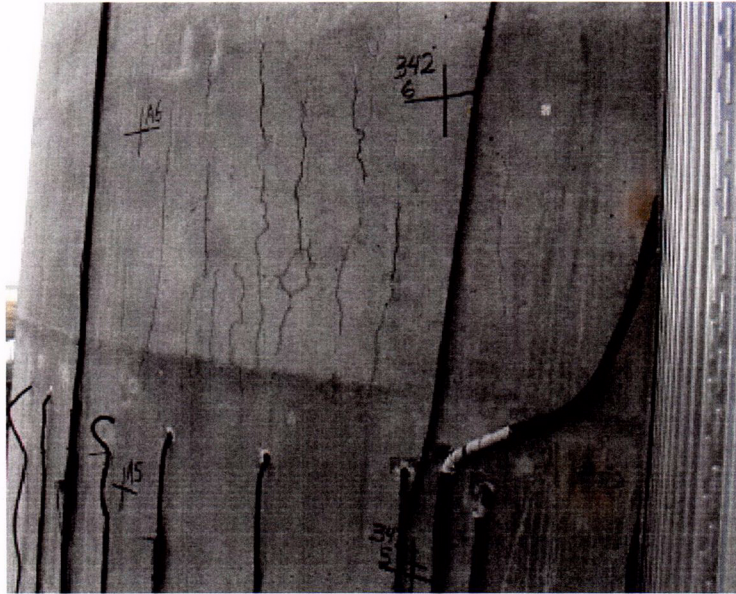
While holding at the ILRT pressure, a limited amount of crack mapping was performed. This was accomplished by tracing all new cracks in predetermined areas and taking still photos of these areas. Cracks in the area to the left of the E/H prior to the SIT were traced in black and are shown in Figure 5.10. New cracks, traced in blue during the ILRT, are shown in Figure 5.11. Cracks widths were not measured.

Figure 5.11 Post-SIT Cracks at Azimuth. 350 degrees, Elev. 4680 to 6200 (Grid 45)

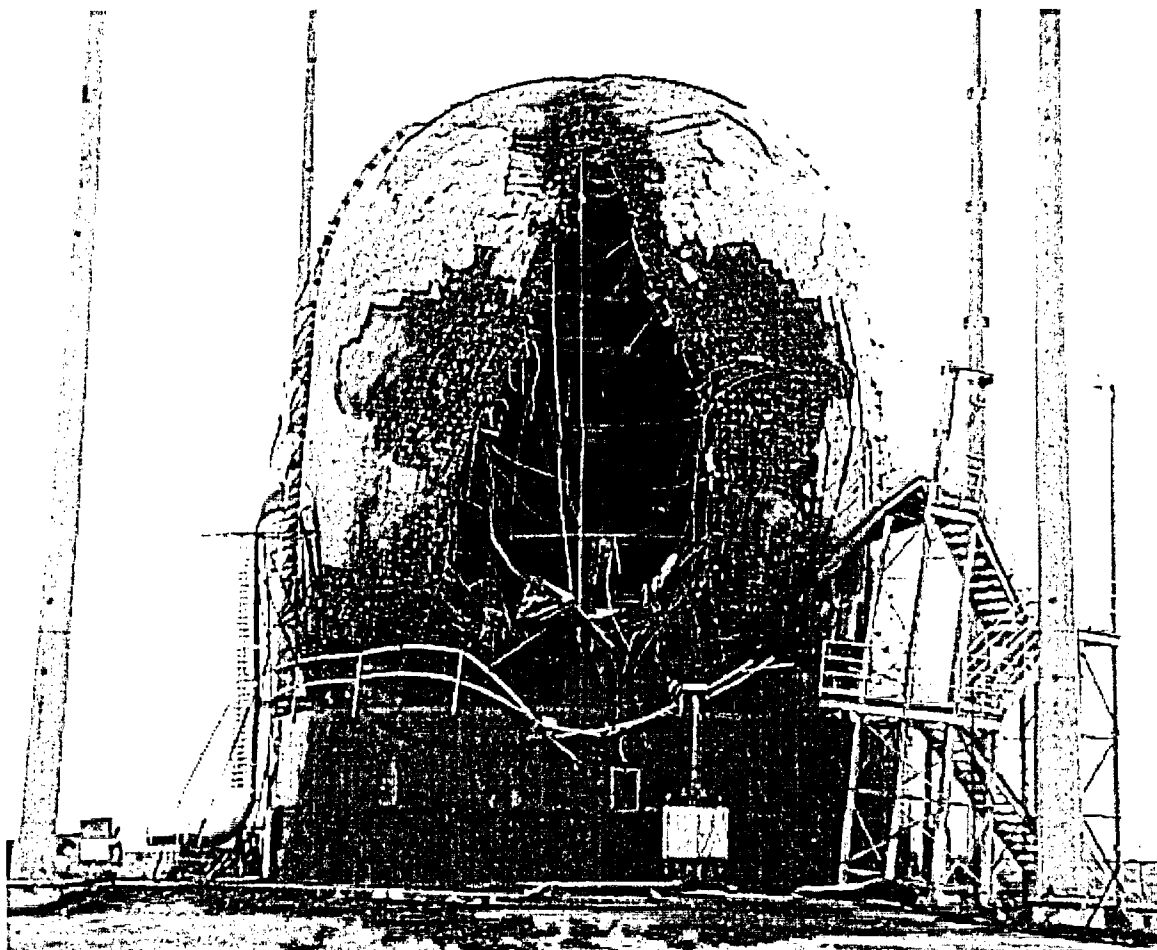
The detailed results of the SFMT are discussed in Section 5.3.3, along with observations from the posttest inspection of the model. In the case of the SFMT, posttest inspection was limited to visual inspection due to the obvious damage and restricted access for safety.

Figure 5.35 PCCV Model after the SFMT
