5.3.2 Limit State Test Results

5.3.2.2 Posttest Inspection

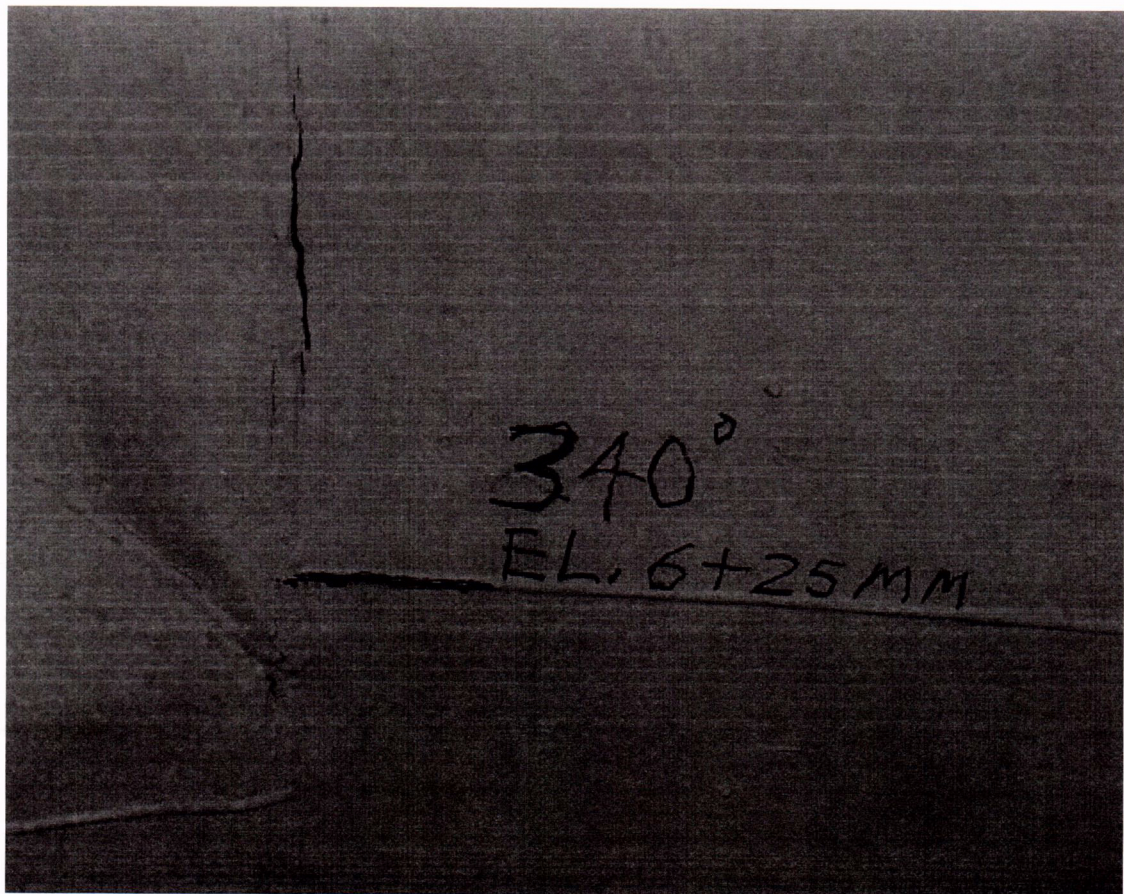
Considering the liner strains near penetrations and other discontinuities, the strains in the vicinity of the E/H are of primary interest since there were indications during the LST that the liner initially tore in this region. Posttest inspection of the liner, described in Section 5.3.2.2, revealed several tears at the edges of the embossment (Figure 5.47), but no apparent damage near the insert plate. The layout of the liner strain gages is shown on Drawing D-SN-P-218 (Appendix E), and reproduced in Figure 5.48 for reference. The highest strains in this region were at the left and right edges of the embossment. The strains adjacent to the insert plate (#19 to #67) were small, nearly all less than 0.2% at maximum pressure, with only a few near the ends of anchors or stiffeners reaching 0.5%.

Figure 5.47 Liner Tear (#15) at E/H

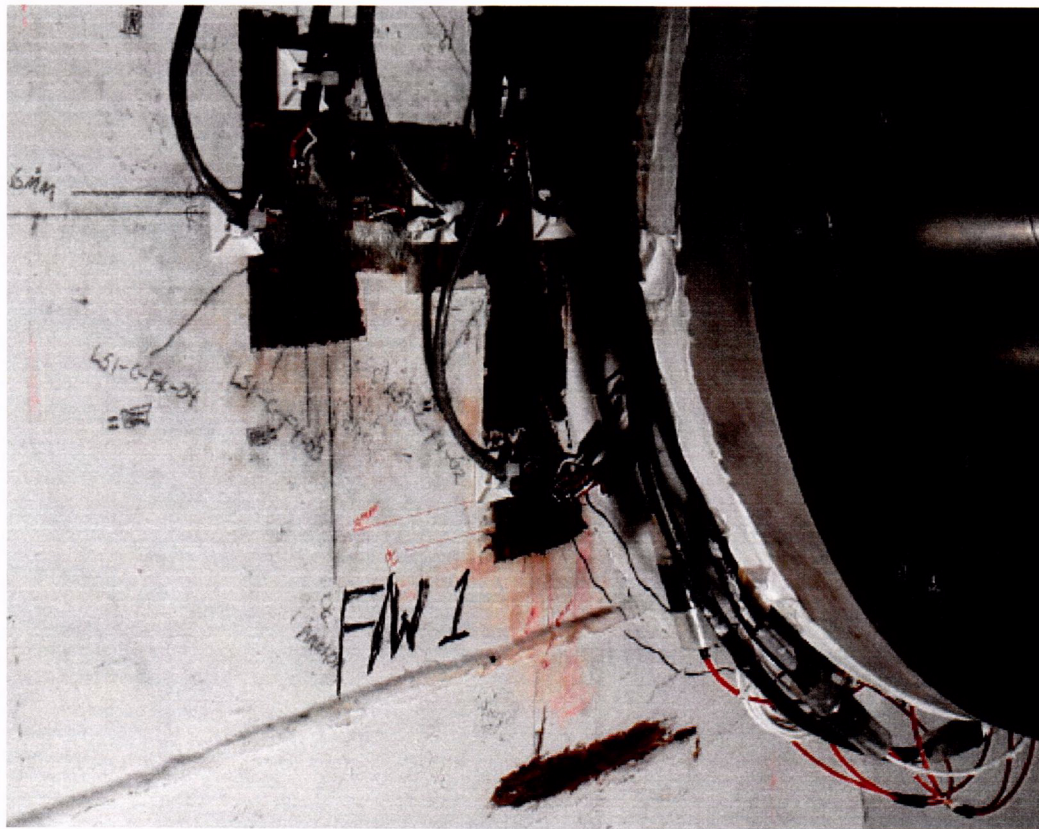
Several large tears occurred at each end of the F/W penetration, beginning at the weld between the thickened insert plate and the liner; however, no tears occurred at the M/S penetration event, though the free-field hoop strains at the M/S are higher since it is closer to the mid-height of the cylinder. There are a number of reasons why this occurred, primarily liner fabrication issues discussed in Section 5.3.2.2. It is interesting to note that even though the strain gages at the F/W penetration were located near the tear (see Figure 5.54), measured strains were relatively low until the very end of the LST, when some strains increased very rapidly. This might indicate that a tear in the vicinity of a strain gage can act as a strain relief mechanism on the surrounding material. The 'jump' in the strain near the end of the test may also be due to material distortion in the vicinity of the tear as the tear propagated. On the other hand, the strains recorded at the M/S penetration begin to climb rapidly at 2.0 to $2.5 P_d$, reaching values as high as 4.5% without resulting in any liner tearing. Detailed inspections of this location did not reveal any evidence of the fabrication problems that were present at the F/W penetration.

Figure 5.54 Liner Tear (#3) and Strain Gages at F/W Penetration

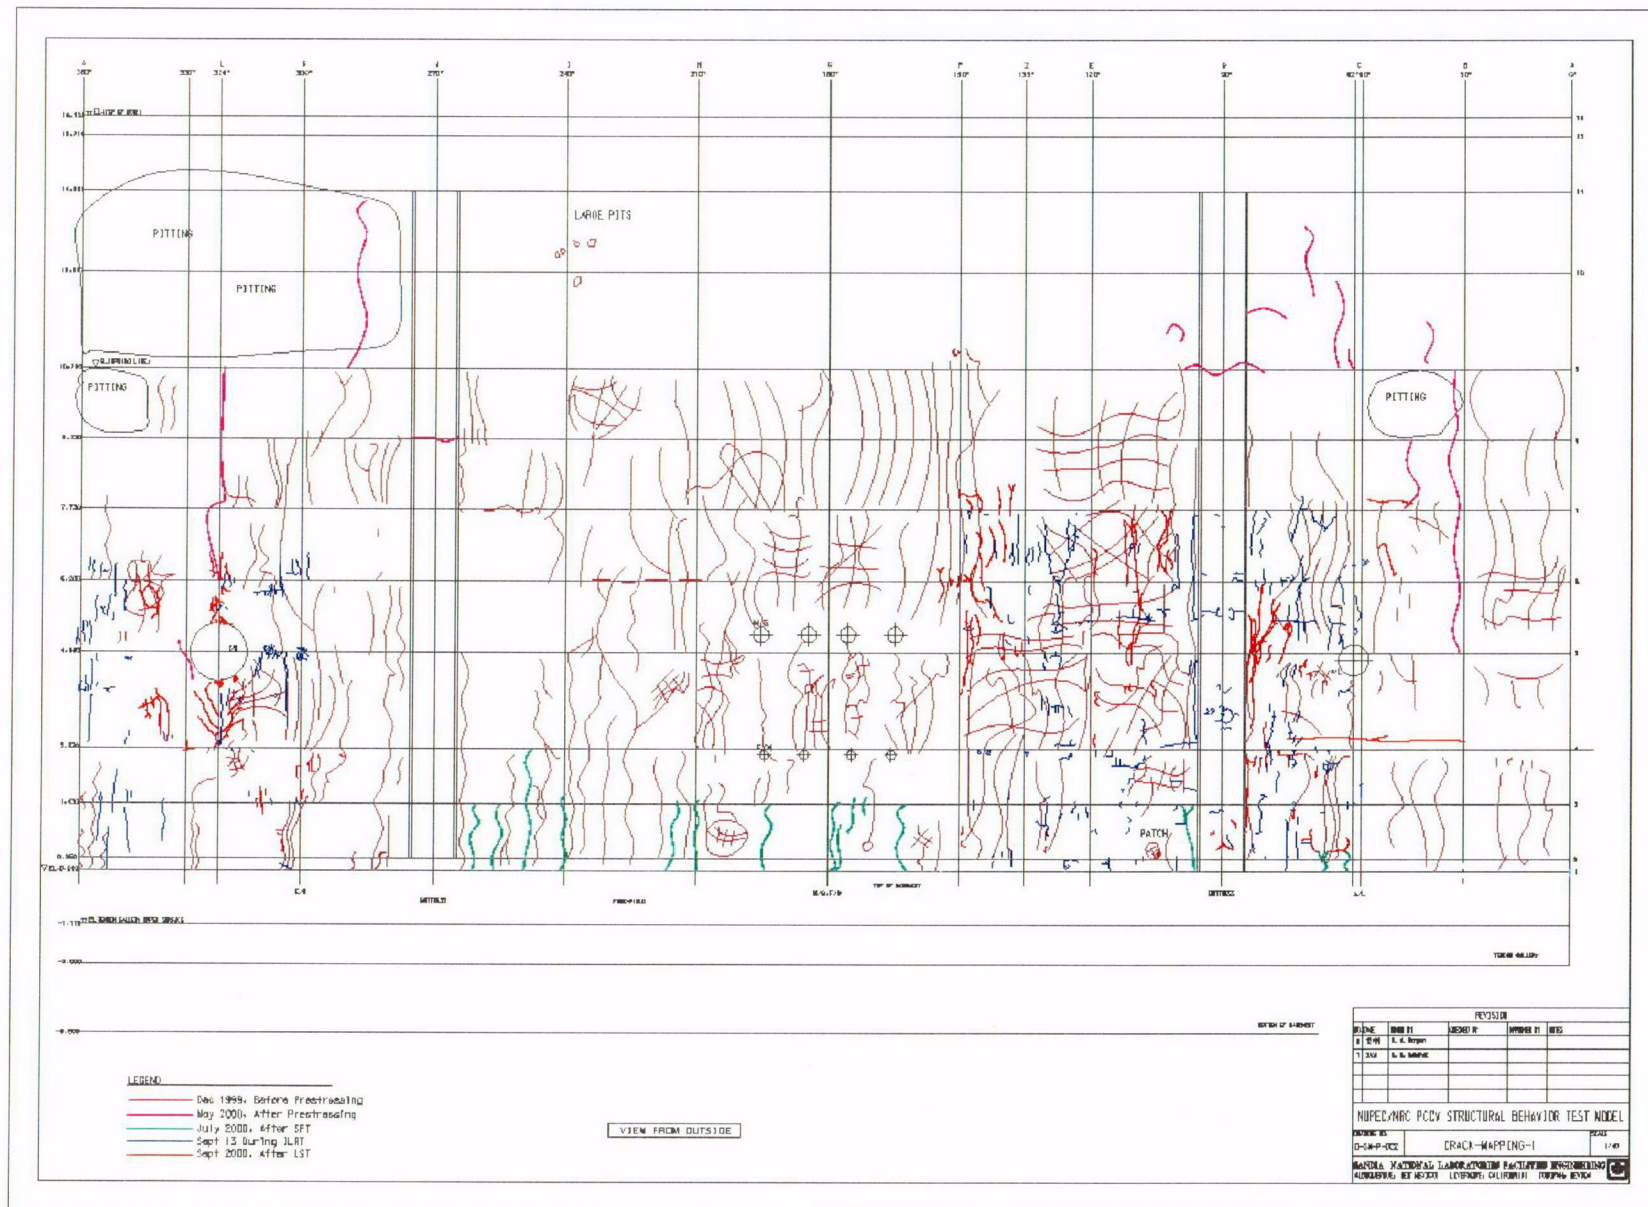
New cracks and extensions of existing cracks within the crack mapping zones resulting from the LST (see Fig. 5.8) were traced in red and the surface was photographed to document the crack locations (e.g. Fig 5.22). The cracks were then transferred to the crack map drawing, shown in Figure 5.76, which shows all the major cracks identified after various loading stages. In general, concrete cracking was not extensive or very severe, with the exception of some areas around the E/H and some of the smaller penetrations. As noted in Chapter 3, there was no effort to measure crack widths. While it can be observed that some of the larger cracks around the E/H are near the liner tear locations, there was no further effort to correlate the crack locations with other events or data.

Figure 5.76 Post-LST Concrete Crack Map

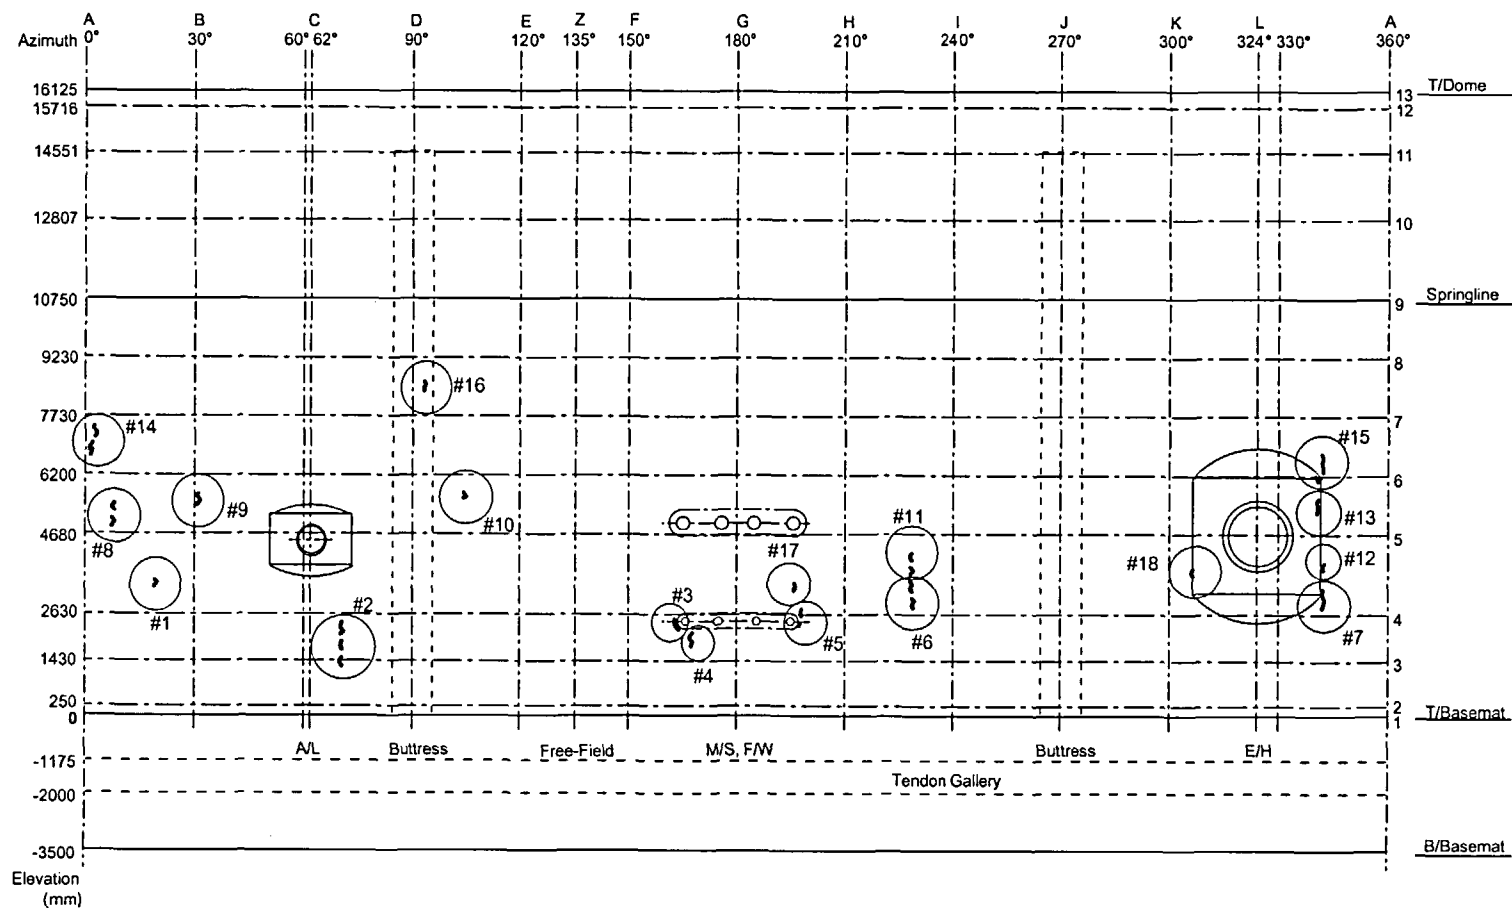
As noted in Section 5.2.3, after entering the model following the LST, the liner surface was examined carefully and 26 discrete tears were found at 18 different locations, the grouping by location being somewhat arbitrary. The location of the tears are mapped in Figure 5.77. The location numbers are subsequently used to identify the tears.

One immediate observation was that each liner tear was at or very near a field weld seam in the liner. No tears were found in the undisturbed parent material or at a shop weld.

Figure 5.77 Post-LST Liner Tears

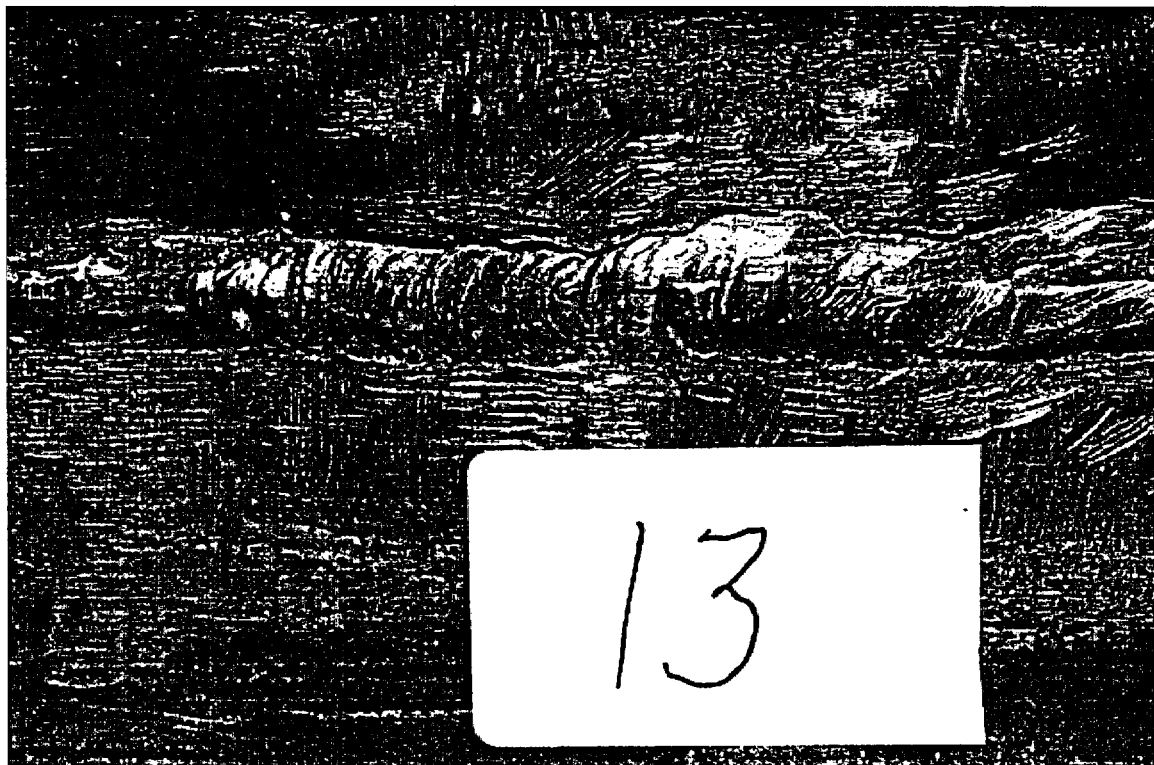
The paint was then removed from each tear, allowing the liner tear to be seen without being obscured by the paint. Each tear was then photographed again for documentation. Figure 5.86 shows an close-up of Tear #13 after removing the paint. With the paint removed, it was clear that the weld was repaired or had been reworked by grinding at nearly every tear. Note the grind marks in Figure 5.86, which occurred during erection and welding of the liner. (The paint was removed by using chemical strippers; no paint was removed by mechanical methods.)

Figure 5.86 Close-Up of Tear #13 after Removal of Paint
