5.3.3 Structural Failure Mode Test Results

5.3.3.2 Posttest Inspection

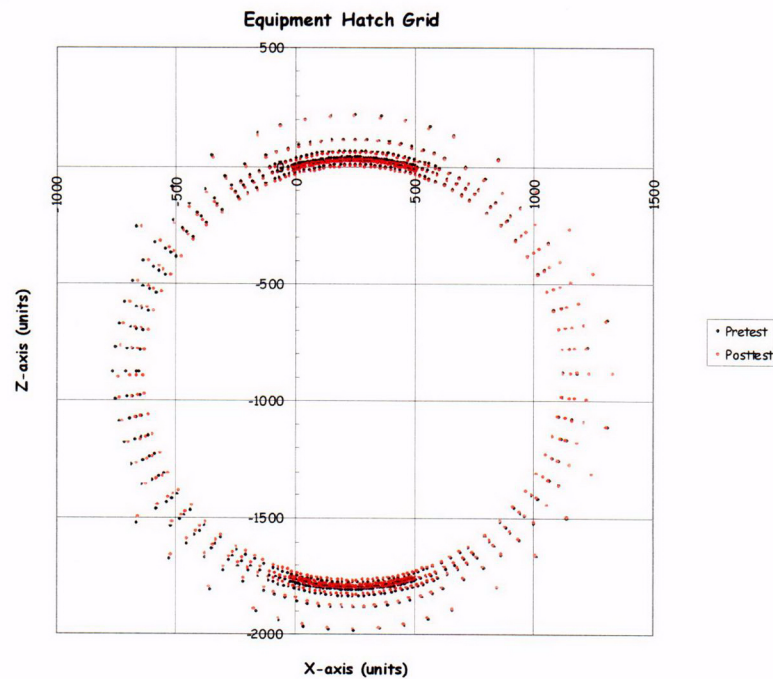
Figure 5.90 E/H Post-LST Displacement

As described in Section 3.2.5.4, a grid was constructed around the E/H to measure the residual strain field after the test. The pretest analysis predicted large strains near the perimeter of the thickened insert plate surrounding the E/H barrel and near the anchors and stiffeners that terminated near the insert. The grid, shown in Figure 5.89, was drawn, and the position of the grid points was obtained using a 3D digital position mapping tool. After the LST, the grid points were mapped again and the pre- and posttest positions were plotted in Figure 5.90.

Unfortunately, as noted previously, the strains in this region were very small and the resulting residual displacements are barely distinguishable from the pretest positions, given the precision of the digital probe. As a result, no useful information was obtained by this effort.

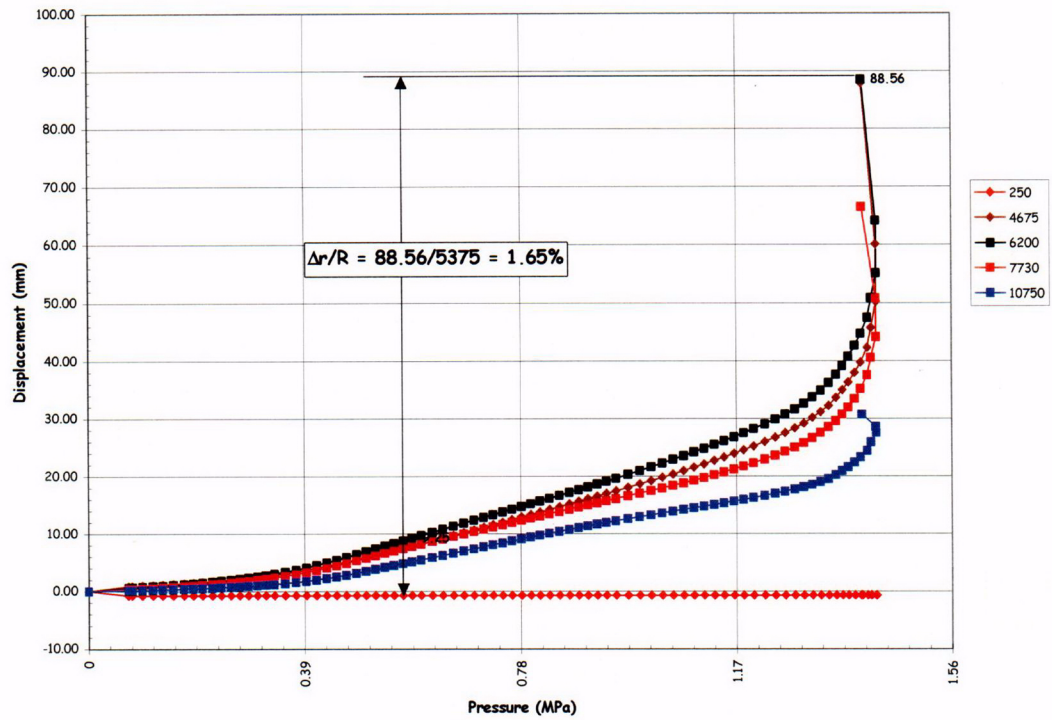
Figure 5.92 SFMT – Radial Displacement at Azimuth 324 degrees (L)

Figure 5.92 displays the displacements at Azimuth 324 degrees, which coincides with the centerline of the E/H. The largest radial displacement recorded during the SFMT, 88.56 mm, again occurred at this azimuth at elev. 6200, above the E/H. Computing the equivalent hoop strain due to pressure at this location from kinematics,

$$@P_{\text{final}} = 3.58P_d: \frac{\Delta r}{R} = \frac{88.56}{5376} = 1.65\%$$

At the peak pressure, $3.65P_d$, the displacement was 55.12 mm, yielding an equivalent hoop strain of 1.02%

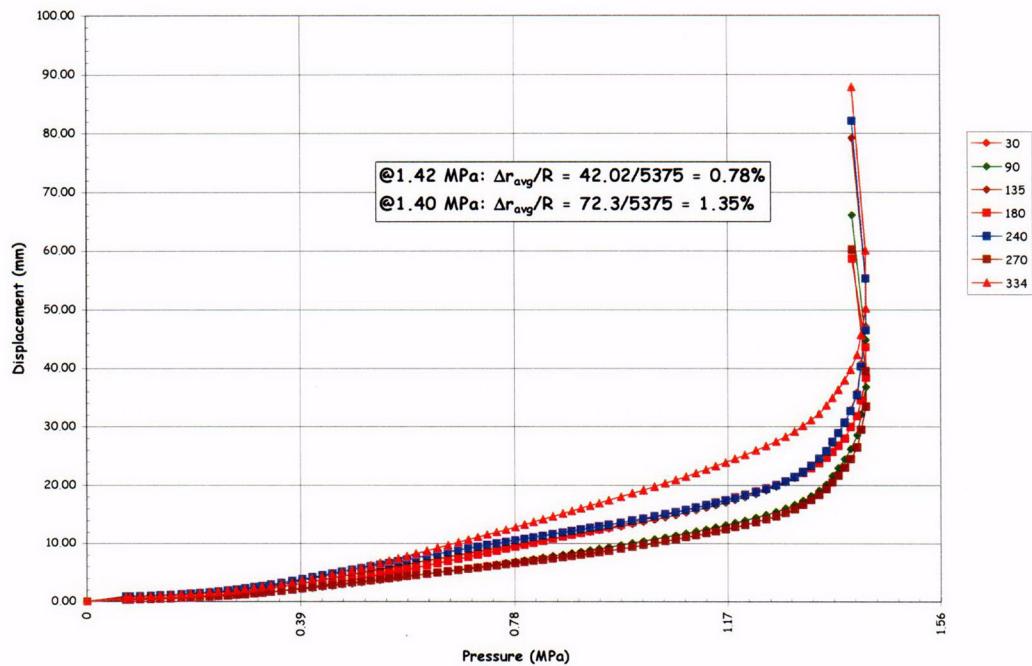
Figure 5.93 SFMT – Radial Displacement at Elev. 4680 (5)

Figure 5.93 compares the displacement response as a function of azimuth at elev. 4680, nominally the mid-height of the cylinder and the centerline of the E/H, A/L, and M/S penetrations. The response is not as uniform as was observed during the LST. Nonetheless, averaging the radial deformation due to pressure yields a nominal average hoop strain of 0.78% at the peak pressure $3.65P_d$. Similarly, the average hoop strain at $3.58P_d$, just prior to rupture, was 1.35%.

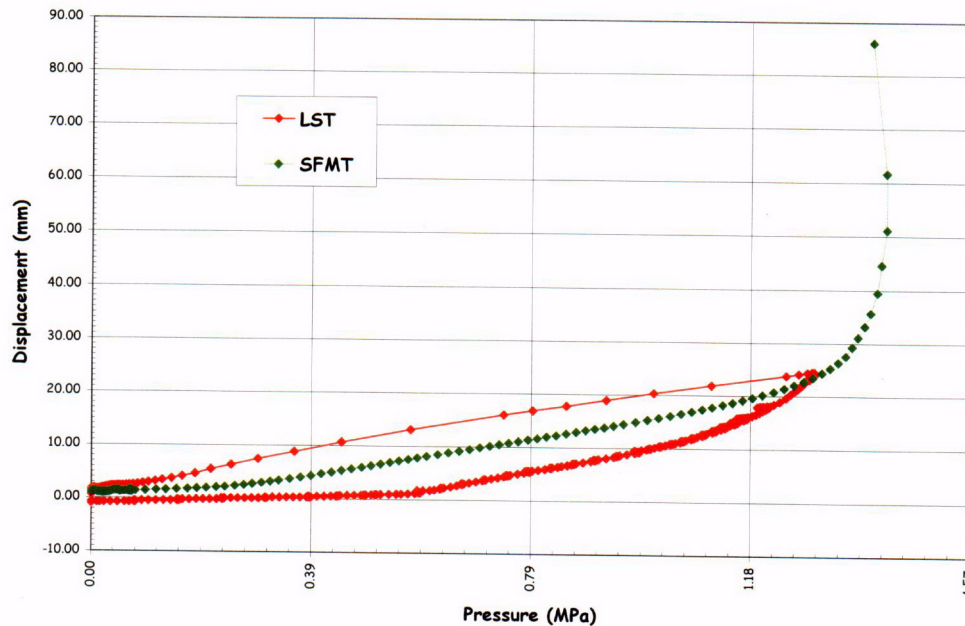
Figure 5.94 SFMT – Radial Displacement at Azimuth 135 degrees, Elev. 6200

During the SFMT, the displacement response of the model is essentially linear to just beyond 3.0 Pd, when global yielding begins to occur prior to rupture. The initial stiffness of the model, however, is less than the initial stiffness during the LST. Figure 5.94 compares the response at the mid-height of the cylinder (Z6) during the LST and the SFMT. (The SFMT response was offset in this figure by adding the residual displacement at the end of the LST to facilitate comparison.) This figure shows that the hoop stiffness during the SFMT is essentially identical to the post-cracking stiffness during and after the LST. It also shows that the SFMT displacement is nearly identical to the LST displacement at the maximum LST pressure, suggesting that, if the LST had continued, the response would have been virtually

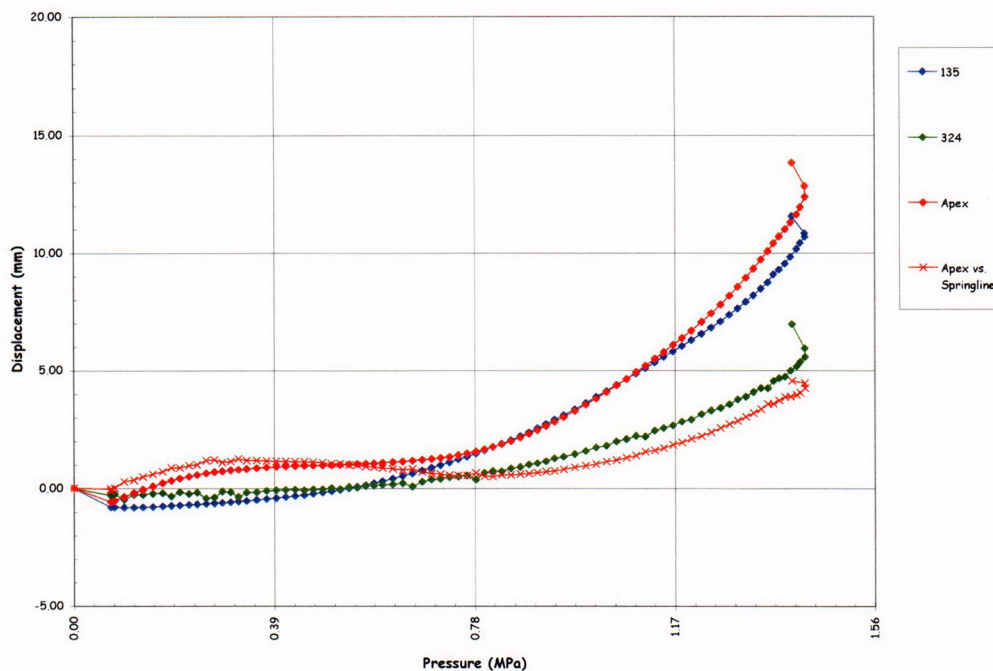
Figure 5.96 SFMT Vertical Displacements at Springline (El. 10750) and Apex

The vertical displacements are shown in Figure 5.96. The maximum vertical displacement at the springline was 10.84 mm at Azimuth 135 degrees, essentially the same as during the LST, and 5.94 mm at Azimuth 324 degrees, less than during the LST. The reason for the small displacement at 324 degrees is not immediately obvious; however, it might be the stiffening effect of the E/H embossment, although this was not observed during the LST. Nevertheless, it is clear that the vessel did not yield in the vertical direction and the vertical strains were still on the order of 0.1%.

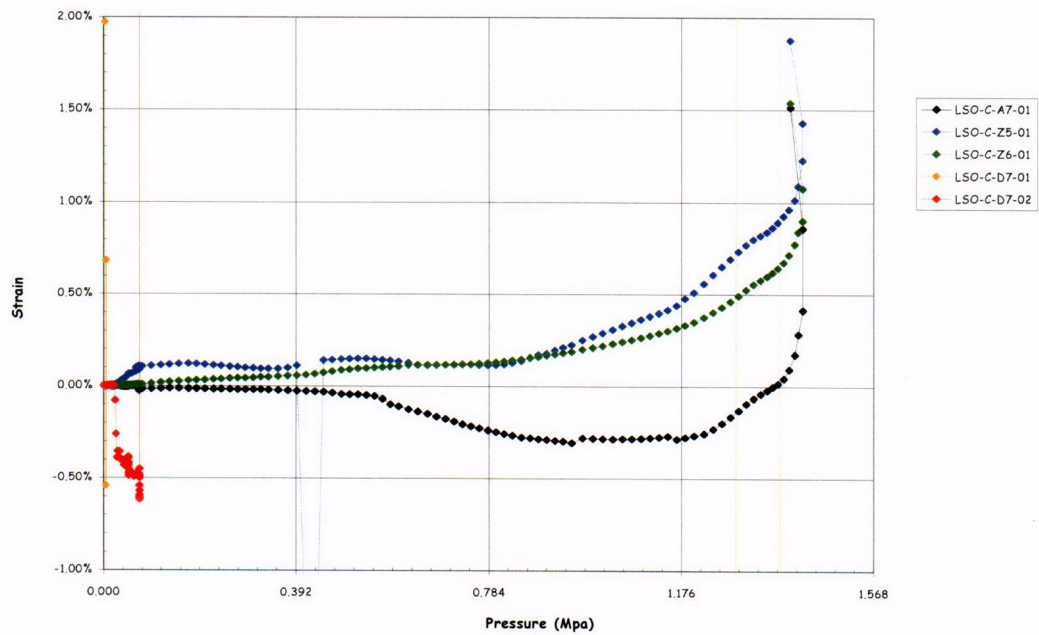
Figure 5.101 SFMT Exterior Liner Strains

The strain histories for the surviving gages are plotted in Figure 5.101. These gages measured the hoop liner strain inside a rathole (see drawing D-SN-P-209, Appendix E) at Azimuth 0 degrees, elev. 7730 (A7) and Azimuth 135 degrees, elev. 4680 and 6200 (Z5 and Z6) at the mid-height of the cylinder. The maximum liner strains at Z5 (1.9%) and Z6 (1.5%) are consistent with the strains calculated from the displacements. At A7, nearest the location where the model ruptured, the hoop strains were consistently lower than those at Z5 and Z6, even going into compression, until the peak pressure was reached, when the strain increased rapidly to a maximum of 1.5% tension. While these were not free-field gages, they nevertheless gave some indication of the hoop strains in the liner.

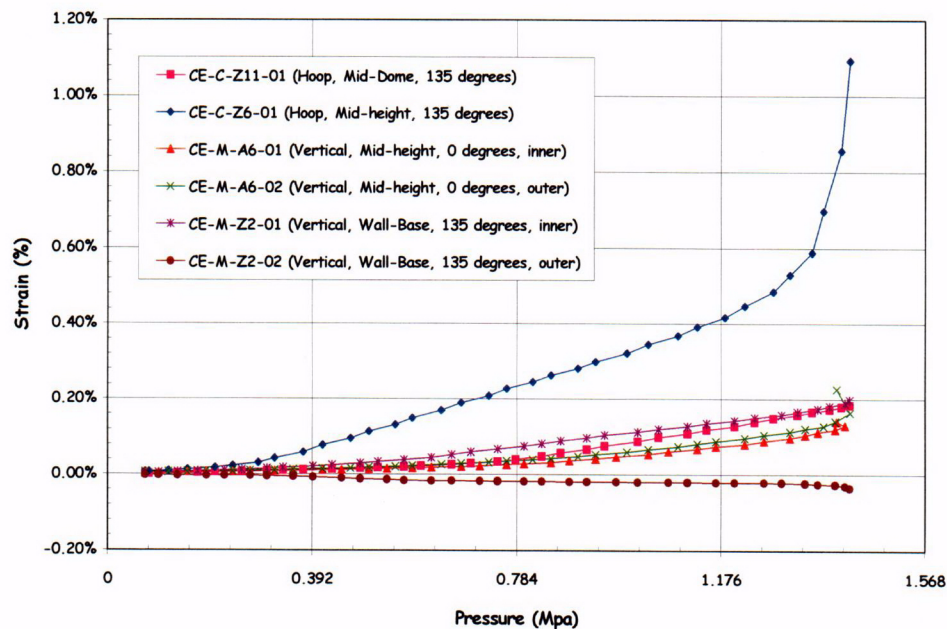
Figure 5.105 SFMT – Concrete (SOFO) Strains

Concrete strains, measured by the surviving SOFO fiber-optic gages, are plotted in Figure 5.105. The maximum hoop strain in the concrete, 1.1% (CE-C-Z6-01) at the mid-height of the cylinder, is a little lower than the displacement-based or rebar strains, but overall the concrete strains are consistent with the other measurements.

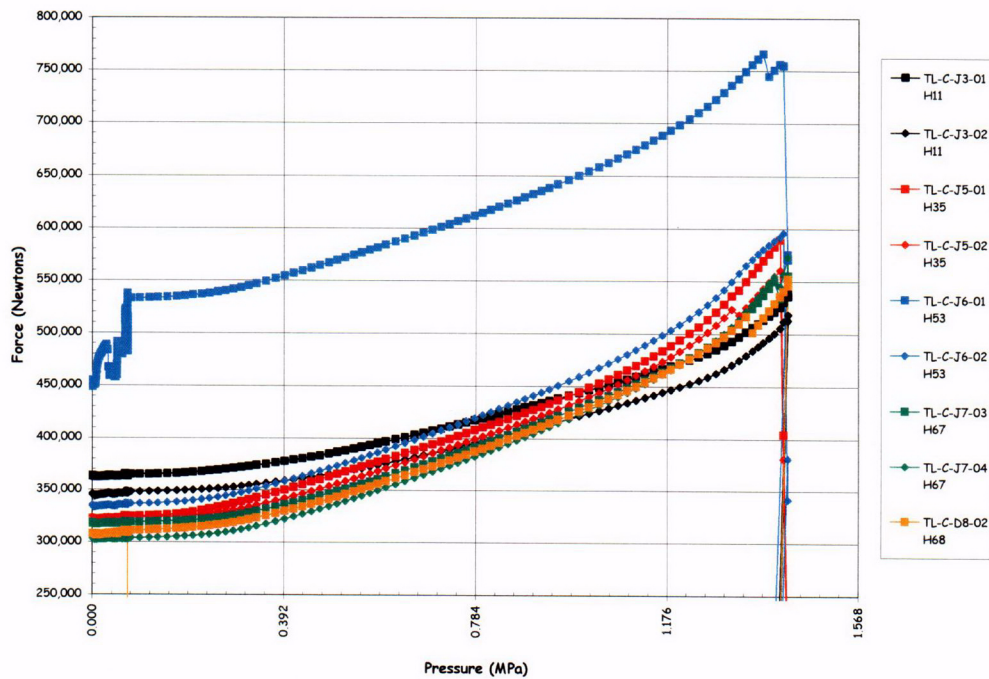
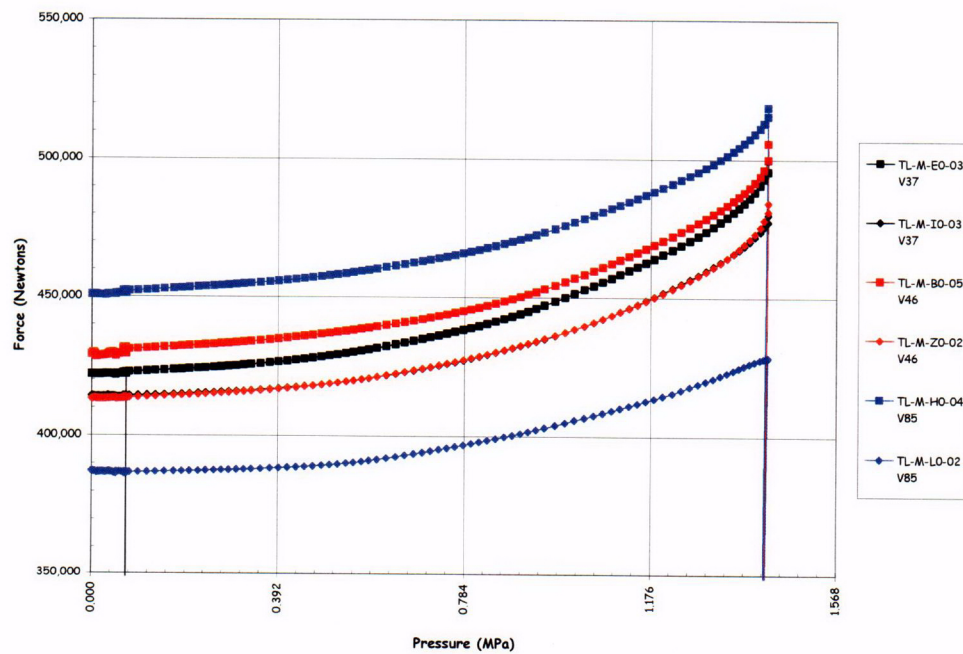
Figures 5.106 and 5.107 show the anchor forces for the instrumented tendons during the SFMT. These anchor forces are representative examples of all the tendon anchors. With the exception of one anchor on H53, the hoop tendon anchor forces increase to nearly 600 kN, which is close to the breaking strength of straight tendons in laboratory tests. It is reasonable to expect that the breaking strength of the curved tendons under field conditions would be lower than the laboratory breaking strength. Load cell TL-C-J6-01 on H53 exhibits an artificially high force near the beginning of the SFMT, most likely from moisture affecting the gage. However, the increased force due to pressure tracks very closely with the other load cells. The vertical tendon anchor forces do not show as large an increase, and the average maximum force only approaches 500 kN, well below the breaking strength. This is consistent with response during the LST and the observation that the vertical tendons did not fail prior to the rupture of the model.

Near the end of the test, sudden decreases in load were observed for several hoop tendon load cells and interpreted as individual strand wires breaking. After reaching the peak pressure, all the load cell readings dropped sharply as the tendons and the model ruptured.

One point deserves mentioning. The tendon anchor forces appear to drop off at or just beyond the peak pressure. This is an artifact of rupture occurring during a data scan. The pressure and strain values were recorded near the beginning of the scan, while the load cells were among the last instruments scanned. If rupture, which occurred in a few seconds, took place during the 30 second data scan, the DAS would associate the pressure before rupture with the load cell reading after rupture, giving the appearance that the tendon anchor forces dropped before the model ruptured.

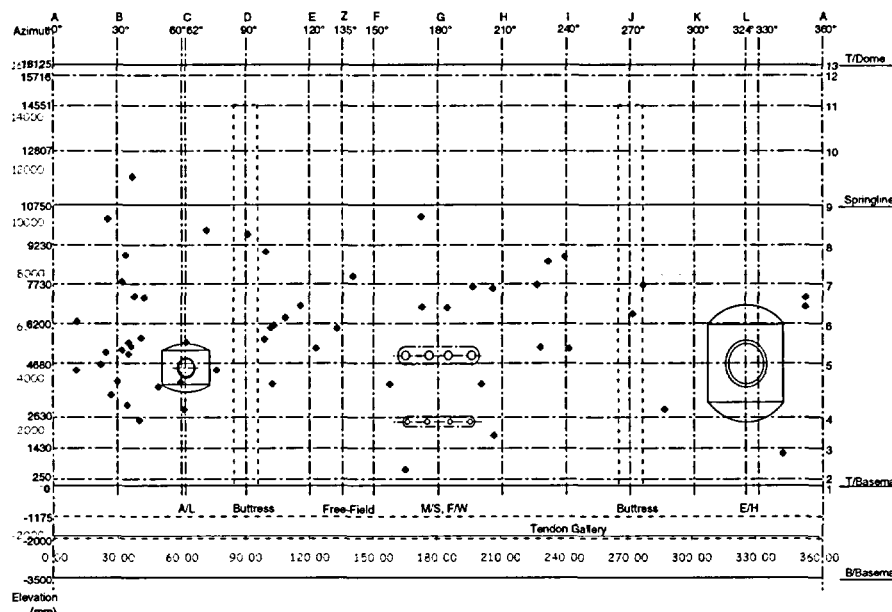
Figure 5.120 SFMT – Wire Break Map

Fifty-seven actual or probable wire break events were identified between 10:39:47 and rupture of the model at 10:46:12. The wire-break event locations are mapped in Figure 5.120.

Other than observing the discontinuities in the tendon load cell and strain time histories that might indicate a wire break, there were no other efforts to correlate the probable wire breaks identified by the acoustic system with the other test data. While it is arguable that the probable wire break events were actual wire breaks, at least a dozen or so were confirmed by the visual records. Figure 5.121 plots the time history of all the acoustic events along with the effective pressure time history. It is readily apparent that the frequency and magnitude of the wire break events increases just prior to rupture.

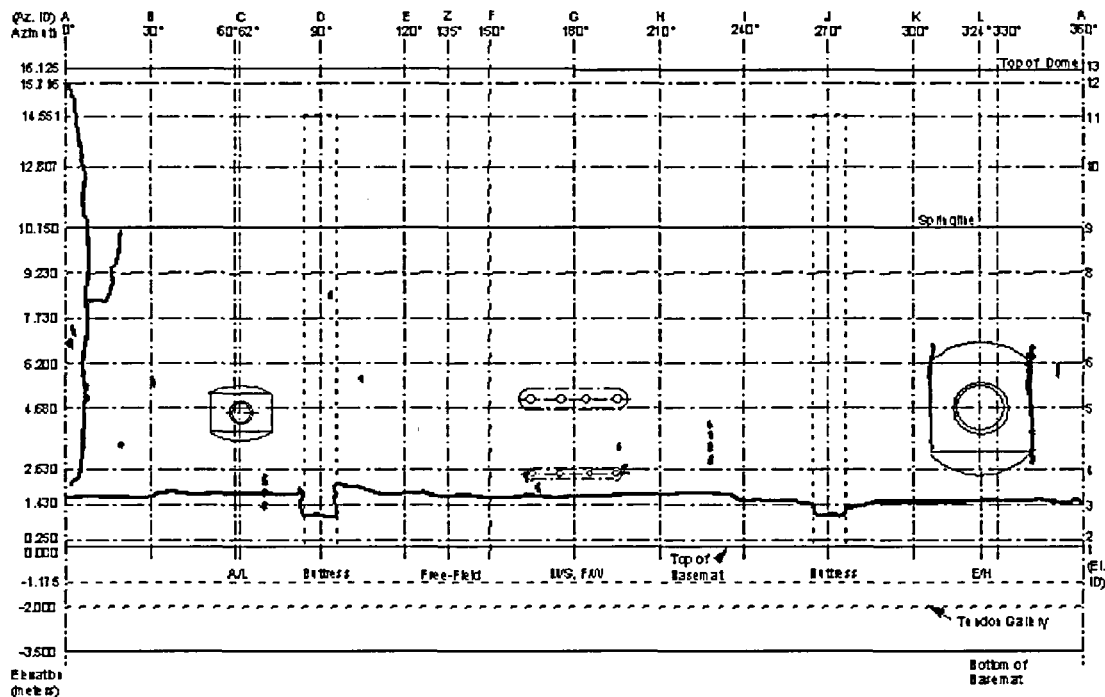
Figure 5.122 SFMT – Rupture Map

The rupture lines are roughly mapped in Figure 5.122. This figure shows the approximate location of major vertical and horizontal rupture lines along with secondary tears at the E/H and adjacent to the main vertical rupture. These secondary tears are most likely associated with previous liner tears and/or cutouts.

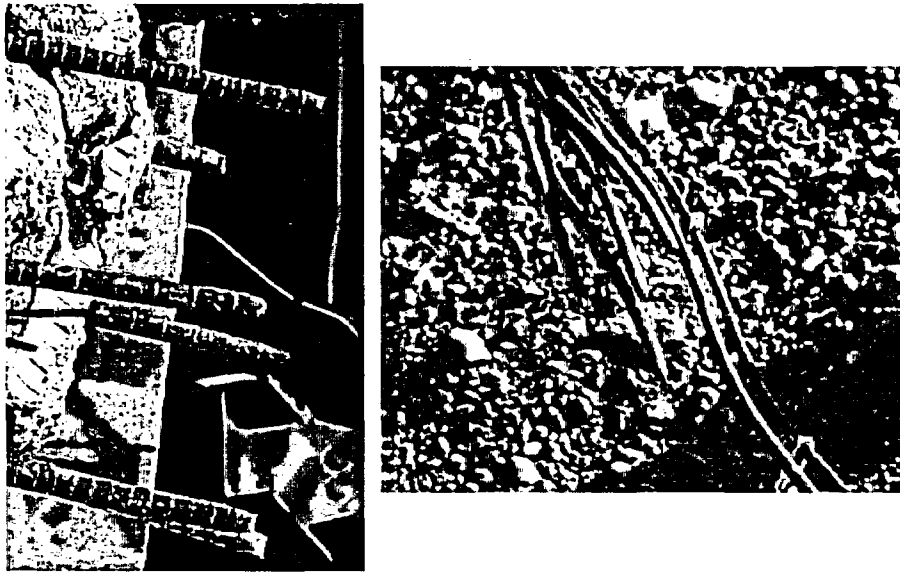
Figure 5.123 SFMT – Rebar and Tendon Strands at the Rupture Line

The hoop rebar and tendons along the main rupture line were also inspected for evidence of any discontinuity or other defects that may have accounted for the location of rupture. The close-up photographs of the rebar and tendon strands in Figure 5.123 clearly show ‘necking’ of the bars and wires, indicating that they failed in a ductile manner with large local strains occurring before failure. These photographs are typical of all the tendons and bars at the rupture. The hoop

bars were spliced mechanically very near the rupture, but there was no evidence that any of the mechanical splices failed or that these in any way biased the location where failure began.

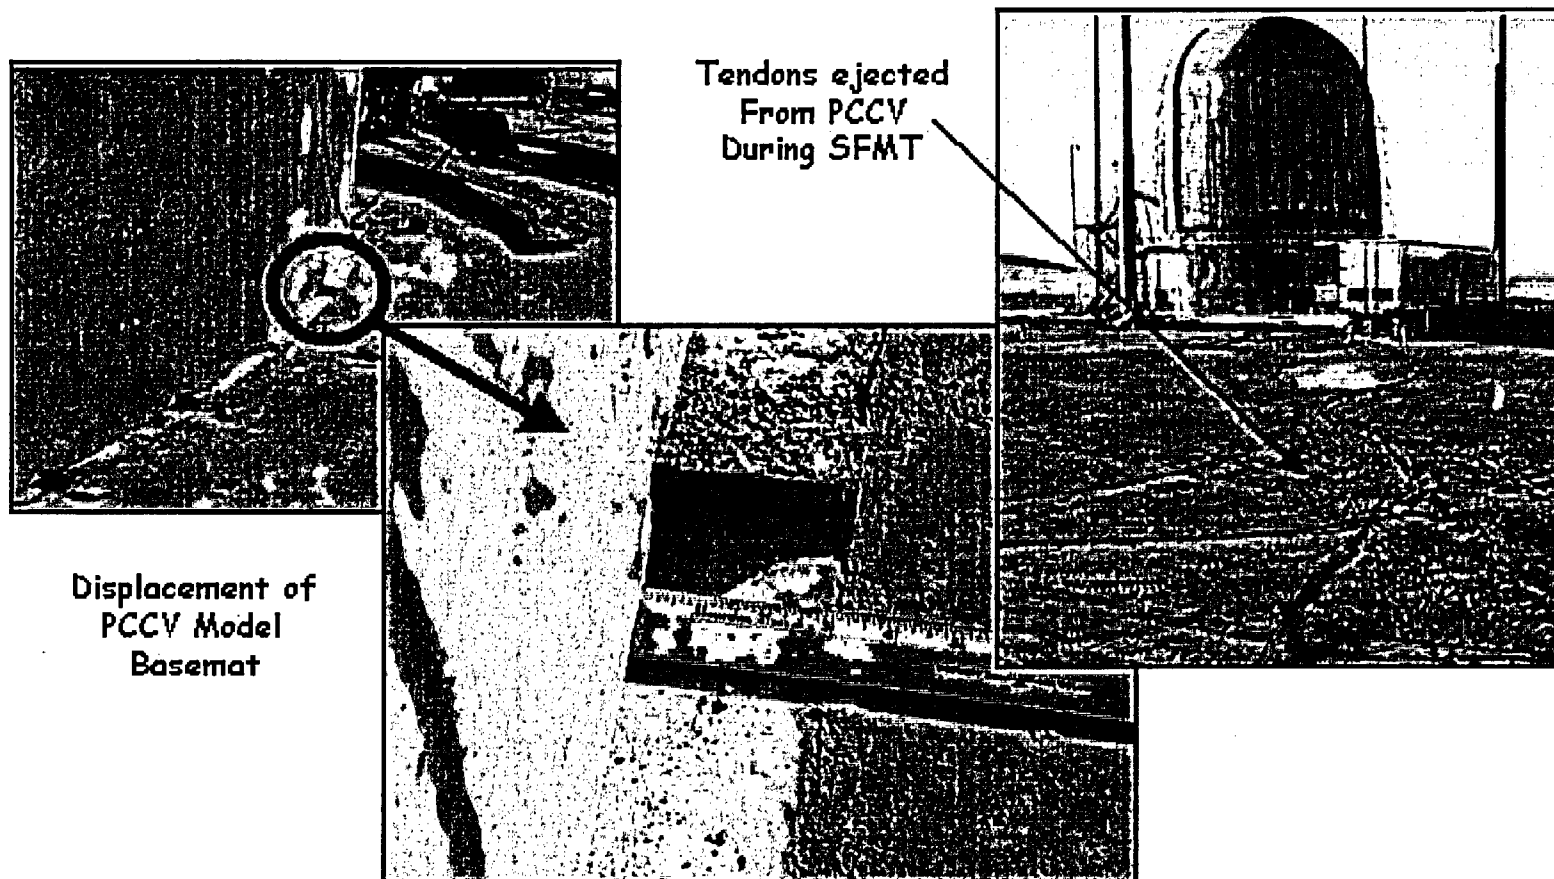
Figure 5.124 SFMT – Model Displacements

The position of the model after the SFMT was also noted. Figure 5.124 shows that the model displaced approximately 3" horizontally and tipped in the opposite direction of the rupture. Six tendons were completely ejected from the model and the final location of major pieces of debris were mapped on the site plan, as shown in Figure 5.125. The location of the debris was not only due to the initial rupture, but also by the flow of 350,000 gallons of water escaping from the model.
