SUBJECT: Relief Request for Previous Repair of Pressurizer Nozzle

Relief Request for Previous Repair of Pressurizer Nozzle

One 1" pipe size pressurizer nozzle (instrument tag number TE-108) on the side of the pressurizer near the bottom. Figure 1 shows the repaired configuration of the TE-108 nozzle.

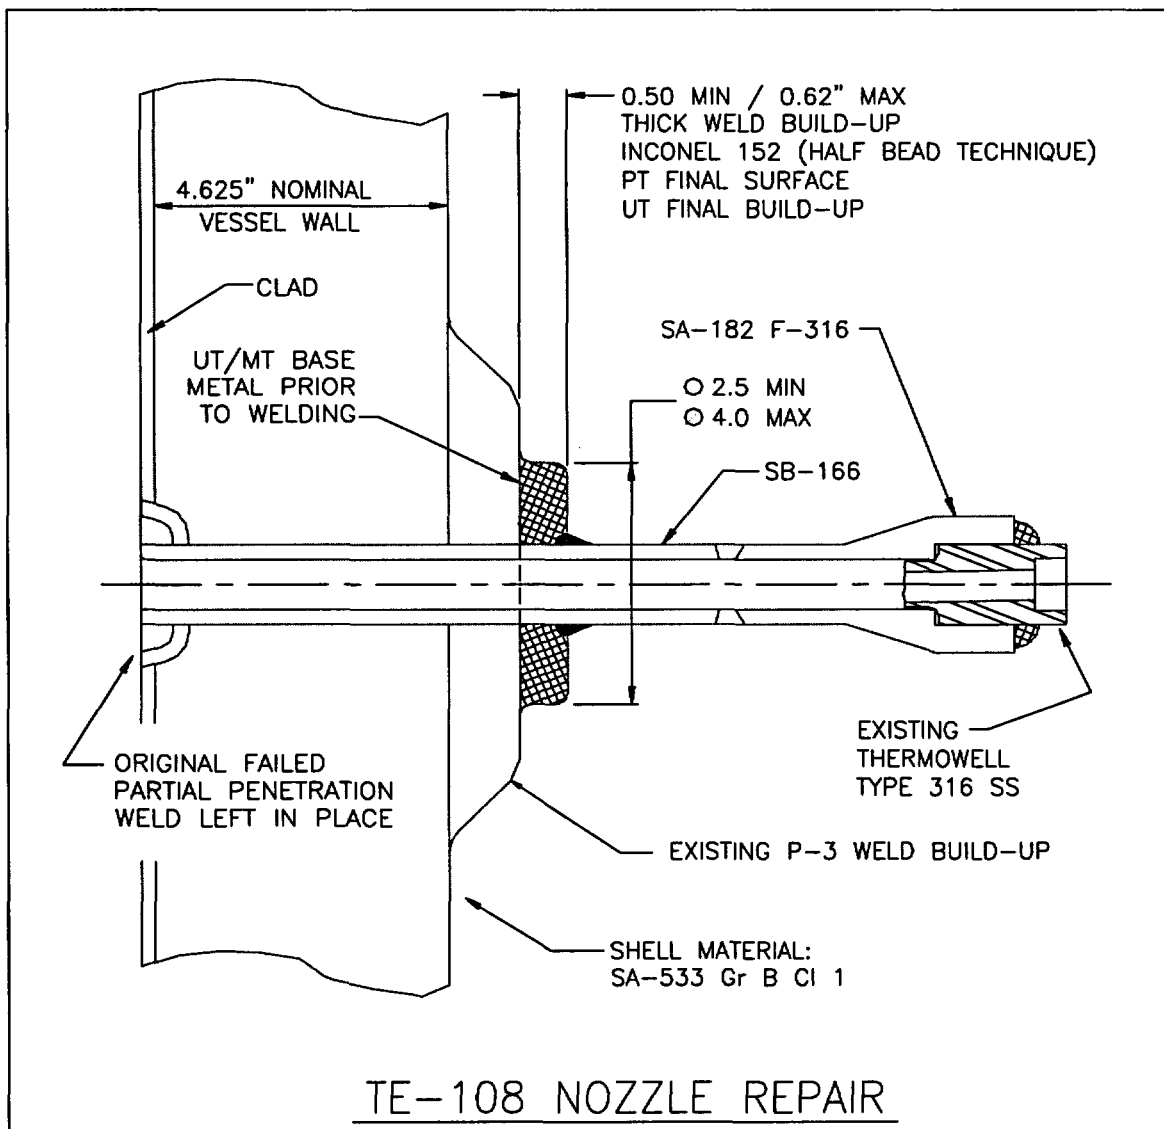
Figure 1: TE-108 – Repaired Nozzle Configuration

In contrast to the requirements of ASME Section XI Code, paragraph IWB-3132.2, a nozzle leak at the TE-108 location on the pressurizer was successfully repaired in October of 2000 without removing the flaw which caused the failure (leakage). Due to the design of the repair which eliminated the pressure boundary function of the element containing the flaw, the following examinations were not performed: 1) NDE to confirm the location of the flaw, 2) Re-

Industry experience has shown that cracks may develop in the Inconel 600 (nozzle) base metal or in the weld metal joining the nozzles to the vessels creating leakage paths for reactor coolant. The cracks are believed to be caused by primary water stress corrosion cracking (PWSCC). The exact leak path, through the weld or through the base metal or through both, frequently cannot be readily determined. To remove all possible leak paths for TE-108 would require access to the interior of the pressurizer and machining or grinding out the attachment weld. Because of the nozzle's location near the bottom of the pressurizer, removal of some or all of the bottom-insertion heater elements would be required for interior access. A repair activity which would remove the flaw would have resulted in a much higher radiation exposure to the personnel involved than the repair performed. Working inside the pressurizer vessel also creates significant personnel safety concerns.

The main portion of the TE-108 nozzle, where it penetrates the vessel wall, is a straight 1" nominal pipe size. It is made of Inconel 600, and has a close tolerance fit into the drilled hole in the vessel wall. The original vessel-to-nozzle attachment weld is a partial penetration J-groove weld inside the vessel to the cladding. The cladding extended into the J-bevel prep area. Welded to the external end of the Inconel nozzle is a type 316 stainless Steel ("safe end") adapter which has a socket-weld end for attachment of a thermo-well for the temperature element.

made in the pad for a partial penetration groove for attaching the nozzle to the pad and was welded. This partial penetration weld, external to the vessel, became the pressure boundary. The original internal J-weld for the nozzle was left in place.

The repair for the nozzle leakage consisted of first overlaying an Inconel 152 pad 0.50" to 0.62" thick to the outside surface of the vessel wall using the temper bead method. A weld prep was

- A) Prior to making the repair, an evaluation of the stresses resulting from leaving the original internal weld in place was made per the ASME Code (Reference 7.1) and found to be acceptable.

- B) As a result of relocating the pressure boundary to the exterior of the vessel shell, the low alloy material of the vessel shell will be exposed to borated reactor coolant in the close tolerance annular area between the nozzle and the bored hole in the vessel wall. Low alloy and carbon steels used for reactor coolant systems components are clad with stainless steel to minimize corrosion resulting from exposure to borated primary coolant. Since the crevice region is not clad, the low alloy steel is exposed to borated water. The recent reactor head degradation discovered at the Davis-Besse unit demonstrated that significant corrosion of carbon and low alloy steels can occur under conditions where boric acid concentrates in an aerated environment. The corrosion rate was estimated to have progressed at up to 2 inches per year. The environment that supported the high corrosion rate was concentrated solutions or wet deposits of boric acid and leakage at a rate to cause local cooling of the reactor vessel head. As a result of the subject nozzle repair weld, there is no mechanism for concentrating boric acid in the annular crevice because there is no active external leakage, and the corrosion rates that will occur in the crevice region will be low. Several laboratory studies described in Reference 7.1 demonstrated that the high corrosion rates observed in concentrated solutions or wet deposits of boric acid will not occur under the operating conditions for the subject nozzle. Thus, the industry experience gained from Davis-Besse and similar events involving reactor coolant system components and fasteners are not applicable to this nozzle repair because of the significant difference in the environmental conditions. Although some minor corrosion may occur in the annular region of the repaired nozzle, the degradation will not proceed to the point where ASME Code requirements will be exceeded before the end of component life (Reference 7.1).

- C) An evaluation of the stability of a postulated flaw was completed under Reference 7.2. The analysis postulates a double-sided crack that has propagated through the J-Weld (nozzle weld) and is beginning to encroach on the carbon steel material that comprises the pressure boundary. It concludes that any J-weld flaws left in place are acceptable for the currently licensed 40-year plant life (i.e., until August 2013). In Reference 7.6, OPPD provided a new Time Limited Aging Analysis commitment to evaluate the repaired nozzle for the proposed license renewal period of extended operation.
