**UNITED STATES
NUCLEAR REGULATORY COMMISSION
REGION IV
611 RYAN PLAZA DRIVE, SUITE 400
ARLINGTON, TEXAS 76011-4005**

**SUBJECT: NRC SPECIAL INSPECTION TEAM REVIEW AND NRC STAFF EVALUATION
OF SOUTH TEXAS PROJECT, UNIT 1, REACTOR PRESSURE VESSEL
BOTTOM-MOUNTED INSTRUMENTATION PENETRATION LEAKAGE
INVESTIGATION AND REPAIR ACTIVITIES**

Bottom-Mounted Instrumentation Nozzle Leakage Investigation and Repair Activities

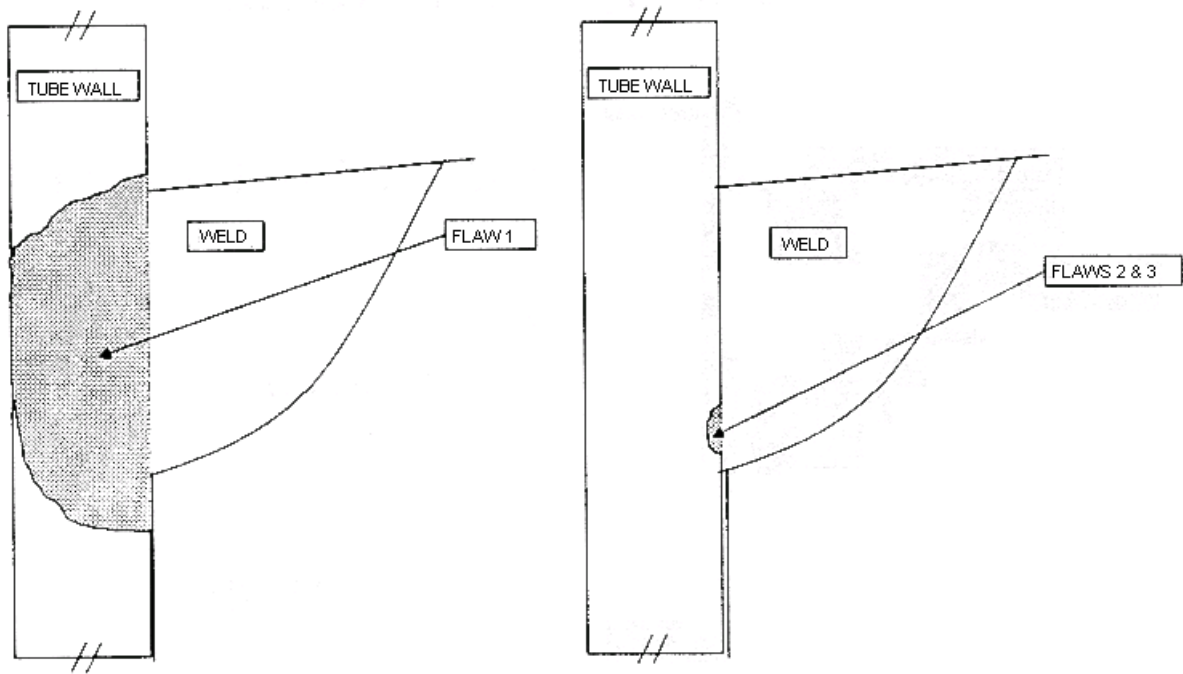
Figure 2

As a result of NDE activities (1) and (3) above, the licensee reported three axially-oriented crack-like indications in the penetration 1 nozzle wall and two axially-oriented crack-like indications in the penetration 46 nozzle wall. As depicted in Figure 2, one of the indications in penetration 1 was characterized as an axial crack with a length of about 1.38 inches, surface breaking on the OD of the nozzle above and below the J-groove weld, as well as surface breaking on the ID of the nozzle. The ID surface breaking nature of this flaw was confirmed by the bobbin coil ETC. The other two indications in penetration 1 were characterized as being small, embedded (i.e., non-surface breaking) cracks near the interface between the nozzle wall and the root pass of the J-groove weld. As depicted in Figure 3, one of the indications in penetration 46 was characterized as an axial crack with a length of about 0.98 inches, surface breaking on the OD of the nozzle above and below the J-groove weld. The other indication in penetration 46 was characterized as an embedded crack having an axial length of 0.95 inches. Figures 2 and 3 were submitted to the NRC as part of the licensee's presentation at a public meeting held at NRC Headquarters on June 5, 2003. However, the UT inspections conducted by the licensee were not demonstrated to be effective for the purpose of examining the subsurface volume of the J-groove weld. Therefore, the licensee's depictions of the indications as shown in Figures 2 and 3 may be incomplete with respect to subsurface cracking of the J-groove weld material. No crack-like indications were identified in any of the other 56 STP, Unit 1, BMI nozzle penetrations [Reference 2].

Penetration #1

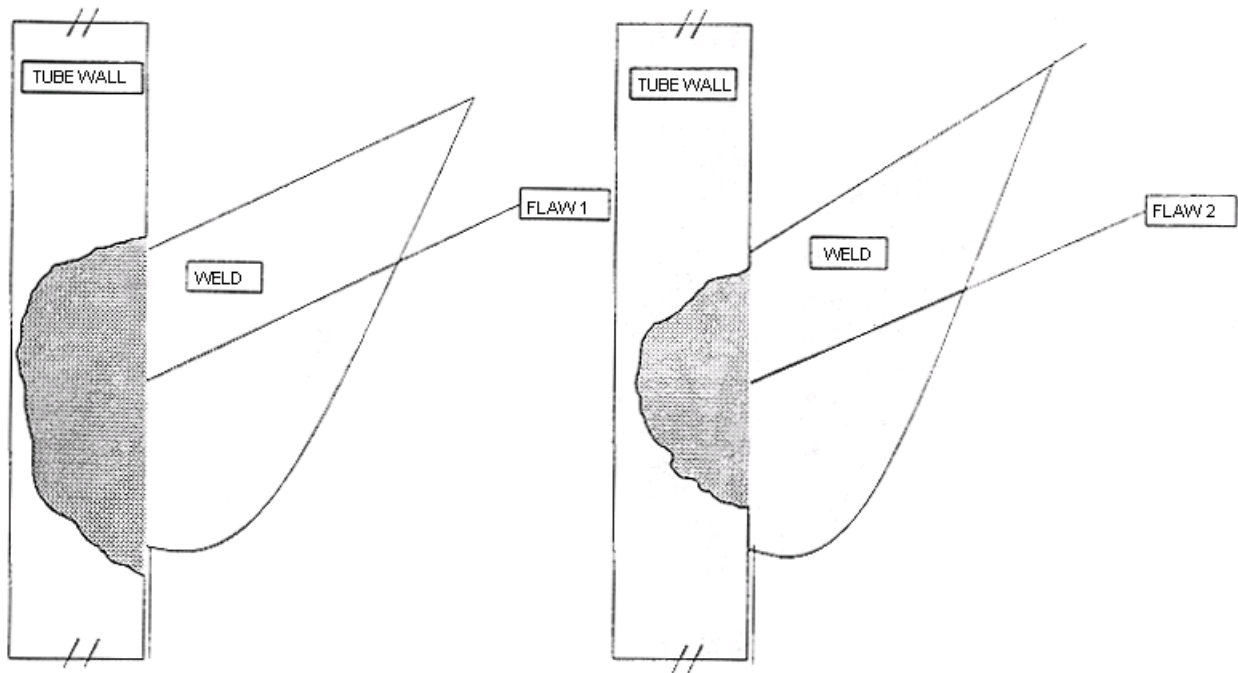
Figure 3

Penetration #46

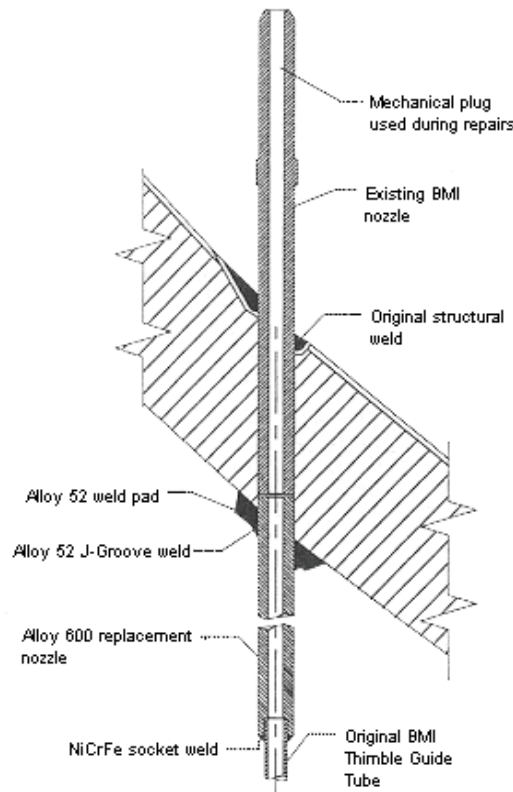
Figure 4

Half-Nozzle Repair

Upon the discovery of the deposits around STP, Unit 1, BMI penetrations 1 and 46, the licensee began the process of designing a potential repair option. The licensee developed a "half-nozzle" repair which was similar in design to those which had been implemented at other facilities for the repair of cracked pressurizer heater penetrations, RCS instrumentation penetrations, etc. This repair option was chosen and characterized as a permanent repair of STP, Unit 1, BMI penetrations 1 and 46. A cross-section of the repair design is shown in Figure 4. The essential elements of the repair design were as follows [Reference 2]:

- (1) The lower portion of the original Inconel Alloy 600 nozzle was cut off flush with the exterior surface of the RPV bottom head.
- (2) An Inconel Alloy 52/152 (the weld wire equivalent of Inconel Alloy 690) temper bead weld pad was welded to the exterior surface of the RPV bottom head at the nozzle penetration.
- (3) A J-groove weld prep was machined into the temper bead weld pad and the remnant of original nozzle which may interfere with the repair installation was bored out of the vessel to a depth of approximately 1.5 inches. Visual inspection of nozzle bores for evidence of low-alloy steel wastage was conducted.
- (4) A new Inconel Alloy 690 nozzle was inserted into the penetration and welded to the temper bead weld pad by an Inconel Alloy 52/152 partial penetration J-groove weld.

The licensee's repair design, therefore, moved the RCS pressure boundary to the exterior surface for the RPV bottom head at the location of the new Inconel Alloy 52/152 J-groove weld.

The licensee's repair design also included a gap between the bottom of the original Inconel Alloy 600 nozzle and the new Inconel Alloy 690 replacement nozzle. This gap was necessary in order to permit thermal expansion of the nozzle halves without the potential for applying interference-related stresses to either the original J-groove weld or the new Inconel Alloy 52/152 J-groove weld. The existence of this gap creates an annular region between the original J-groove weld and the half-nozzle repair in which the low-alloy steel of the RPV bottom head is exposed to borated RCS water. The licensee analyzed the potential for boric acid corrosion of the low-alloy steel in this region. The licensee concluded that due to low oxygen levels in the reactor coolant (except during refueling outages, a condition which was also accounted for) and the stagnant conditions, which are expected to exist within the annular region; corrosion of the
