July 30, 2003
LIC-03-0100

SUBJECT: Response to Request for Additional Information - Ft. Calhoun Station Steam Generator Report (TAC No. MB6954)

**Response to NRC Request for Additional Information
Ft. Calhoun Station Steam Generator Report**

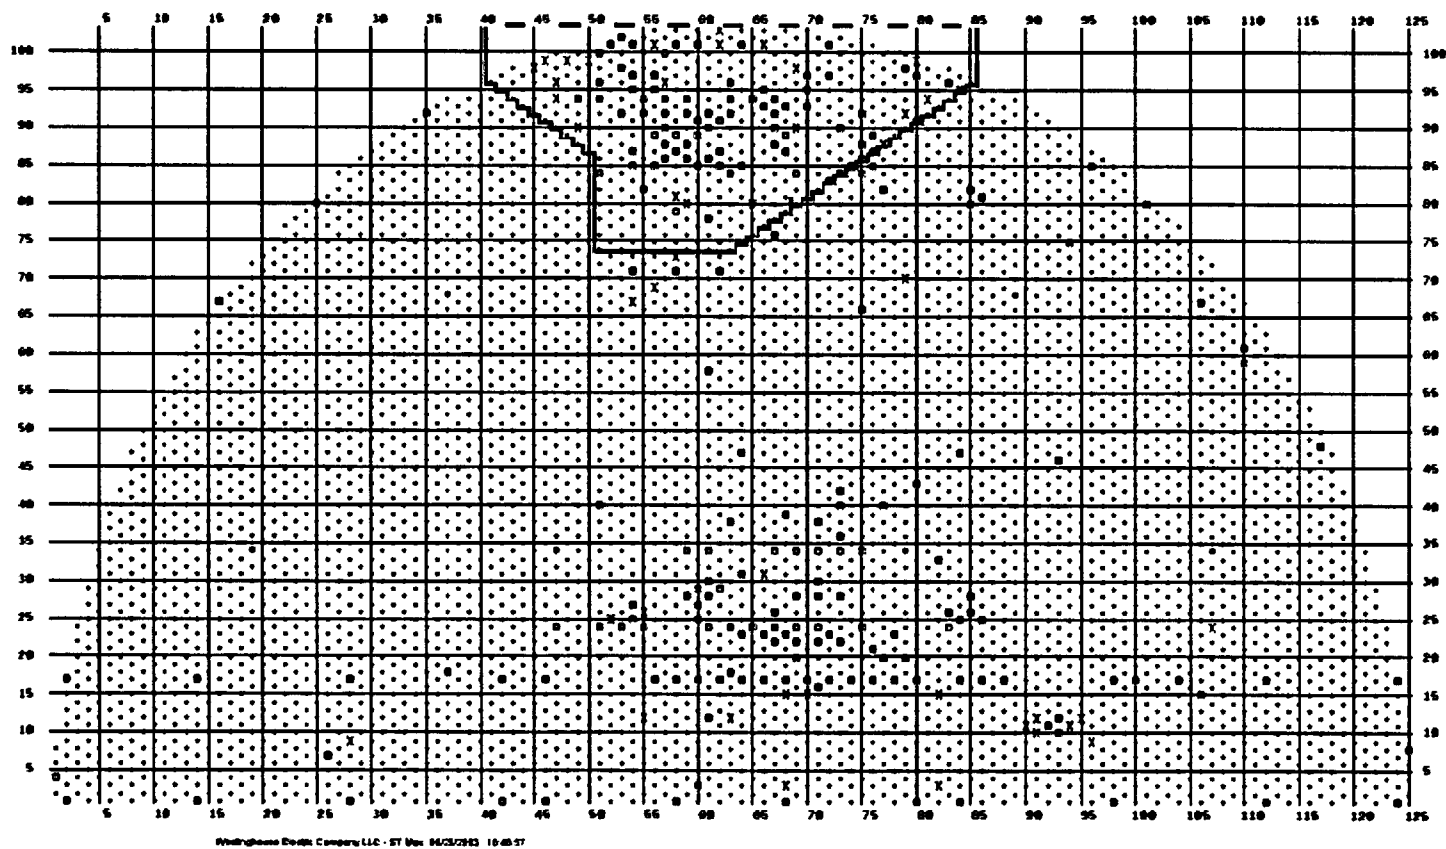
Figure 1

Tables 3 and 4 provide this information for all of the flaws detected in the last examination and figures 1 and 2 are tubesheet maps with the locations of flawed tubes and their proximity to the critical area. ODSCC indications were identified in the critical area which were only detected by the MRPC probe. However none of these flaws were challenging from a leakage or structural integrity perspective (the deepest was estimated at 40% TW based on plus point amplitude sizing). In addition, no degradation of the type defining the CA were observed in the buffer zone and additional program expansion was not required per the EPRI PWR Steam Generator Examination Guidelines, Revision 5.

SG - A TUBES REPAIRED DURING 02RFO

- X 44 TUBE PLUGGED IN 2002
- 6 STAY ROD
- 218 EXISTING PLUGGED TUBE

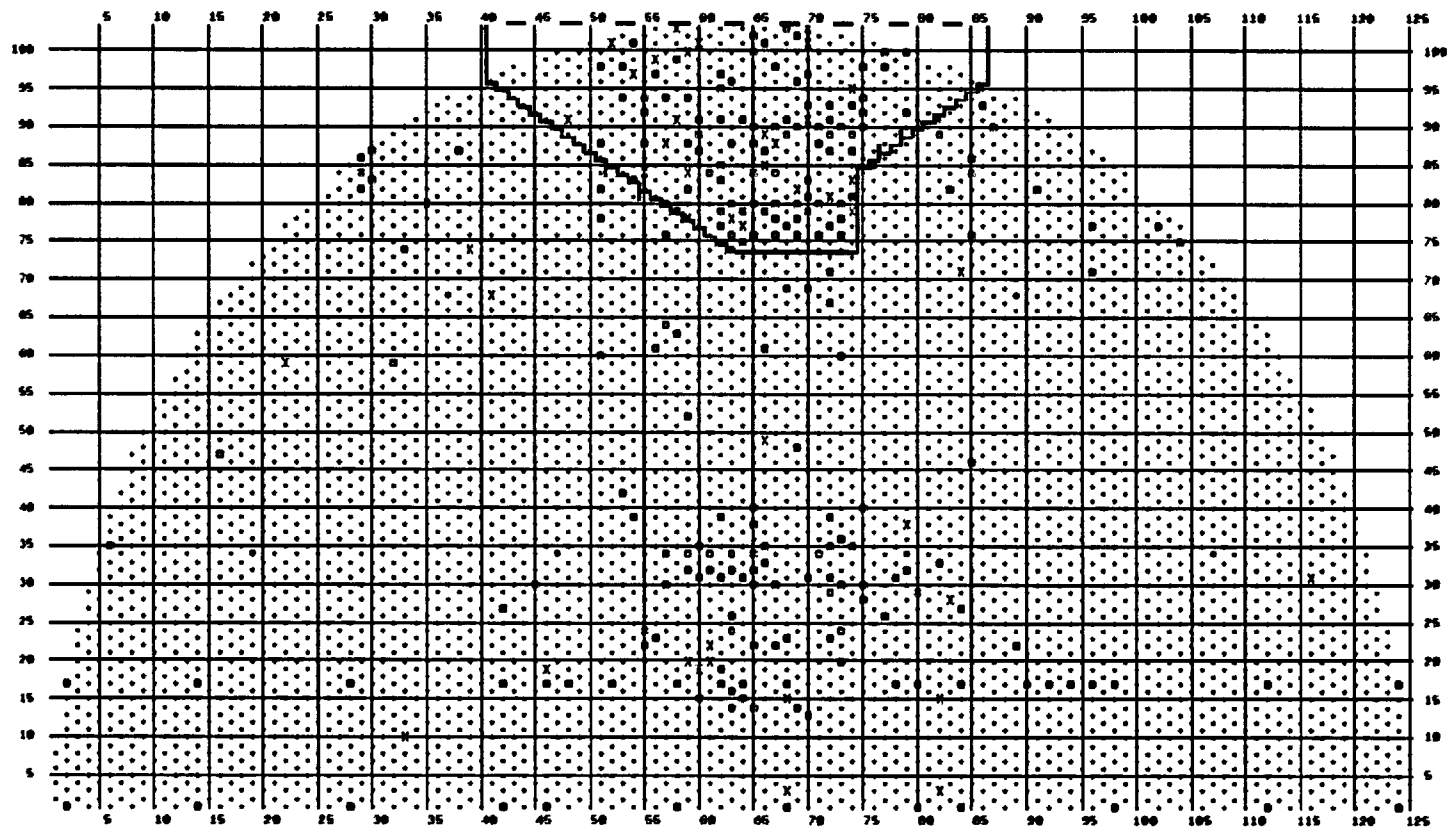
Figure 2

SG - B TUBES REPAIRED DURING 02RFO

- X 44 TUBE PLUGGED IN 2002
- 6 STAY ROD
- 227 EXISTING PLUGGED TUBE
