July 30, 2003

Subject: Davis-Besse Nuclear Power Station Incore Monitoring Instrumentation Nozzle
Inspections

**SUMMARY OF INCORE MONITORING INSTRUMENTATION (IMI) NOZZLE
INSPECTIONS AND RELATED ACTIVITIES DURING THE DAVIS-BESSE
NUCLEAR POWER STATION THIRTEENTH REFUELING OUTAGE**

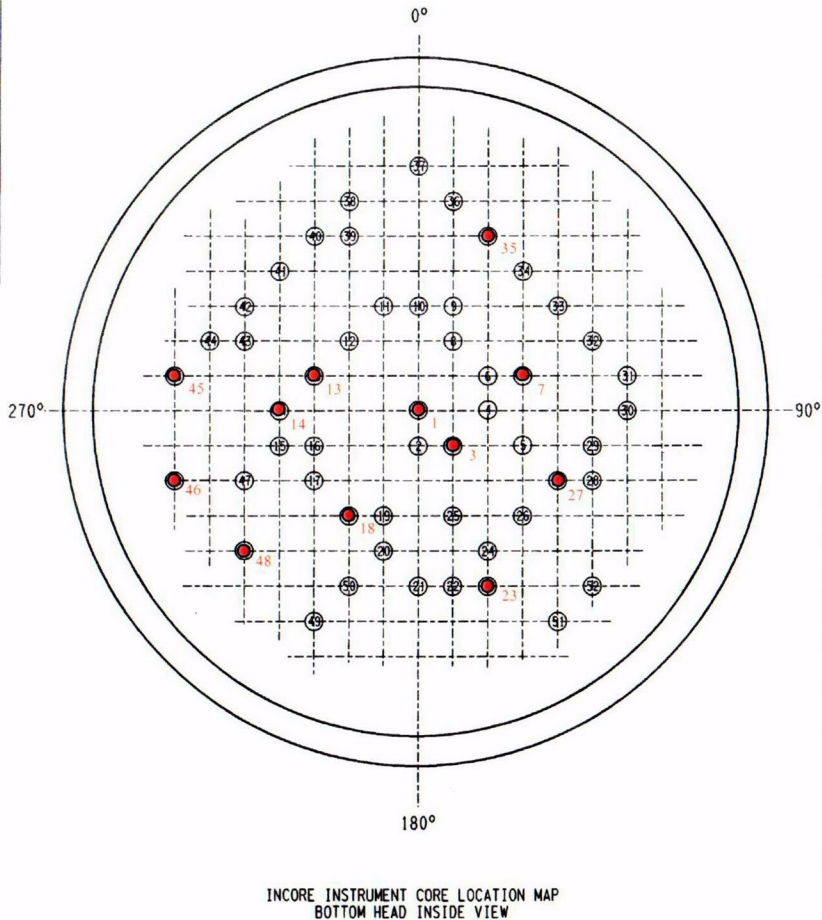
Sampling of Deposits

Since the deposits were flat and tightly adhering to the vessel and nozzle surfaces, wire brushes and cleaning pads were used to collect deposit samples from two trails of residue on the lower sides of the Reactor Vessel and from twelve IMI nozzles on the bottom of the Reactor Vessel (see attached figure). The samples were collected in accordance with recommendations in Framatome ANP's (reactor vendor) document, "Recommended IMI Nozzle Inspection Plan".

- Decreasing lithium and boron concentrations in the samples from Nozzle #27 to #3 to #1 (i.e., from the more peripheral nozzle locations to the center location) would suggest a flow path, however, the southeast quadrant (90° to 180° location on the attached figure) flow sample concentrations were less than the concentrations at Nozzle #27. Nozzle #27 had the highest lithium and boron concentrations of any of the samples: lithium 12,548 parts per million, boron 39,469 parts per million.

- The total activity peaked in the southeast quadrant boric acid trail sample, then decreased in a downhill direction to Nozzle #27, Nozzle #3, and then Nozzle #1. This is consistent with the southeast quadrant boric acid trail providing material to those nozzles.

- Nozzle sample locations (●)
