**WATTS BAR NUCLEAR PLANT (WBN) UNIT 1 – PETITION PURSUANT TO
10 CFR 2.206 – REACTOR COOLANT SYSTEM STAINLESS STEEL CLADDING**

WATTS BAR NUCLEAR PLANT (WBN) UNIT 1 UNION OF CONCERNED SCIENTISTS 10 CFR 2.206 PETITION REACTOR COOLANT SYSTEM (RCS) STAINLESS STEEL CLADDING

Safety Injection (SI) Accumulator Tank 3 Cladding

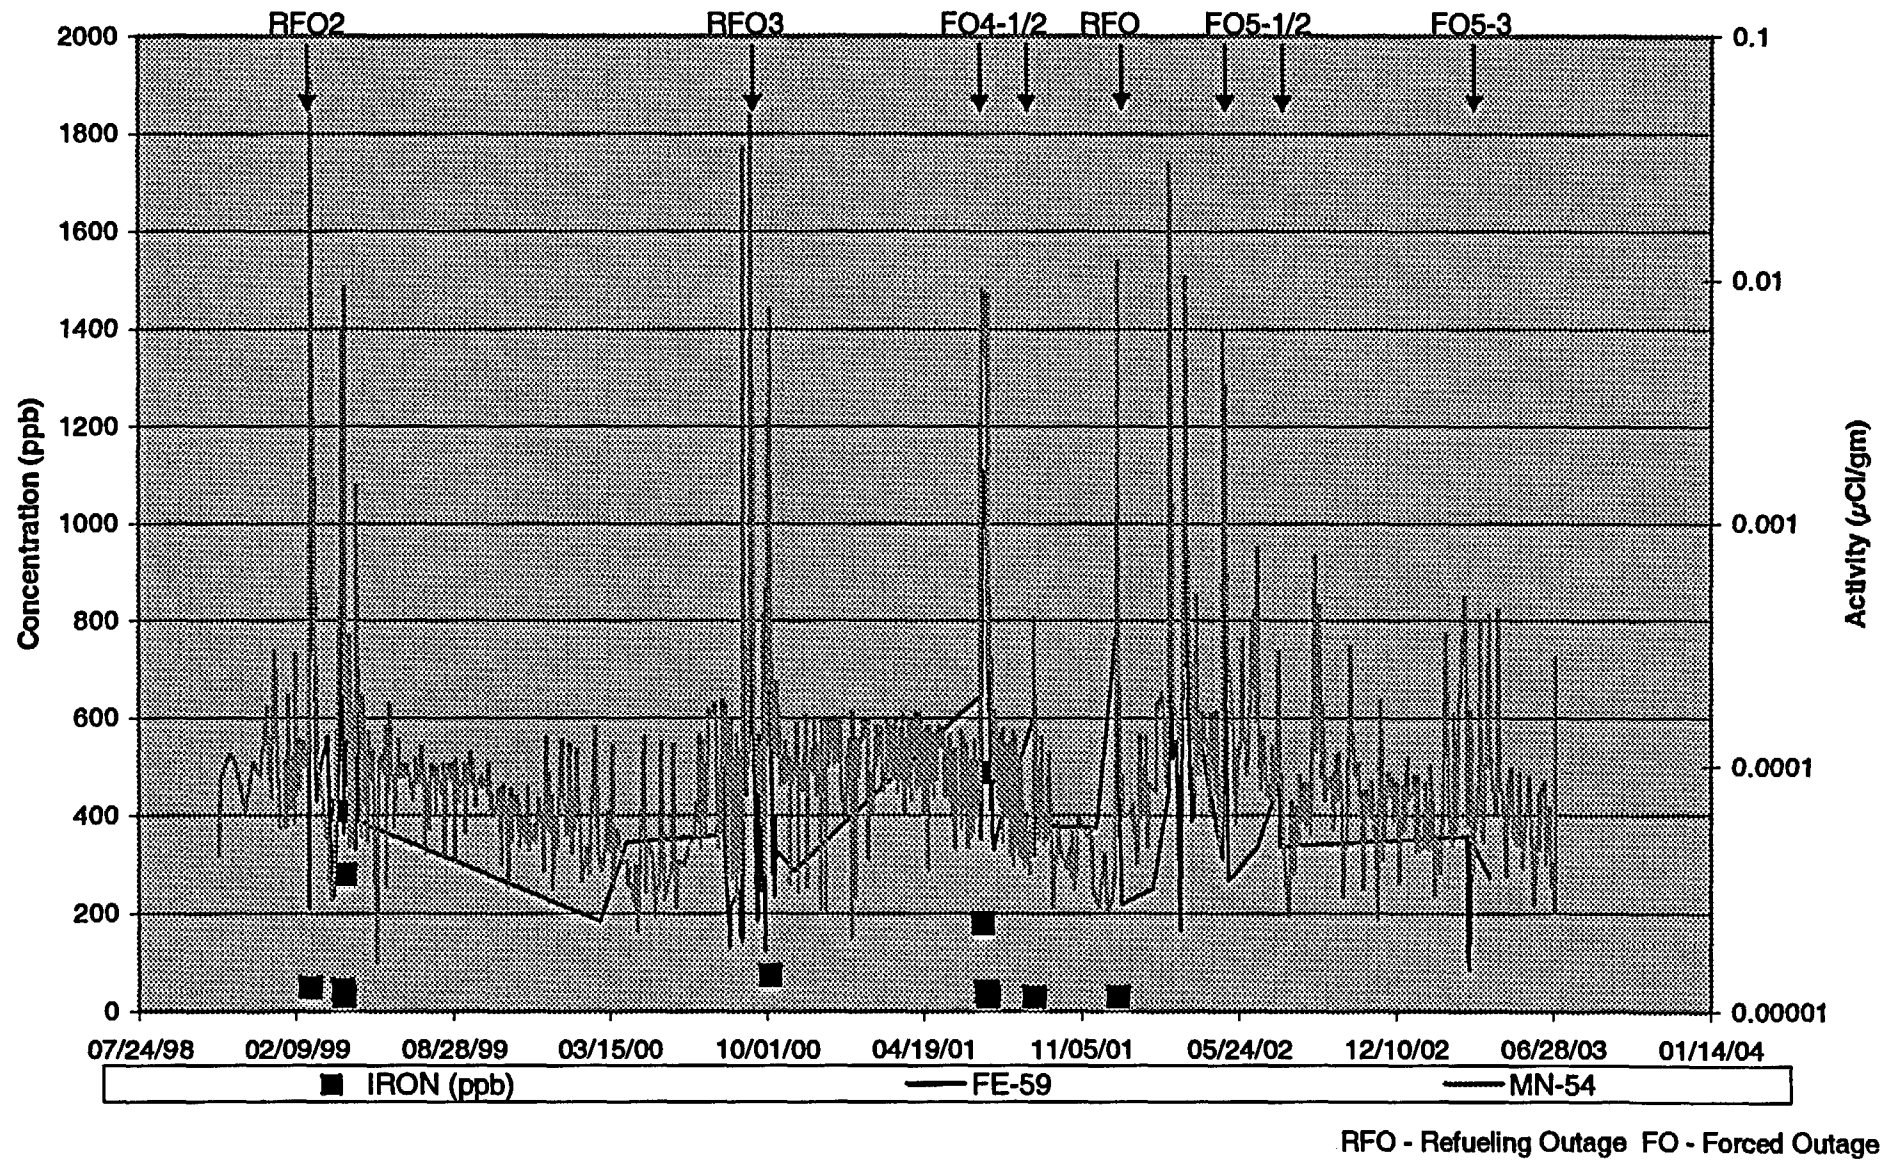
RCS Iron

While TVA does not typically analyze the reactor coolant system for iron concentration, it does measure certain isotopes which are corrosion products produced in the reactor core via neutron activation of iron. Manganese (Mn) 54, with a 312 day half life, is produced via a (n,p) activation of Iron (Fe) 54 which exists as 5.85 percent of all natural occurring iron. Fe-59, with a 44.5 day half life, is produced via a (n, γ) interaction of Fe-58 which is present in 0.28 percent of natural occurring iron. Since both of these isotopes have relatively long half lives, these activities can be trended to provide an indication of the reactor coolant system iron trend. The graph provided in Enclosure 3 indicates the trend using the above isotopes. Based on this data, the dissolved iron in the RCS is considered to be negligible.

It should be noted that the plant outages are indicated on the graph provided in Enclosure 3. The increase in iron in the reactor coolant during an outage results from chemistry changes in the RCS during the change from plant operation to refueling conditions. Prior to moving fuel, the boron concentration is increased to approximately 2500 ppm boron. This increase in boron to shutdown concentrations and plant cooldown causes a decrease in the coolant pH, which in turn causes an increase in soluble iron corrosion products in the coolant.

Given these several indicators, there are no bases to conclude that the reactor coolant is degrading the uncladded areas in the inlet nozzles.
