Subject: Braidwood Station, Unit 1 Tenth Refueling Outage Steam Generator Inservice  
Inspection Summary Report

**STEAM GENERATOR EDDY CURRENT INSPECTION REPORT**

**CYCLE 10 REFUELING OUTAGE (A1R10)**

**April 2003**

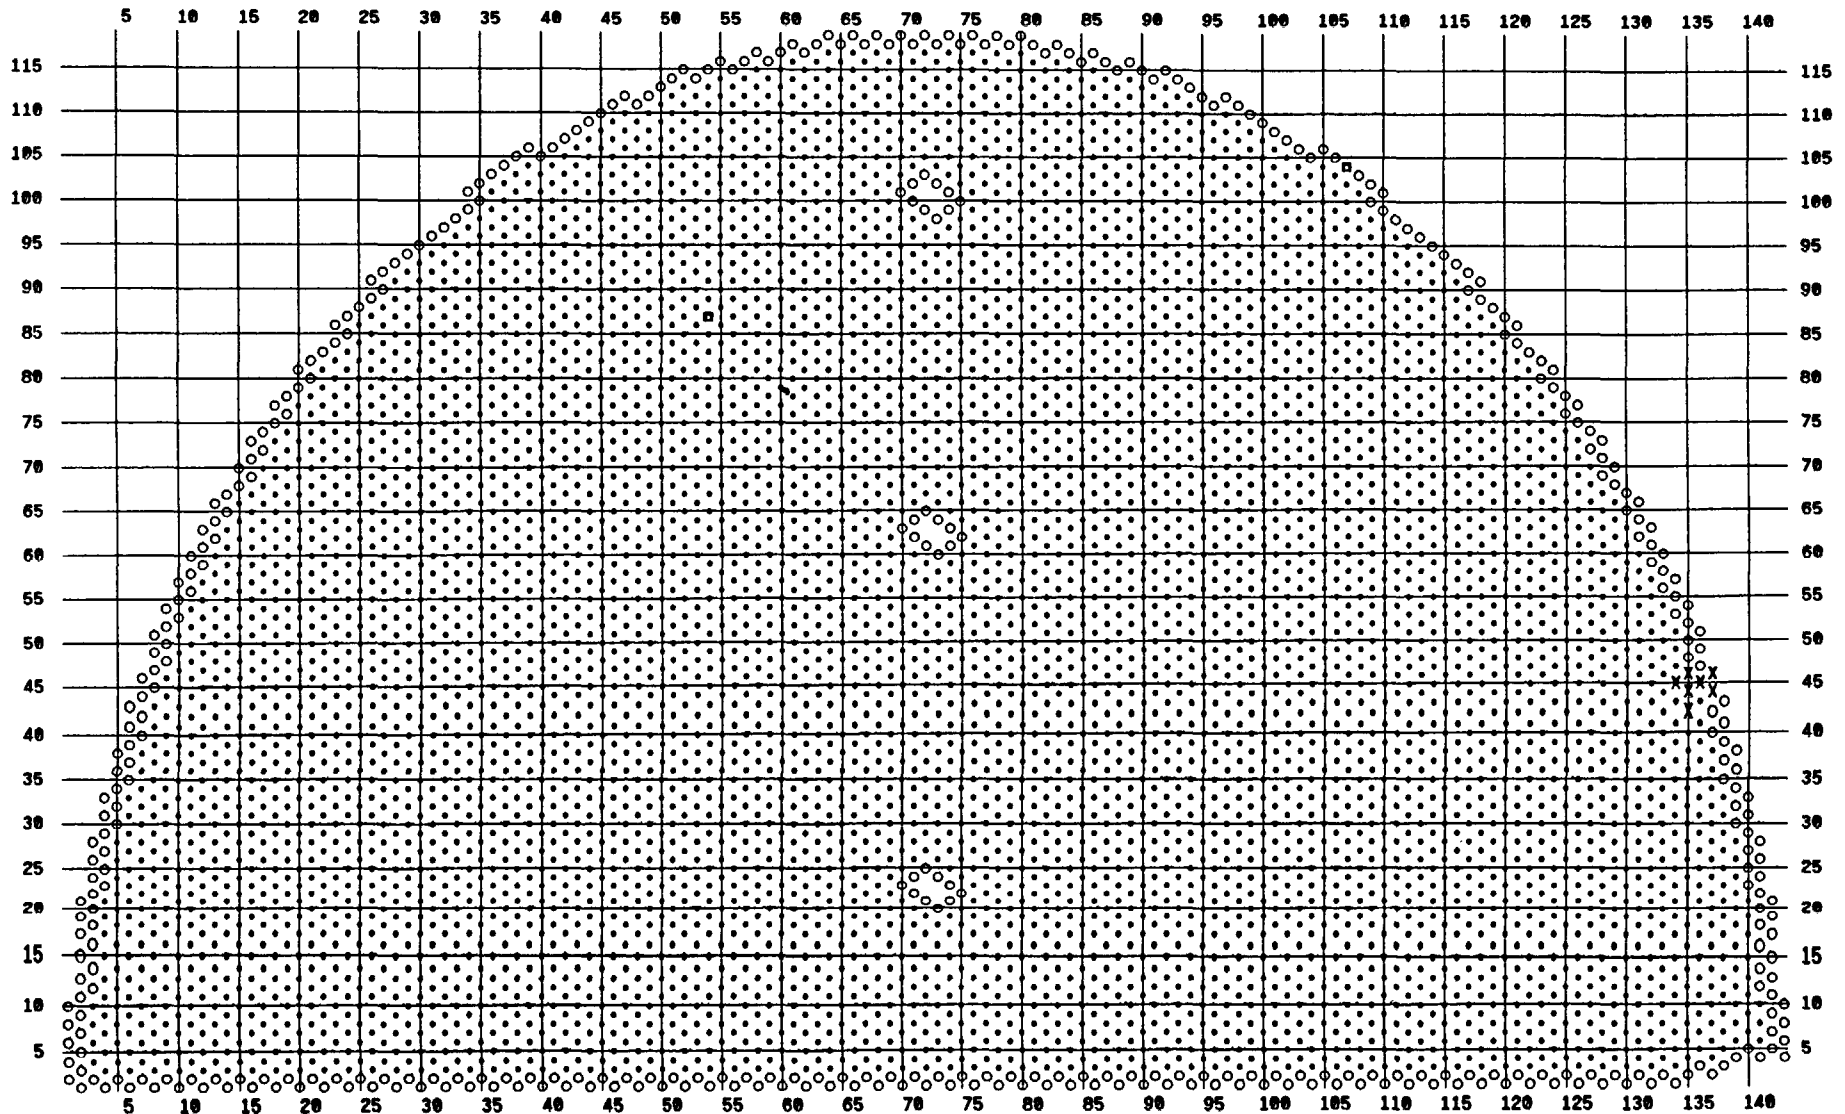
# SG - A TUBES DAMAGED BY FOREIGN OBJECTS

- 5.1.3 **Foreign Object Wear** – A total of 15 tubes were plugged due to wear associated with 3 foreign objects. An additional 6 tubes which did not have any signs of tube wear were also plugged in order to bound foreign objects that were not able to be successfully removed from the SG. Of the 15 tubes with foreign object wear the largest was 48% through wall. The EPRI Appendix H plus-point technique 21988.1 was utilized in this inspection for depth sizing of all foreign object wear. All tubes with foreign object wear were removed from service by mechanical tube plugging regardless of percent through wall. Table 5.1.3 below provides a summary of the foreign object wear found during this SG inspection. Refer to Attachment B for additional details.

X 7 TUBE DAMAGED BY FOREIGN  
OBJECT AT COLD LEG TOP OF  
TUBESHEET

ROW	COL	VOLTS	DEG	IND	PER	CHN	LOCN	INCH1	INCH2	I	CRLEN	CEG	BEGT	ENDT	PDIA	PTYPE	CAL	L
45	134			NDD									TEC	TEH	.560	RBART	3	H
45	134	.14	107	SVI		P1	TSC	.10		0	.598	79	TSC	TSC	.560	ZPSNM	8	C
45	134	.15	0	PCT	15	2	TSC	.28					TSC	TSC	.560	ZPSNM	8	C
45	134	.13	106	PID		P1	TSC	.19					TSC	TSC	.560	ZPSNM	66	C
42	135	.28	0	PCT	25	2	TSC	.48					TSC	TSC	.560	ZPSNM	8	C
42	135	.27	98	SVI		P1	TSC	.49		0	.521	80	TSC	TSC	.560	ZPSNM	8	C
42	135	.26	120	DTI		P1	TSC	.56					TEC	TEH	.560	RBART	65	H
42	135	.24	100	PID		P1	TSC	.60					TSC	TSC	.560	ZPSNM	66	C
44	135	1.61	113	DTI		P1	TSC	.31					TEC	TEH	.560	RBART	3	H
44	135	.76	82	SVI		P1	TSC	.26					TSC	TSC	.560	ZPSNM	8	C
44	135	.75	0	PID		2	TSC	.31					TSC	TSC	.560	ZPSNM	8	C
44	135	.70	0	PCT	48	2	TSC	.37					TSC	TSC	.560	ZPSNM	8	C
46	135			NDD									TEC	TEH	.560	RBART	3	H
46	135	.11	97	SVI		2	TSC	.23		0	.358	79	TSC	TSC	.560	ZPSNM	8	C
46	135	.11	0	PCT	12	2	TSC	.23					TSC	TSC	.560	ZPSNM	8	C

46	135	.11	95	PID		P1	TSC	.23					TSC	TSC	.560	ZPSNM	66	C
45	136			NDD									TEC	TEH	.560	RBART	3	H
45	136	.21	0	PCT	20	2	TSC	.09					TSC	TSC	.560	ZPSNM	8	C
45	136	.21	115	SVI		2	TSC	.15		0	.539	182	TSC	TSC	.560	ZPSNM	8	C
45	136	.18	115	PID		P1	TSC	.10					TSC	TSC	.560	ZPSNM	66	C
44	137			NDD									TEC	TEH	.560	RBART	3	H
44	137	.04	105	SVI		2	TSC	.14		0	.203	32	TSC	TSC	.560	ZPSNM	8	C
44	137	.04	0	PCT	5	2	TSC	.15					TSC	TSC	.560	ZPSNM	8	C
44	137	.04	101	PID		P1	TSC	.13					TSC	TSC	.560	ZPSNM	66	C
46	137			NDD									TEC	TSH	.560	RBART	3	H
46	137	.14	0	PCT	14	2	TSC	.28					TSC	TSC	.560	ZPSNM	8	C
46	137	.12	99	SVI		2	TSC	.31		0	.300	77	TSC	TSC	.560	ZPSNM	8	C
46	137			NDD									TEC	TEH	.560	RBART	65	H
46	137	.12	106	PID		2	TSC	.30					TSC	TSC	.560	ZPSNM	66	C
ROW	COL	VOLTS	DEG	IND	PER	CHN	LOCN	INCH1	INCH2	I	CRLEN	CEG	BEGT	ENDT	PDIA	PTYPE	CAL	L

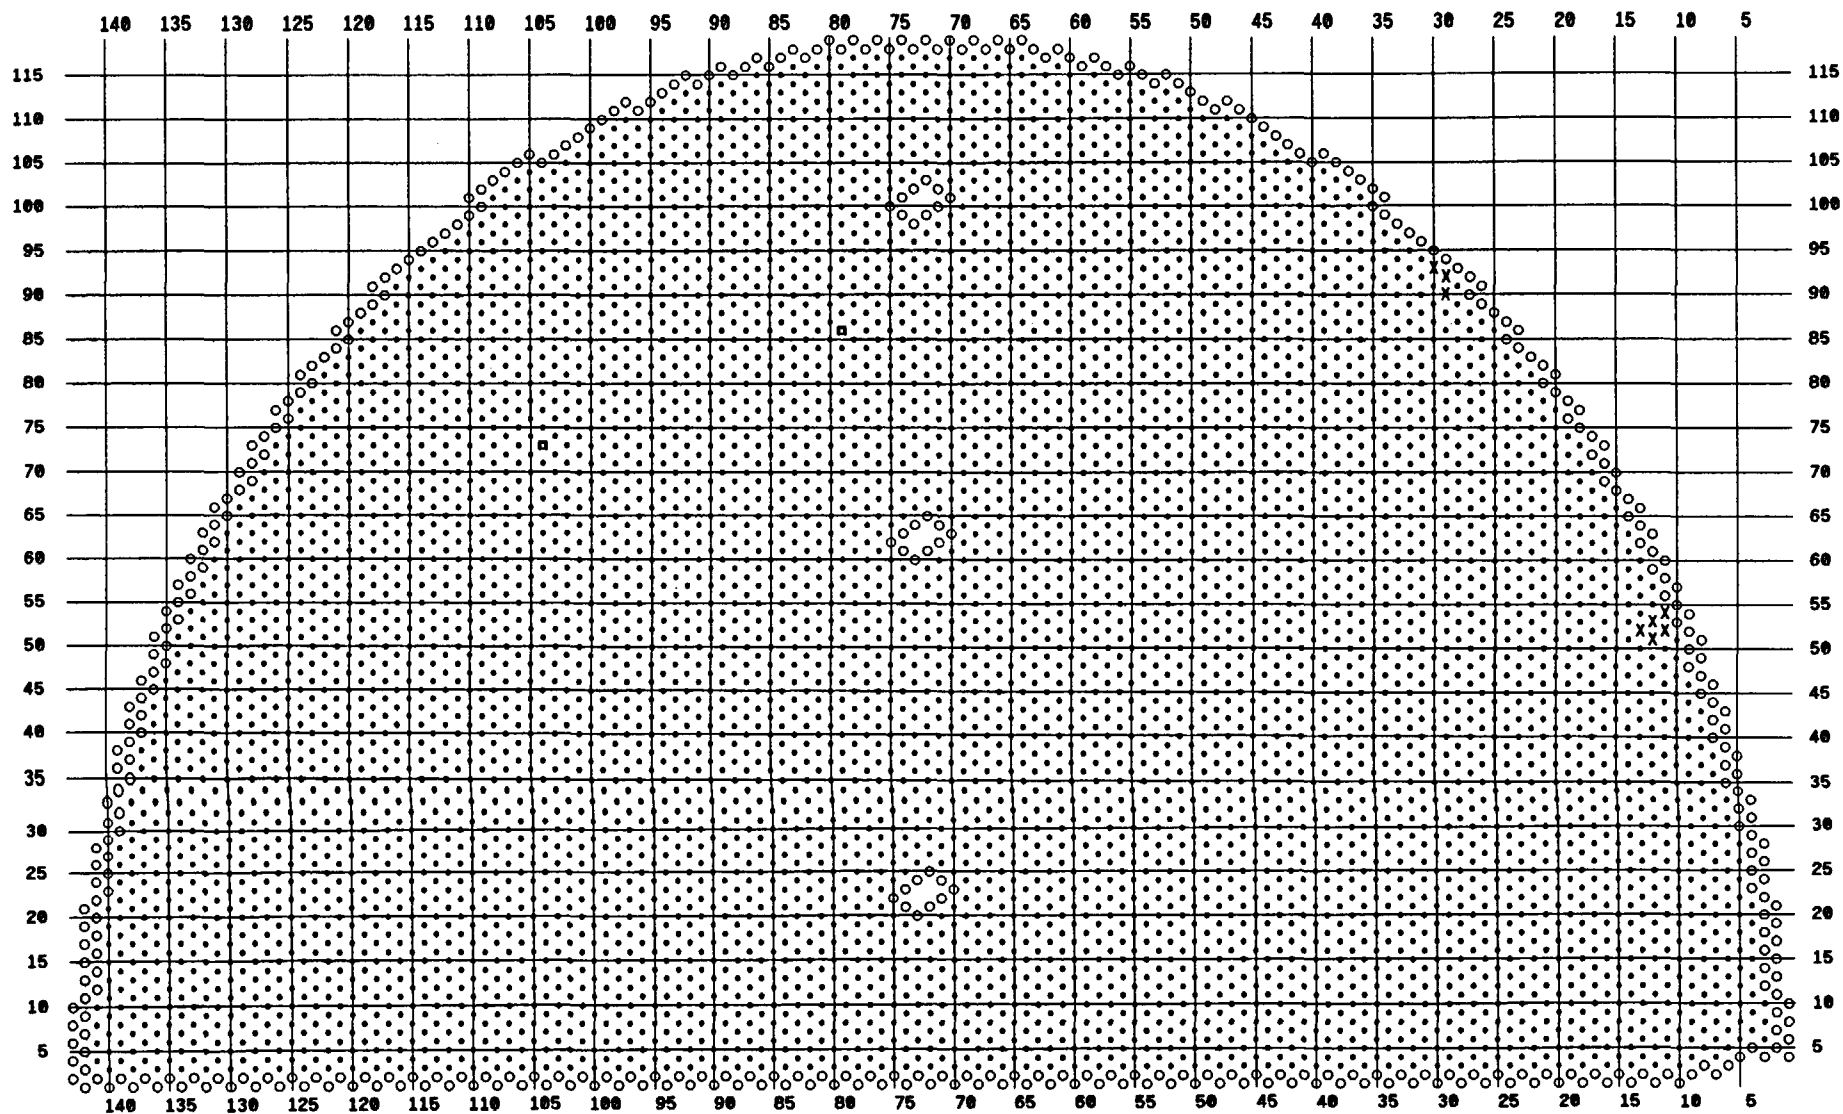
# SG - B TUBES DAMAGED BY FOREIGN OBJECTS

X 8 TUBE DAMAGED BY FOREIGN  
OBJECT AT HOT LEG TOP OF  
TUBESHEET

ROW	COL	VOLTS	DEG	IND	PER	CHN	LOCN	INCH1	INCH2	I	CRLEN	CEG	BEGT	ENDT	PDIA	PTYPE	CAL	L
52	11	.15	137	DFI		1	TSH	.94					TEC	TEH	.560	RBART	5	H
52	11	.09	88	SVI		P1	TSH	.94					TSH	TSH	.560	ZPSNM	55	H
52	11	.08	86	PID		2	TSH	.94					TSH	TSH	.560	ZPSNM	59	H
52	11	.09	0	PCT	11	P1	TSH	1.39		0	.344	71	TSH	TSH	.560	ZPSNM	59	H
54	11			NDD									TEC	TEH	.560	RBART	5	H
54	11	.13	77	SVI		2	TSH	.87					TSH	TSH	.560	ZPSNM	61	H
54	11	.12	80	PID		2	TSH	.81					TSH	TSH	.560	ZPSNM	63	H
54	11	.13	0	PCT	13	2	TSH	.92		0	.310	63	TSH	TSH	.560	ZPSNM	63	H
51	12	.05	87	SVI		2	TSH	.95					TSH	TSH	.560	ZPSNM	61	H
51	12	.10	71	PID		2	TSH	1.03					TSH	TSH	.560	ZPSNM	63	H
51	12	.06	0	PCT	7	2	TSH	1.17		0	.311	40	TSH	TSH	.560	ZPSNM	63	H
53	12	.11	81	SVI		2	TSH	1.56					TSH	TSH	.560	ZPSNM	61	H
53	12	.12	0	PCT	12	2	TSH	1.50		0	.349	63	TSH	TSH	.560	ZPSNM	63	H
53	12	.10	71	PID		2	TSH	1.54					TSH	TSH	.560	ZPSNM	63	H
52	13			NDD									TEC	TEH	.560	RBART	5	H

52	13	.04	67	SVI		2	TSH	.34					TSH	TSH	.560	ZPSNM	61	H
52	13	.03	40	PID		2	TSH	.25					TSH	TSH	.560	ZPSNM	63	H
52	13	.03	0	PCT	4	2	TSH	.38		0	.156	31	TSH	TSH	.560	ZPSNM	63	H
90	29			NDD									TEC	TEH	.560	RBART	1	H
90	29	.05	106	SVI		P1	TSH	.23					TSH	TSH	.560	ZPSNM	65	H
90	29	.14	94	PLP		1	TSH	.26					TSH	TSH	.560	ZPSNM	65	H
90	29	.06	0	PCT	7	P1	TSH	.26		0	.288	85	TSH	TSH	.560	ZPSNM	65	H
90	29	.04	120	PID		P1	TSH	.23					TSH	TSH	.560	ZPSNM	67	H
92	29			NDD									TEC	TEH	.560	RBART	1	H
92	29	.05	91	SVI		P1	TSH	.60					TSH	TSH	.560	ZPSNM	65	H
92	29	.16	93	PLP		1	TSH	.64					TSH	TSH	.560	ZPSNM	65	H
92	29	.17	0	PCT	17	P1	TSH	.75		0	.674	140	TSH	TSH	.560	ZPSNM	65	H
92	29	.10	94	PID		P1	TSH	.60					TSH	TSH	.560	ZPSNM	67	H
93	30			NDD									TEC	TEH	.560	RBART	11	H
93	30	.06	0	PCT	7	P1	TSH	.49		0	.249	85	TSH	TSH	.560	ZPSNM	65	H
93	30	.14	87	PLP		1	TSH	.55					TSH	TSH	.560	ZPSNM	65	H
93	30	.06	87	SVI		P1	TSH	.55					TSH	TSH	.560	ZPSNM	65	H

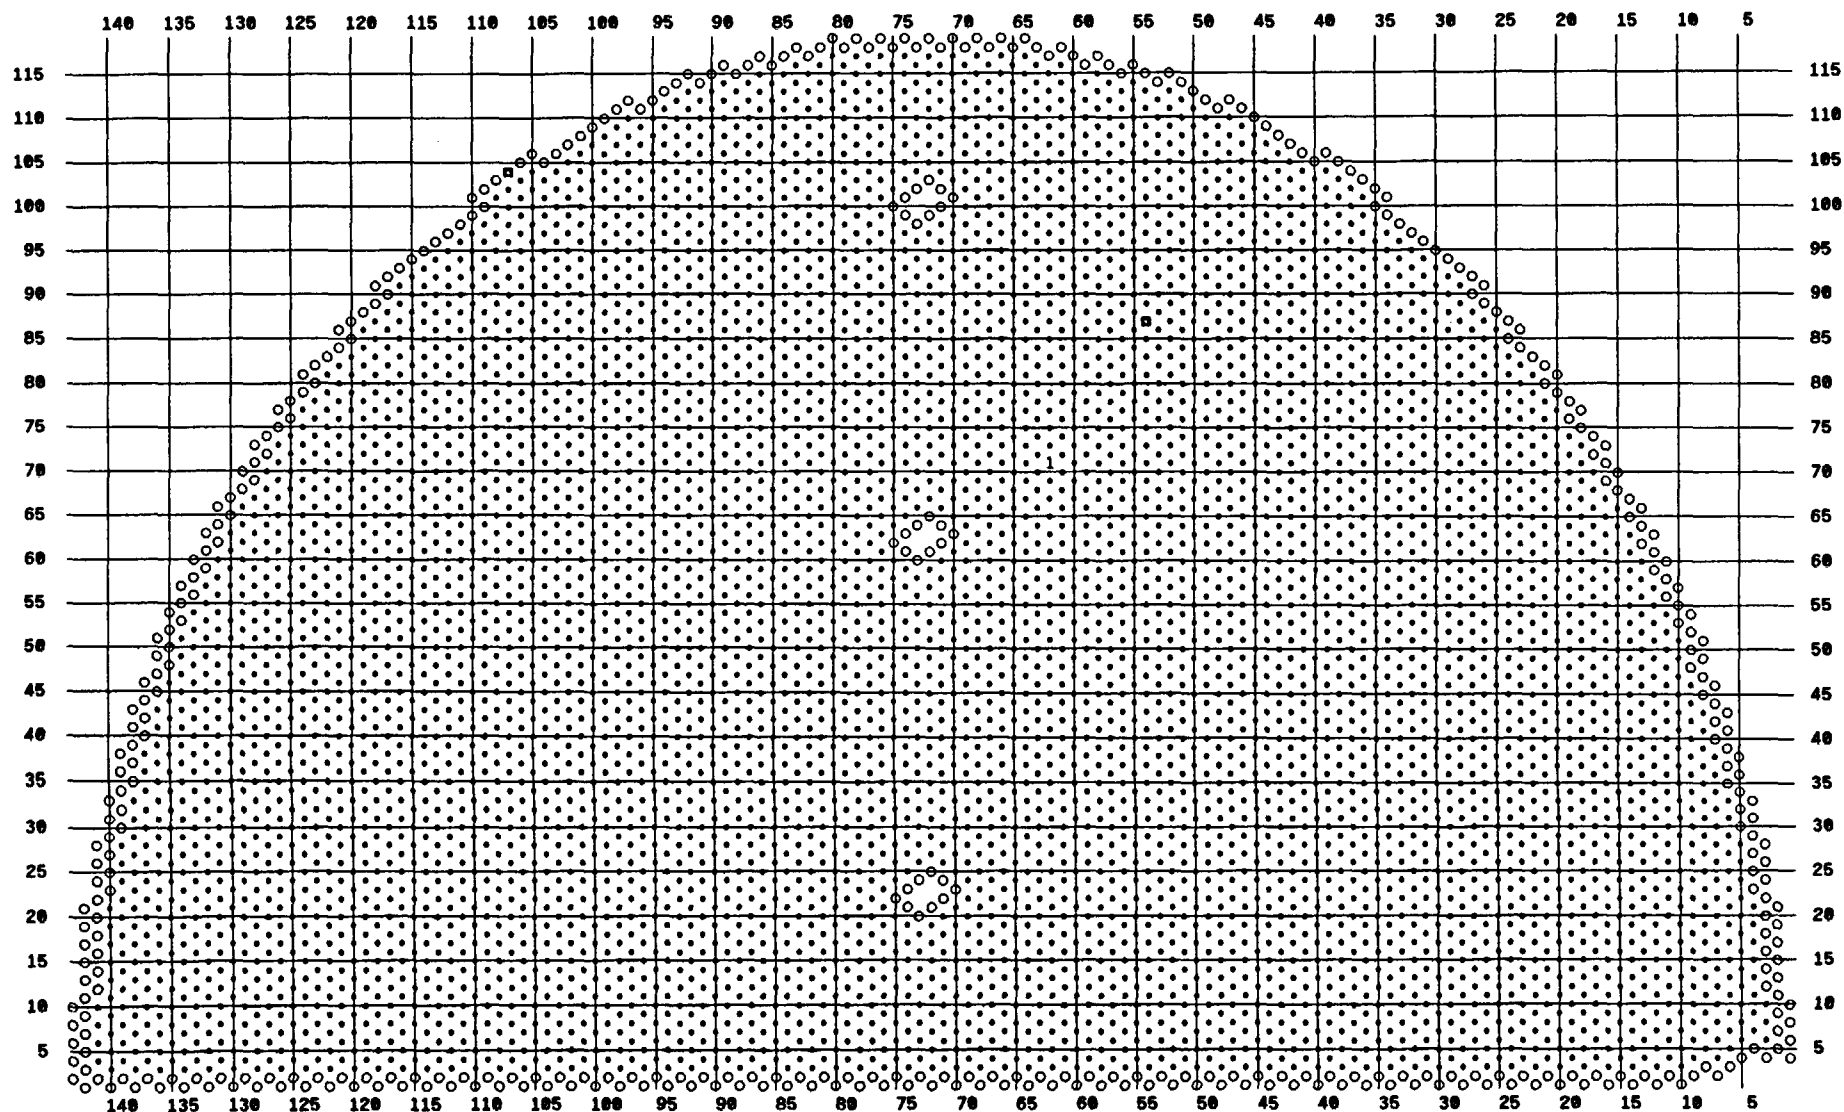
# SG - A FAN BAR WEAR INDICATIONS

- 5.1.1 Fan Bar Wear – A total of 7 tubes showed indications of Fan Bar wear. The largest indication of Fan Bar wear was 10% through wall. The EPRI Appendix H bobbin coil technique 96004.3 was utilized in this inspection for depth sizing of all Fan Bar wear. Refer to Attachment B for detailed locations and sizing for all Fan Bar wear.

1 1 INDICATION 1 TO 19 PERCENT

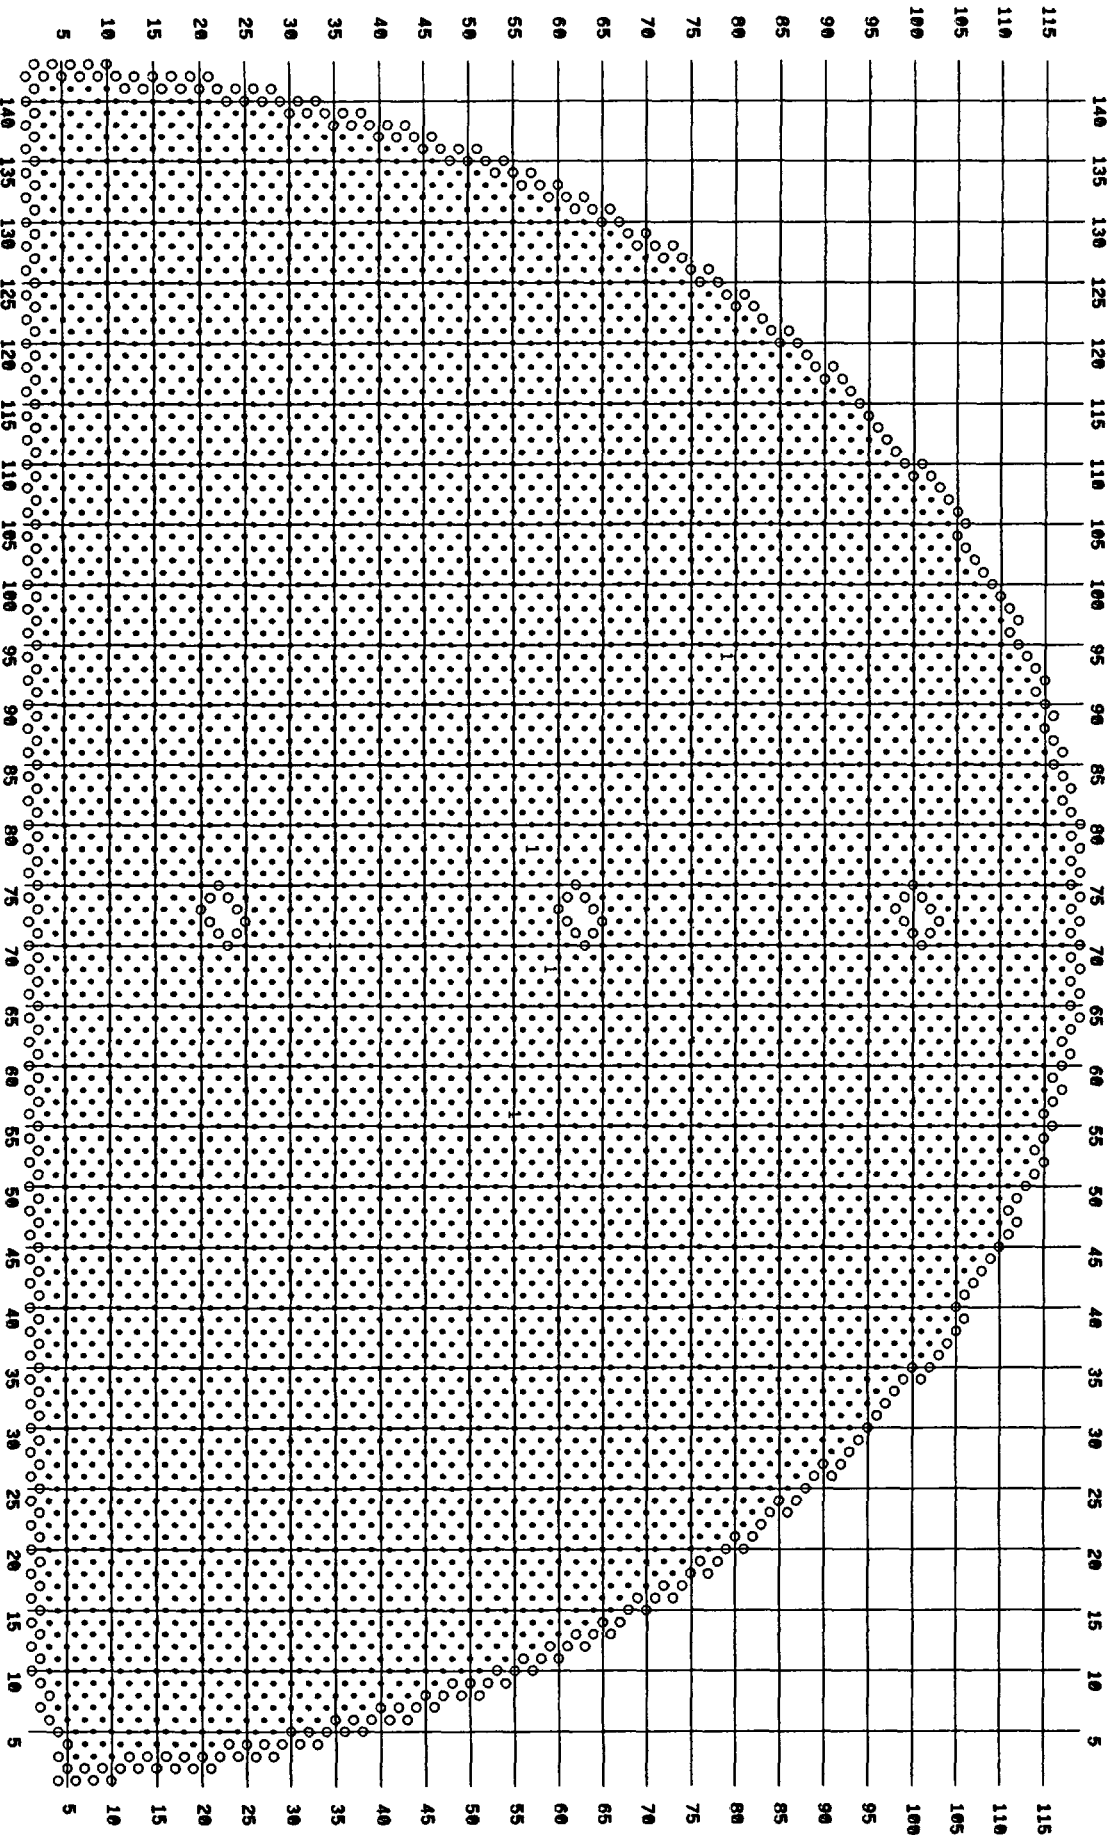
# SG - C FAN BAR WEAR INDICATIONS

1 5 INDICATION 1 TO 19 PERCENT

ROW	COL	VOLTS	DEG	IND	PER	CHN	LOCN	INCH1	INCH2	BEGT	ENDT	PDIA	PTYPE	CAL	L
55	56	.47	0	PCT	10	P2	F05	1.61		TEH	TEC	.560	RBART	22	C
55	56	.30	86	VOL		1	F05	1.64		09C	F04	.520	ZPUEF	44	C
59	68	.21	0	PCT	5	P2	F05	1.05		TEH	TEC	.560	RBART	22	C
59	68	.17	131	VOL		1	F05	.87		09C	F03	.520	ZPUEF	44	C
35	70	.04	251	MBM		6	TSH	12.60		TEH	TEC	.560	RBART	20	C
35	70	.24	0	PCT	6	P2	F05	1.49		TEH	TEC	.560	RBART	20	C
35	70	.20	110	VOL		1	F05	1.53		09C	F04	.520	ZPUEF	44	C
57	78	.42	0	PCT	9	P2	F06	.68		TEC	TEH	.560	RBART	23	H
57	78	.29	103	VOL		1	F06	.99		09C	F04	.520	ZPUEF	44	C
79	94	.45	0	PCT	8	P2	F06	-1.09		TEC	TEH	.560	RBART	21	H
79	94	.39	96	VOL		1	F06	-1.14		09C	F05	.520	ZPUEF	44	C
ROW	COL	VOLTS	DEG	IND	PER	CHN	LOCN	INCH1	INCH2	BEGT	ENDT	PDIA	PTYPE	CAL	L

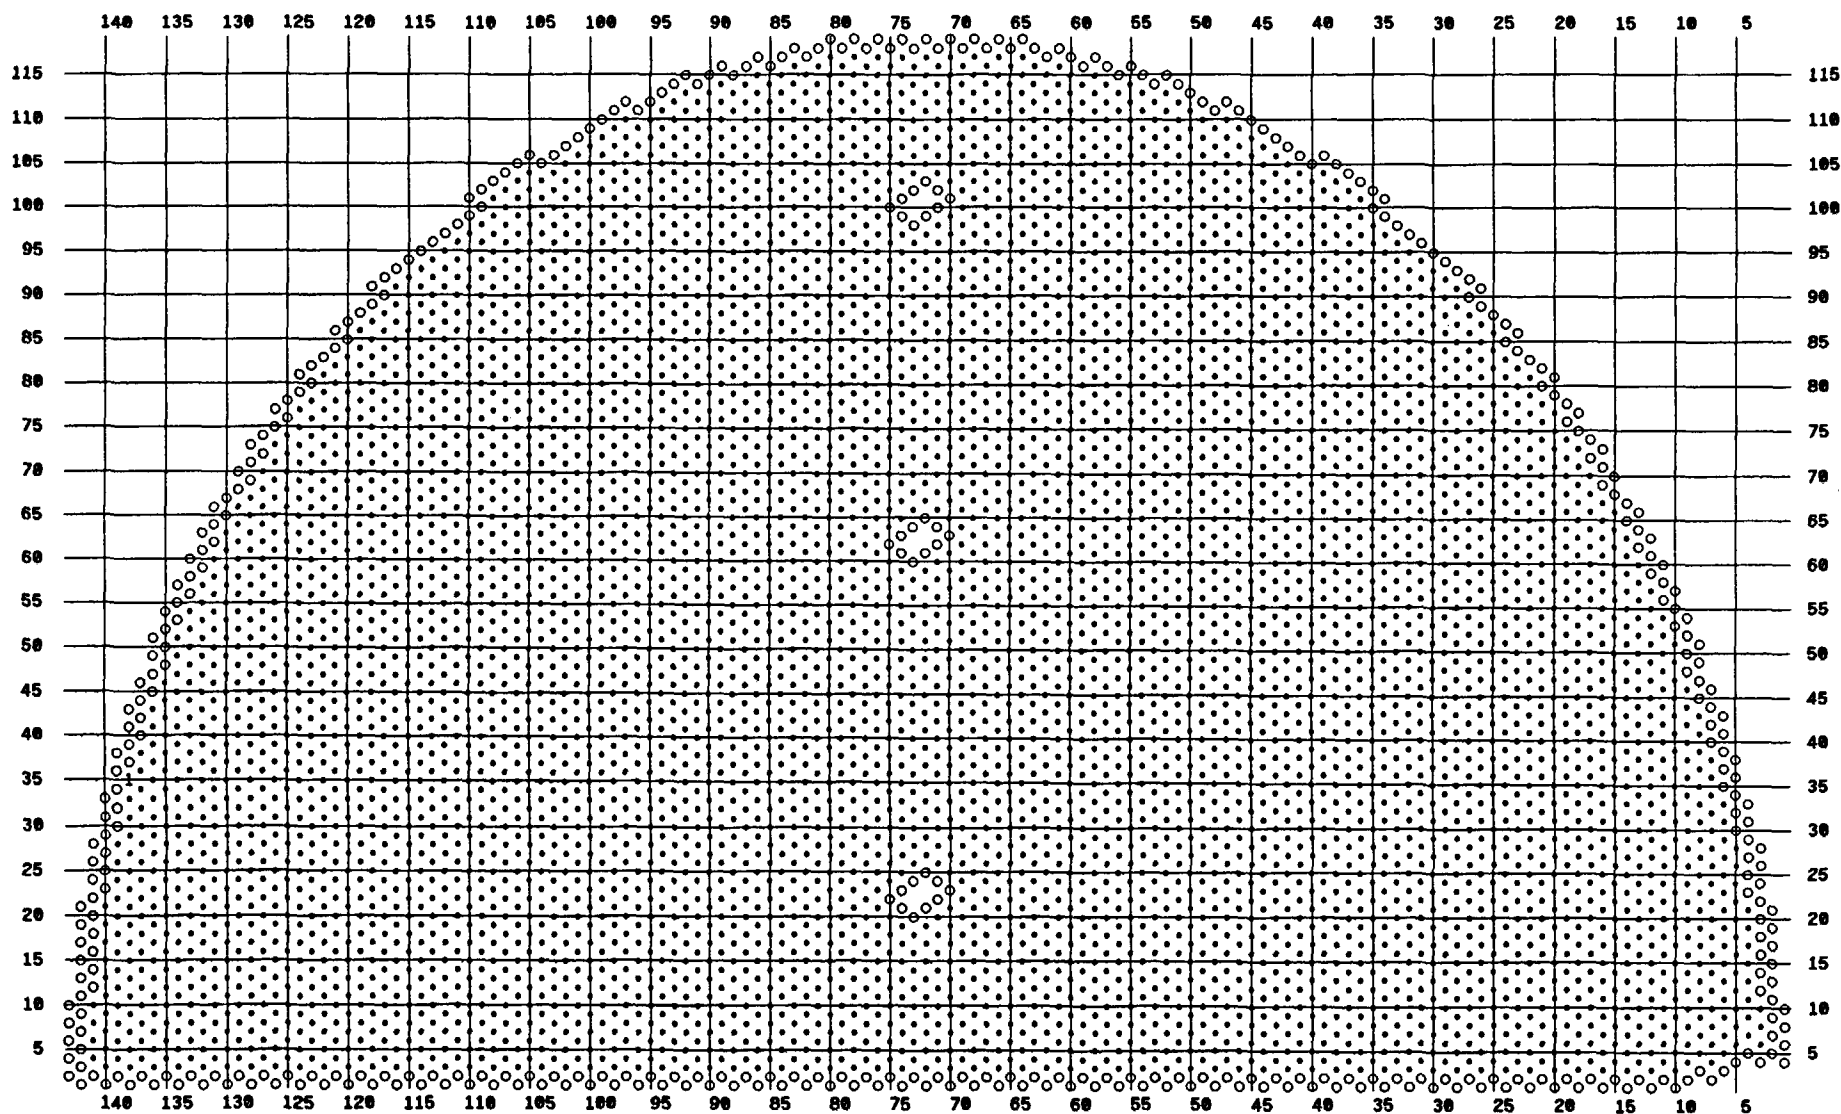
# SG - D FAN BAR WEAR INDICATIONS

1 1 INDICATION 1 TO 19 PERCENT

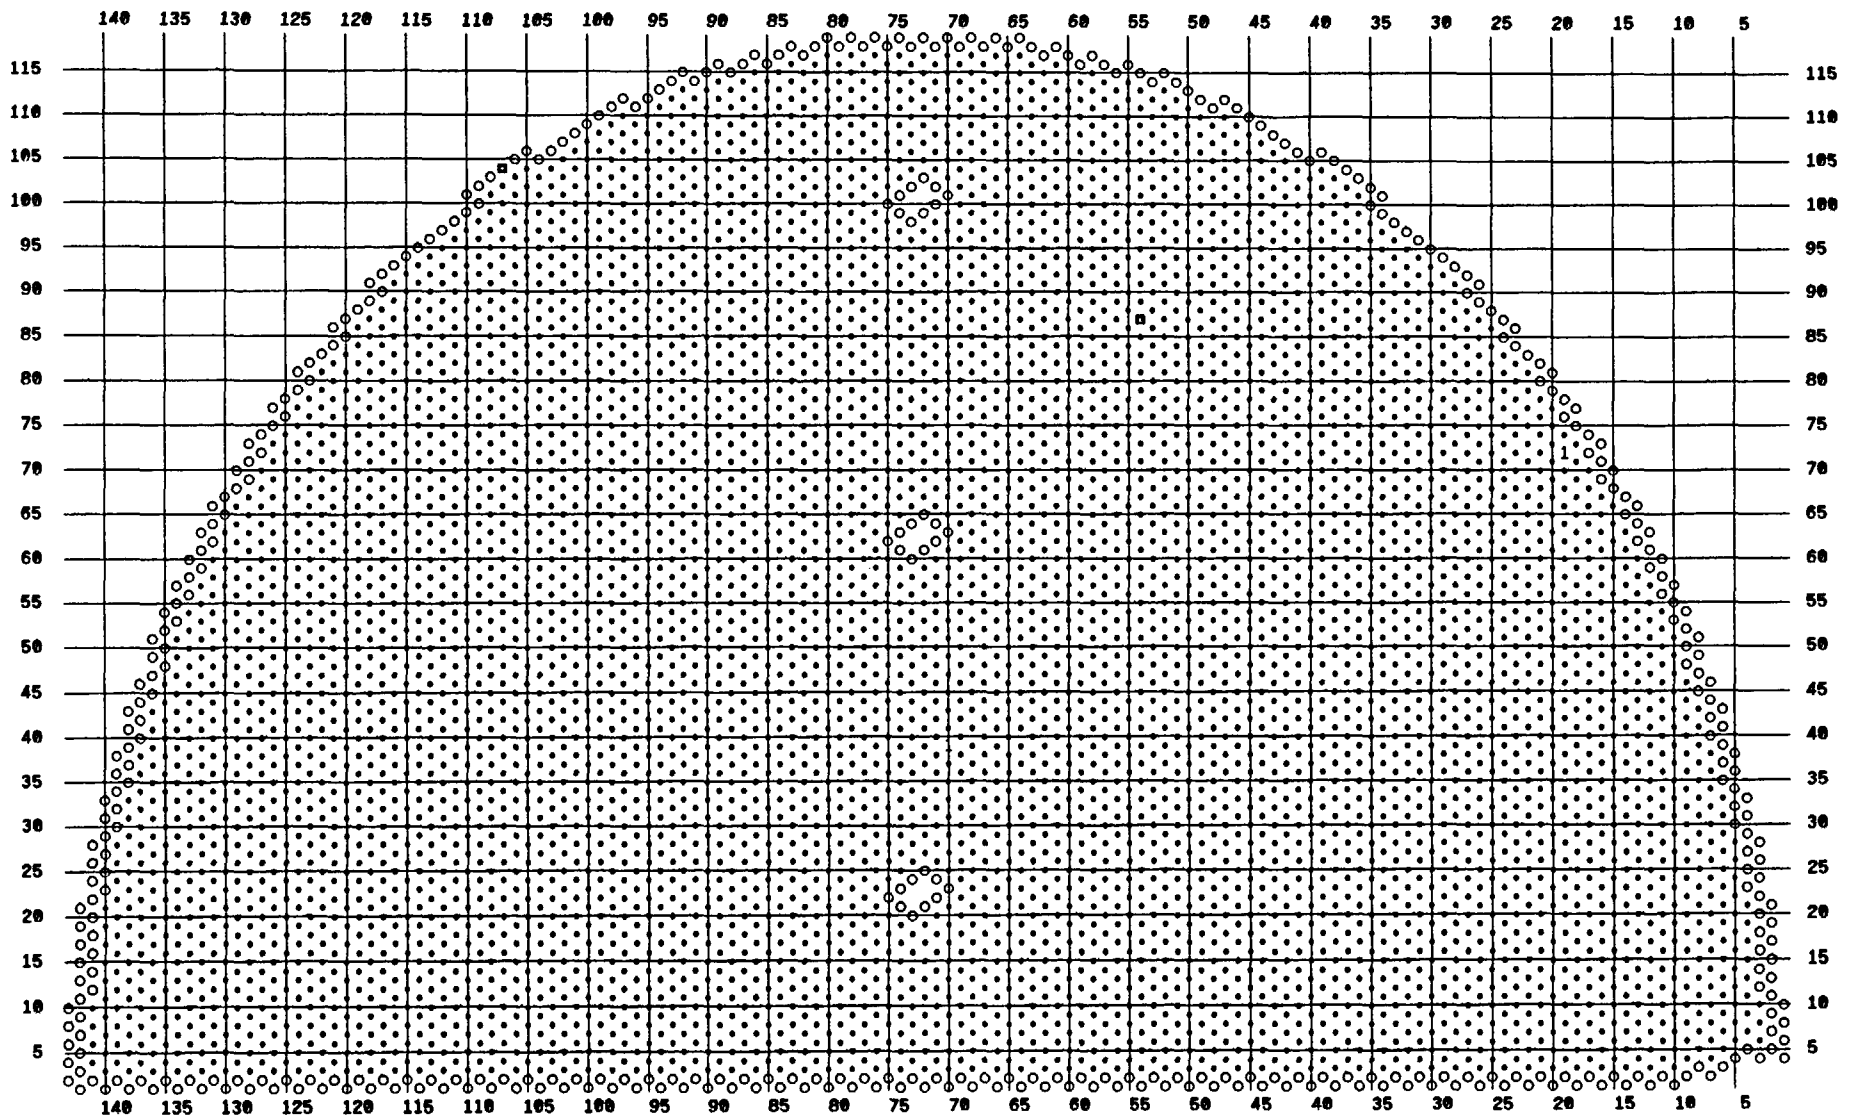
# SG - A LATTICE GRID WEAR INDICATIONS

- 5.1.2 **Lattice Grid Wear** – A total of 5 tubes showed indications of Lattice Grid wear. The largest indication of Lattice Grid wear was 12% through wall. The EPRI Appendix H bobbin coil technique 96004.3 was utilized in this inspection for depth sizing of all Lattice Grid wear. Refer to Attachment B for detailed locations and sizing for all Lattice Grid wear.

1 2 INDICATION 1 TO 19 PERCENT

ROW	COL	VOLTS	DEG	IND	PER	CHN	LOCN	INCH1	INCH2	BEGT	ENDT	PDIA	PTYPE	CAL	L
72	19	.17	0	PCT	5	P2	05H	.36		TEH	TEC	.560	RBART	48	C
39	70	.45	0	PCT	12	P2	01H	-1.59		TEH	TEC	.560	RBART	62	C
ROW	COL	VOLTS	DEG	IND	PER	CHN	LOCN	INCH1	INCH2	BEGT	ENDT	PDIA	PTYPE	CAL	L

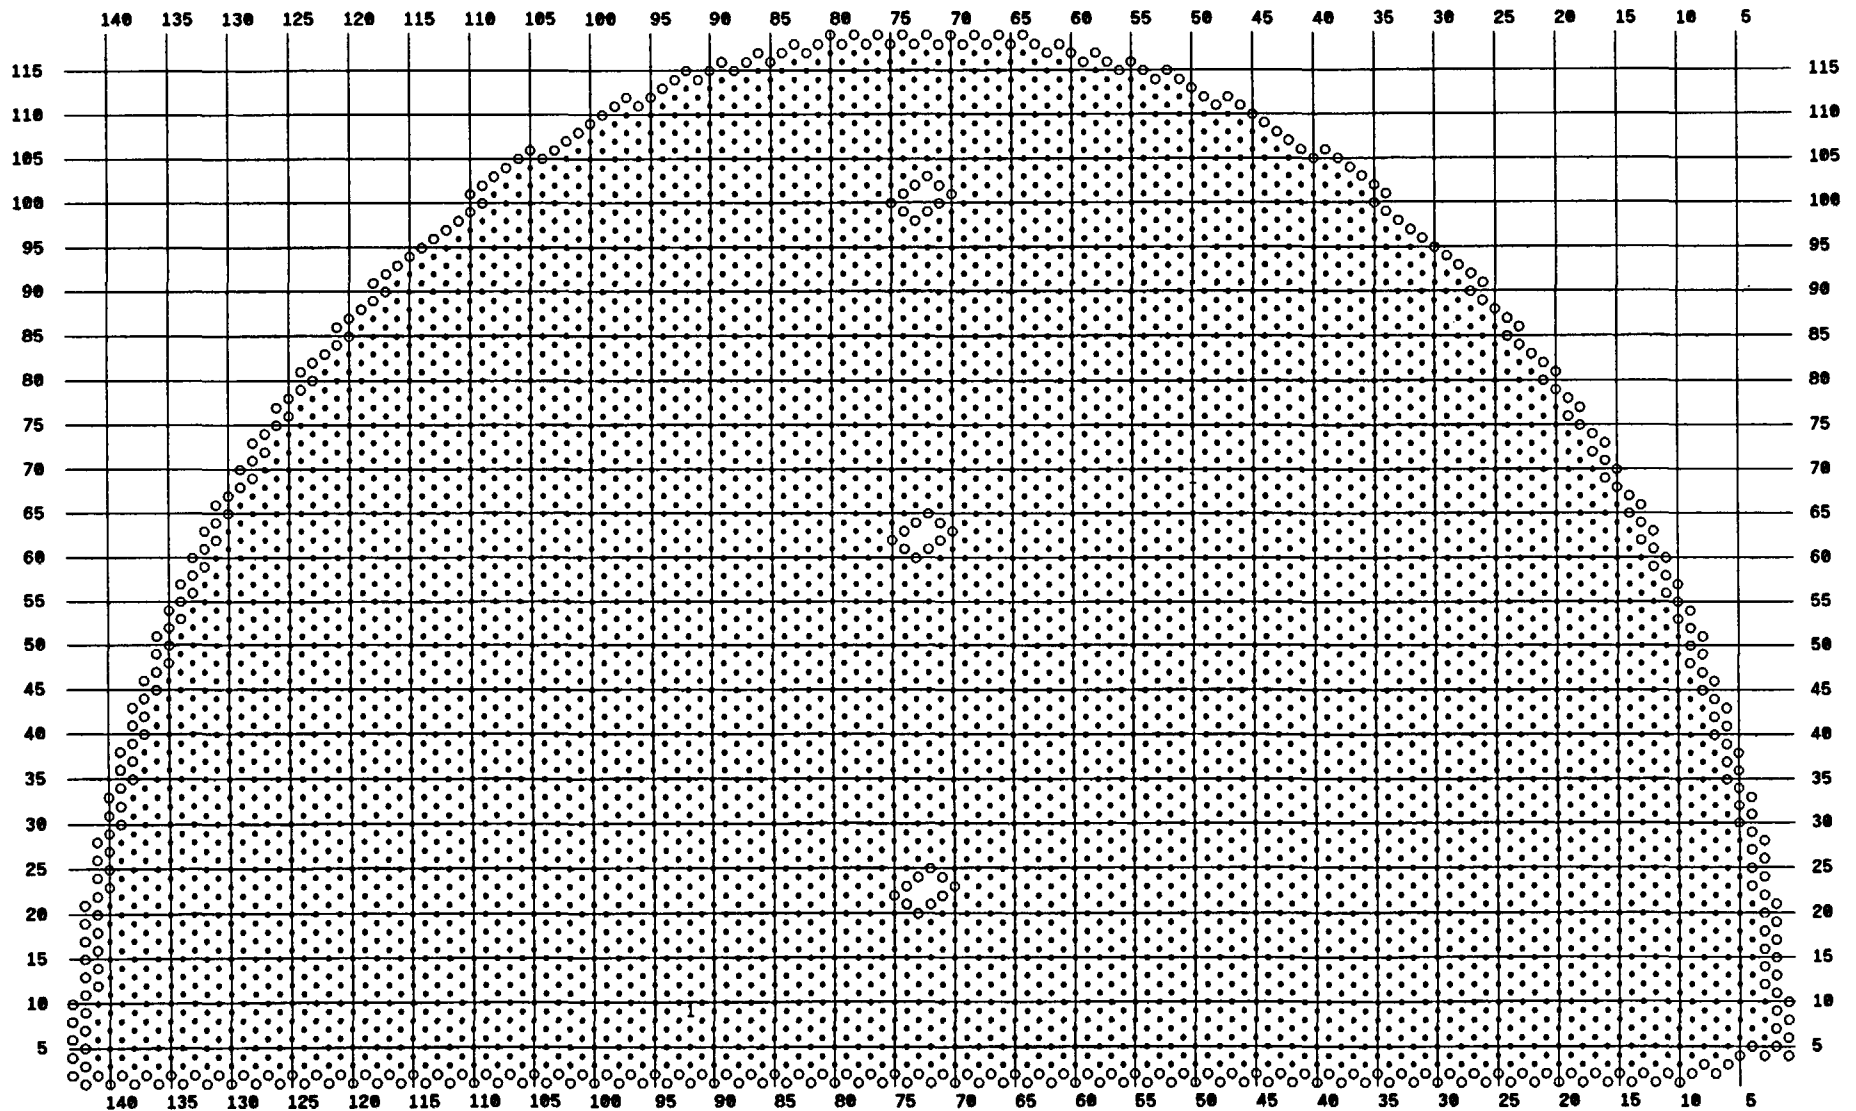
# SG - C LATTICE GRID WEAR INDICATIONS

1 2 INDICATION 1 TO 19 PERCENT

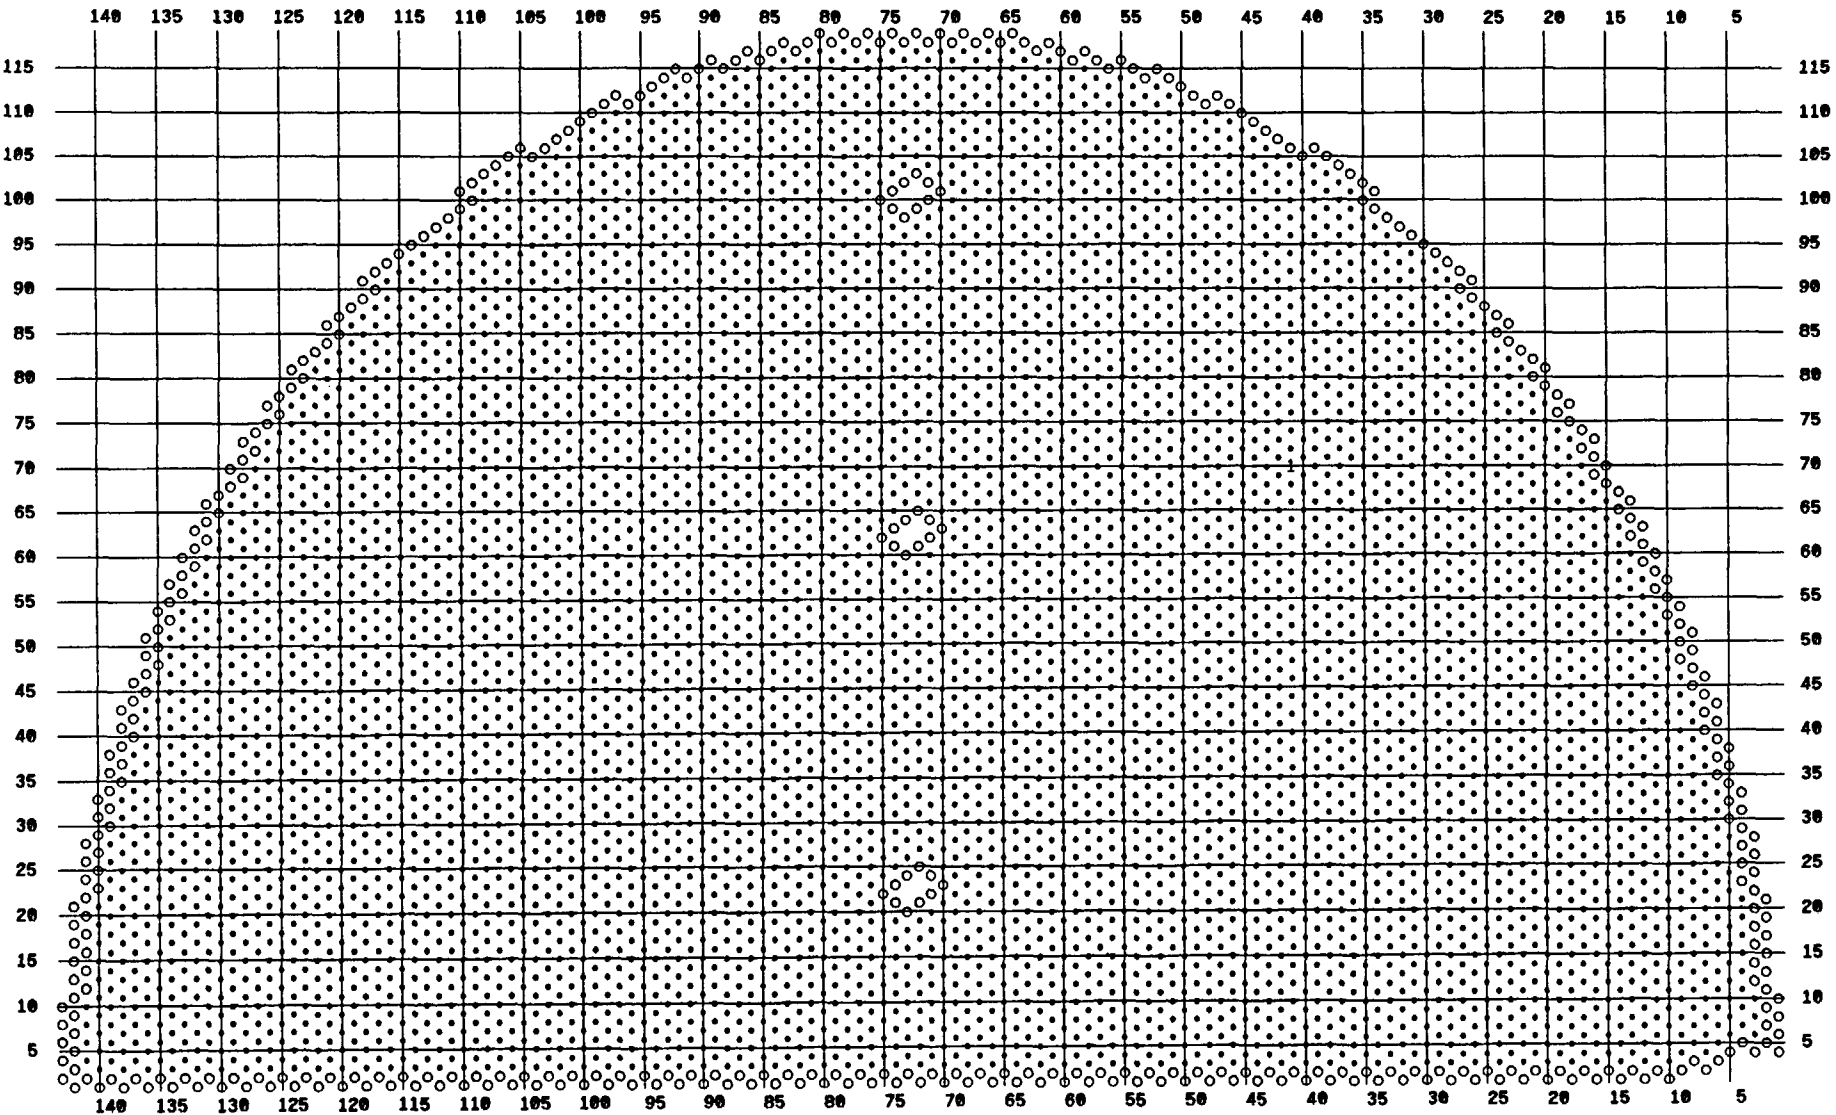
# SG - D LATTICE GRID WEAR INDICATIONS

1 1 INDICATION 1 TO 19 PERCENT

ROW	COL	VOLTS	DEG	IND	PER	CHN	LOCN	INCH1	INCH2	BEGT	ENDT	PDIA	PTYPE	CAL	L
70	41	.26	0	PCT	6	P2	02H	-1.57		TEC	TEH	.560	RBART	33	H
70	41	.25	78	VOL		2	02H	-1.64		02H	02H	.560	ZPSNM	53	H

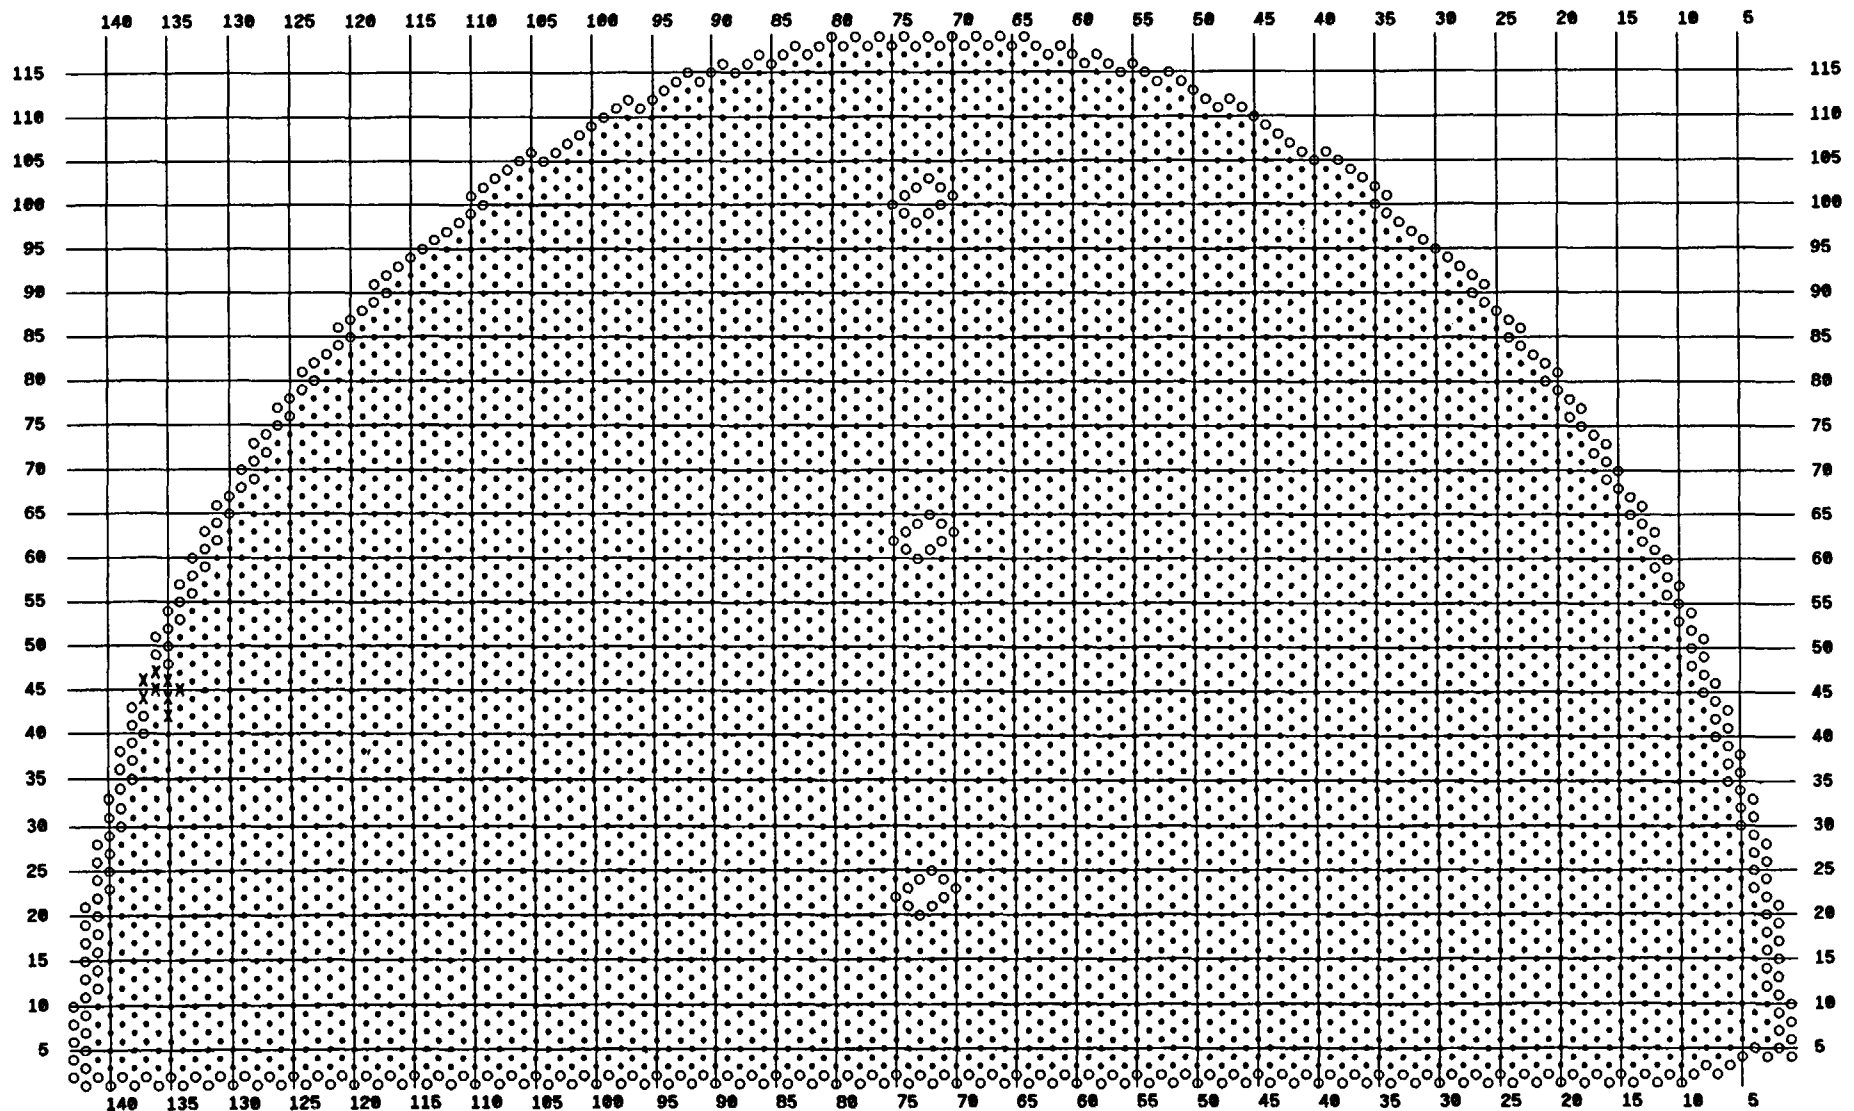
# SG - A TUBES REPAIRED DURING A1R10

ROW	COL	VOLTS	DEG	IND	PER	CHN	LOCN	INCH1	INCH2	BEGT	ENDT	PDIA	PTYPE	CAL	L
45	134			NDD						TEC	TEH	.560	RBART	3	H
45	134	.14	107	SVI		P1	TSC	.10		TSC	TSC	.560	ZPSNM	8	C
45	134	.15	0	PCT	15	2	TSC	.28		TSC	TSC	.560	ZPSNM	8	C
45	134	.13	106	PID		P1	TSC	.19		TSC	TSC	.560	ZPSNM	66	C
42	135	.28	0	PCT	25	2	TSC	.48		TSC	TSC	.560	ZPSNM	8	C
42	135	.27	98	SVI		P1	TSC	.49		TSC	TSC	.560	ZPSNM	8	C
42	135	.26	120	DTI		P1	TSC	.56		TEC	TEH	.560	RBART	65	H
42	135	.24	100	PID		P1	TSC	.60		TSC	TSC	.560	ZPSNM	66	C
44	135	1.61	113	DTI		P1	TSC	.31		TEC	TEH	.560	RBART	3	H
44	135	.76	82	SVI		P1	TSC	.26		TSC	TSC	.560	ZPSNM	8	C
44	135	.75	0	PID		2	TSC	.31		TSC	TSC	.560	ZPSNM	8	C
44	135	.70	0	PCT	48	2	TSC	.37		TSC	TSC	.560	ZPSNM	8	C
46	135			NDD						TEC	TEH	.560	RBART	3	H
46	135	.11	97	SVI		2	TSC	.23		TSC	TSC	.560	ZPSNM	8	C
46	135	.11	0	PCT	12	2	TSC	.23		TSC	TSC	.560	ZPSNM	8	C
46	135	.11	95	PID		P1	TSC	.23		TSC	TSC	.560	ZPSNM	66	C

45	136			NDD						TEC	TEH	.560	RBART	3	H
45	136	.21	0	PCT	20	2	TSC	.09		TSC	TSC	.560	ZPSNM	8	C
45	136	.21	115	SVI		2	TSC	.15		TSC	TSC	.560	ZPSNM	8	C
45	136	.18	115	PID		P1	TSC	.10		TSC	TSC	.560	ZPSNM	66	C
47	136			TBP						TEC	TEH	.560	RBART	3	H
47	136			NDD						TSC	TSC	.560	ZPSNM	8	C
44	137			NDD						TEC	TEH	.560	RBART	3	H
44	137	.04	105	SVI		2	TSC	.14		TSC	TSC	.560	ZPSNM	8	C
44	137	.04	0	PCT	5	2	TSC	.15		TSC	TSC	.560	ZPSNM	8	C
44	137	.04	101	PID		P1	TSC	.13		TSC	TSC	.560	ZPSNM	66	C
46	137			NDD						TEC	TSH	.560	RBART	3	H
46	137	.14	0	PCT	14	2	TSC	.28		TSC	TSC	.560	ZPSNM	8	C
46	137	.12	99	SVI		2	TSC	.31		TSC	TSC	.560	ZPSNM	8	C
46	137			NDD						TEC	TEH	.560	RBART	65	H
46	137	.12	106	PID		2	TSC	.30		TSC	TSC	.560	ZPSNM	66	C
ROW	COL	VOLTS	DEG	IND	PER	CHN	LOCN	INCH1	INCH2	BEGT	ENDT	PDIA	PTYPE	CAL	L

X 8 TUBE STABILIZED AND PLUGGED  
IN THE COLD LEG; PLUGGED IN  
THE HOT LEG
