Subject: Braidwood Station, Unit 1 Tenth Refueling Outage Steam Generator Inservice  
Inspection Summary Report

**STEAM GENERATOR EDDY CURRENT INSPECTION REPORT**

**CYCLE 10 REFUELING OUTAGE (A1R10)**

**April 2003**

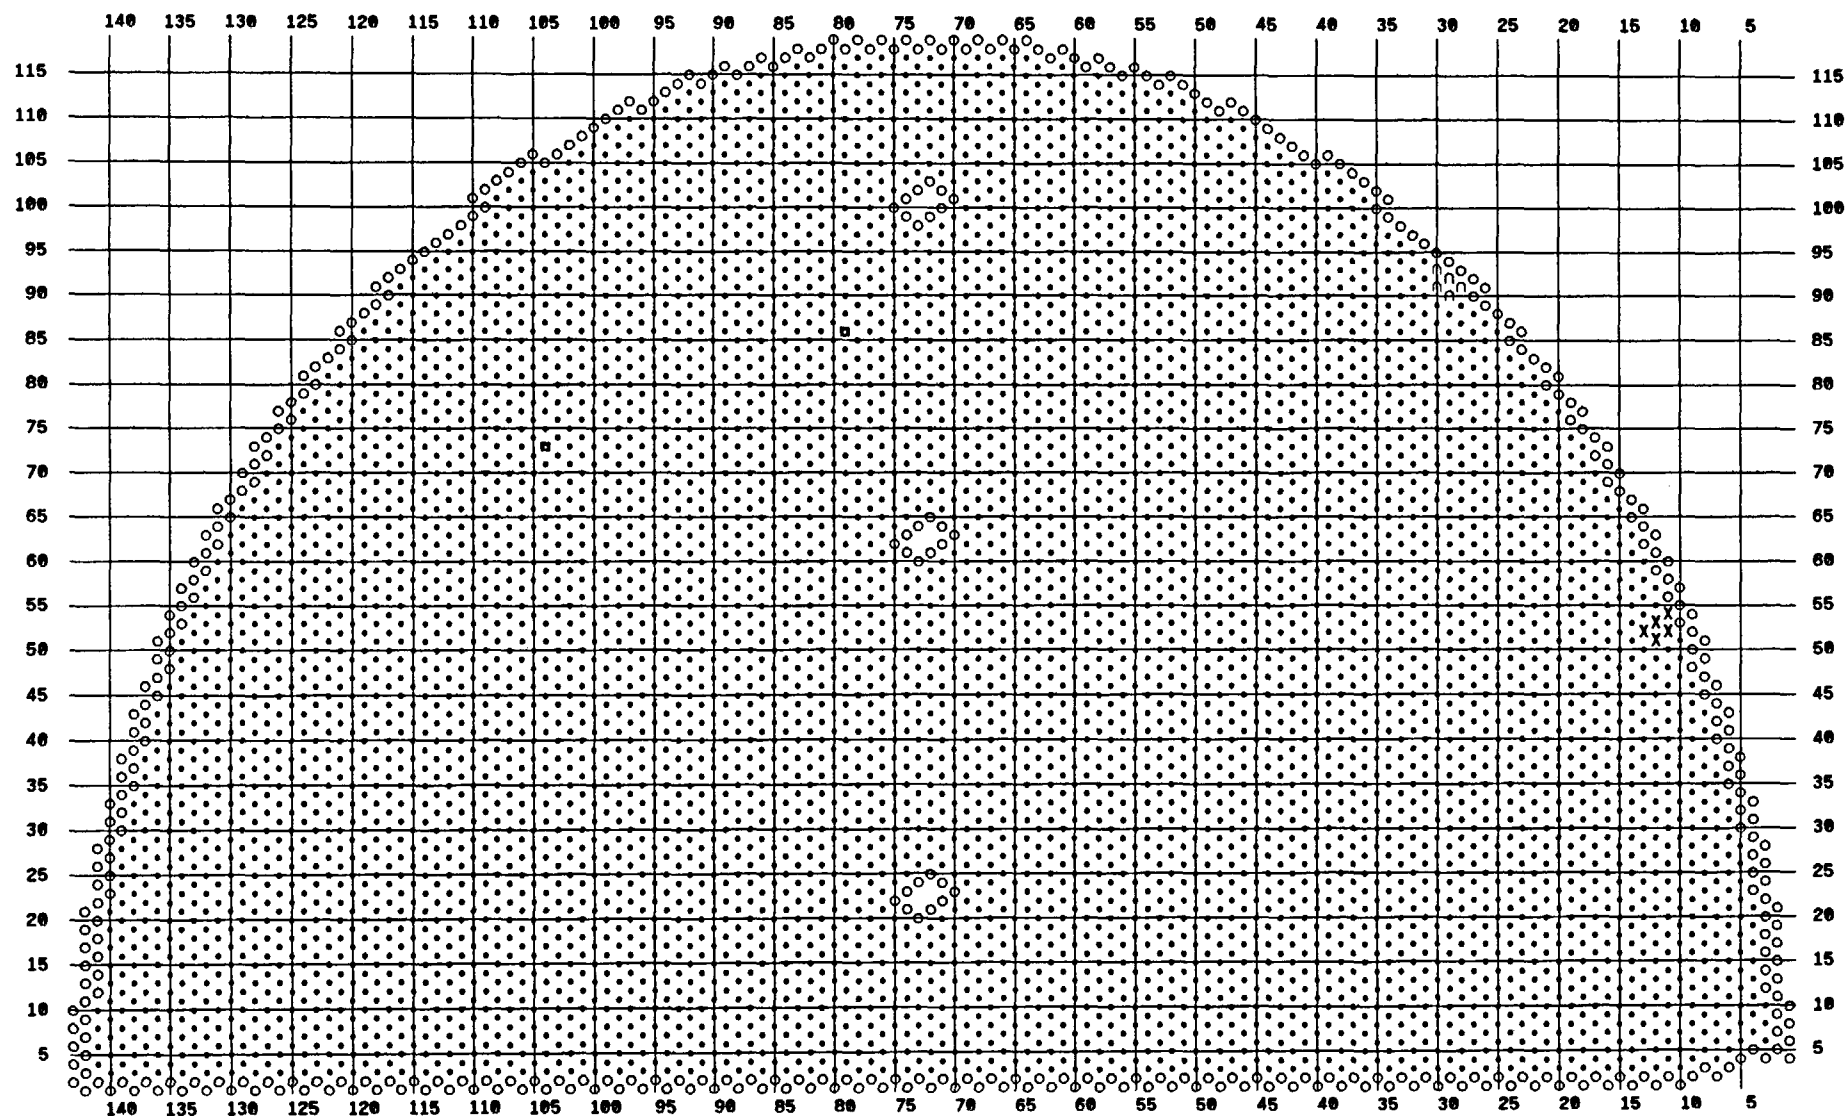
# SG - B TUBES REPAIRED DURING A1R10

ROW	COL	VOLTS	DEG	IND	PER	CHN	LOCN	INCH1	INCH2	I	CRLEN	CEG	BEGT	ENDT	PDIA	PTYPE	CAL	L
52	11	.15	137	DFI		1	TSH	.94					TEC	TEH	.560	RBART	5	H
52	11	.09	88	SVI		P1	TSH	.94					TSH	TSH	.560	ZPSNM	55	H
52	11	.08	86	PID		2	TSH	.94					TSH	TSH	.560	ZPSNM	59	H
52	11	.09	0	PCT	11	P1	TSH	1.39		0	.344	71	TSH	TSH	.560	ZPSNM	59	H
54	11			NDD									TEC	TEH	.560	RBART	5	H
54	11	.13	77	SVI		2	TSH	.87					TSH	TSH	.560	ZPSNM	61	H
54	11	.12	80	PID		2	TSH	.81					TSH	TSH	.560	ZPSNM	63	H
54	11	.13	0	PCT	13	2	TSH	.92		0	.310	63	TSH	TSH	.560	ZPSNM	63	H
51	12	.05	87	SVI		2	TSH	.95					TSH	TSH	.560	ZPSNM	61	H
51	12	.10	71	PID		2	TSH	1.03					TSH	TSH	.560	ZPSNM	63	H
51	12	.06	0	PCT	7	2	TSH	1.17		0	.311	40	TSH	TSH	.560	ZPSNM	63	H
53	12	.11	81	SVI		2	TSH	1.56					TSH	TSH	.560	ZPSNM	61	H
53	12	.12	0	PCT	12	2	TSH	1.50		0	.349	63	TSH	TSH	.560	ZPSNM	63	H
53	12	.10	71	PID		2	TSH	1.54					TSH	TSH	.560	ZPSNM	63	H
52	13			NDD									TEC	TEH	.560	RBART	5	H

52	13	.04	67	SVI		2	TSH	.34					TSH	TSH	.560	ZPSNM	61	H
52	13	.03	40	PID		2	TSH	.25					TSH	TSH	.560	ZPSNM	63	H
52	13	.03	0	PCT	4	2	TSH	.38		0	.156	31	TSH	TSH	.560	ZPSNM	63	H
91	28			NDD									TEC	TEH	.560	RBART	7	H
91	28			NDD									TSH	TSH	.560	ZPSNM	65	H
91	28			TBP									TSH	TSH	.560	ZPSNM	65	H
90	29			NDD									TEC	TEH	.560	RBART	1	H
90	29	.05	106	SVI		P1	TSH	.23					TSH	TSH	.560	ZPSNM	65	H
90	29	.14	94	PLP		1	TSH	.26					TSH	TSH	.560	ZPSNM	65	H
90	29	.06	0	PCT	7	P1	TSH	.26		0	.288	85	TSH	TSH	.560	ZPSNM	65	H
90	29	.04	120	PID		P1	TSH	.23					TSH	TSH	.560	ZPSNM	67	H
92	29			NDD									TEC	TEH	.560	RBART	1	H
92	29	.05	91	SVI		P1	TSH	.60					TSH	TSH	.560	ZPSNM	65	H
92	29	.16	93	PLP		1	TSH	.64					TSH	TSH	.560	ZPSNM	65	H
92	29	.17	0	PCT	17	P1	TSH	.75		0	.674	140	TSH	TSH	.560	ZPSNM	65	H
92	29	.10	94	PID		P1	TSH	.60					TSH	TSH	.560	ZPSNM	67	H
91	30			TBP									TSH	TSH	.560	ZPSNM	65	H
91	30			NDD									TSH	TSH	.560	ZPSNM	65	H

x 5 TUBE PLUGGED IN BOTH LEGS

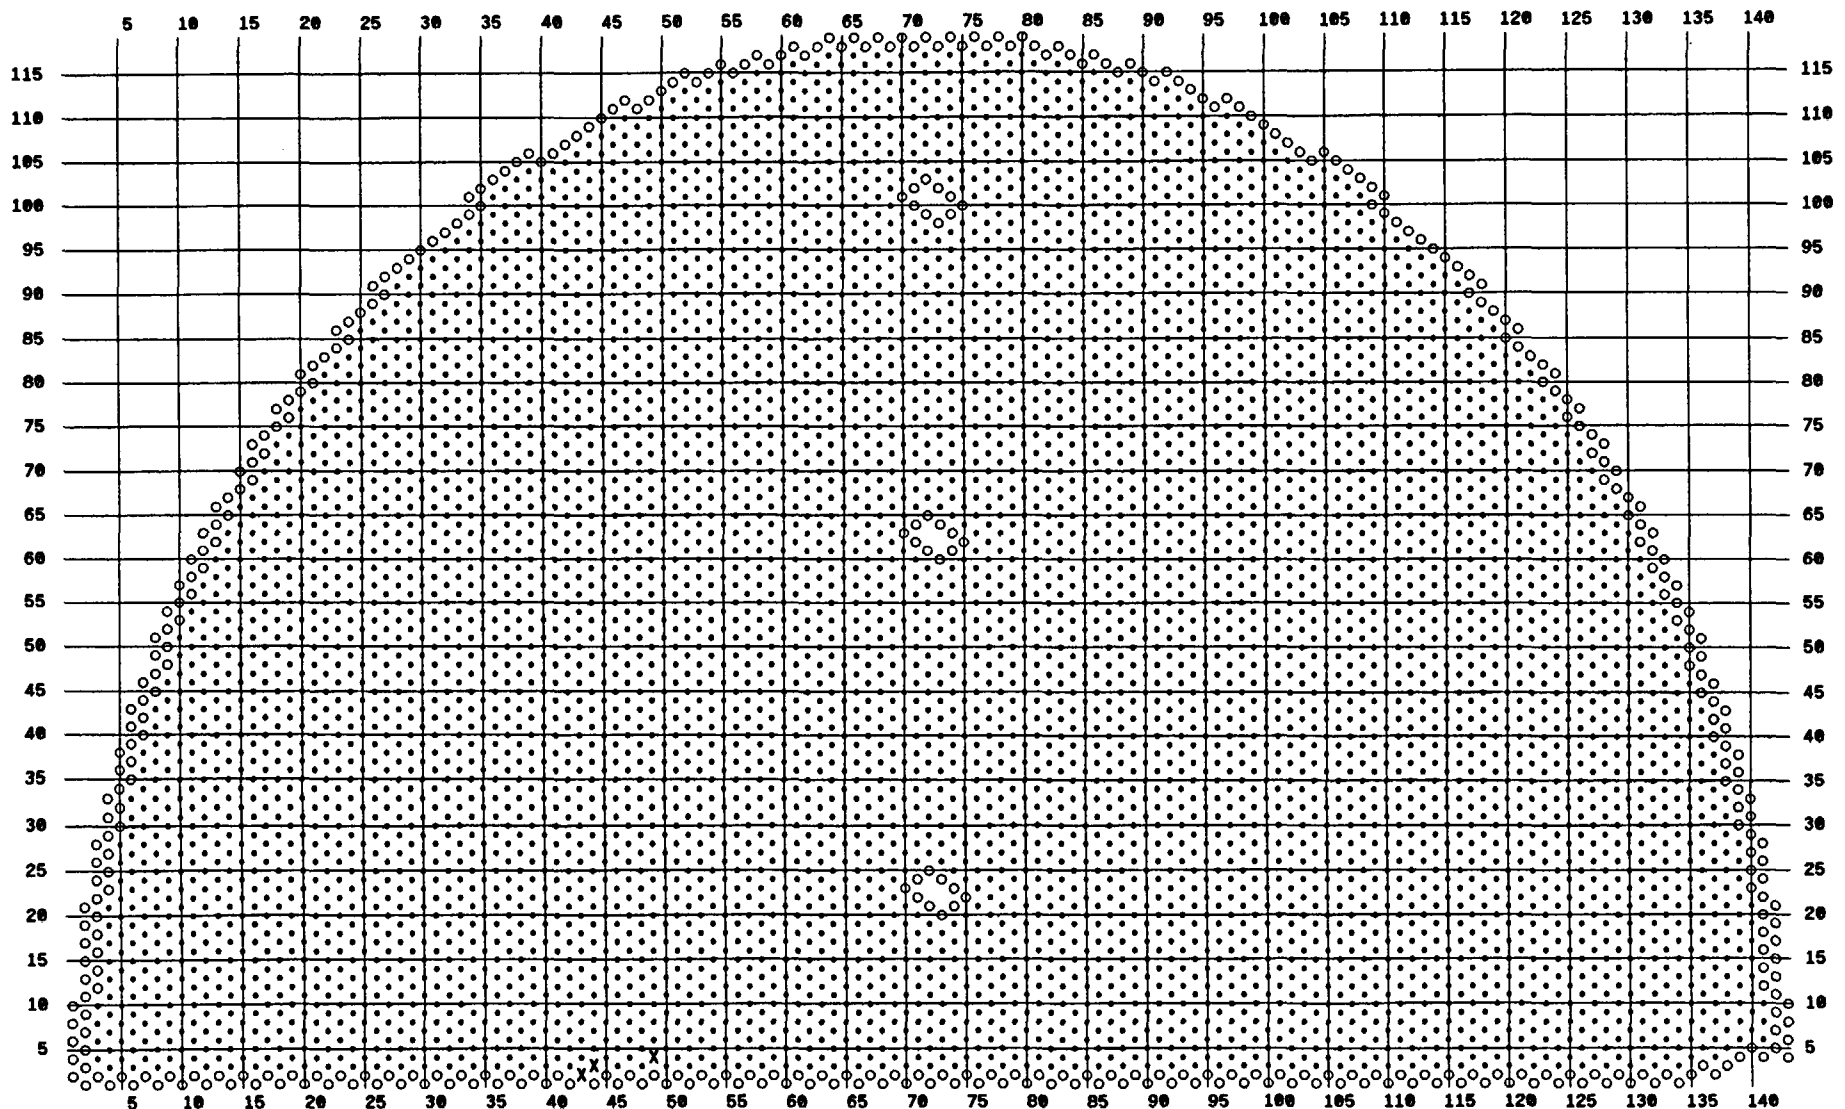
# SG - C TUBES REPAIRED DURING A1R10

ROW	COL	VOLTS	DEG	IND	PER	CHN	LOCN	INCH1	INCH2	BEGT	ENDT	PDIA	PTYPE	CAL	L
3	48			NDD						09H	TEC	.540	RBART	12	C
3	48			NDD						09H	TEH	.560	RBART	37	H
3	48	.12	238	PLP		7	TSH	.21		TSH	TSH	.560	ZPSNM	57	H
3	48			TBP						TSH	TSH	.560	ZPSNM	59	H
3	48	.11	111	PID		2	TSH	.21		TSH	TSH	.560	ZPSNM	59	H
2	49			NDD						09H	TEC	.540	RBART	10	C
2	49			NDD						09H	TEH	.560	RBART	41	H
2	49	.04	224	PLP		7	TSH	.07		TSH	TSH	.560	ZPSNM	57	H
2	49			TBP						TSH	TSH	.560	ZPSNM	59	H
2	49	.03	106	PID		2	TSH	.18		TSH	TSH	.560	ZPSNM	59	H
4	49	.11	235	PLP		7	TSH	.07		TSH	TSH	.560	ZPSNM	57	H
4	49			TBP						TSH	TSH	.560	ZPSNM	59	H
4	49	.09	122	PID		2	TSH	.28		TSH	TSH	.560	ZPSNM	59	H
ROW	COL	VOLTS	DEG	IND	PER	CHN	LOCN	INCH1	INCH2	BEGT	ENDT	PDIA	PTYPE	CAL	L

X 3 TUBE STABILIZED AND PLUGGED  
IN THE HOT LEG AND PLUGGED IN  
THE COLD LEG DURING A1R10
