**Subject: Robins Air Force Base (RAFB) Report - Repair and
Refurbishment of C-141 Aircraft Counterweights, Contract
F09603-97-C-0435, 0003AA & 0003AB**

SCIENTIFIC AND TECHNICAL REPORT CONDITION ASSESSMENT/COST ANALYSIS REPORT

REPAIR AND REFURBISHMENT OF C-141

AIRCRAFT COUNTERWEIGHTS

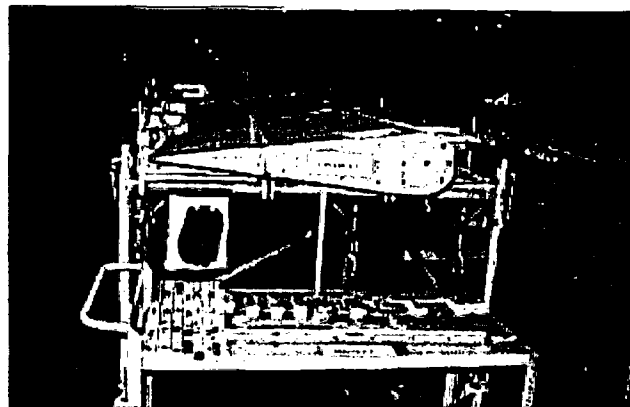
Figure 3, Counterweights Removed From Elevator

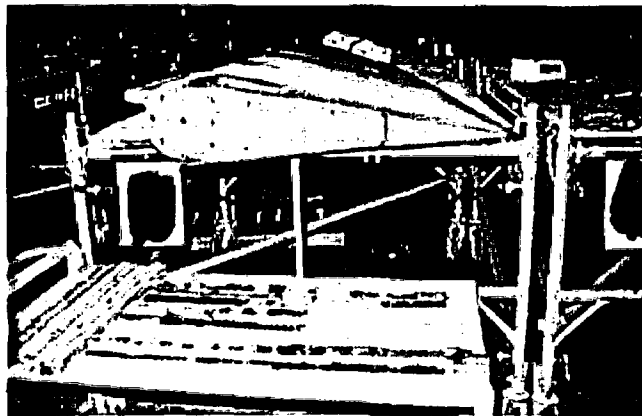
Figure 4, Counterweights Removed From Elevator

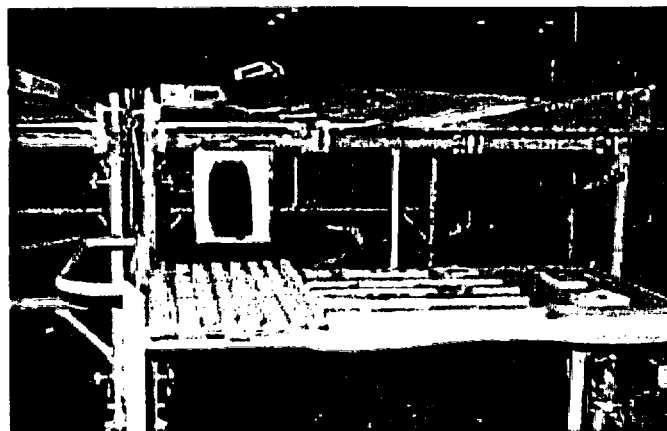
Figure 5, Counterweights Removed From Elevator

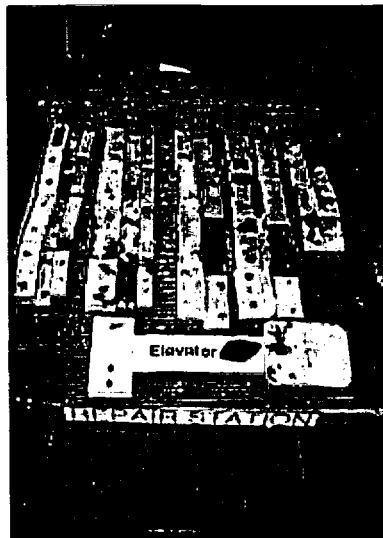
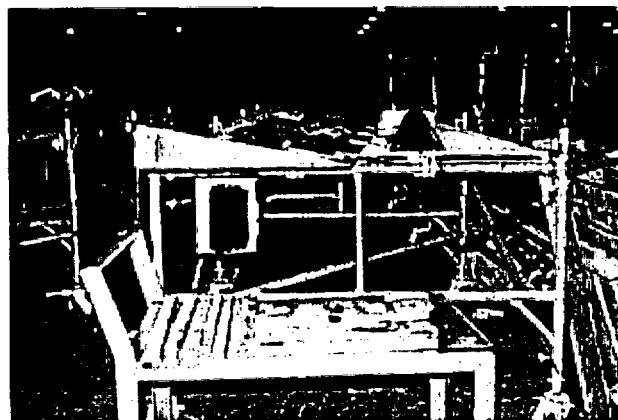
Figure 6, Counterweights Removed From Elevator

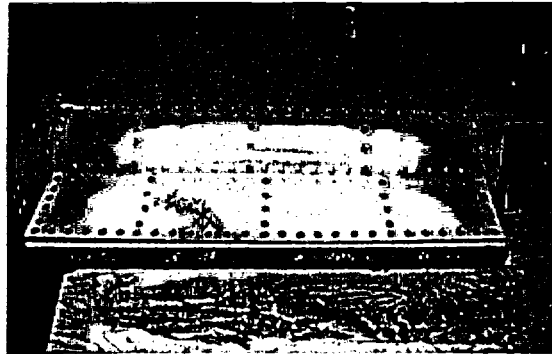
Figure 7, Elevator Cover Being Removed

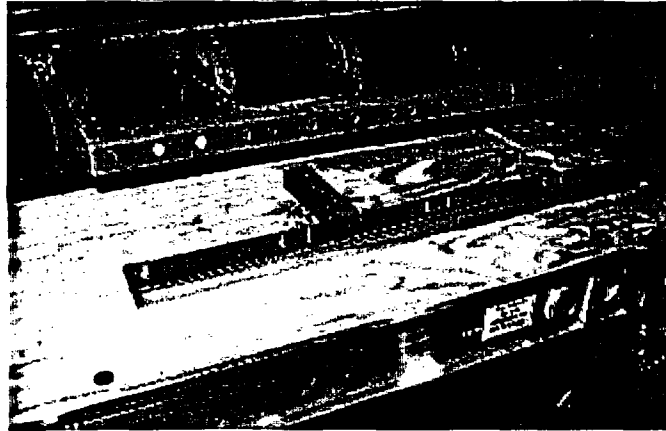
Figure 11, Photographs Taken During Installation of the
Elevator Counterweights

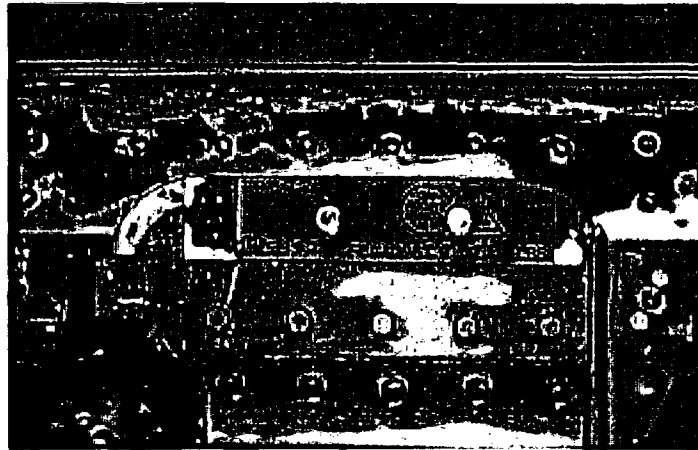
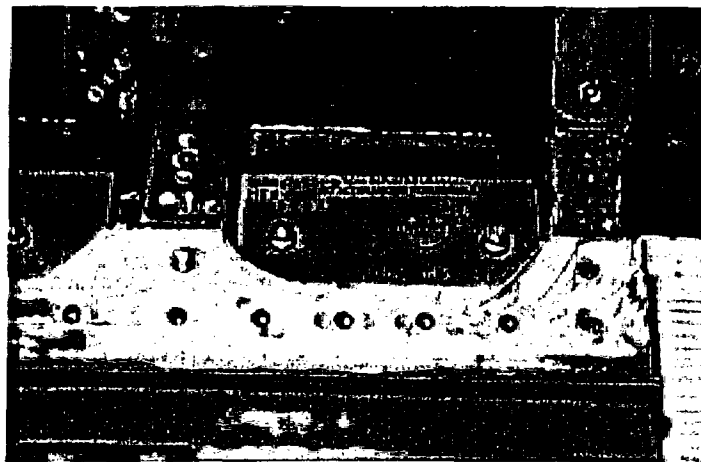
Figure 12, Closeup of Installed Elevator Counterweights

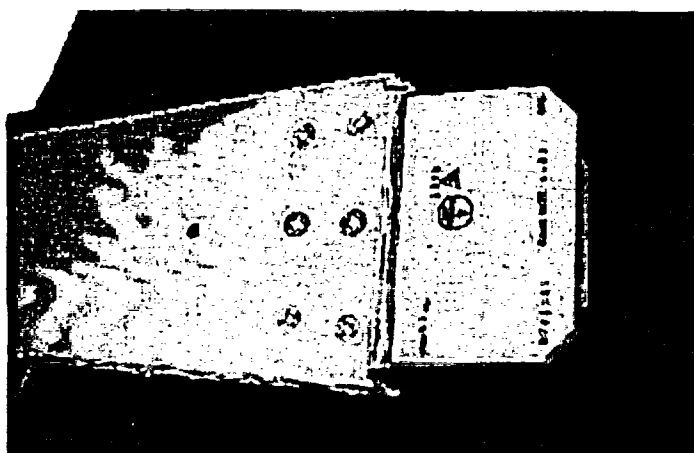
Figure 13, Photograph of Installed Counterweights
on End of Flight Control Surface
