PG&E Letter DCL-03-093

Docket No. 50-275, OL-DPR-80
Docket No. 50-323, OL-DPR-82
Diablo Canyon Units 1 and 2
Licensee Event Report 2-2003-007-00
Technical Specification TS 3.8.4 Violation Due To Common Mode Battery
Charger Failures

LICENSEE EVENT REPORT (LER)

Technical Specification TS 3.8.4 Violation Due To Common Mode Battery Charger Failures

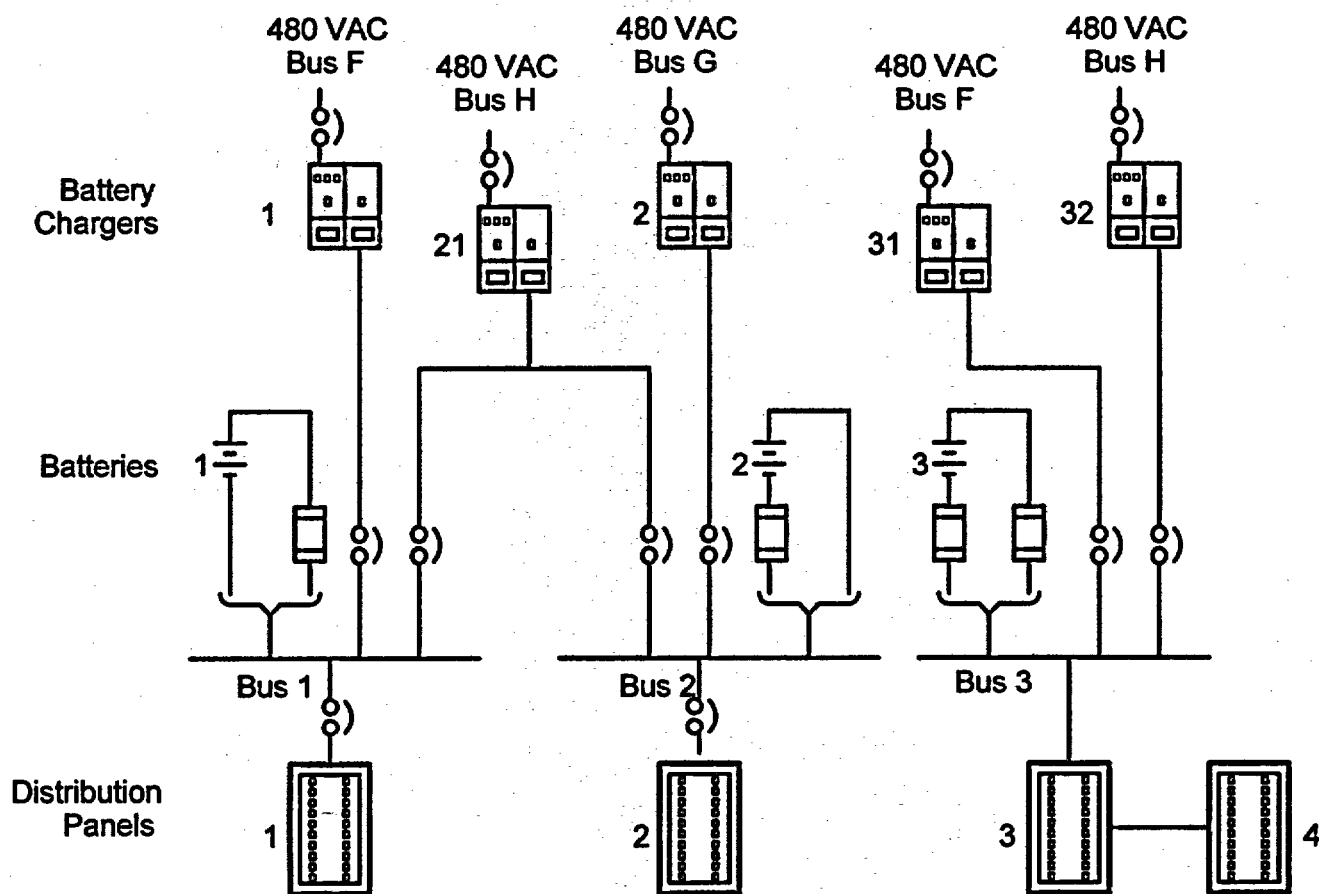
Figure 1 – Single Line Diagram of the 125 Volt DC Vital Power Supply System

Each Diablo Canyon Power Plant (DCPP) Unit has three 60 cell, 125 Volt DC (VDC) vital batteries and five full capacity battery chargers (BTCs). Each of the three vital 125 VDC busses has a dedicated battery and charger. The design of the vital 125 VDC system is such that a battery may be supplied by two full capacity chargers: one supplied from its associated 480 volt alternating current (480 VAC) vital bus, or an alternate charger supplied by another 480 VAC vital bus. The first additional charger can be switched to either of two of the batteries. The second charger is a redundant charger for the third vital battery. See Figure 1 – "Single Line Diagram of the 125 Volt DC Vital Power Supply System."
