Subject: Davis-Besse Nuclear Power Station
Transmittal of Final Report on Examination of the Reactor Vessel Head
Degradation, and Safety Significance Assessment Update

**EXAMINATION OF THE REACTOR VESSEL (RV) HEAD DEGRADATION
AT DAVIS-BESSE**

**BWX TECHNOLOGIES, INC.
BWXT SERVICES, INC.
REPORT 1140-025-02-24**

**IMPACT OF LABORATORY EXAMINATION RESULTS
ON THE
SAFETY SIGNIFICANCE ASSESSMENT
OF THE
DEGRADED REACTOR VESSEL HEAD**

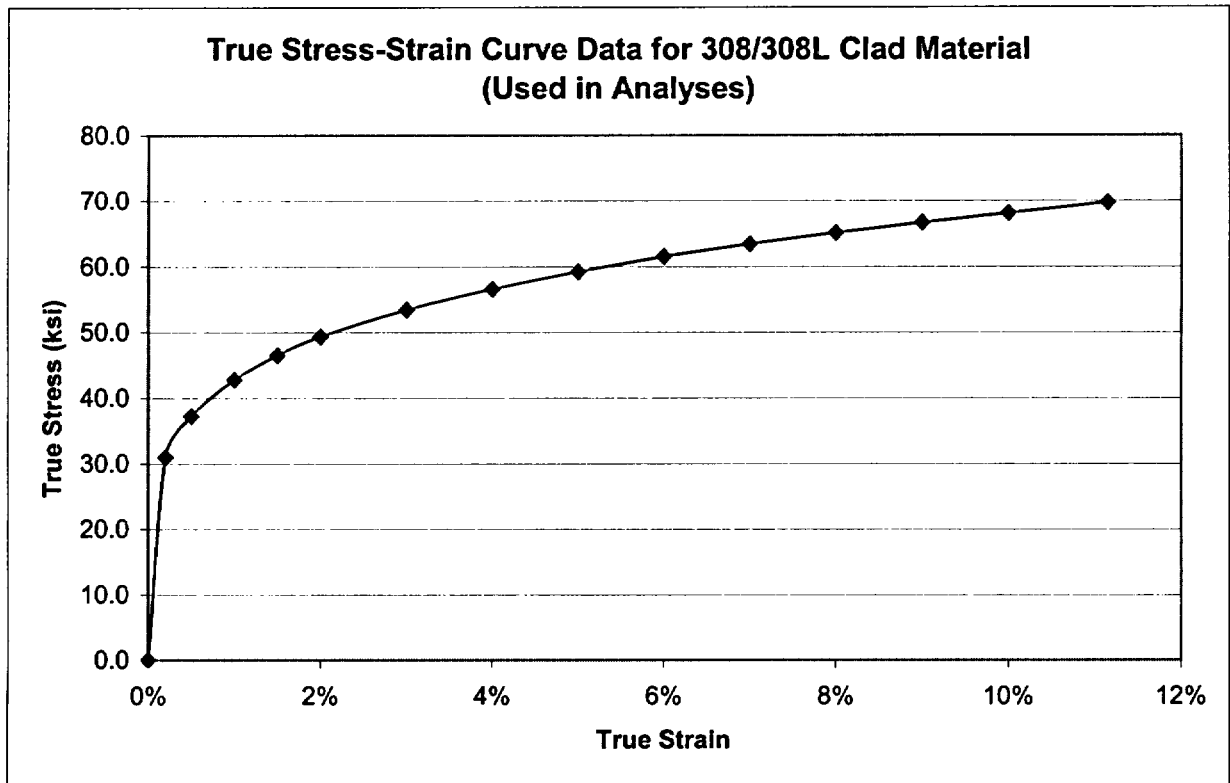
Figure 1. True Stress-Strain Curve for Stainless Steel Type 308/308L Clad Materials
Used in Analyses

- Two bounding clad thicknesses (0.297 and 0.125 inch) were considered in this evaluation. The evaluation assumed a defect-free cladding.
- A very conservative stress-strain curve was used in the evaluation. A plot of the stress-strain curve is shown in Figure 1.

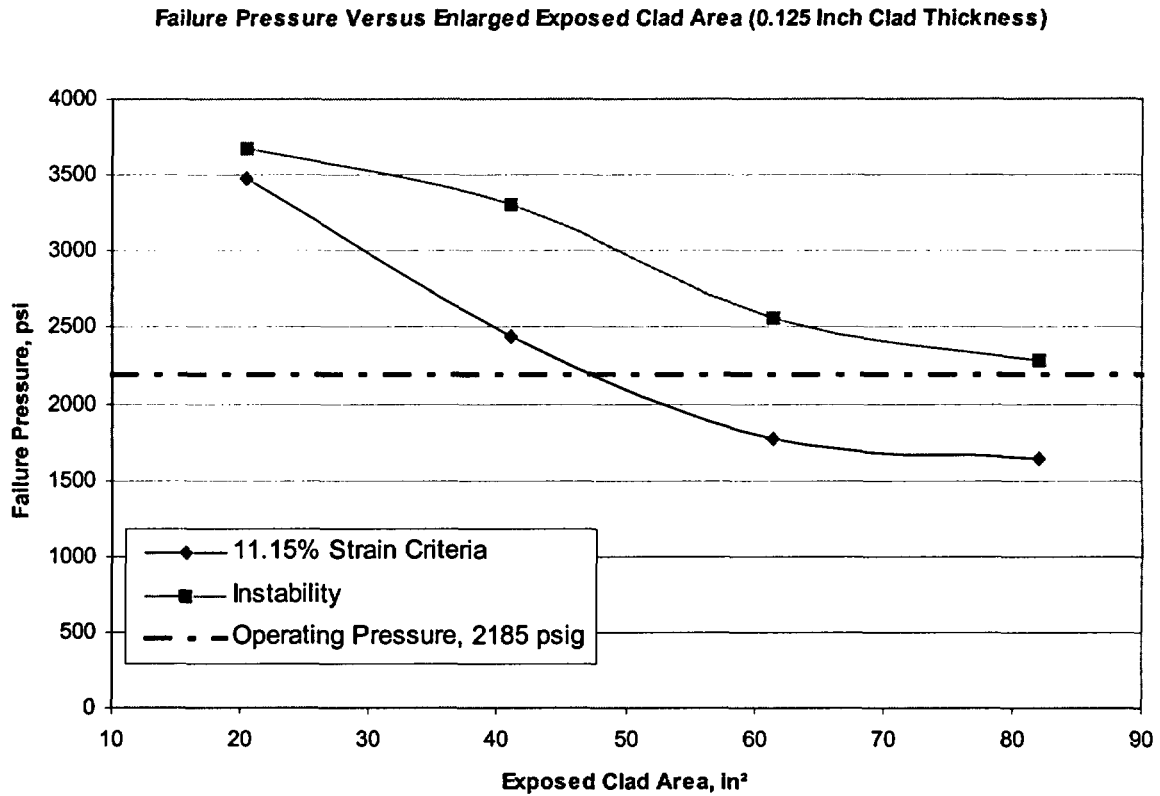
Figure 2. Failure Pressure Versus Cavity Exposed Area (Clad Thickness = 0.125 inches)

- The results of the evaluation are summarized in Figures 2 and 3 for the two clad thickness cases considered. As can be seen from these Figures, significant margins exist for the exposed cladding area of 20.5 square inches even for the cladding thickness of 0.125 inches regardless of the failure criterion used. As shown in Figures 2 and 3, two failure criteria were used in the analyses; one based on plastic instability and the other based on the maximum strain limited to 11.15%.

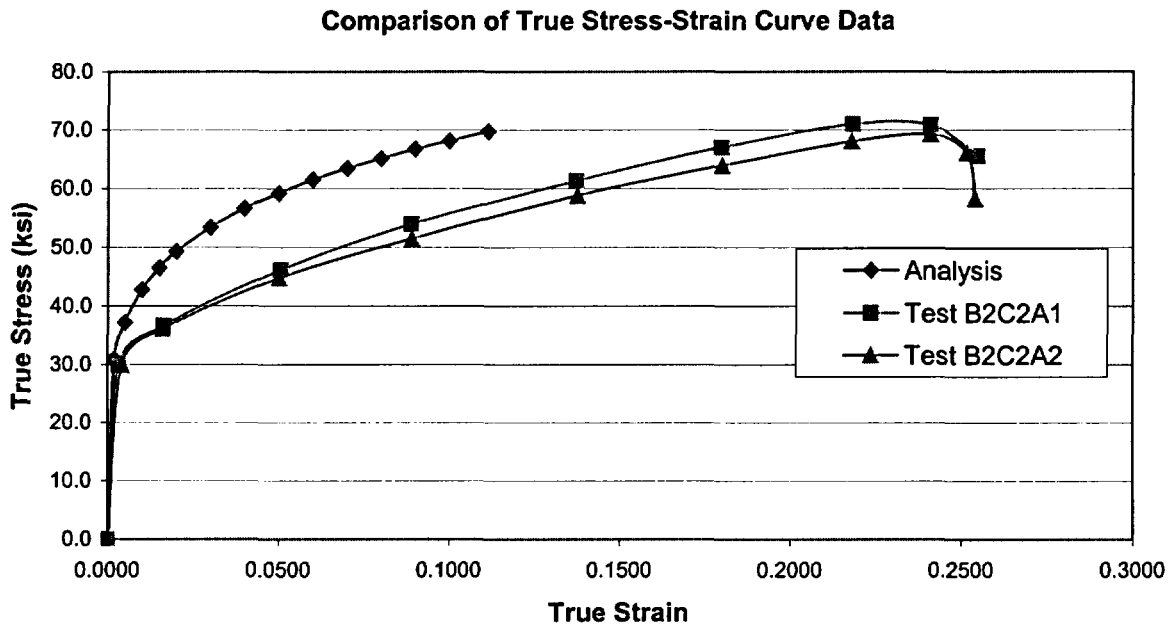
Figure 4. Comparison of Actual Stress-Strain Curve to That Used in the Analyses

- The actual exposed area of the cladding is approximately 16.5 sq. inches.
- The actual stress-strain curve of the cladding material is much tougher (measured by the area under the stress-strain curve) and more ductile (measured by the failure strain) than that used in the analysis. A comparison of the two curves is shown in Figure 4. It should be noted that the engineering stress-strain curves from Reference 4 have been converted to true stress-strain curves for the comparison in Figure 4.

- Because of the ductile nature of the actual cladding material as demonstrated by its high toughness and ductility, the cladding is expected to fail by net section plastic collapse. As such, the crack tip stress intensity factor is not of essence and only the remaining ligament of the cladding is critical to the determination of the failure pressure.
