BWX Technologies, Inc.

**EXAMINATION OF THE REACTOR VESSEL (RV) HEAD DEGRADATION
AT DAVIS-BESSE**

**PREPARED FOR
FRAMATOME ANP, INC.**

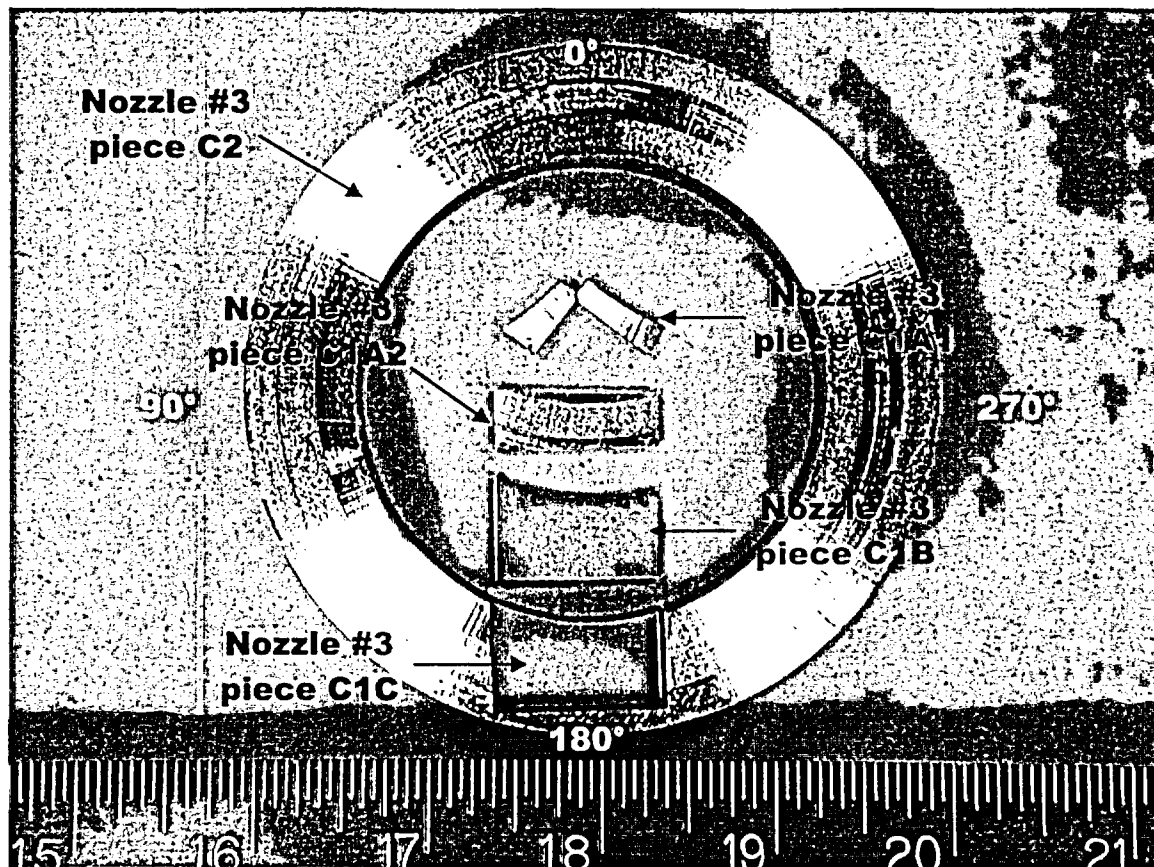
A fluorescent dye penetrant test was performed on the exposed surfaces of piece C. This test revealed several axial cracks present on the lower portion of the nozzle inner diameter (ID) surface near the 180° orientation (i.e., uphill side of nozzle opposite the cavity). Refer to Figure 2.4.1 for the results of this examination. The largest crack in this area extended approximately 0.5" in length axially and ~0.125" deep radially from the ID surface of the nozzle. No other indications were found. It is evident that all other cracks identified by on-site NDE were within the 4-1/2" section bored away during the CRDM nozzle removal process.

Figure 2.4.1: Photograph taken under a black light showing the PT results for nozzle #3. Several axial cracks were present near 180°; the largest crack extended ~0.5" in length axially and ~0.125" deep radially from the ID surface.

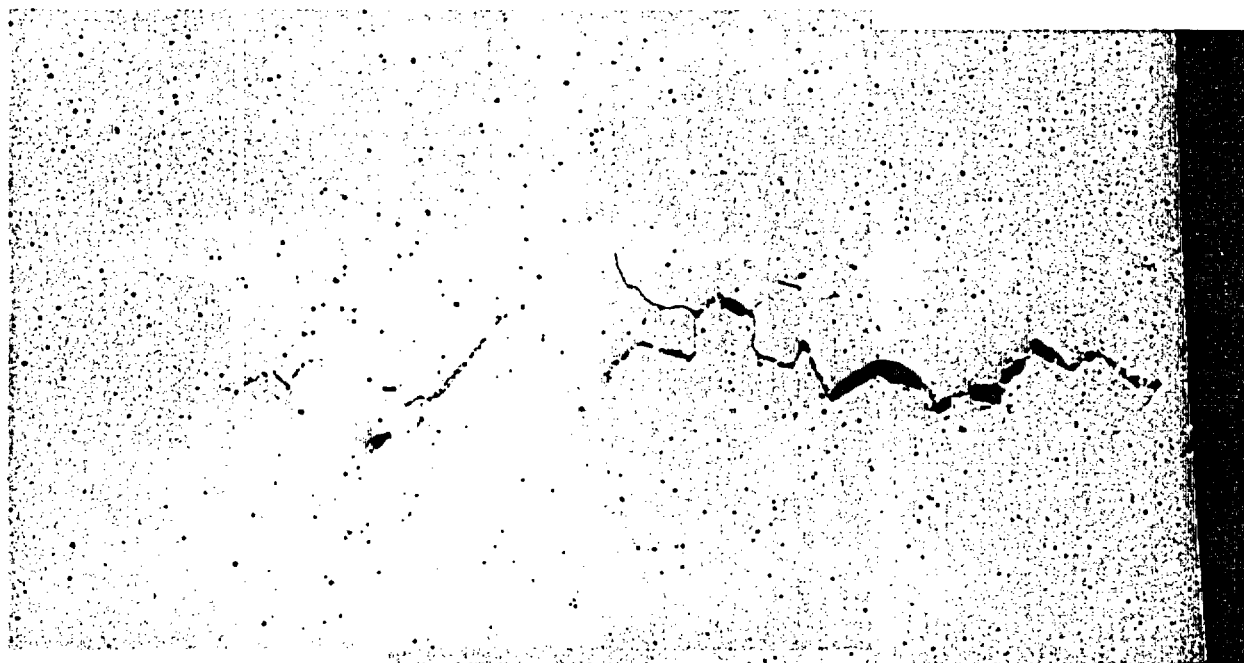
Figure 2.6.1 provides a low magnification photograph of the mounted sample C1B. In this photograph, the largest crack is visible near 180° along with the string of Knoop microhardness indents near 175°. The base material hardness was generally uniform across the nozzle wall in the area tested and ranged from HK 179.1 to 221.3 (refer to the table in Figure 2.6.1).

Figure 2.6.1: Low magnification photograph of the nozzle #3 C1B metallographic mount showing location of largest crack and Knoop microhardness indents (top) and microhardness results (bottom).

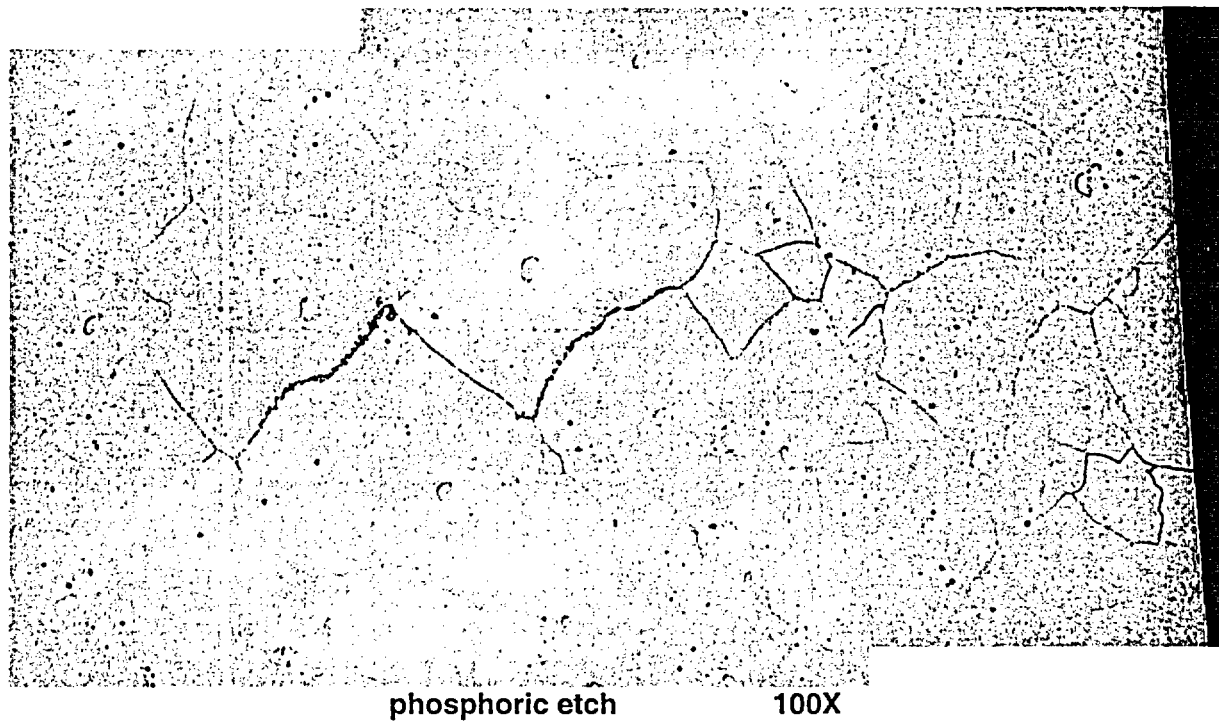
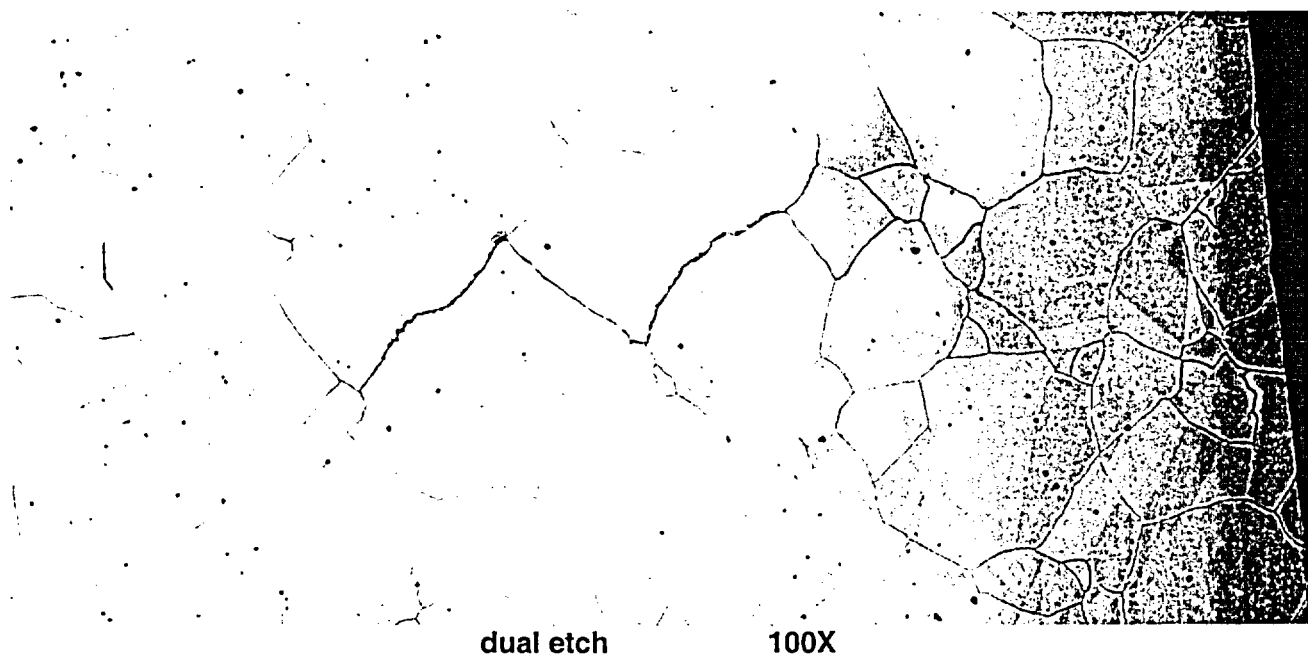
Figure 2.6.2 provides higher magnification micrographs of the largest crack at 180°, which extended approximately 0.1" below the nozzle ID surface. The crack path is clearly intergranular in nature. The same crack morphology was observed for a smaller crack located near 170° (Figure 2.6.3). This crack extended approximately 0.05" below the nozzle ID surface. Micrographs showing the typical appearance of the nozzle base material microstructure are provided in Figure 2.6.4 (100X) and Figure 2.6.5 (375X). The microstructure consisted of equiaxed grains ranging in size from ASTM 1 to 6, with an average size of ASTM 3. Also observed throughout the microstructure were titanium or niobium carbonitrides (large yellow-to-orange color particles in Figure 2.6.6) and a semi-continuous to discontinuous network of grain boundary carbides.

Figure 2.6.2: Micrographs showing the intergranular nature of the largest crack near 180°. The crack extended approximately 0.1" below the nozzle ID surface (located to the right in these micrographs).

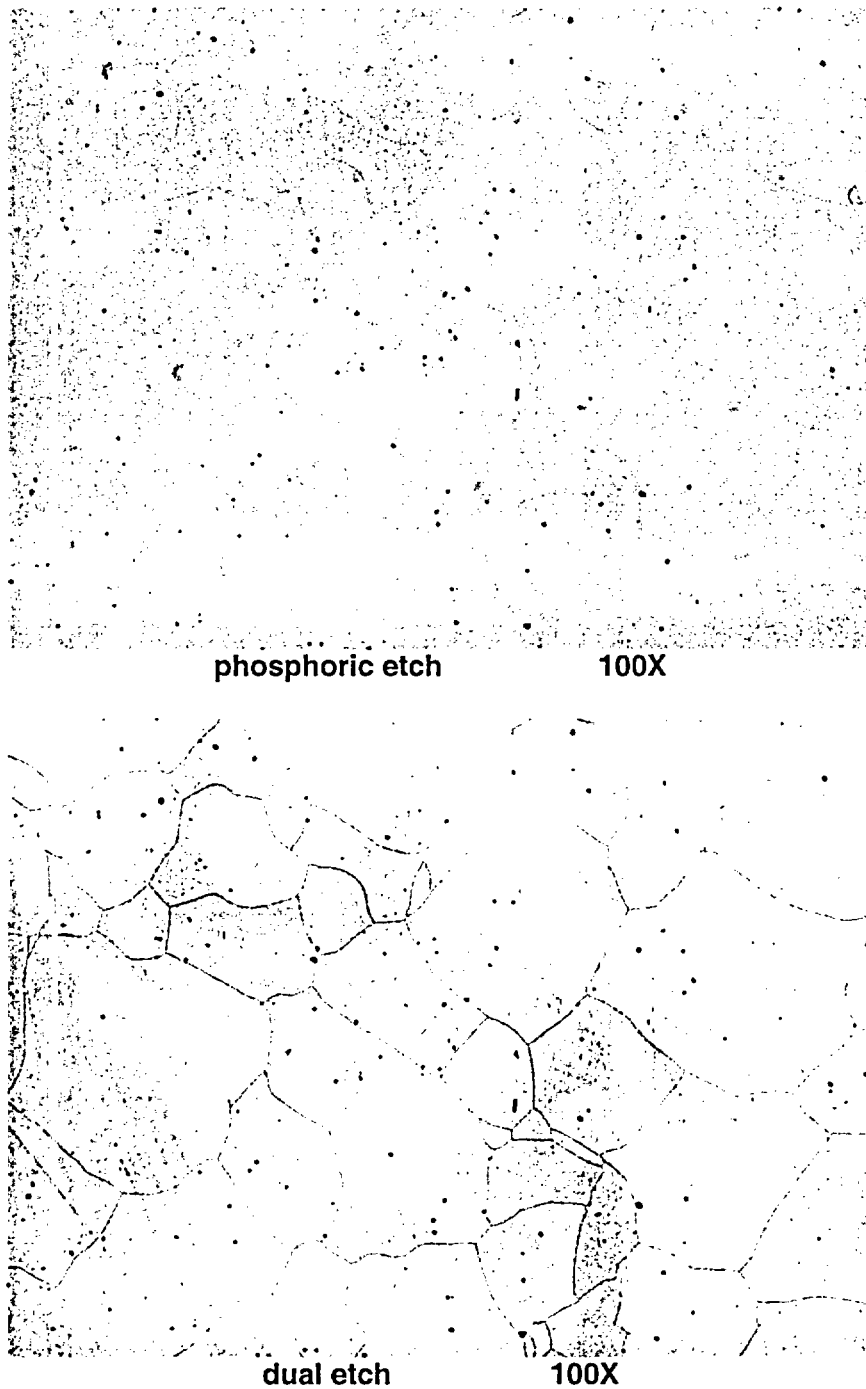
Figure 2.6.3: Micrograph showing the intergranular nature of a smaller nozzle crack located near 170°. This crack penetrated approximately 0.05" below the nozzle ID surface (located to the right in these micrographs).

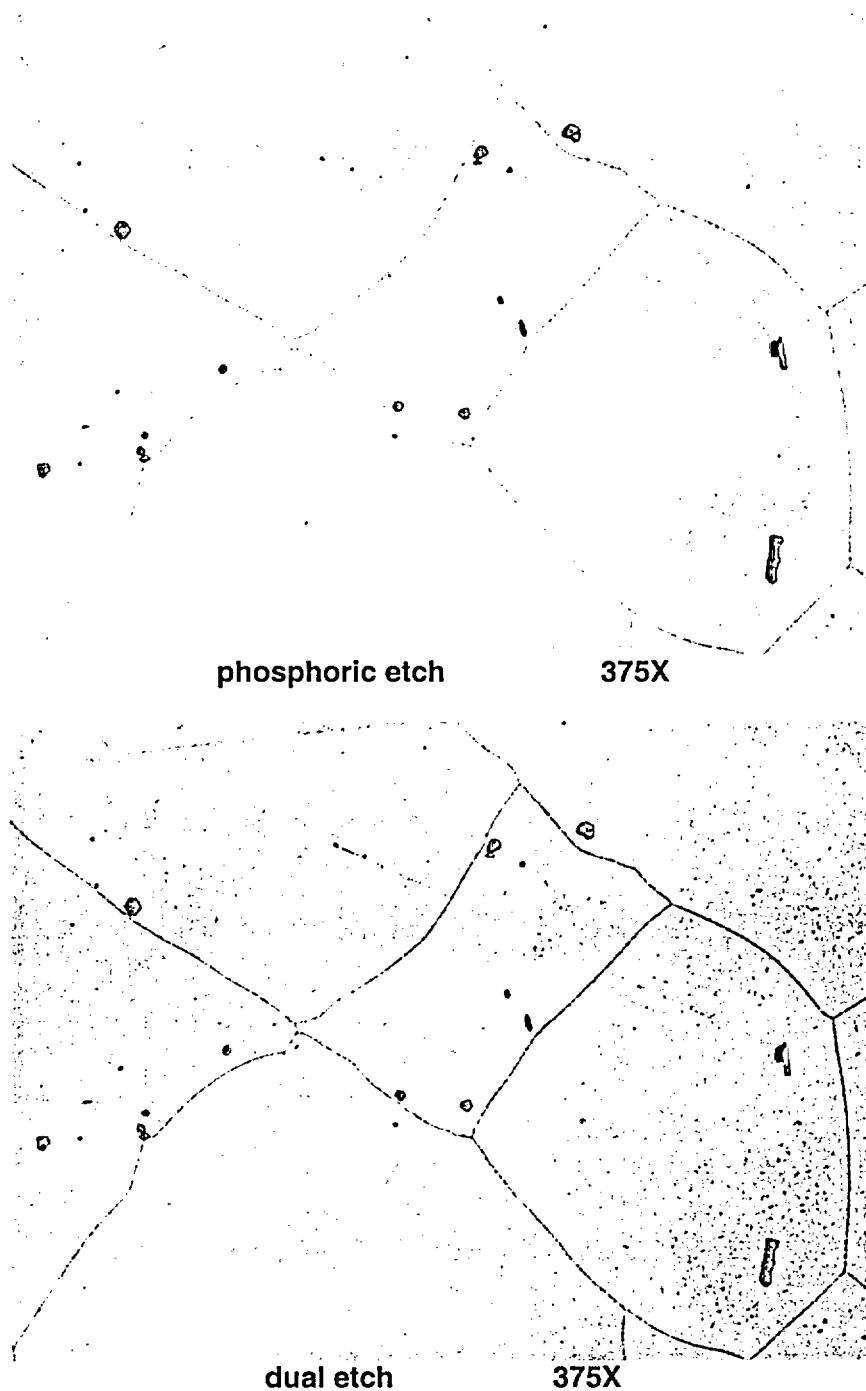
Figure 2.6.4: Typical micrographs of the nozzle base material. The grain size ranged from ASTM 1-6 and averaged ASTM 3.

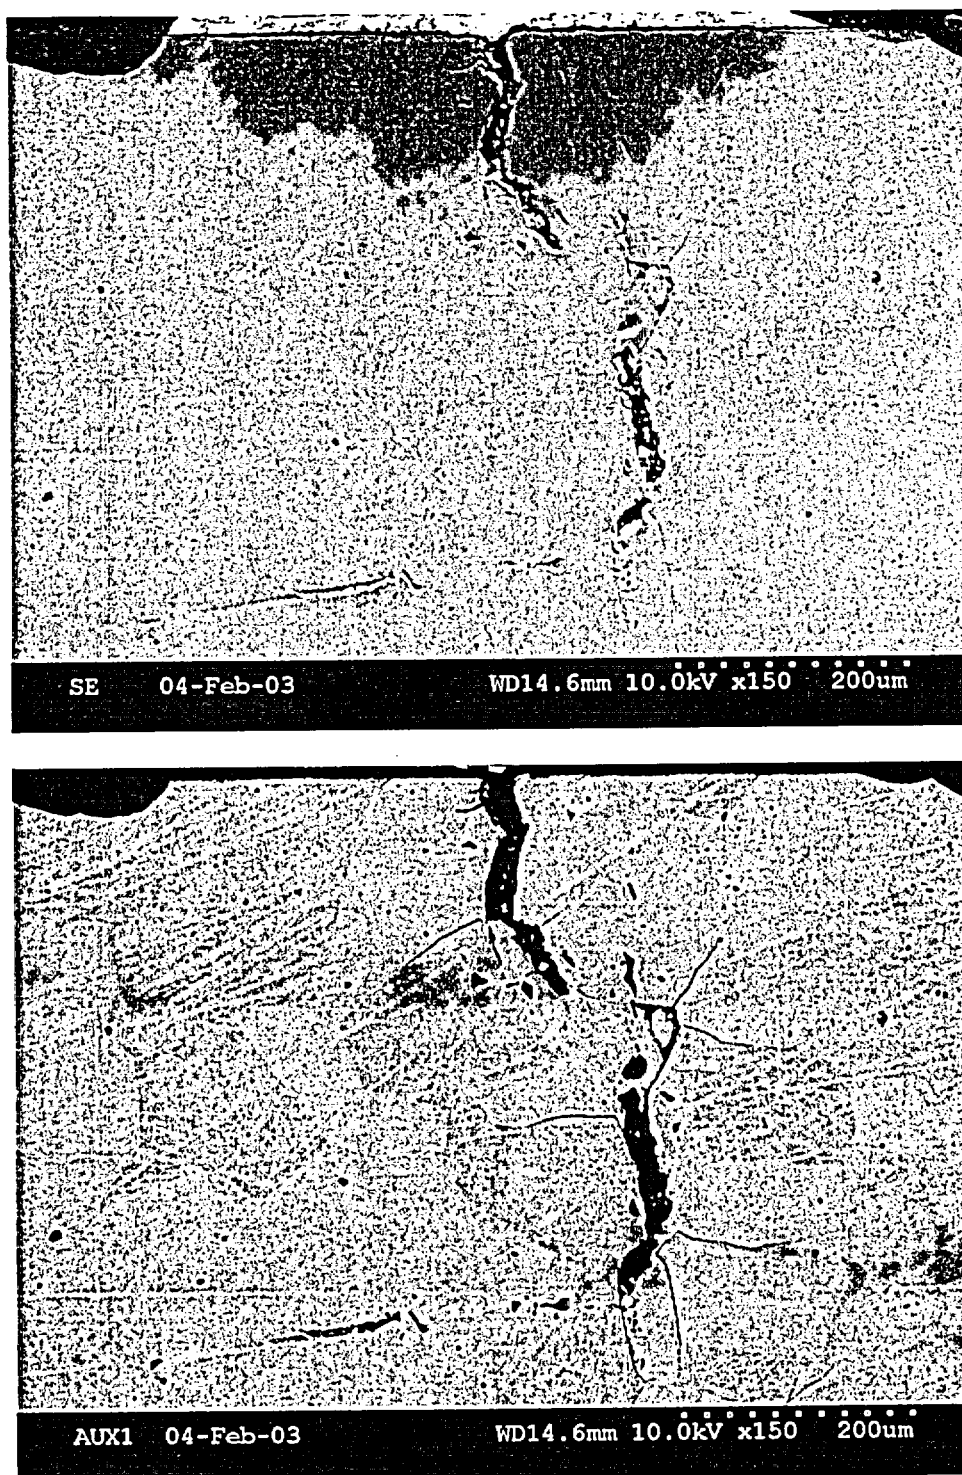
Figure 2.6.6: Higher magnification micrographs showing the discontinuous nature of the carbides at the grain boundaries.

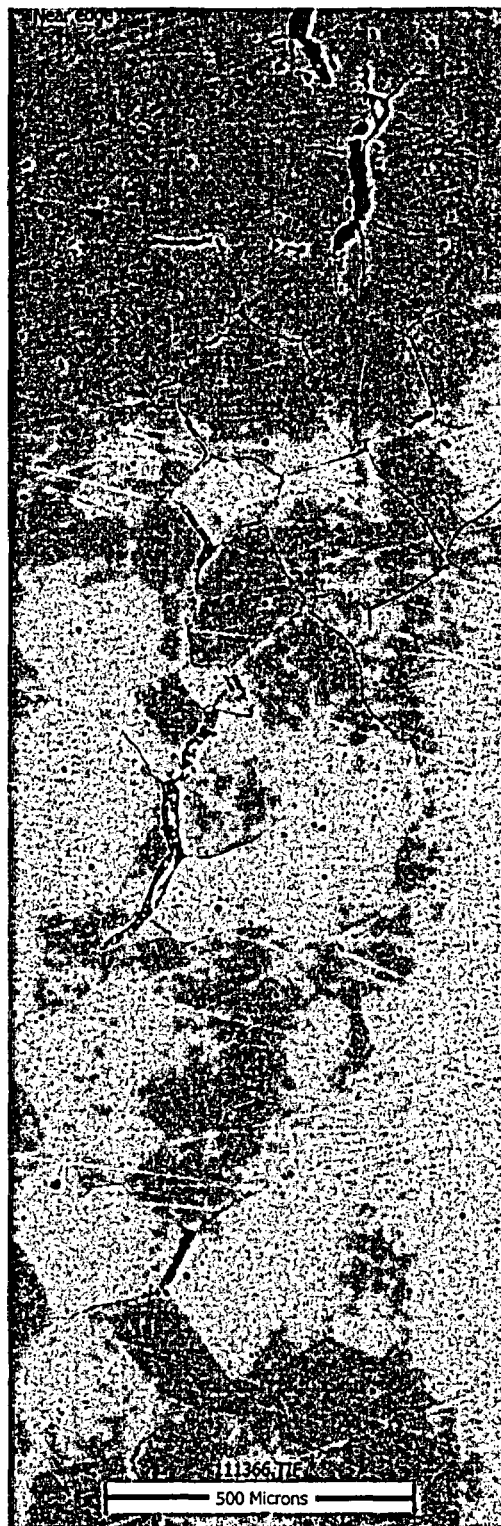
Figure 2.7.2: Mosaic showing full crack length (BSE), which was approximately 0.08" below the ID surface. Cracking was intergranular. ~82X

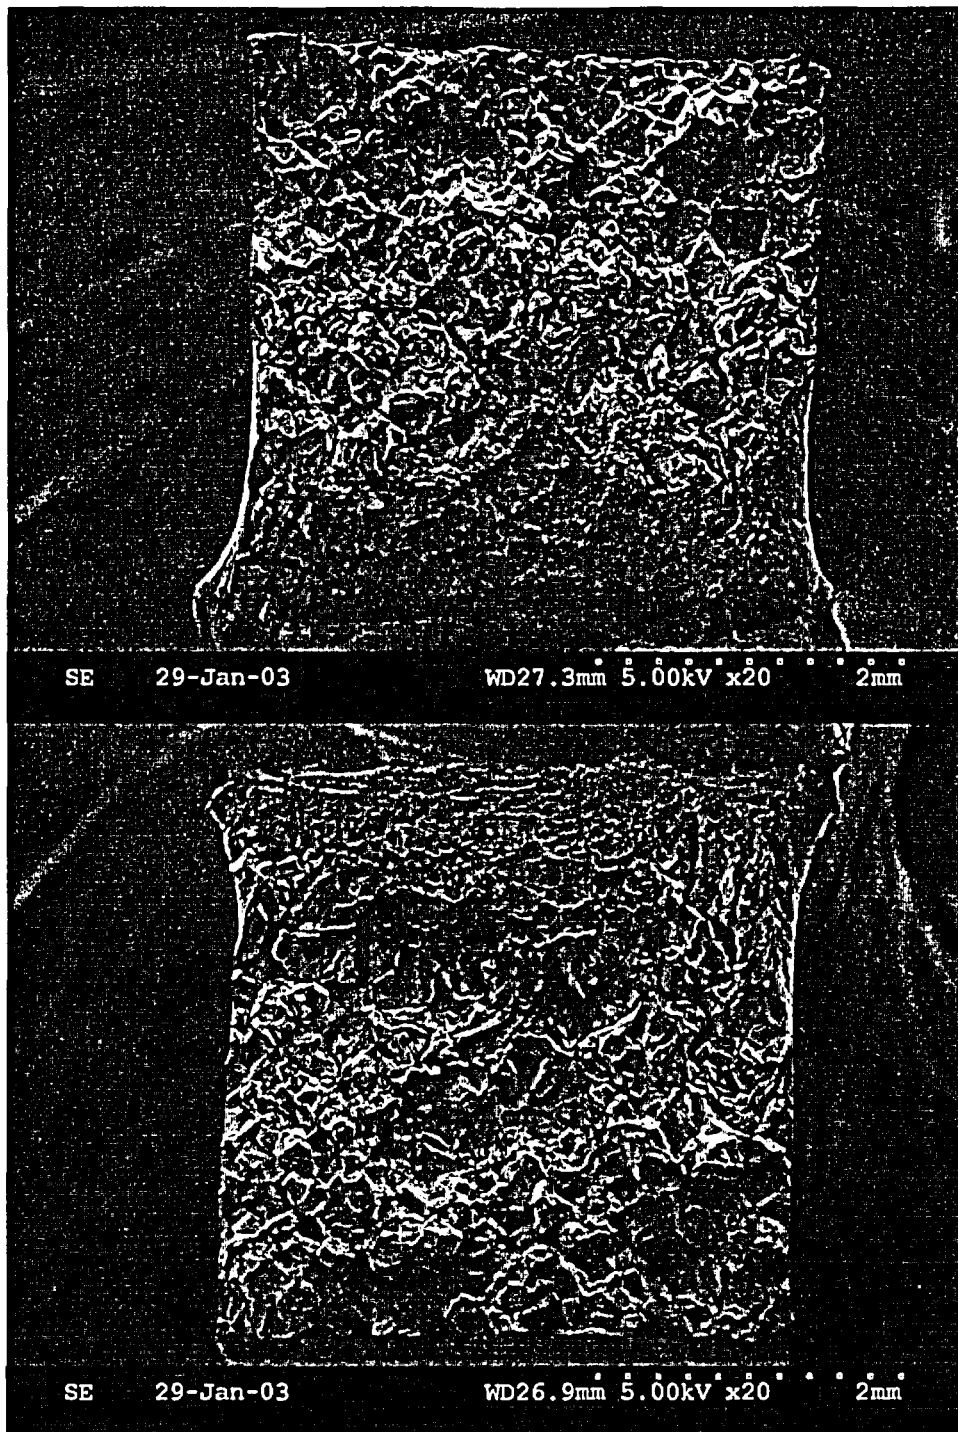
The lower portion of the largest crack was opened up for SEM/EDS examinations. Low magnification micrographs taken in the SE and BSE imaging modes are presented in Figures 2.7.6 and 2.7.7, respectively. The in-service cracking was intergranular and extended approximately 0.12" maximum below the nozzle ID surface. In the BSE imaging mode, the in-service fracture surface exhibited a darker contrast compared to the laboratory fracture, which is indicative of an oxide layer (i.e., lower atomic number) on the in-service fracture surface. SE micrographs showing the typical appearance of the fracture surface near the nozzle ID surface and toward the crack tip are provided in Figure 2.7.8. The intergranular grain facet selected for EDS analysis is shown in Figure 2.7.9 along with the EDS spectrum. In this area, the grain boundary layer contained carbon, oxygen, aluminum, silicon, chromium, iron, and nickel, along with a trace amount of titanium.

Figure 2.7.6: SE images of two halves of nozzle open crack sample. In-service cracking was intergranular in nature and extended a maximum ~0.12" deep. The laboratory fracture was ductile. 20X

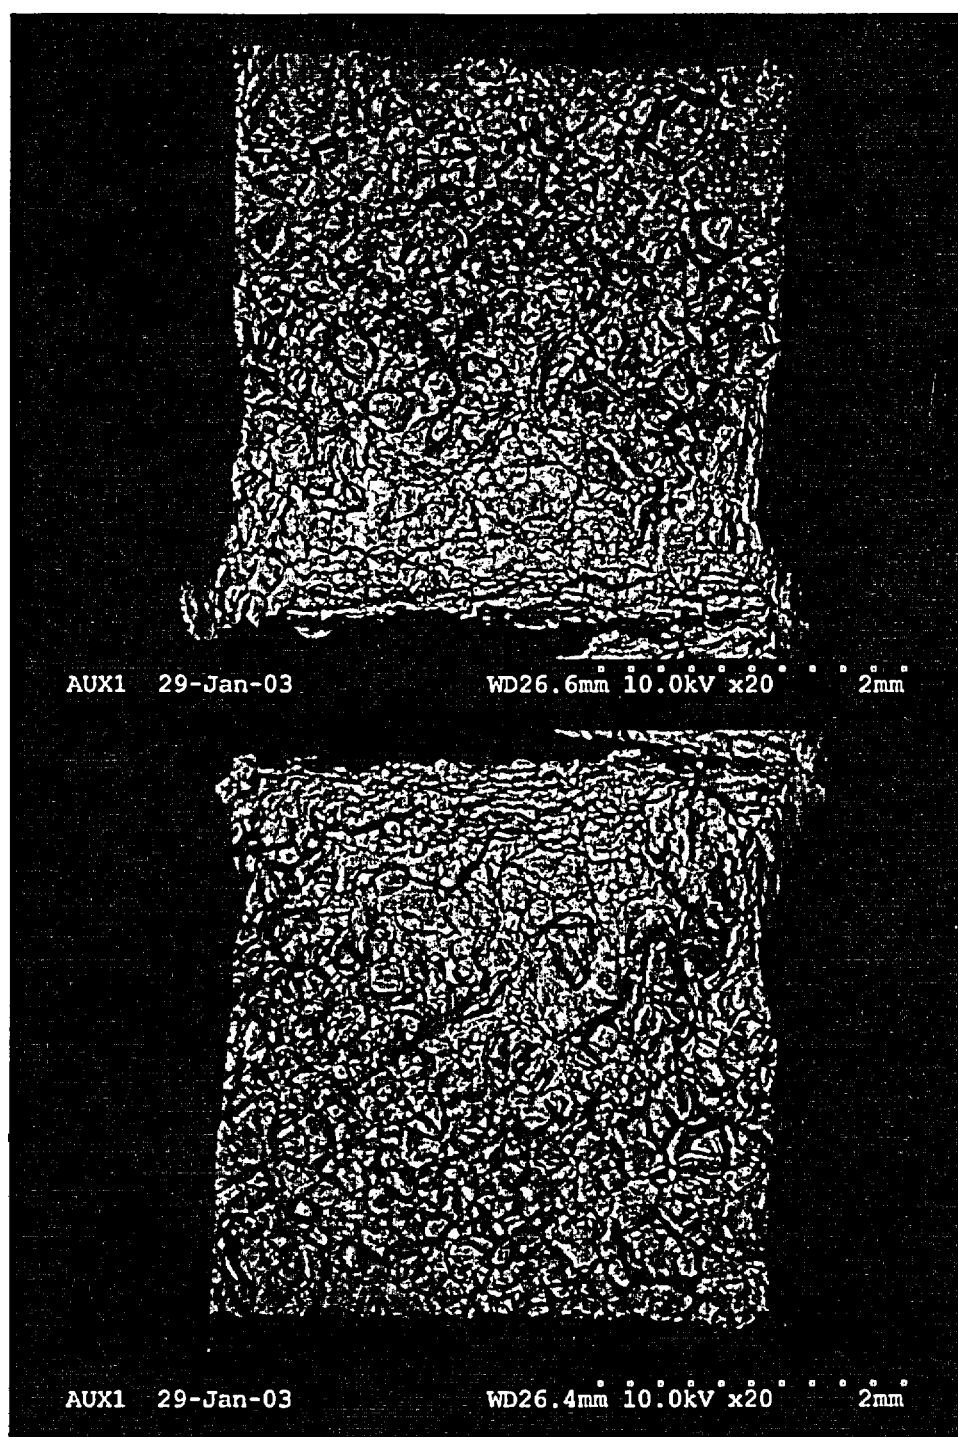
Figure 2.7.7: BSE images of two halves of nozzle open crack sample. The darker contrast of the in-service crack indicates the presence of an oxide layer (lab fracture is fresher) 20X

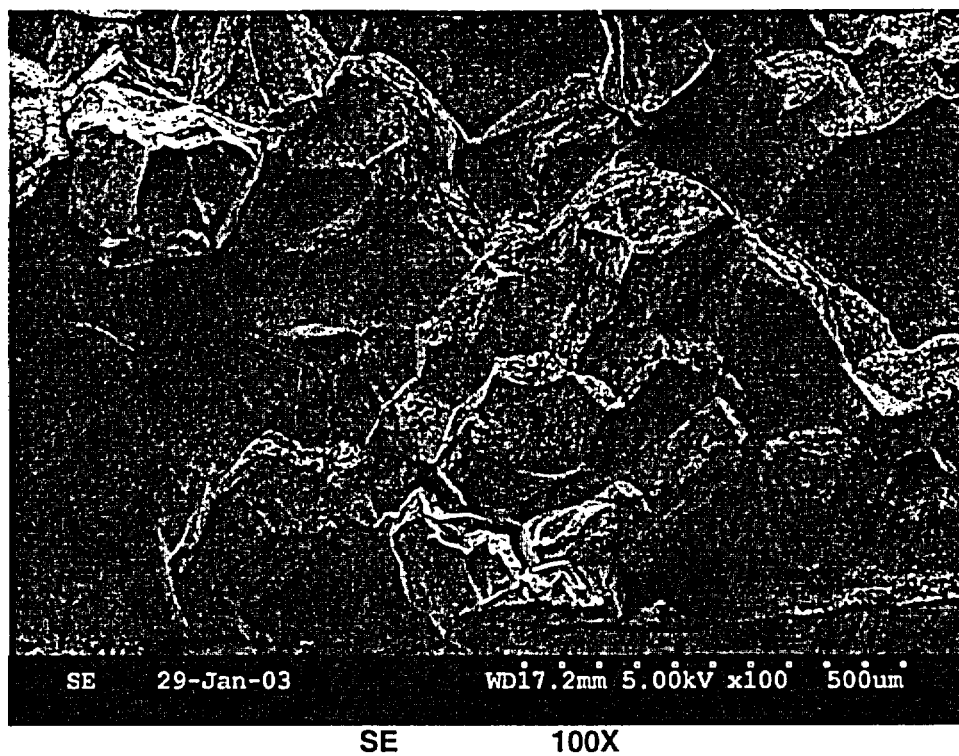
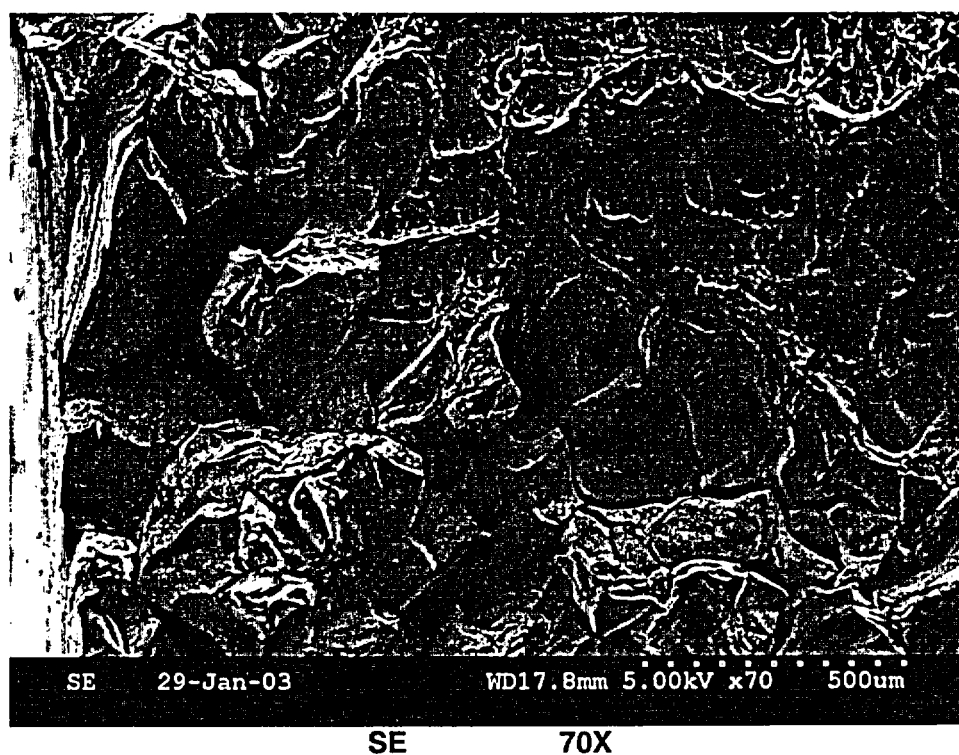
Figure 2.7.8: Micrographs showing typical intergranular appearance of in-service crack (top-near ID; bottom-at crack tip).

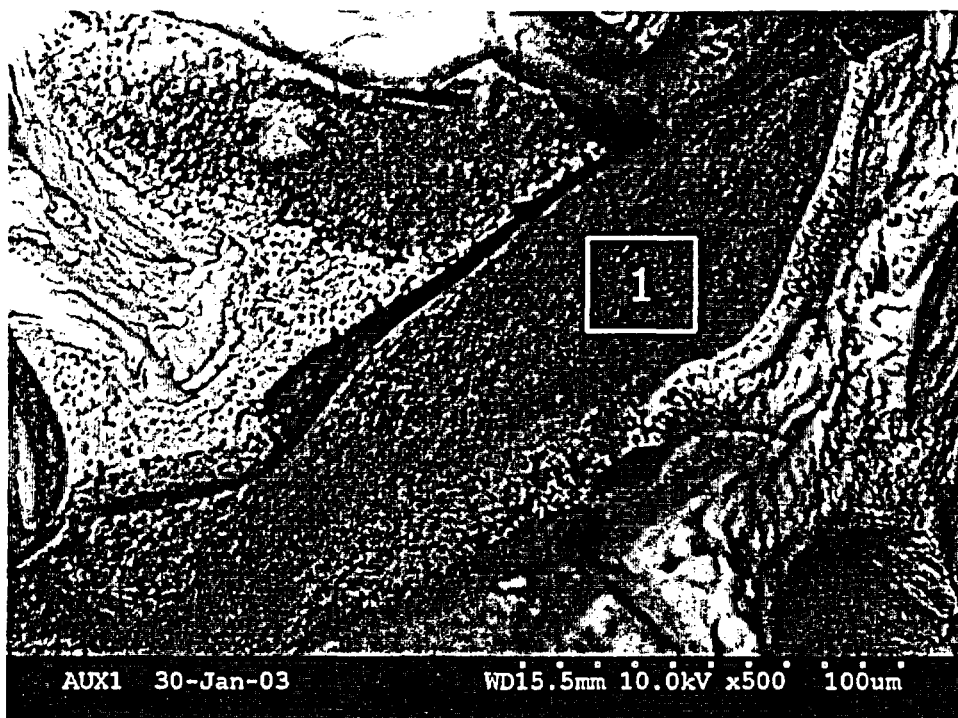
Figure 2.7.9: EDS spectrum collected from area 1 above. This area contained carbon, oxygen, aluminum, silicon, chromium, iron, and nickel, along with a trace amount of titanium.

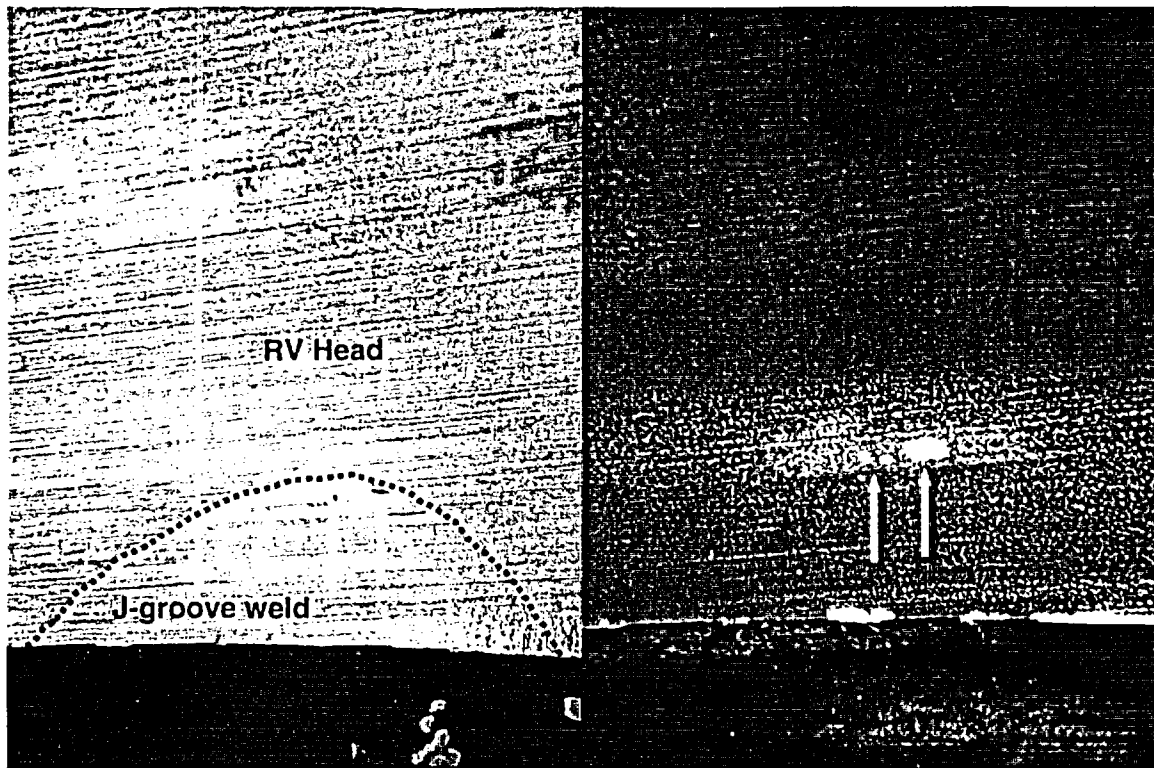
Fluorescent dye penetrant tests were conducted on the cut surfaces of cuts #1, #2, and #3 to characterize the bondline between the stainless steel cladding and the RV head. No evidence of disbond was noted in any of the areas examined. A few small voids were noted in the nozzle #11 J-groove weld adjacent to the low alloy steel RV head on the cut #3 surface (Figure 3.4.1).

Figure 3.4.1: PT results for cut #3. A small weld void was present near the root of the nozzle #11 J-groove weld. Normal photo is on the left, black light photo on right. There was no evidence of cladding disbond noted on any of the cut faces examined. ~1X

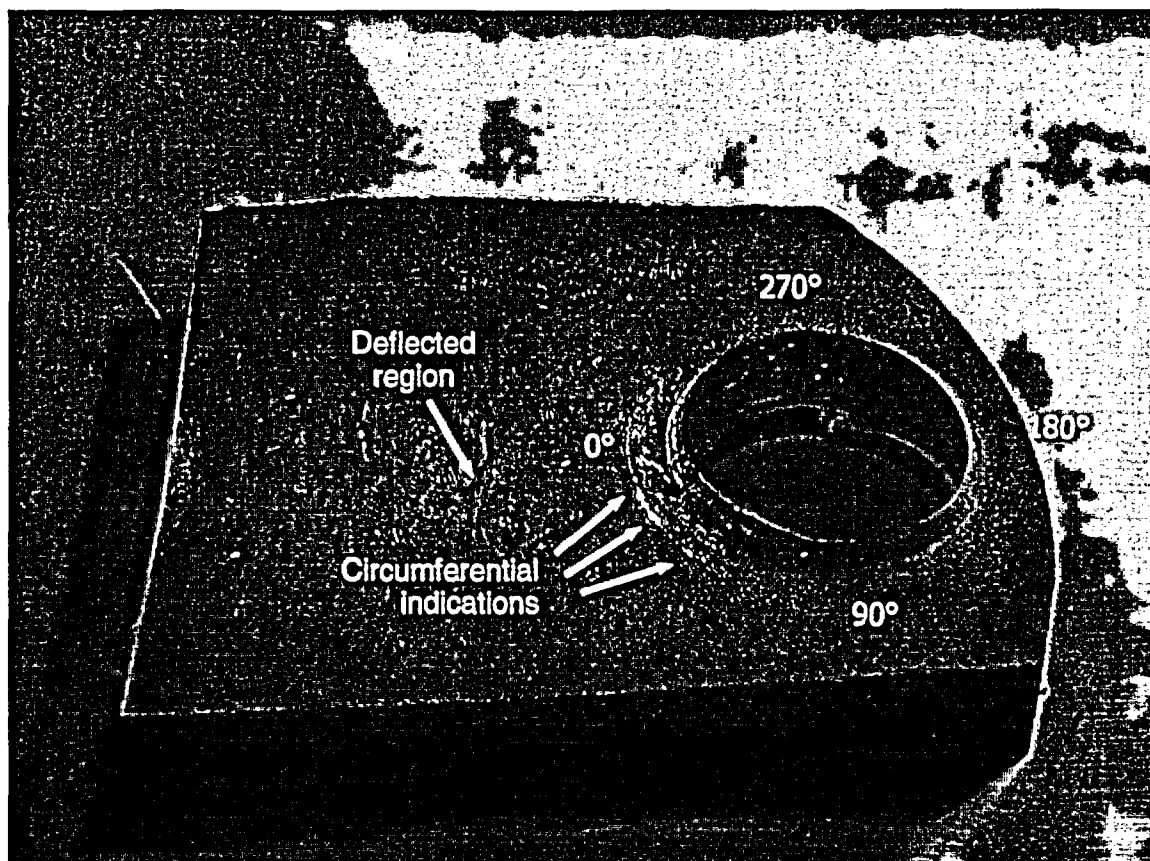
A penetrant test was also performed on the RCS side of the cladding below the cavity. The results, shown in Figure 3.4.2, indicated no evidence of cracking in the deflected region below the cavity. A discontinuous string of short circumferential indications was observed on the nozzle #3 J-groove weld surface approximately 0.75" from the nozzle #3 bore. These indications were located from 0° to 45°. No other indications were observed on the RCS side of the stainless cladding and nozzle #3 J-groove weld.

Figure 3.4.2: Circumferential indications on RCS side of cladding from ~0° to 45°. No indications were present in the upward-deflected region of the cladding.

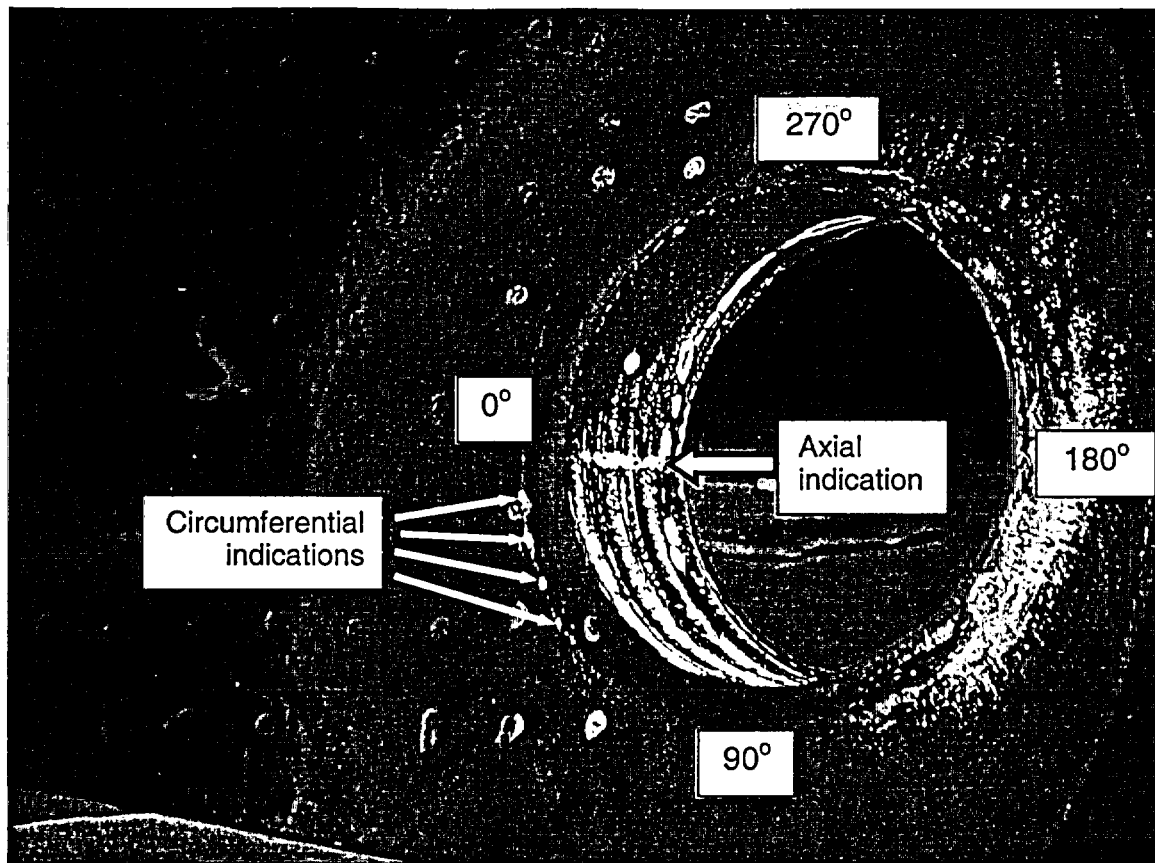
The penetrant results for the nozzle #3 bore are shown Figure 3.4.3. A large axial crack was noted in the nozzle #3 bore near the 10° orientation. The 10° orientation was in line with the farthest extent, or nose, of the cavity. Figure 3.4.4 shows the nozzle #3 J-groove weld looking from the top of the RV head. The axial crack near 10° is visible on the top

Figure 3.4.3: PT results for nozzle #3 J-groove weld bore and cladding underside. The J-groove weld contained an axial indication near 10° on the bore ID and circumferential indications on the RCS side from ~20° to ~45°.

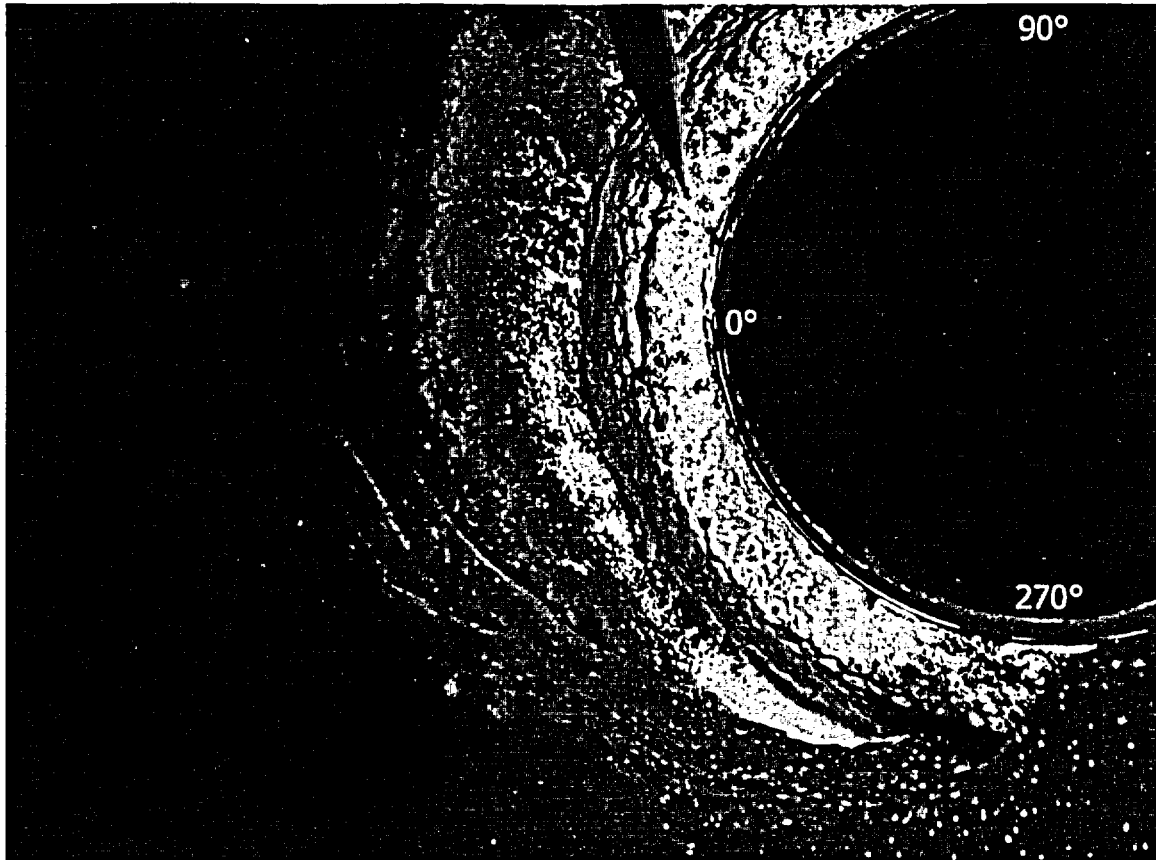
surface of the J-groove weld, which indicated that the cracking extended completely through the J-groove weld.

Figure 3.4.4: PT results for upper surface of exposed J-groove weld. The axial crack is visible near 10° (rough weld texture produced high PT background).

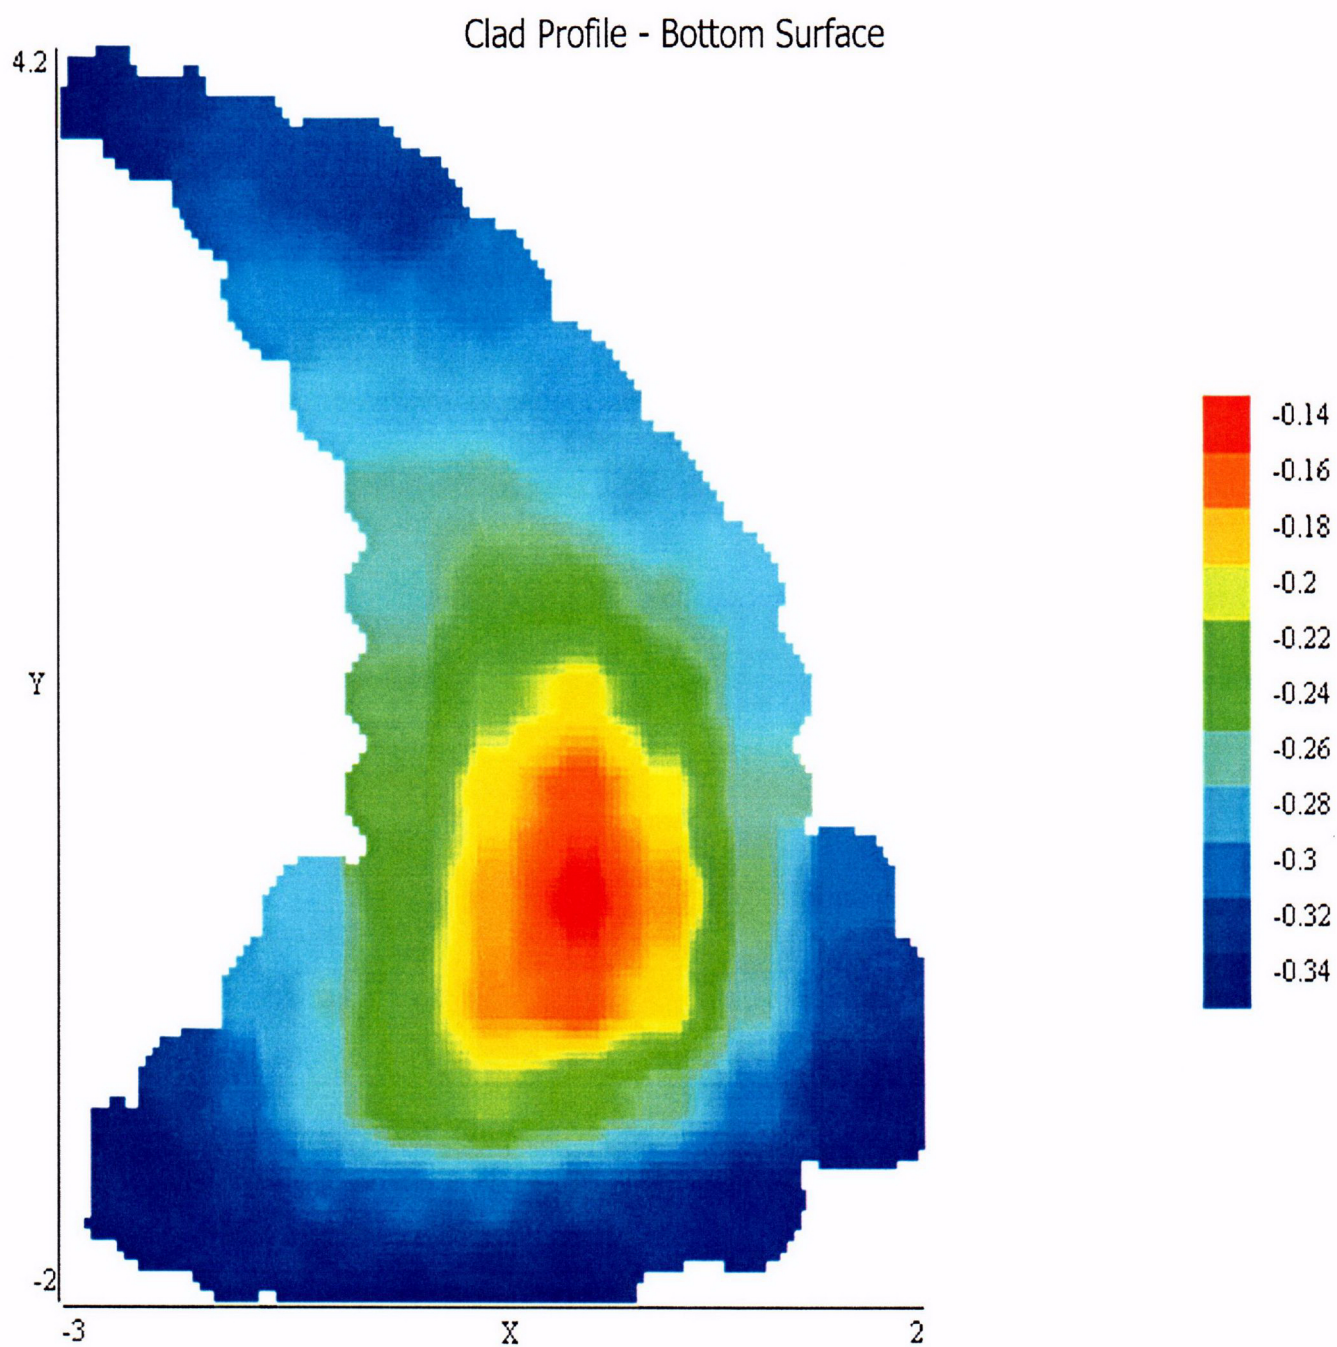
Figure 3.5.7: Exposed cladding surface with superimposed colorized thickness data. The thinnest areas of cladding occurred adjacent to the J-groove weld toward the 90° (0.202") and 270° (0.208") locations.

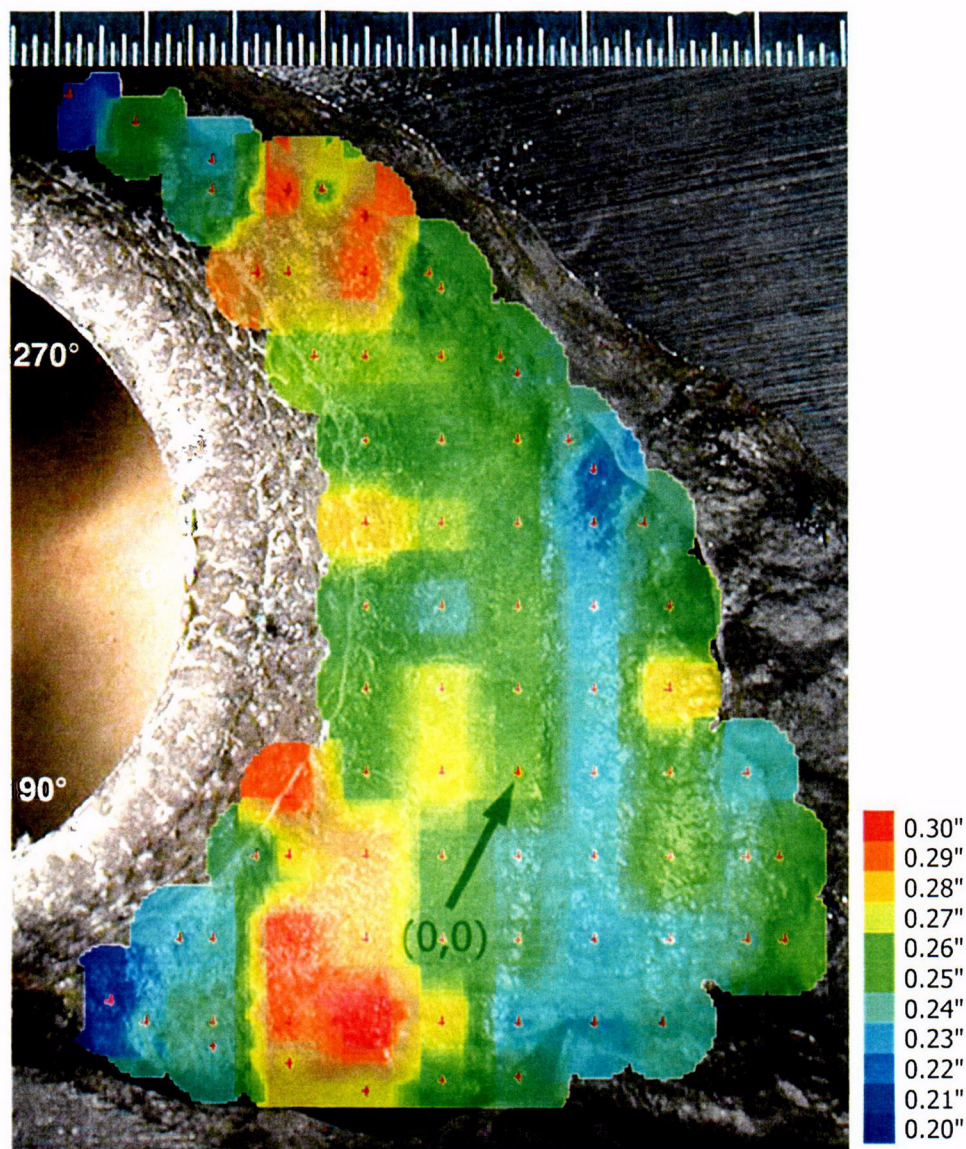
Higher magnification inspections were performed on the exposed cladding after the thickness measurements were complete. Figure 3.6.1 shows the cracking present in the exposed cladding surface. The most pronounced cracking occurred between two cladding weld beads. A higher magnification montage showing the extent of cladding cracking is provided in Figure 3.6.2. Several fine cracks were noted both above (toward 270°) and below (toward 90°) the main cracking. Higher magnification photographs of the main cracks are provided in Figure 3.6.3 and 3.6.4.

Figure 3.6.1: Photograph showing crack in exposed cladding in deflected region. Red dot indicates (0, 0) coordinates for thickness measurements.
