BWX Technologies, Inc.

**EXAMINATION OF THE REACTOR VESSEL (RV) HEAD DEGRADATION
AT DAVIS-BESSE**

**PREPARED FOR
FRAMATOME ANP, INC.**

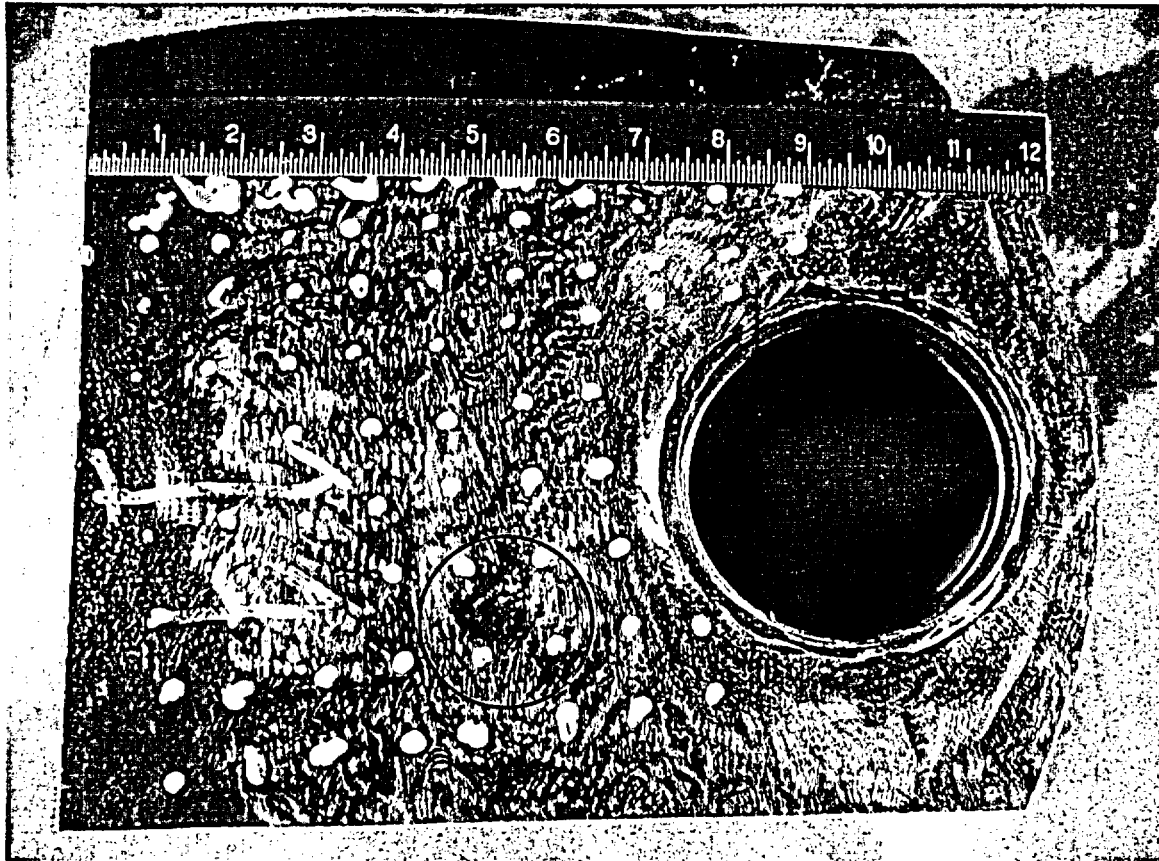
The RCS side of the cladding is shown at low magnification in Figure 3.6.5. The red circle in this figure delineates the deflected portion of the exposed cladding, which is shown at higher magnification in Figure 3.6.6. No cracks were observed on the RCS side of the cladding in the deflected region.

Figure 3.6.5: Low magnification photograph of the cavity underside. The red circle shows the area of maximum deflection. The white dots were applied at Davis-Besse for the UT thickness measurements. The two parallel lines toward the left indicate the Nozzle 11 position, which is outside the photo on the left. This maximum bulging area is shown at higher magnification in the next figure.

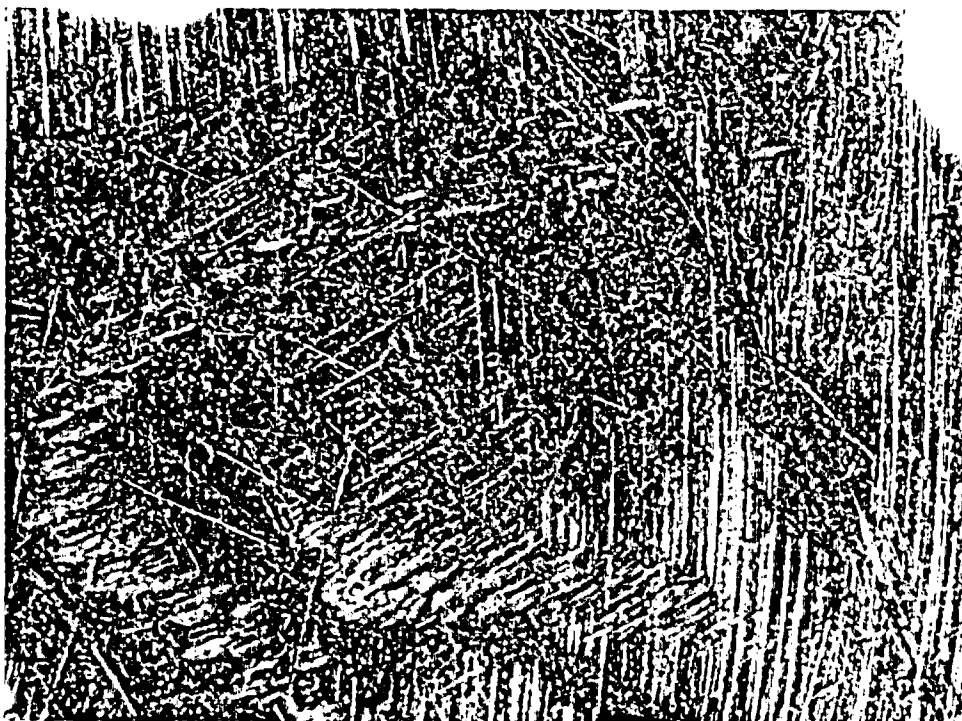
Figure 3.6.6: Higher magnification photographs of cavity underside in area of maximum deflection. No cracks were observed in this area.

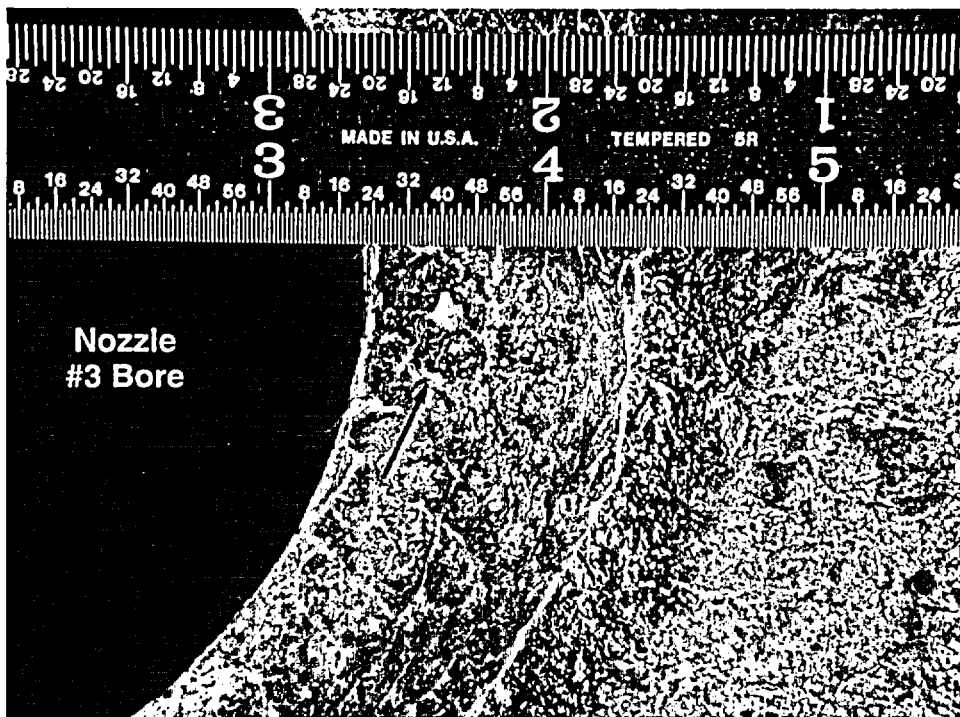
The nozzle #3 J-groove weld bore near the 10° (downhill side) is shown in Figure 3.6.7. These photos show the extent of the axial cracking at 10°. Looking at the nozzle #3 bore (upper photo in Figure 3.6.7), it can be seen that the axial crack is present from the RCS side of the J-groove weld up to the top of the J-groove weld. The crack is also visible on the top of the J-groove weld (lower photo in Figure 3.6.7), indicating the crack extended completely through the J-groove weld. Axial cracks were also visible on the uphill side of the nozzle #3 bore near the 180° orientation (Figure 3.6.8). These cracks were not as wide or long as the axial crack at 10°.

Figure 3.6.7: Photographs showing axial crack in nozzle #3 J-groove weld near 10°.

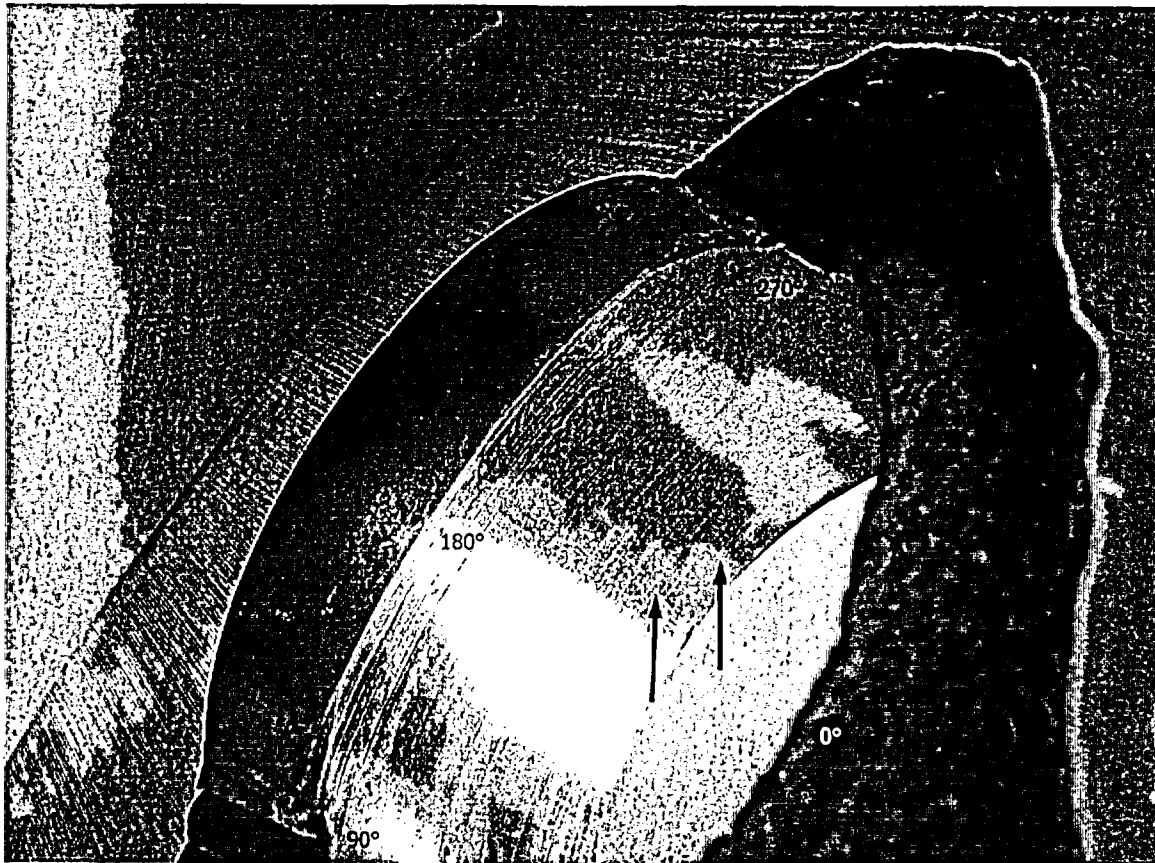
Figure 3.6.8: Axial cracks located on J-groove weld bore near 180°. ~0.75X
