Table 5.1: Sample identification listing for Piece A2A.

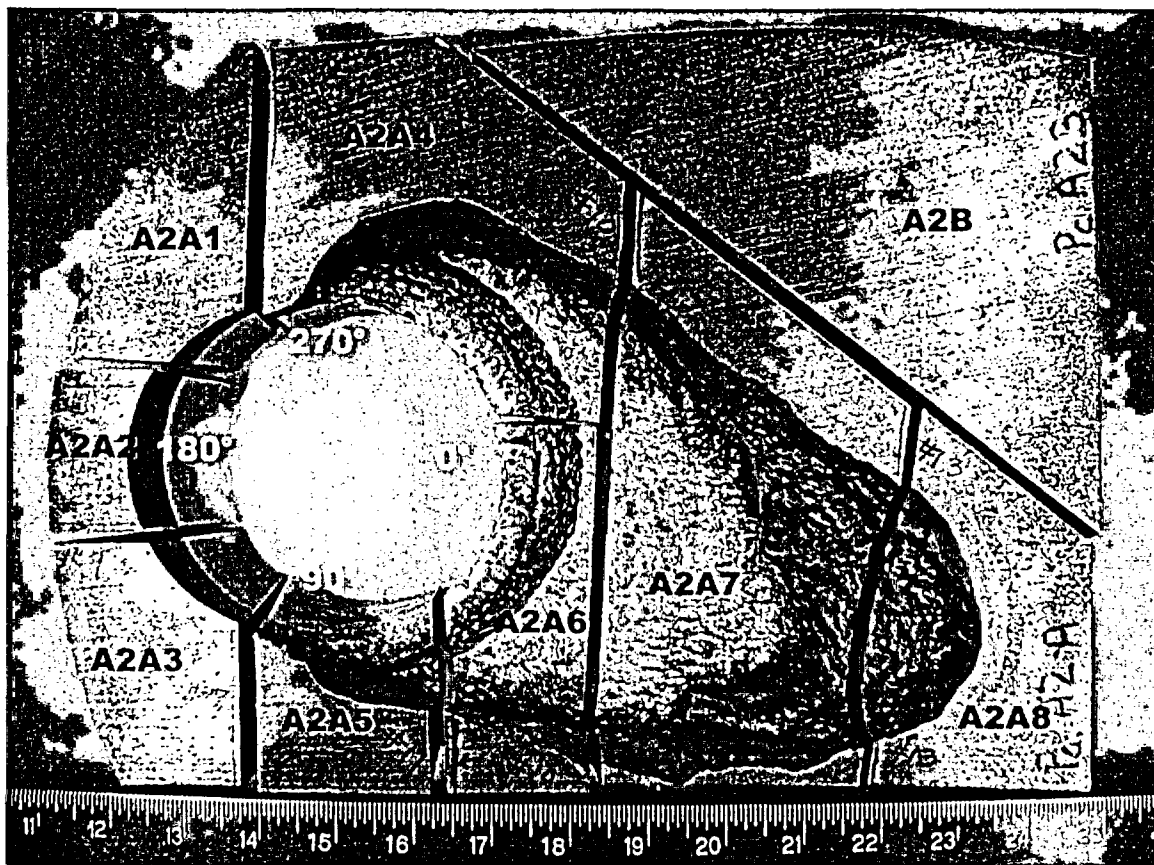
Figure 5.1: Sectioning of Piece A2A (lower portion of cavity) showing new sample identifications.

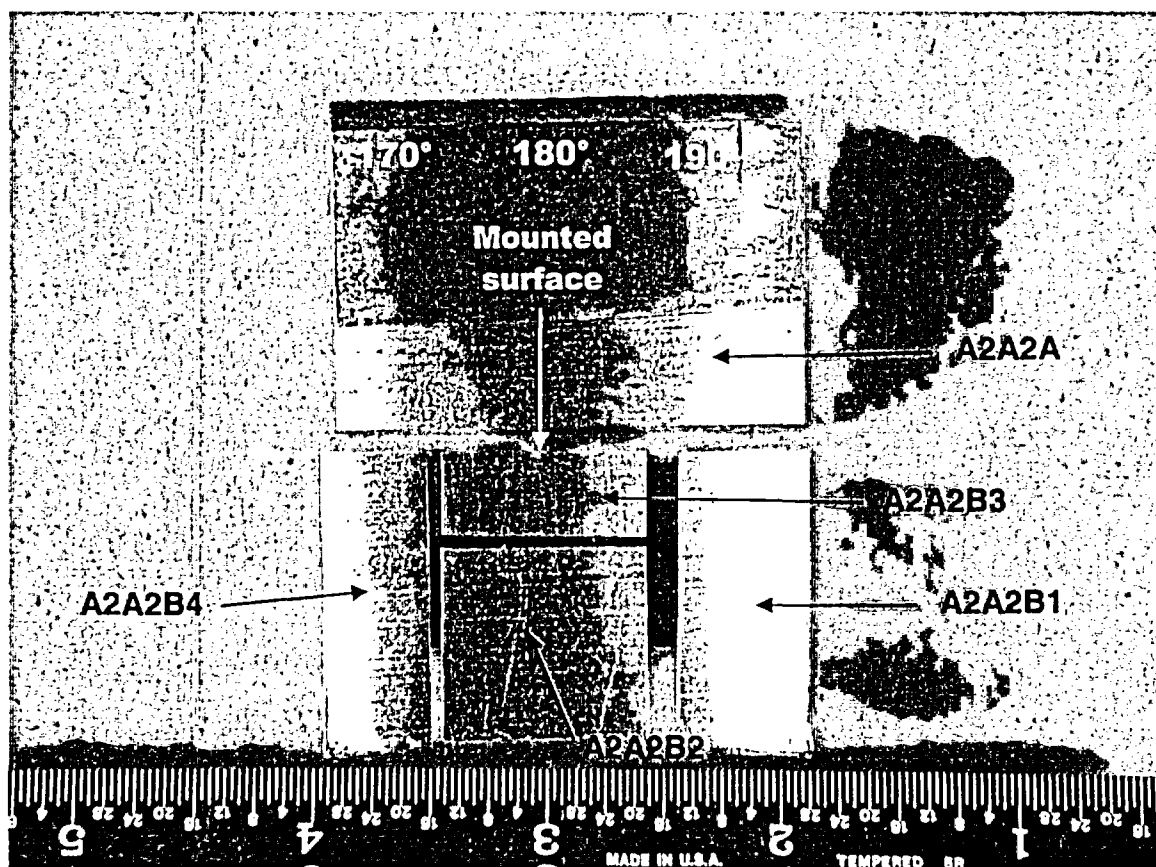
Figure 5.2: Sectioning of Piece A2A2, looking at the ID of the J-groove weld bore.

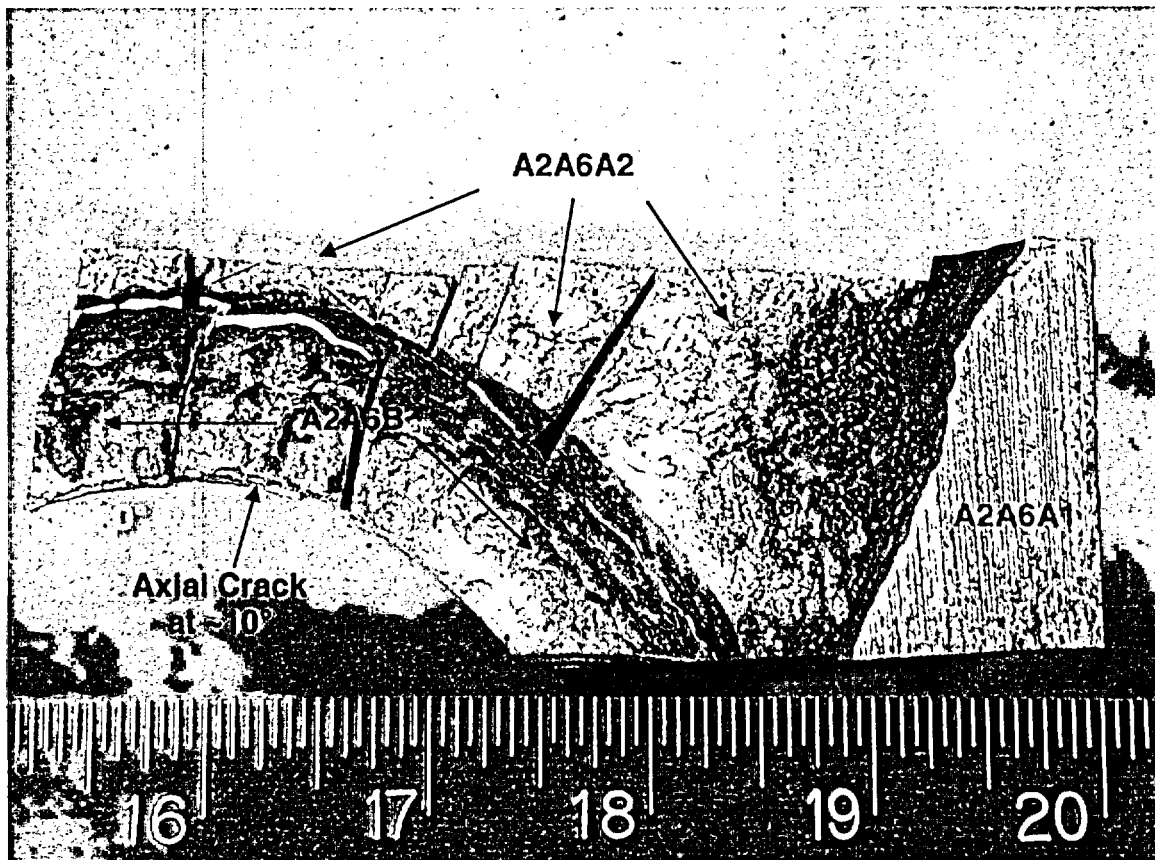
Figure 5.4: Piece A2A6 was first sectioned into Pieces A2A6A and A2A6B. Piece A2A6A was further sectioned into Pieces A2A6A1 and A2A6A2. Both cuts were made on the same plane, parallel to the paper. The first cut line is partially visible; Piece A2A6B is the upper portion of the weld. The second cut line between Pieces A2A6A1 and A2A6A2 is obscured by Piece A2A6A1.

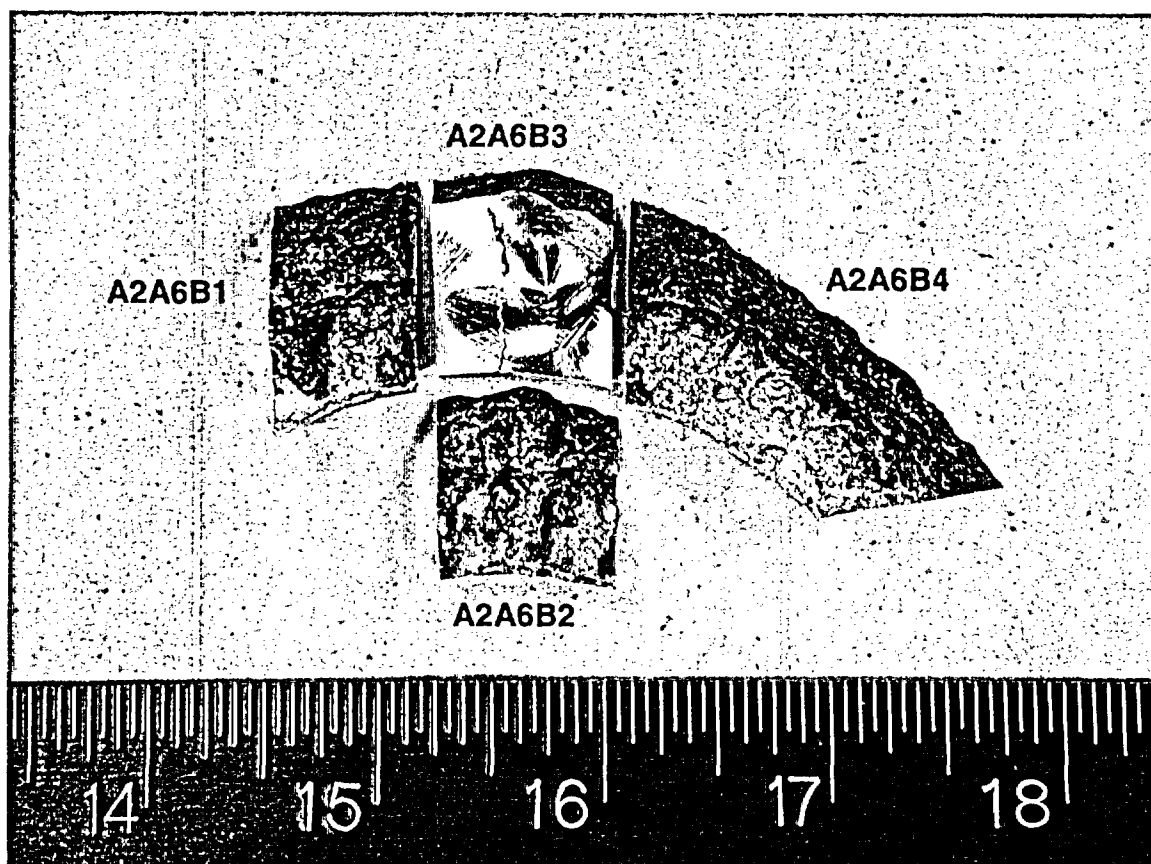
Figure 5.5: Piece A2A6B after sectioning. The bottom surface of A2A6B2 was mounted. The axial crack in A2A6B3 was opened up for SEM.

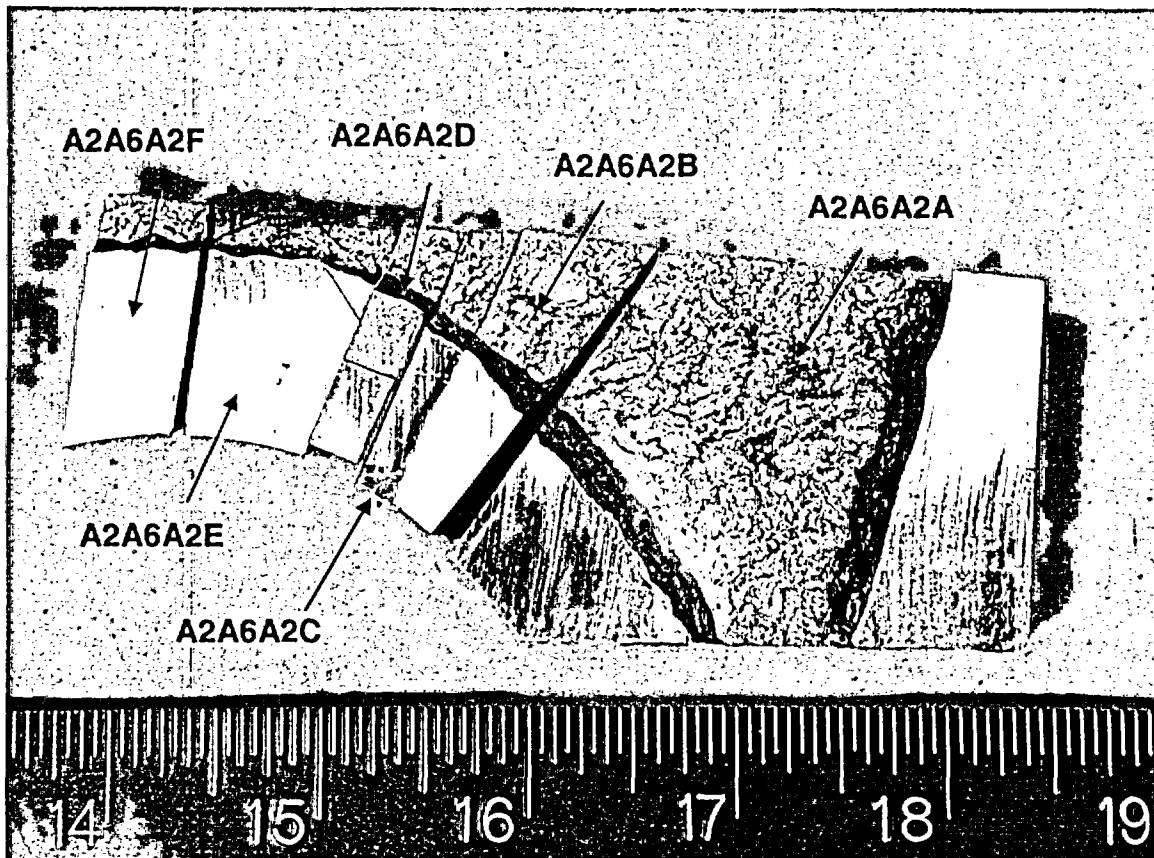
Figure 5.6: Piece A2A6A2 after sectioning. Additional sections were made on A2A6A2B, -C, -D, and -E. Refer to the following four tables and figures.

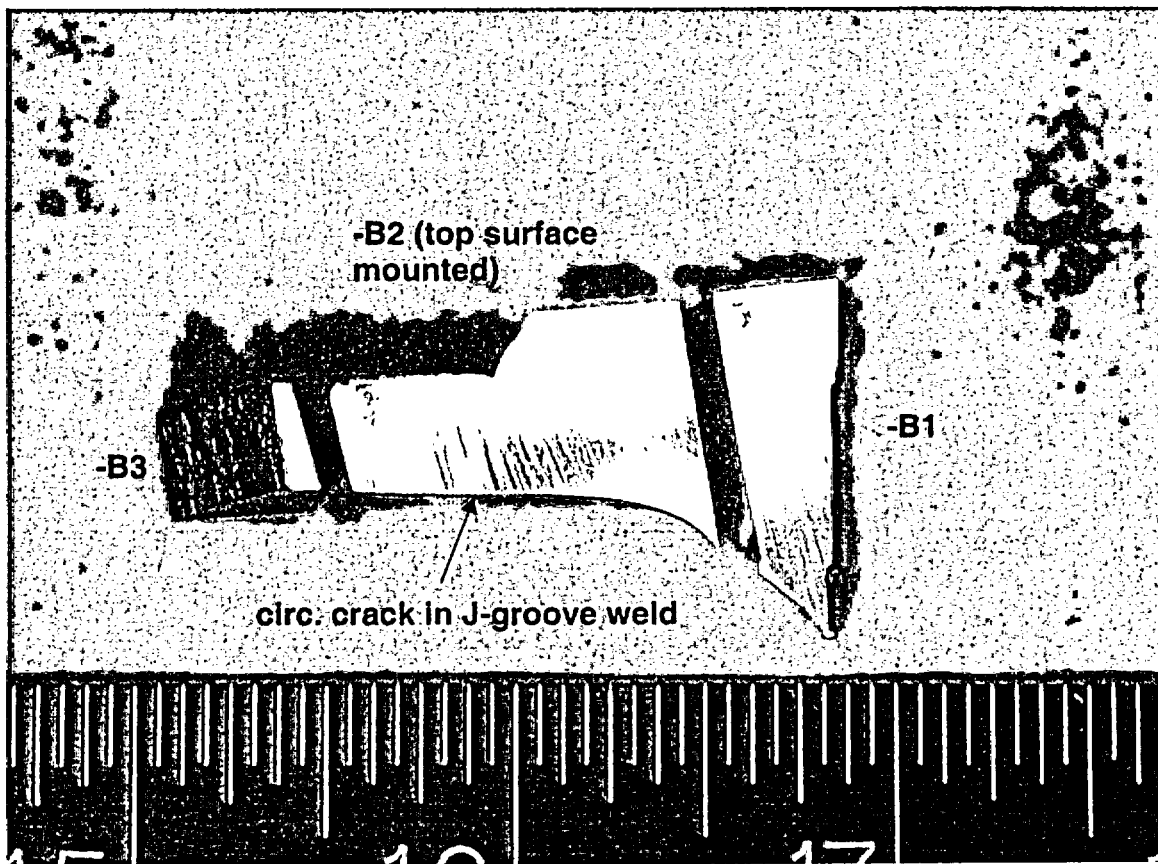
Figure 5.7: Piece A2A6A2B after sectioning (side view of Figure 5.6). The top surface of A2A6A2B2 was mounted.

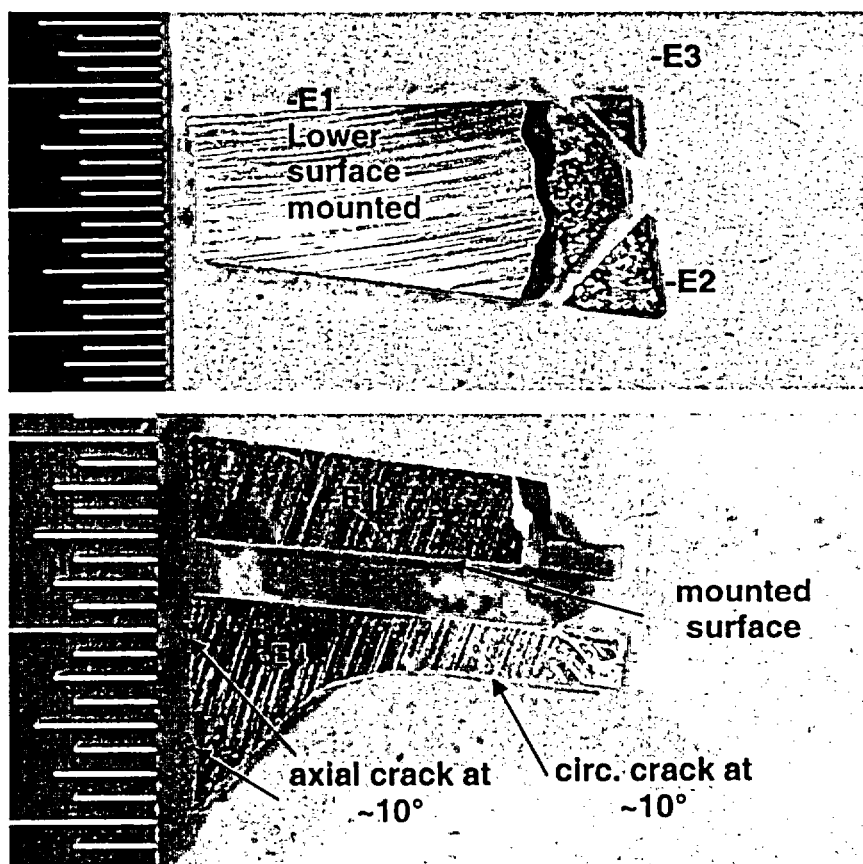
Figure 5.10: Section photo for Piece A2A6A2E (side view of Figure 5.6). The mounted surface of Piece A2A6A2E1 is indicated. Piece A2A6A2E4 is reserved for PNL.

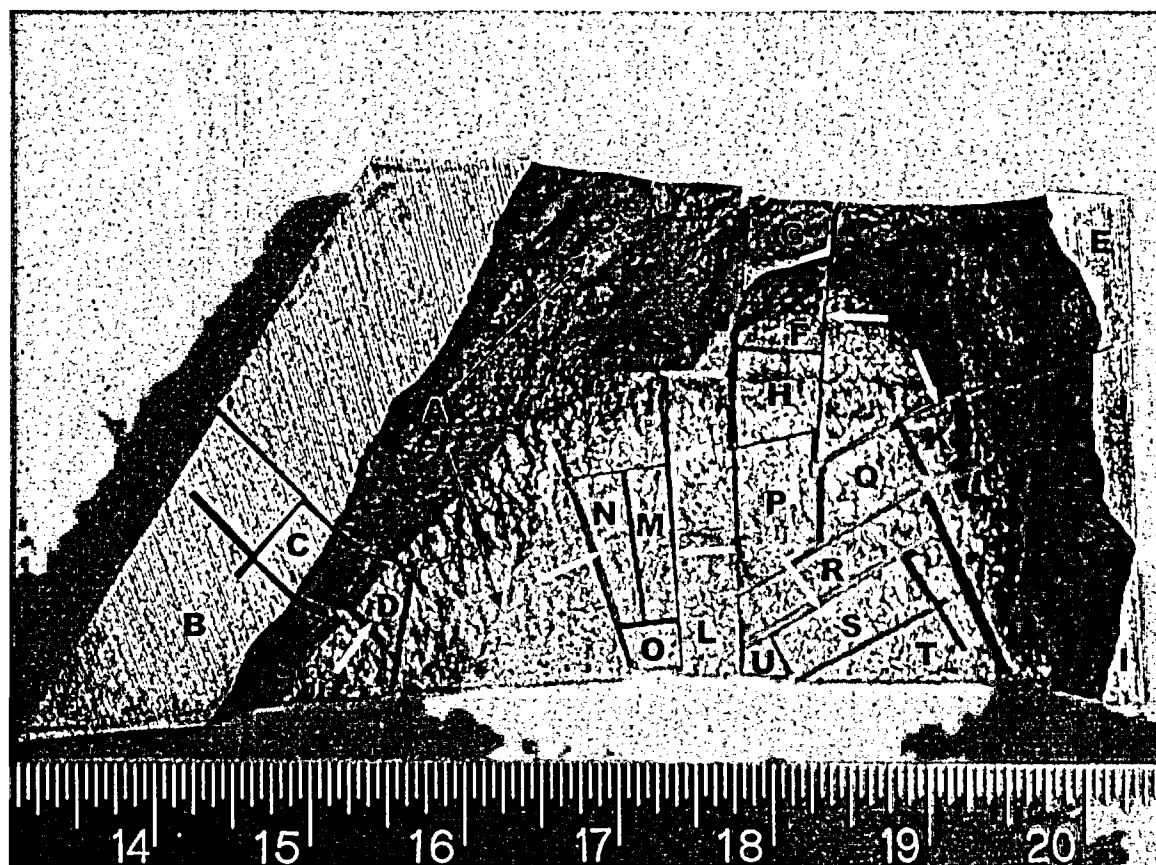
Figure 5.11: Section photo for Piece A2A7. The mounted surfaces for the -D, -F, -K, -M, -N, and -S samples are indicated by the white arrows. Further sectioning of Piece A2A7L is shown in Figure 5.12.

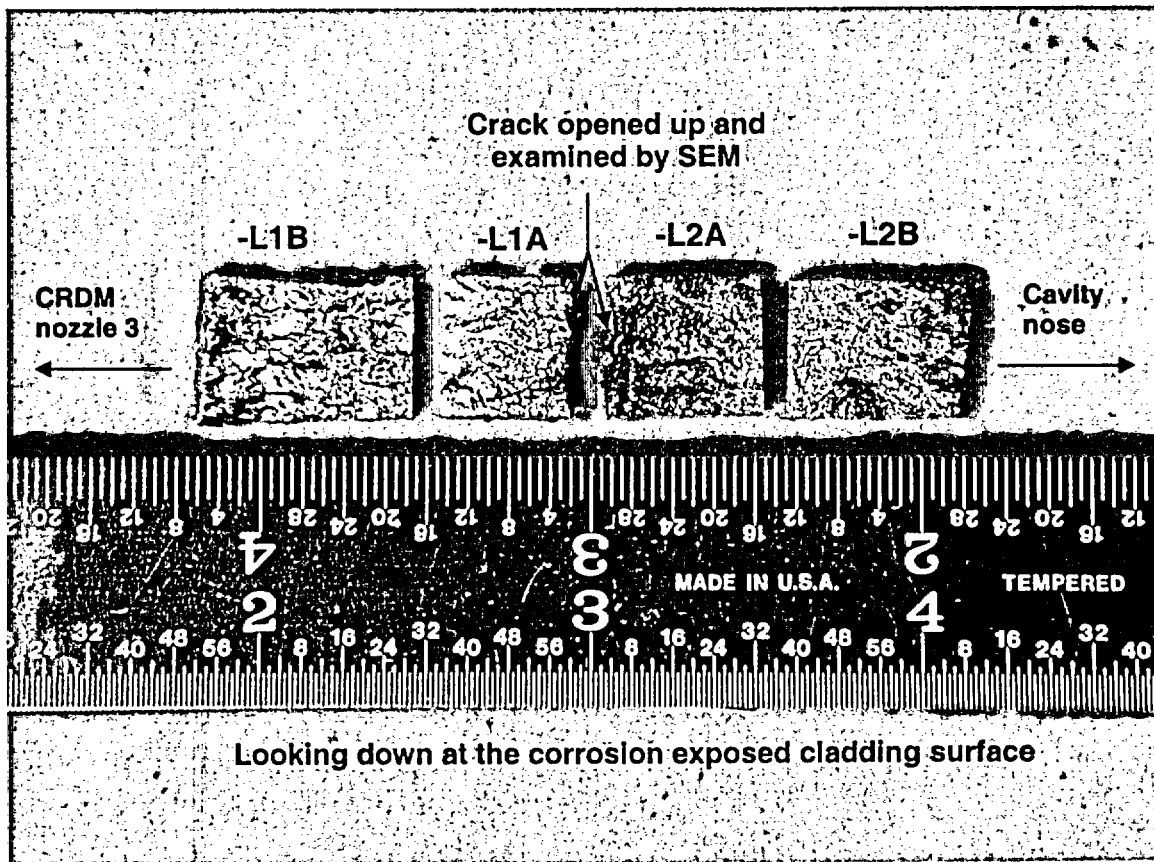
Figure 5.12: Section photo for Piece A2A7L. The main crack located near the center of A2A7L was opened in the laboratory, resulting in Pieces A2A7L1 and A2A7L2. Additional sections, which created the -A and -B pieces, were made to facilitate the SEM examinations. The surfaces examined by SEM are indicated.

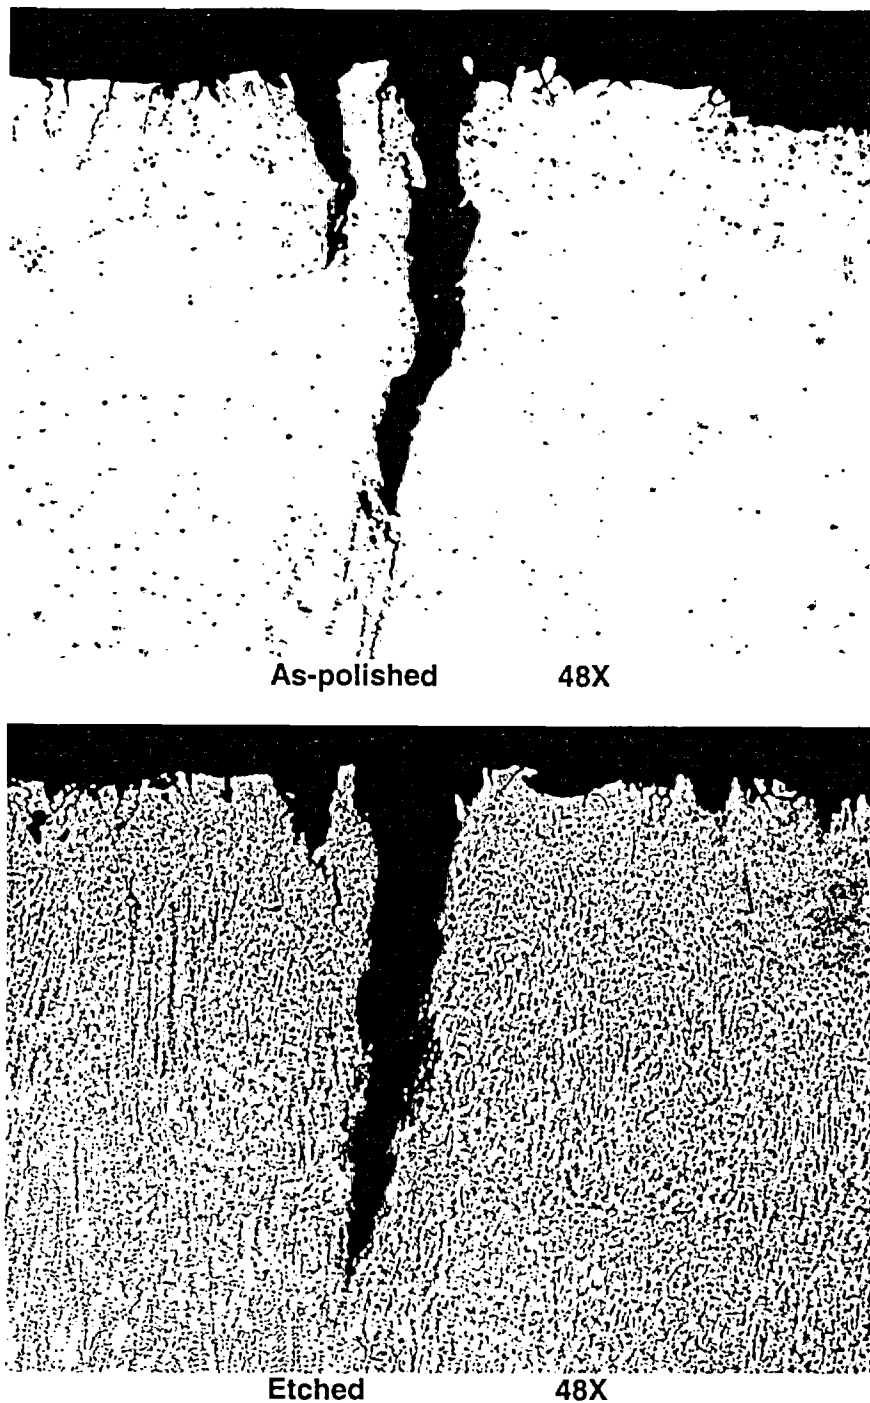
**Figure 6.1.1.3: Micrographs showing the deepest crack observed in A2A7M. Fine intergranular or interdendritic cracks emanating from the crack tip are visible. The crack tip is estimated to be approximately 0.057" (1.47 mm) below the surface. The cracks in the above two photos are the same, but are shown at slightly different planes due to re-polishing.**

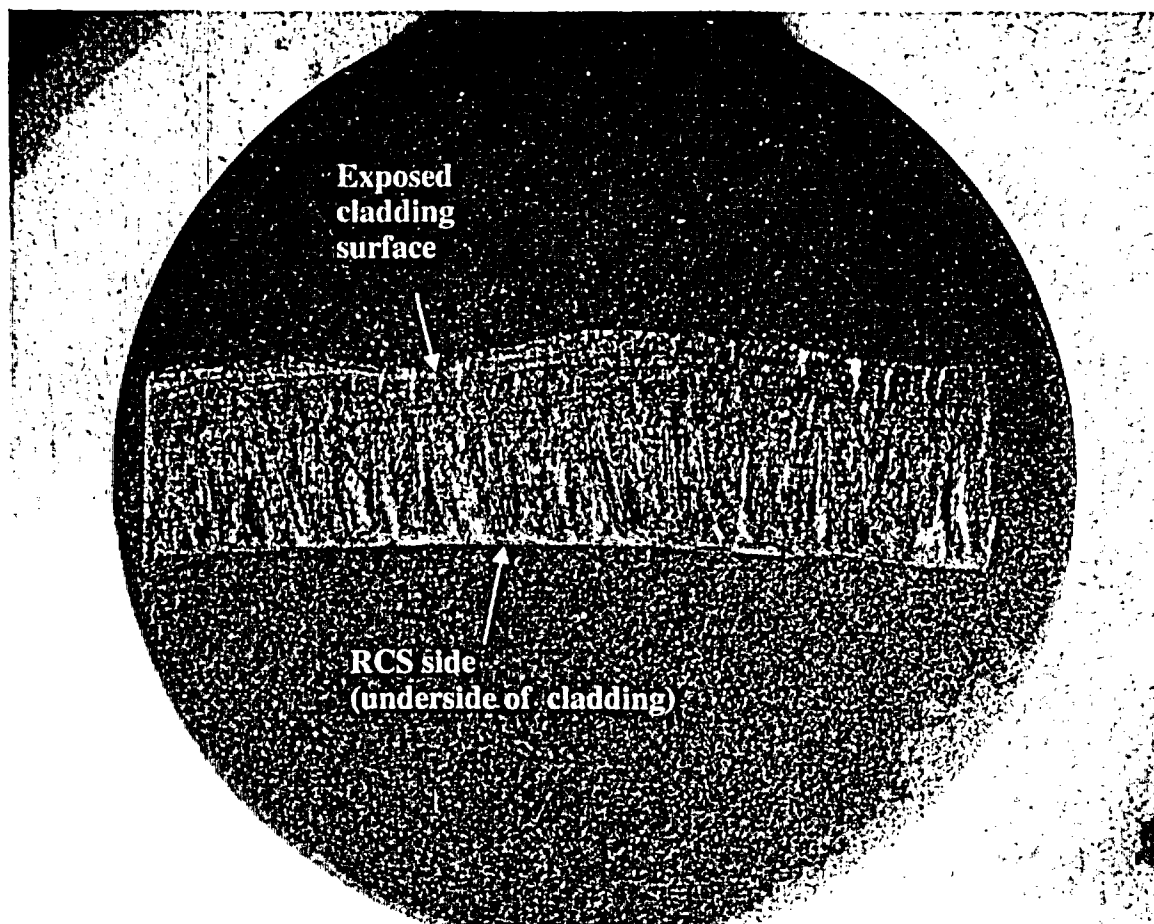
Figure 6.2.1.1: 4X macro photograph of metallurgical mount A2A7N. Refer to Figure 5.11 for the sample orientation.

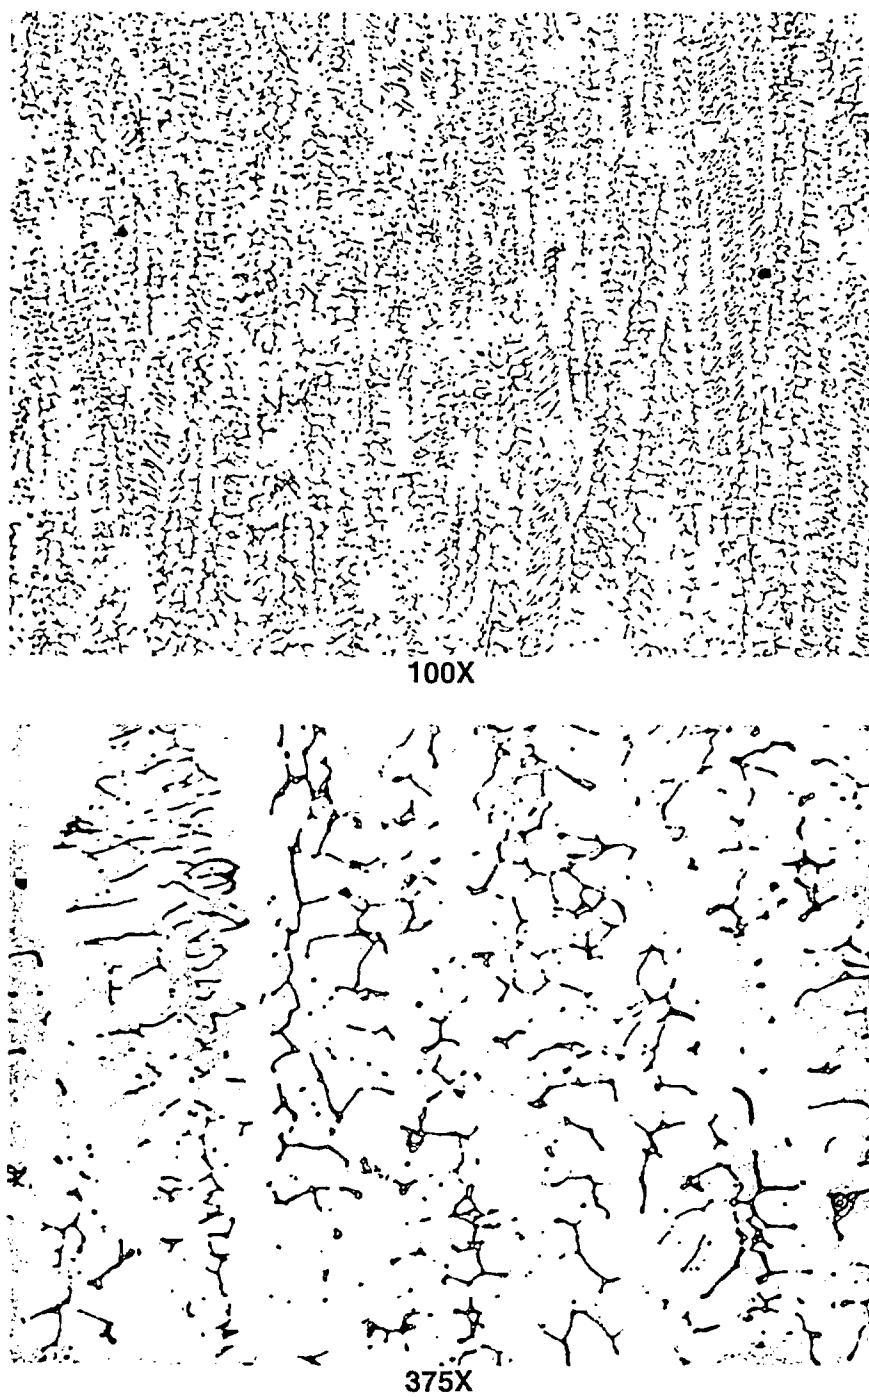
Figure 6.2.1.4: Typical clad microstructure in the mid-thickness of the cladding.

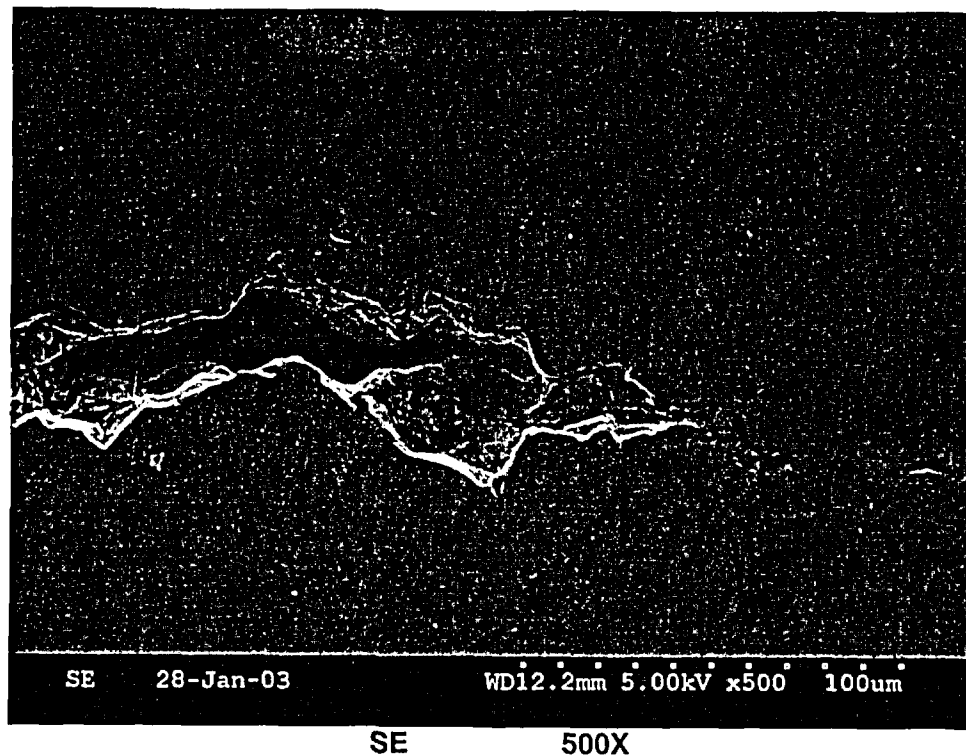
Figure 6.2.2.2: Higher magnification SEM micrographs of crack tip, showing the interdendritic crack path along the elongated ferrite pools.

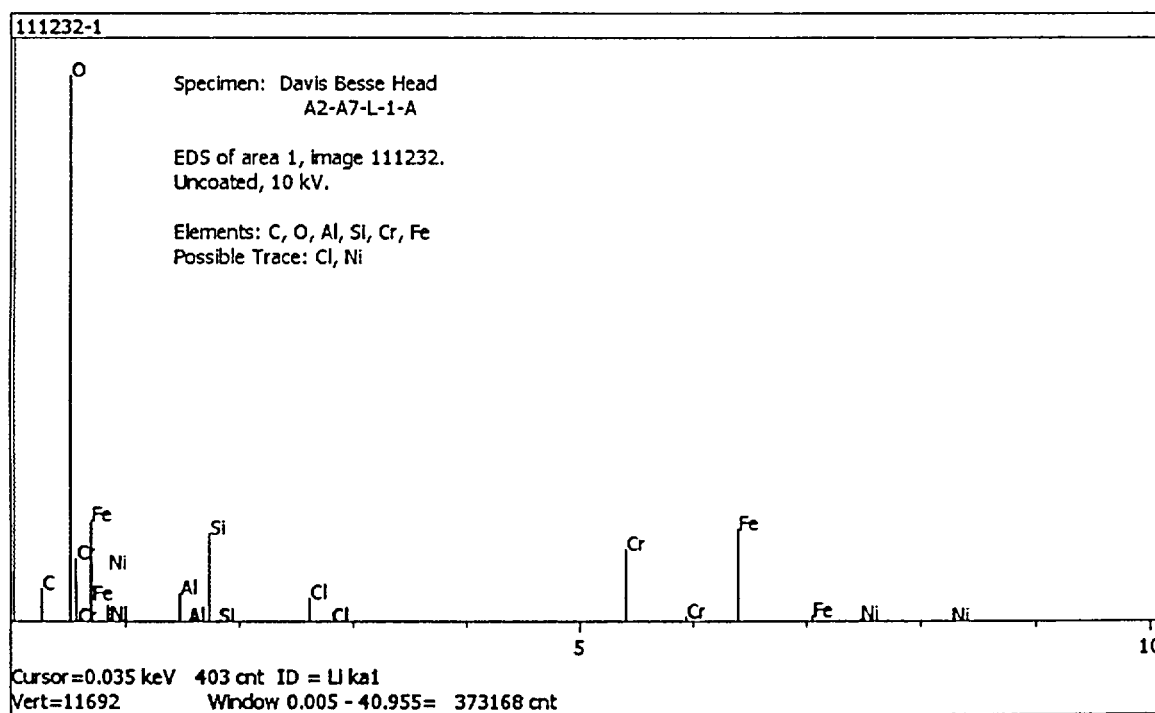
Figure 6.4.1.7: SEM micrograph and EDS results for deposited region near area "E". The corrosion deposits contained carbon, oxygen, along with iron, aluminum, silicon, and chromium. Possible trace levels of nickel and chlorine were also detected in this area.

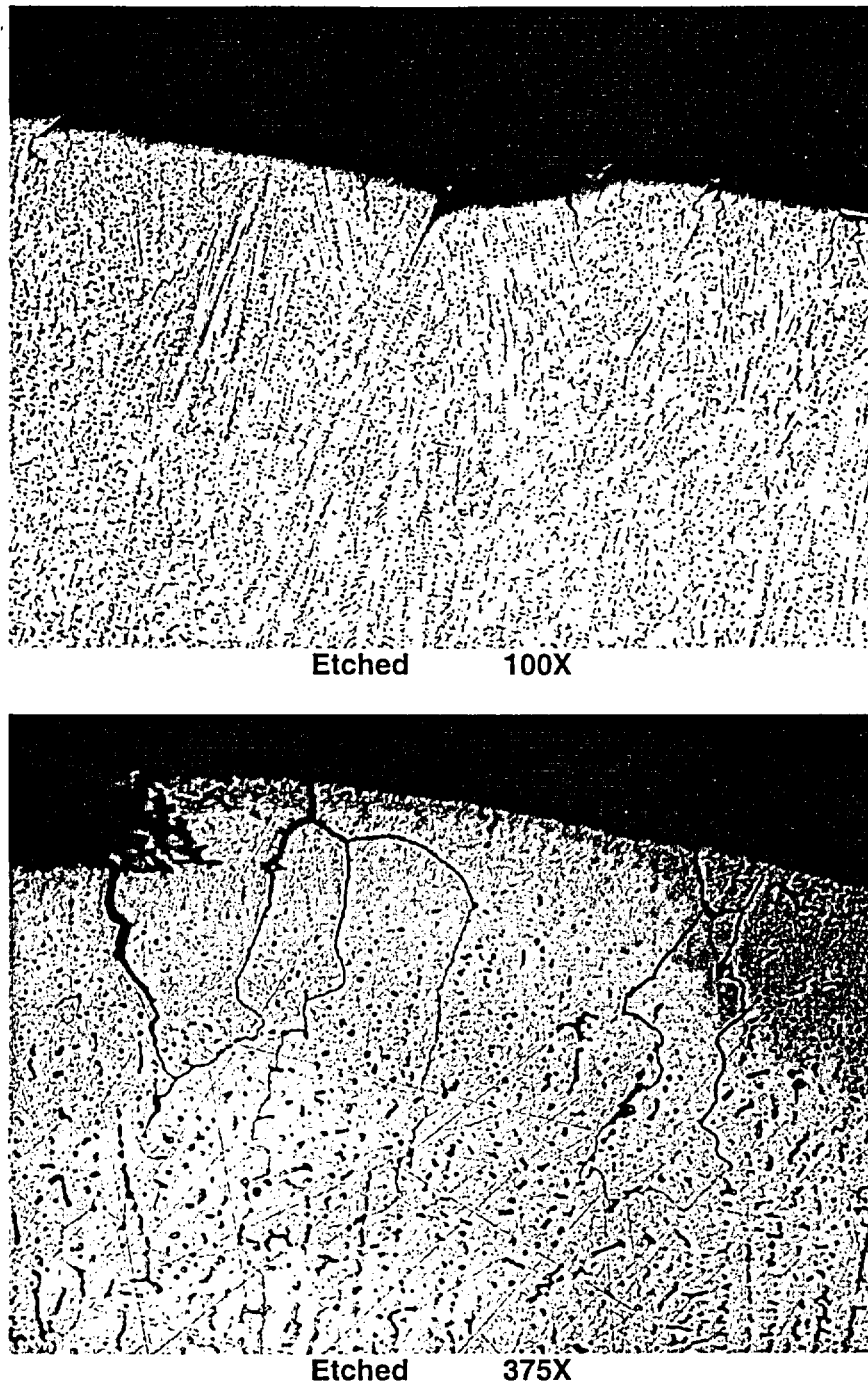
**Figure 6.5.1.5: Micrographs of the cladding surface exposed due to boric acid corrosion of the RV head low alloy steel. Intergranular attack (IGA) of stainless steel cladding to a depth of the first or second layers of grains is clearly visible. The IGA is probably due to oxygenated and highly concentrated boric acid. There was no evidence of plastic deformation observed in the cladding in this area.**

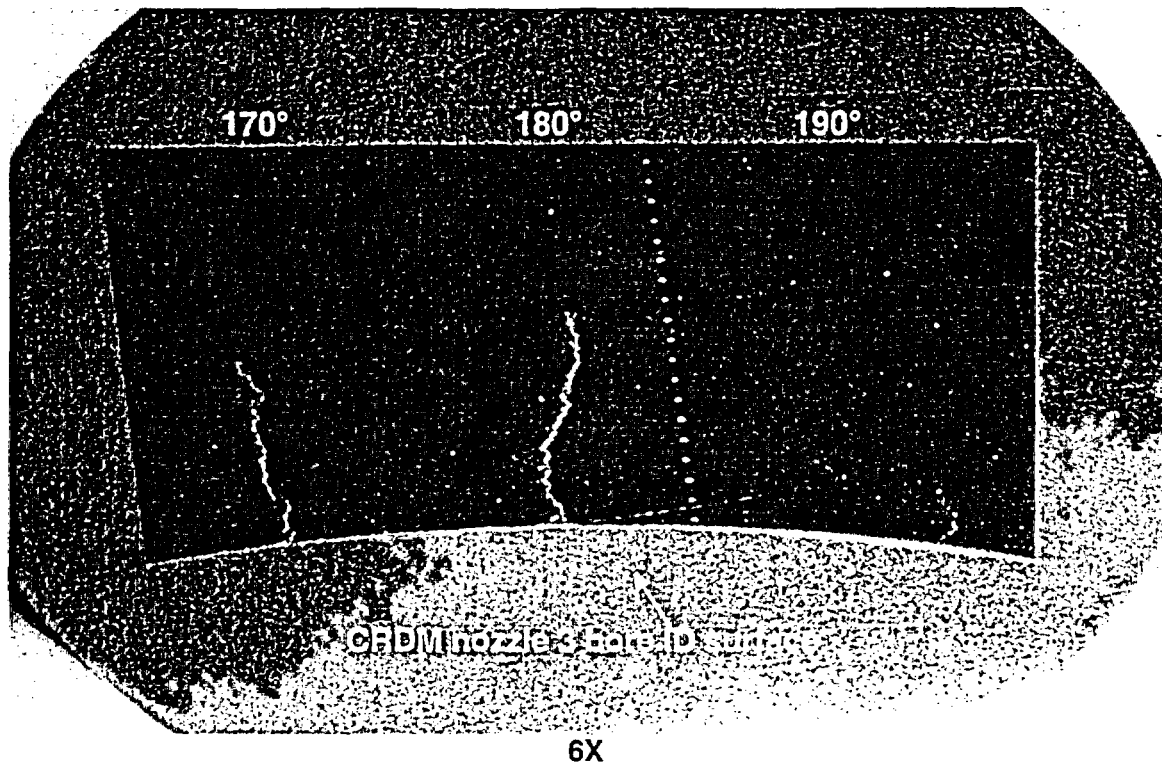
Figure 7.1.1.1: Macro photograph and Knoop microhardness results for metallographic sample A2A2B3 (see Figure 5.2 for the sample orientation). The lower concave surface is the I.D. of the nozzle 3 bore from the nozzle removal process. The crack tips of the two cracks are estimated to be approximately 0.24" and 0.20" below the surface, respectively. The indentations from the microhardness traverse are visible. The elevated microhardness level near the surface is due to the surface cold work layer from the boring of nozzle 3 removal process (see Figures 5.2 and 7.1.1.5).

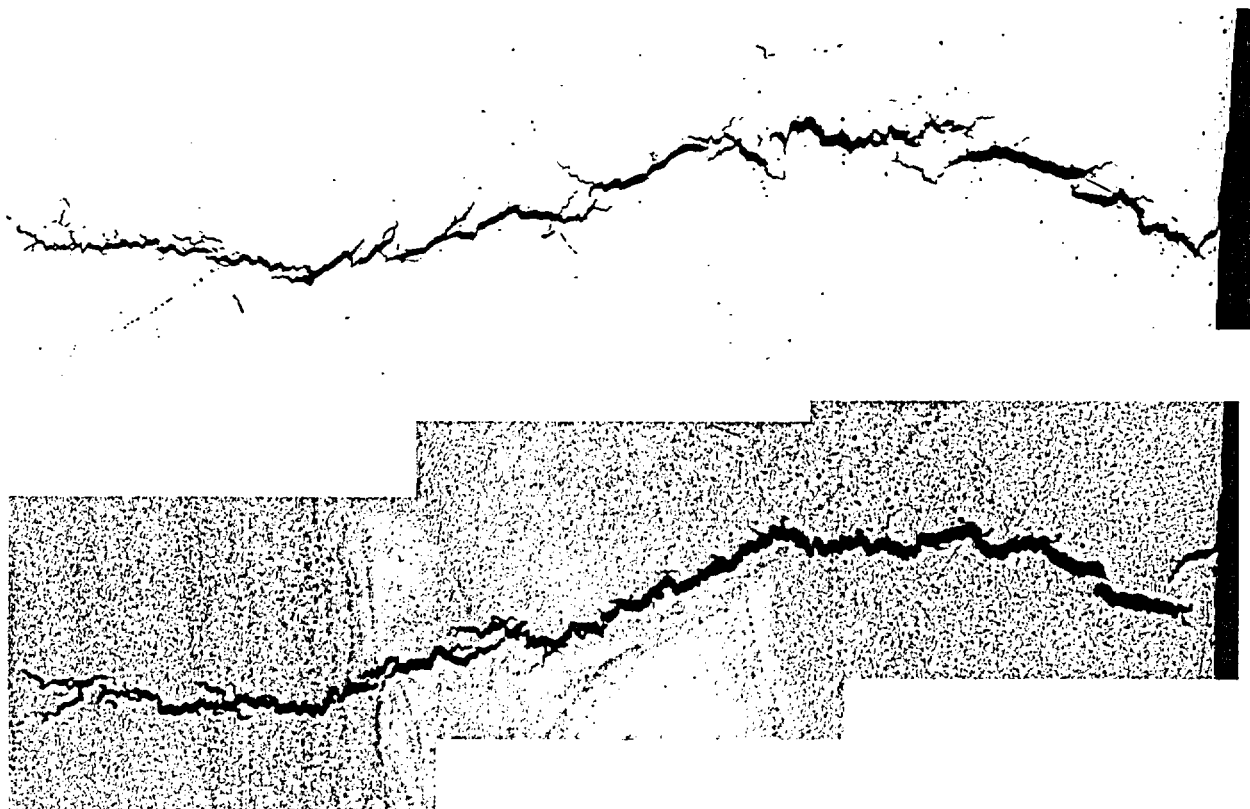
Figure 7.1.1.2: Micrographs showing the crack at  $\sim 180^\circ$  in sample A2A2B3. Top as-polished, bottom etched. Both micrographs 24X.

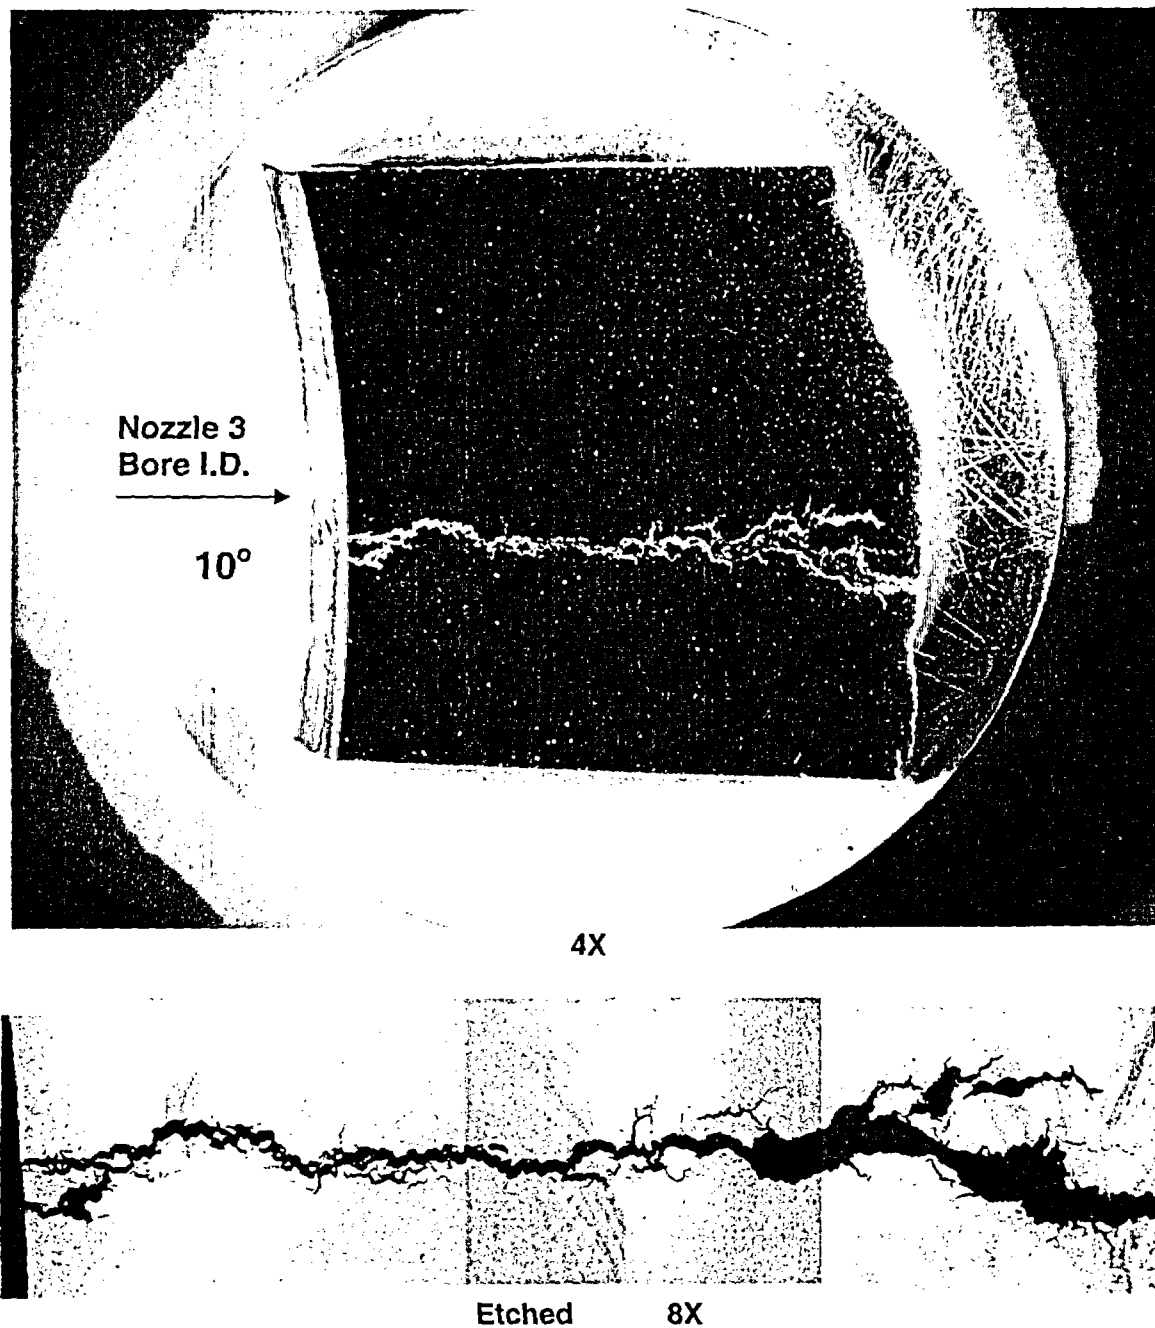
Figure 7.2.1.1: Macro photograph of metallographic mount sample A2A6B2 (see Figures 5.4 and 5.5 for the sample orientation). The axial cracking at  $\sim 10^\circ$  is through the J-groove weld, in contrast to the cracking near  $180^\circ$ , which was partially through the weld. A slightly higher magnification micrograph is also provided.

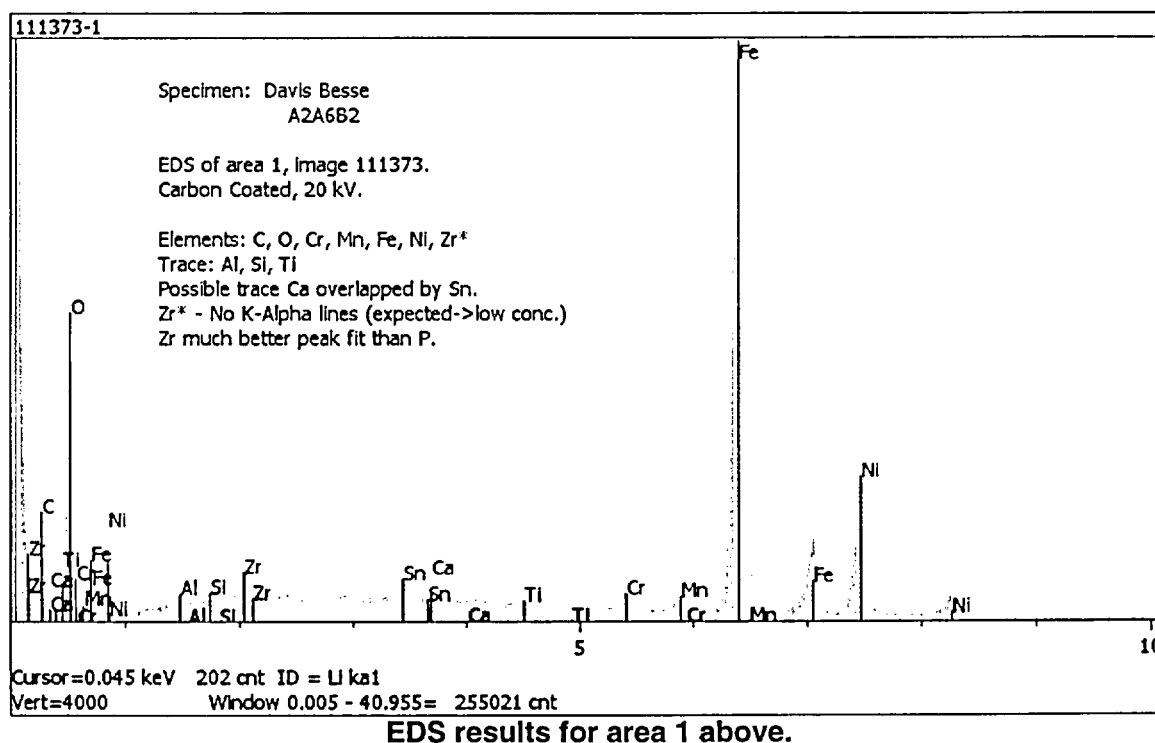
Figure 7.2.2.1: BSE micrograph showing portion of crack filled with corrosion products. The EDS results indicated high concentrations of carbon, oxygen, iron, and nickel.

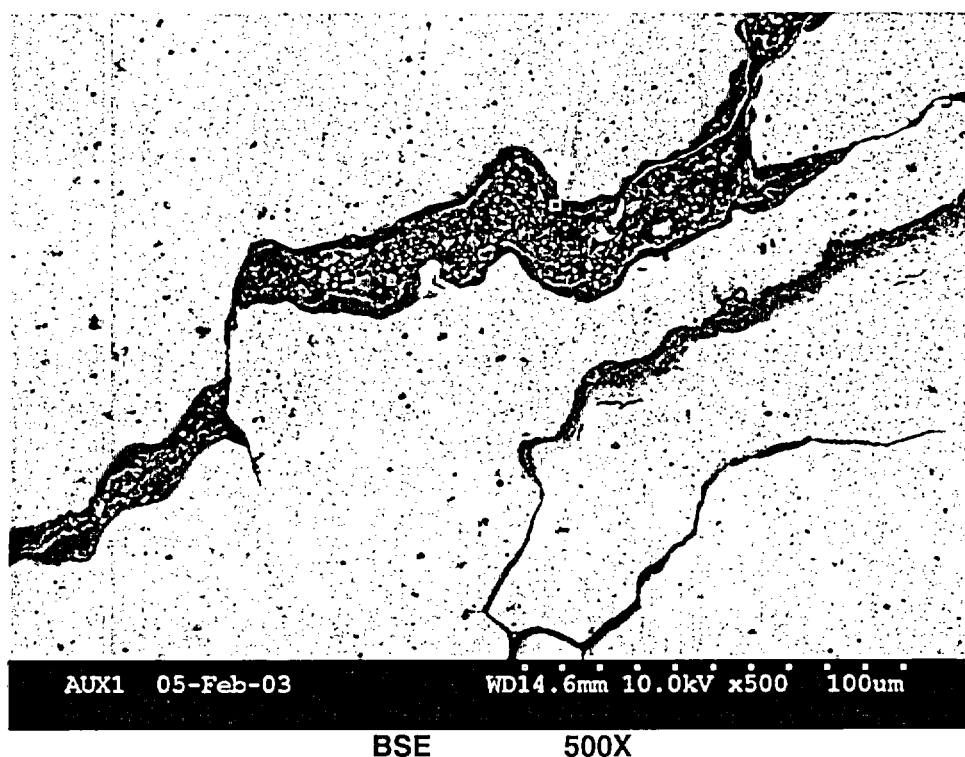
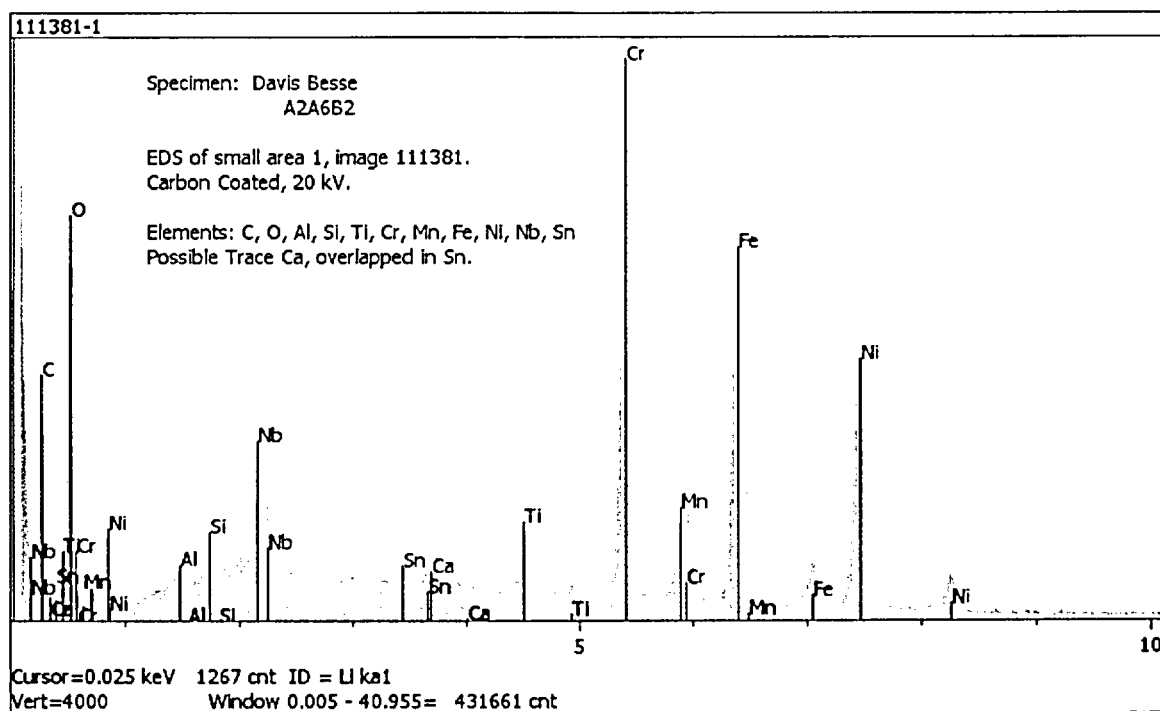
Figure 7.2.2.2: BSE micrograph showing corrosion products near crack tip. The EDS results collected from the area 1 indicated high concentrations of carbon, oxygen, niobium, titanium, chromium, manganese, iron, and nickel.

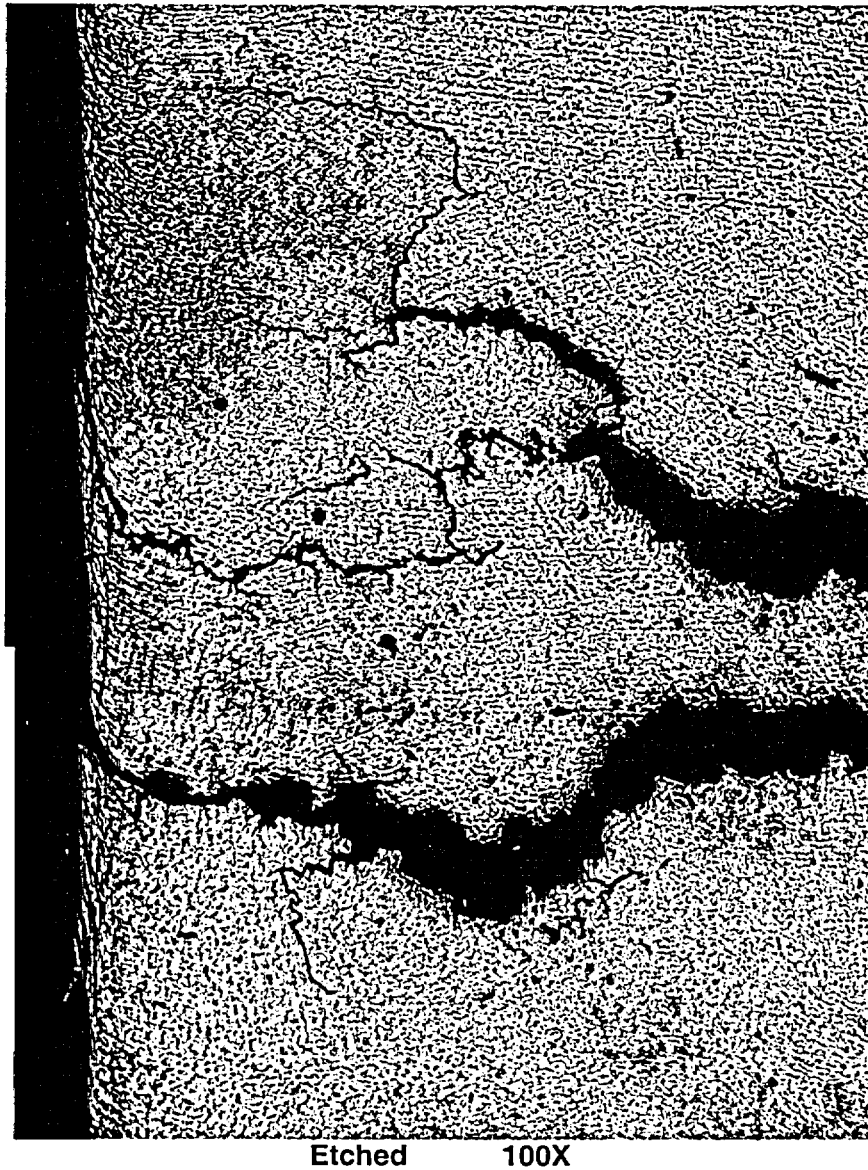
**Figure 7.2.3.3: Cracks located near the bored surface. Surface cold work layer is due to the boring (nozzle removal) process.**
