Table 5.1: Sample identification listing for Piece A2A.

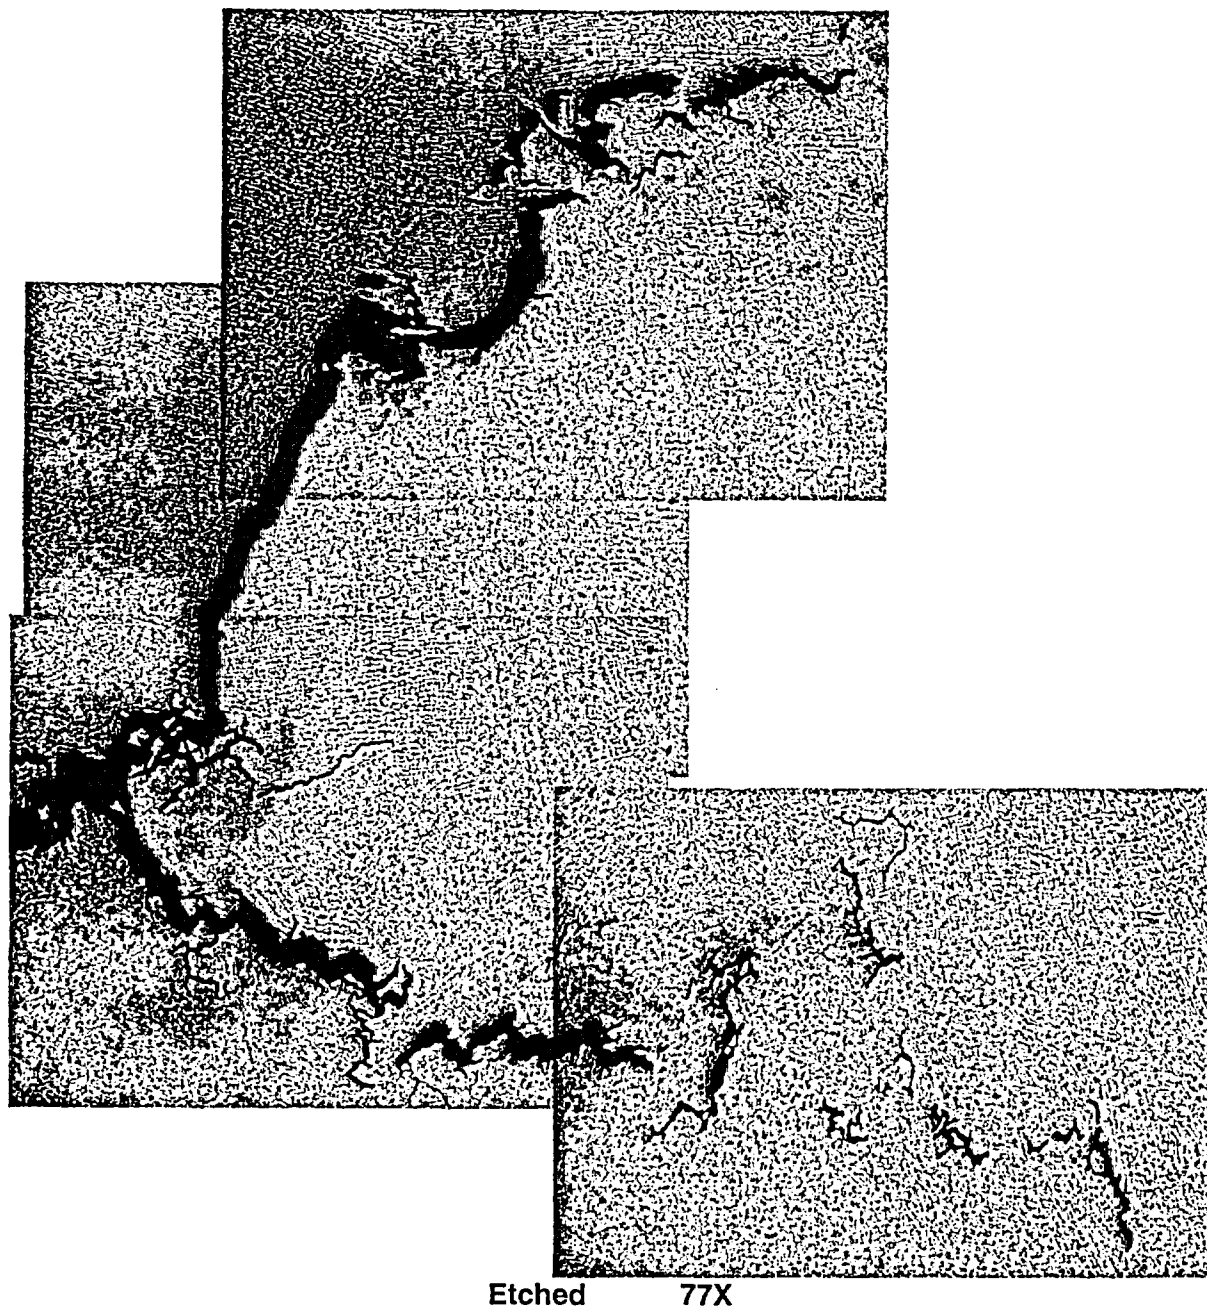
Figure 7.2.3.5: Crack tips toward the J-groove weld O.D.

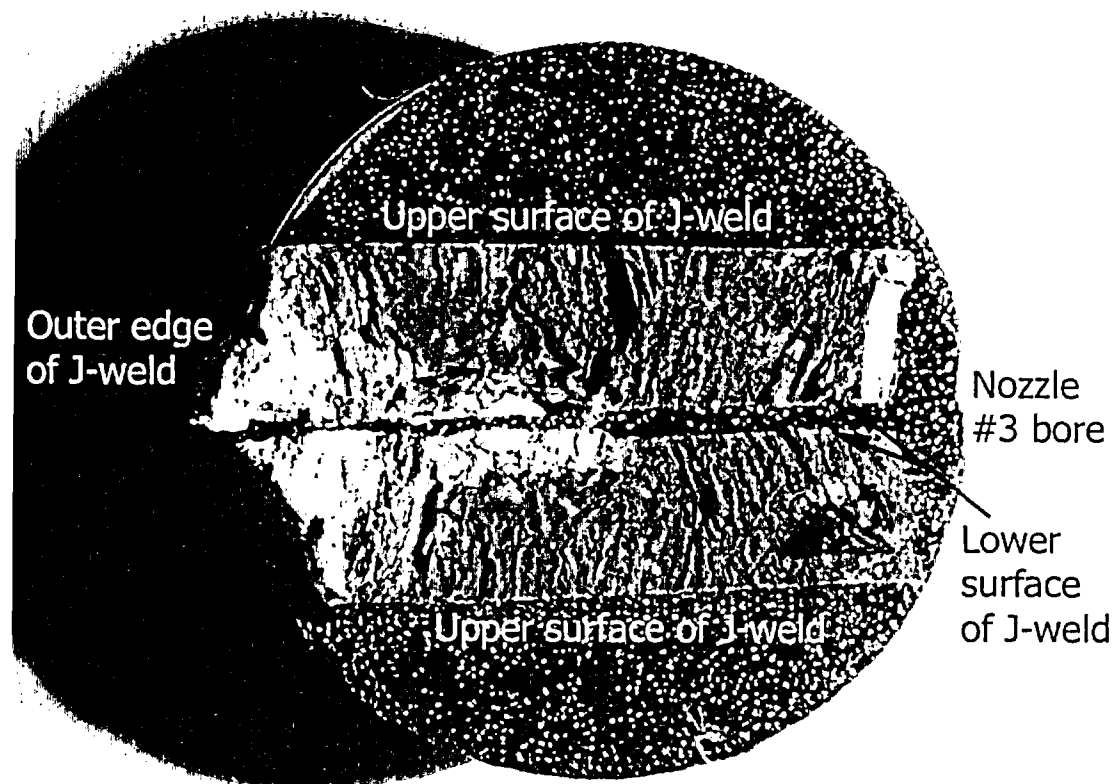
Figure 7.2.4.1: Macro photograph of sample A2A6B3 with the middle portion of the axial cracking at  $\sim 10^\circ$  opened-up for SEM. Refer to Figures 5.4 and 5.5 for the sample location.

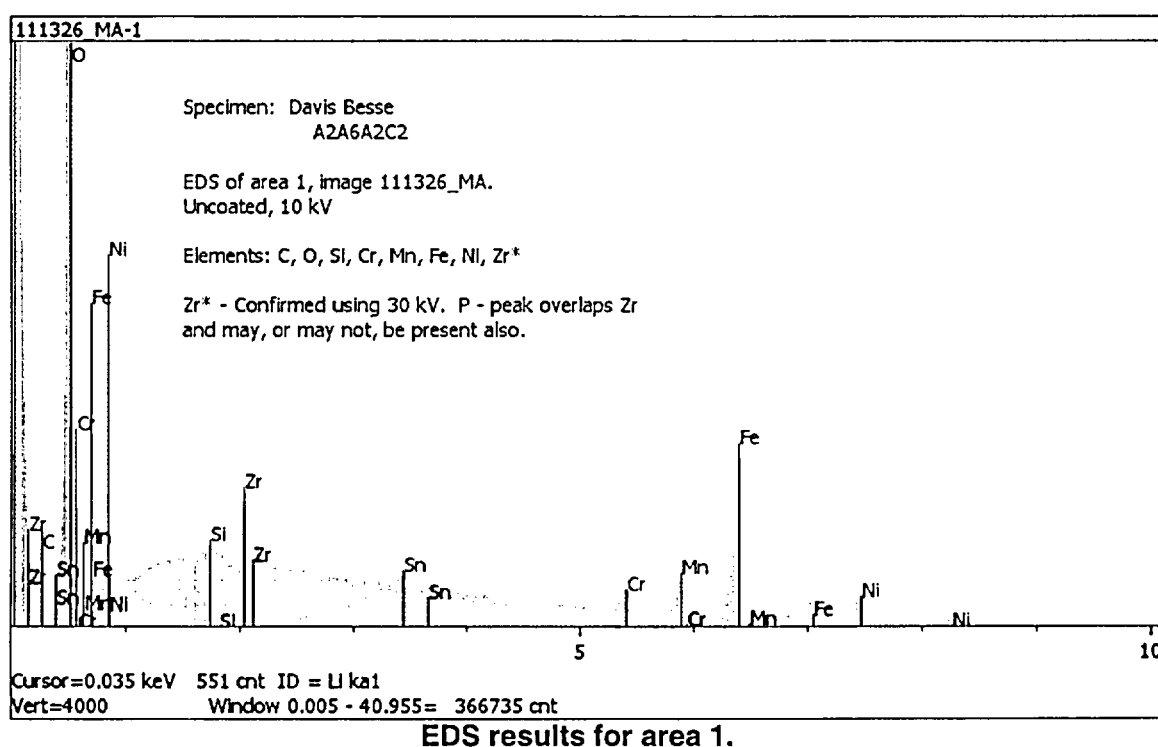
**Figure 7.2.4.6: BSE micrograph mosaic of the open crack surface (same area as Figure 7.2.4.2) along with EDS results for three areas of the fracture surface. The dark area in the BSE image indicates the fracture surface was covered by a thick oxide layer. The light area (right side) indicates a fresh fracture surface due to crack opening-up (i.e., less oxide on surface). For area 1, the primary elements included carbon, oxygen, silicon, chromium, manganese, iron, nickel, and zirconium.**

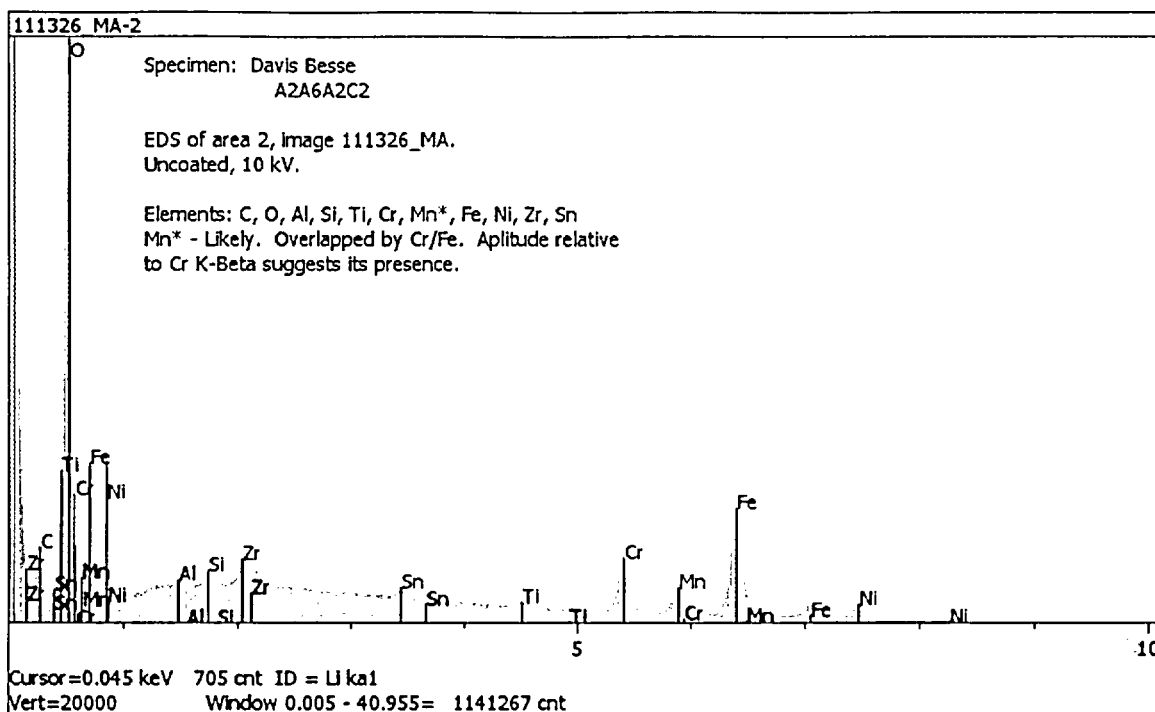
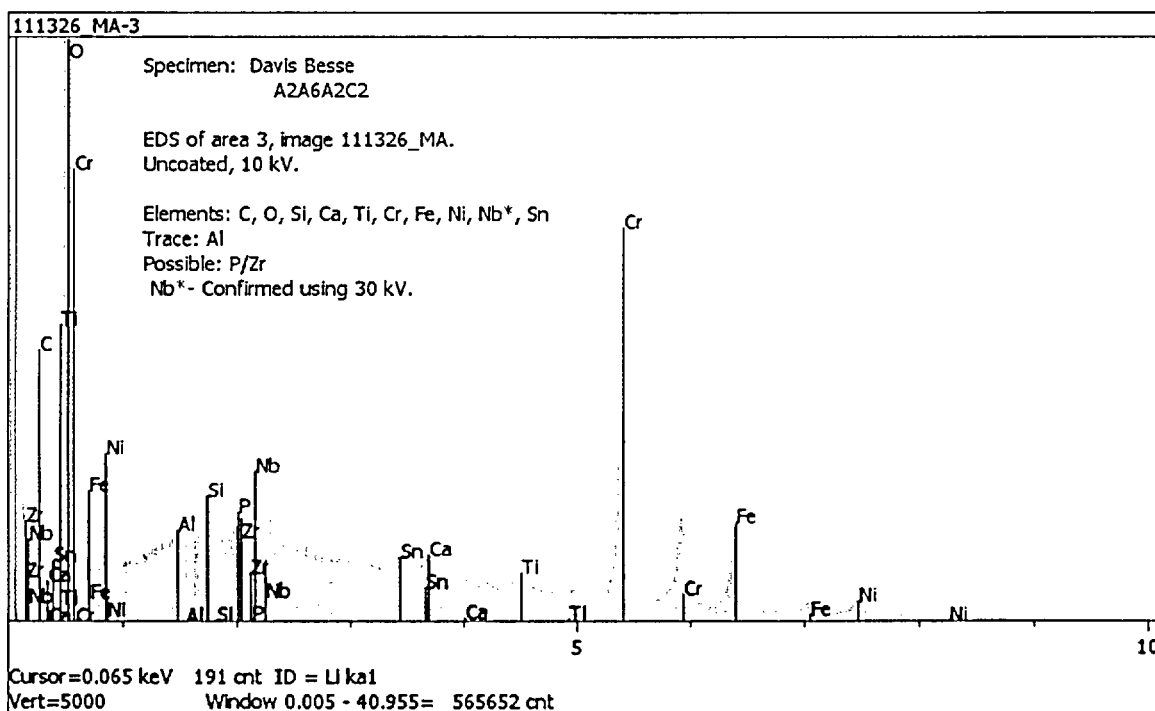
Figure 7.2.4.6 (cont.): For area 2, the primary elements included carbon, oxygen, silicon, chromium, manganese, iron, nickel, and zirconium. Similar results were obtained for area 3, except area 3 also contained niobium and calcium.

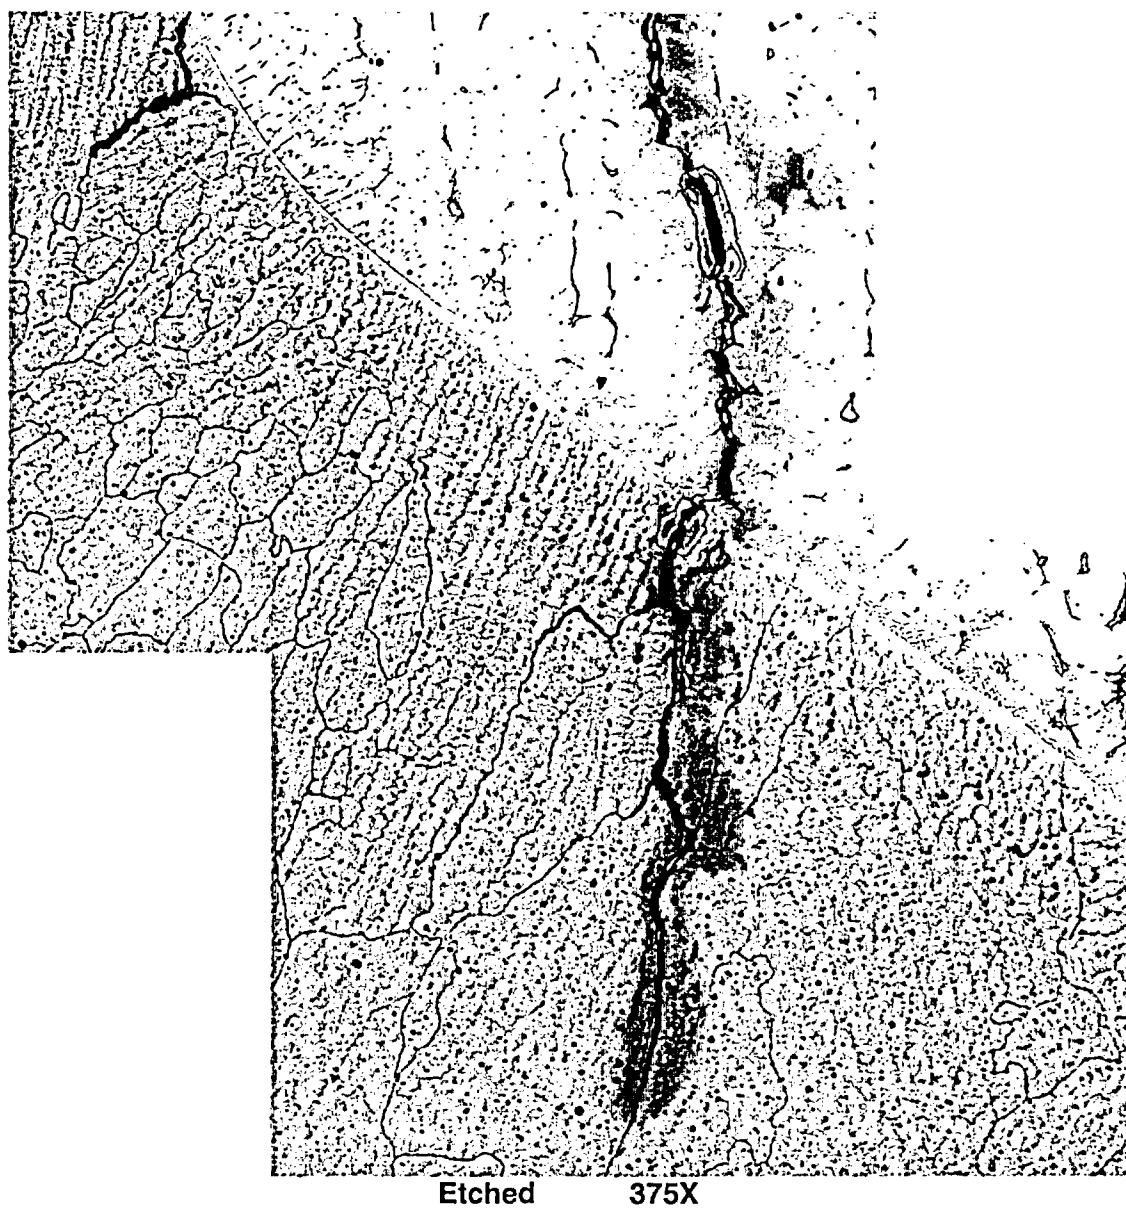
**Figure 7.3.1.4: Higher magnification micrograph showing intergranular or interdendritic cracking initiating at the cladding surface and extending into the J-groove weld.**

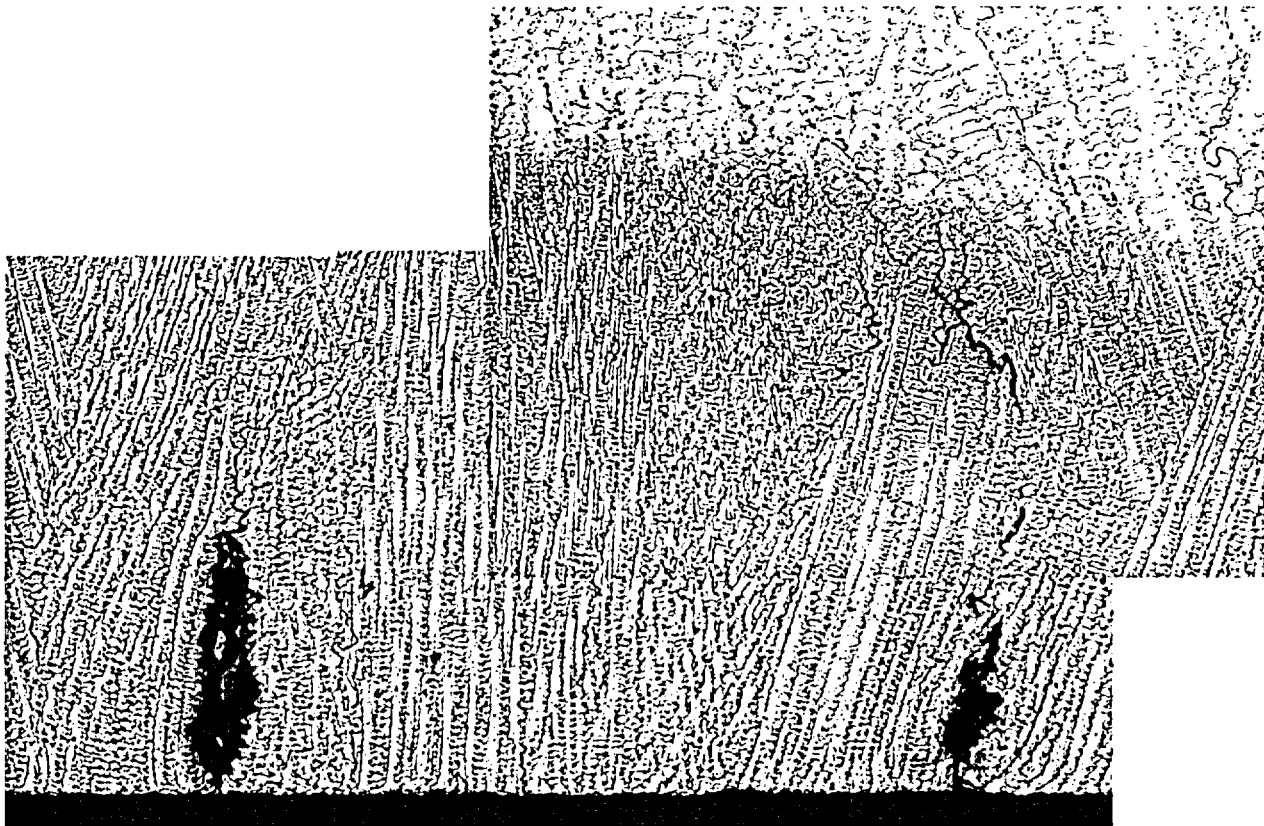
Etched 170X

Figure 7.3.1.6: Micrograph showing the shallow circumferential cracks in the J-groove weld. The cracking is intergranular or interdendritic, with a maximum depth of approximately 0.019" below the surface. The two wider crack regions just below the surface may have been dendrites or grains encircled by cracks that subsequently dropped out during sample preparation.

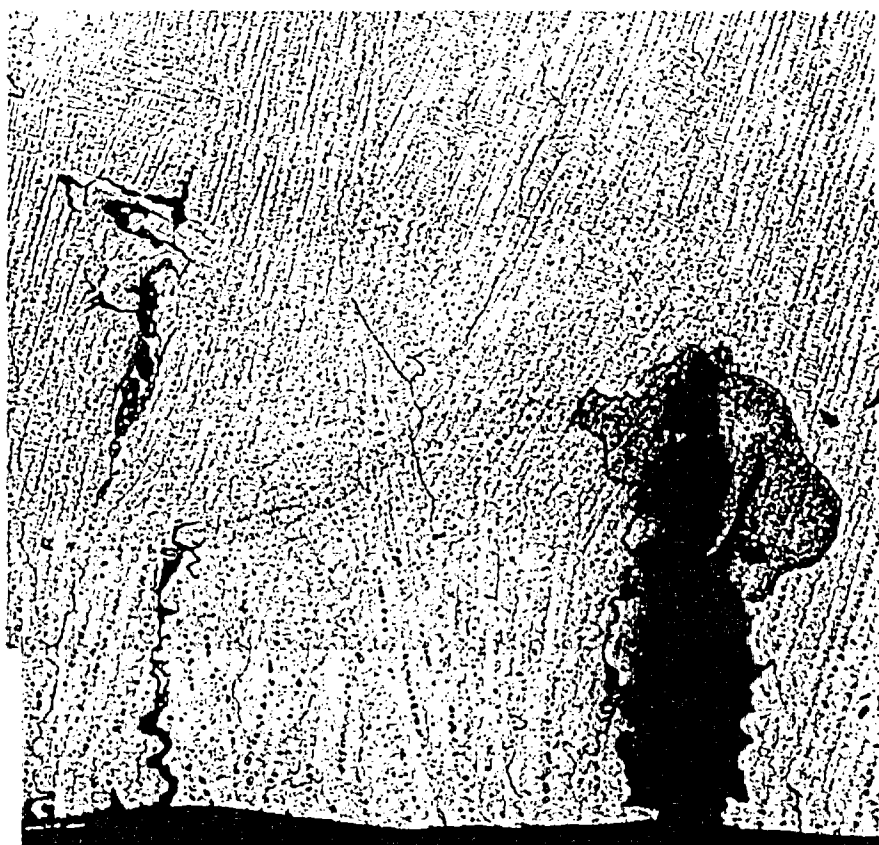
Etched 190X

Figure 7.3.2.2: Micrograph showing the circumferential intergranular/interdendritic cracks in the J-groove weld. The maximum cracking depth is approximately 0.018" below the surface. The cavity just below the surface may be due to dendrites or grains encircled by the cracks that dropped out during sample grinding and polishing.

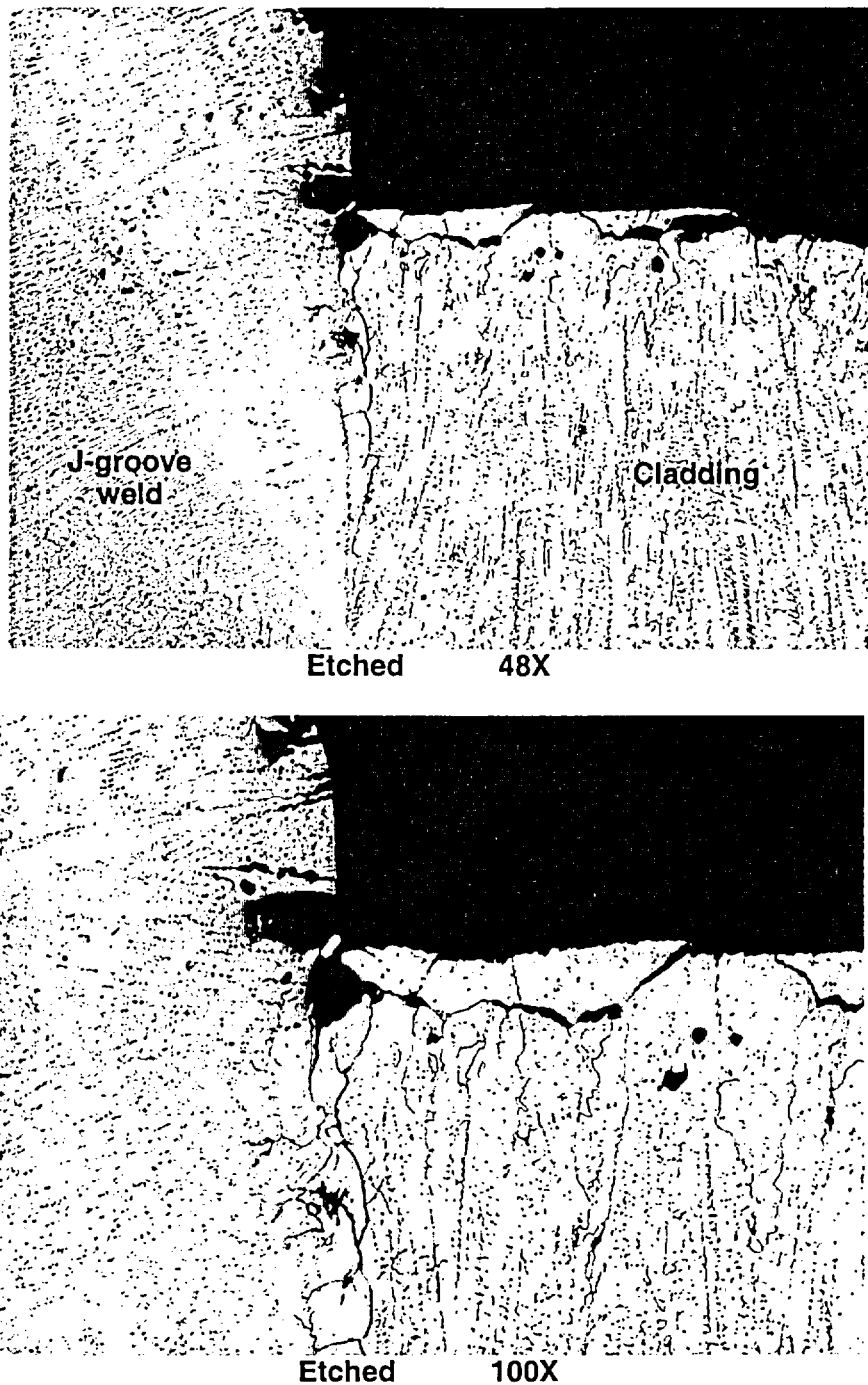
**Figure 7.3.2.3: Micrographs showing the intergranular or interdendritic cracking between the J-groove weld and cladding interface. The micrographs shown here are mirror of the photo in Figure 7.3.2.1. Intergranular attack (IGA) is also evident on the exposed surface of J-groove weld and cladding (surface exposed to oxygenated boric acid). This cracking was likely initiated by IGA.**

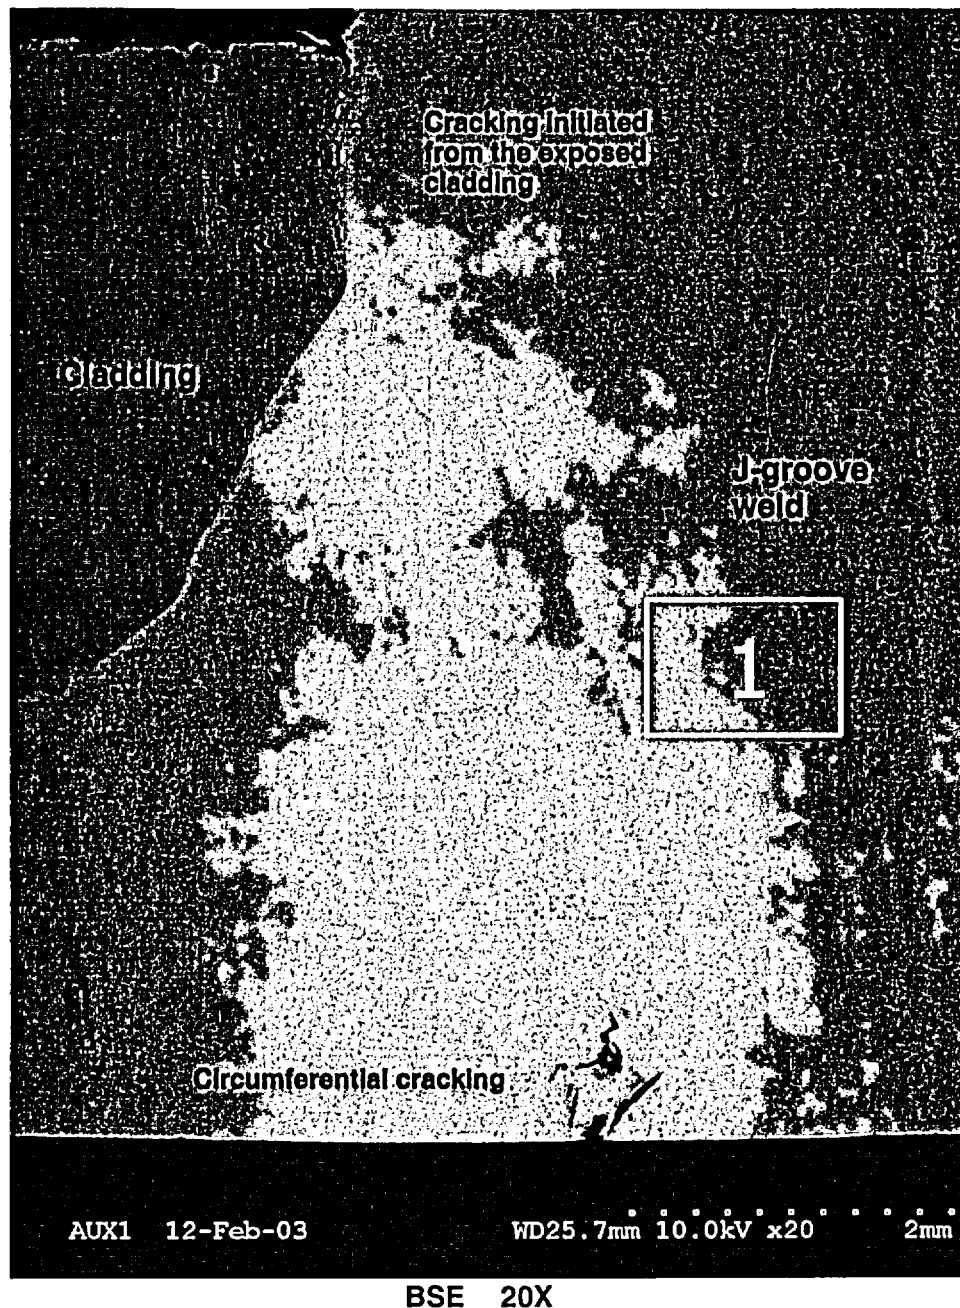
Figure 7.3.3.1: Low magnification BSE micrograph of sample A2A6A2D2 showing the cracking in the exposed cladding surface and the axial cracking in the J-groove weld surface exposed to RCS. The EDS spectrum collected from area 1 is presented in Figure 7.3.3.2.

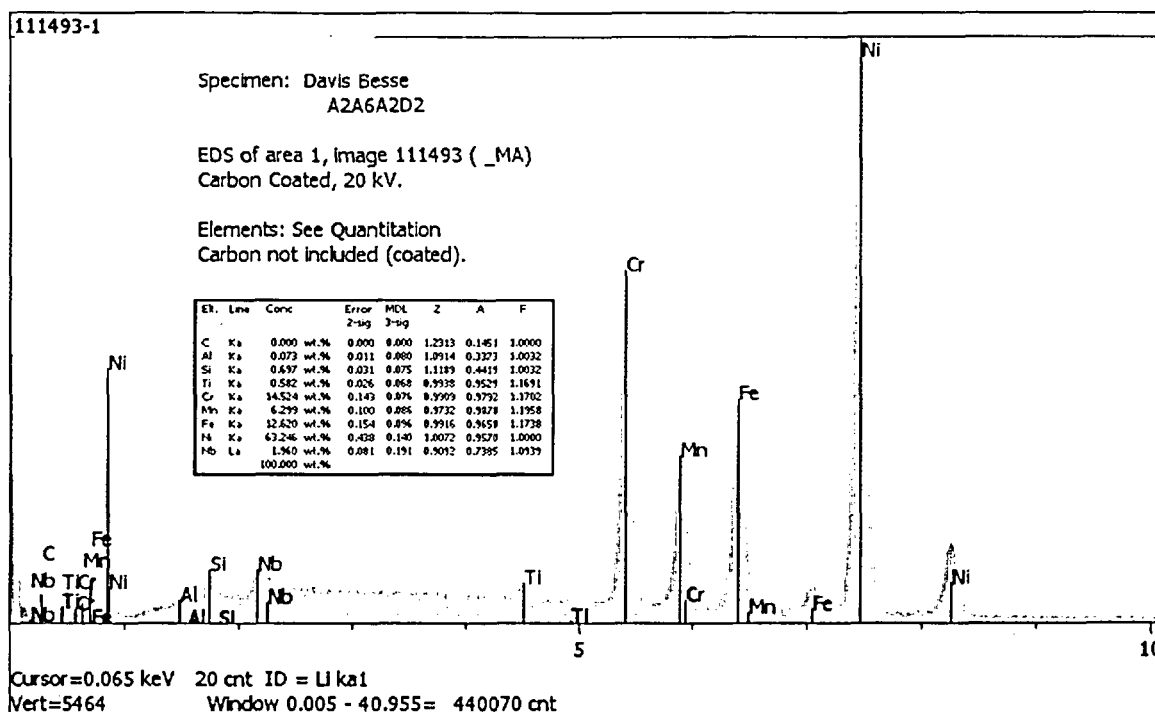
Figure 7.3.3.2: The EDS spectrum for area 1 in Figure 7.3.3.1. The semi-quantitative results from this area, which was located within the J-groove weld, were consistent with Alloy 182 weld metal.

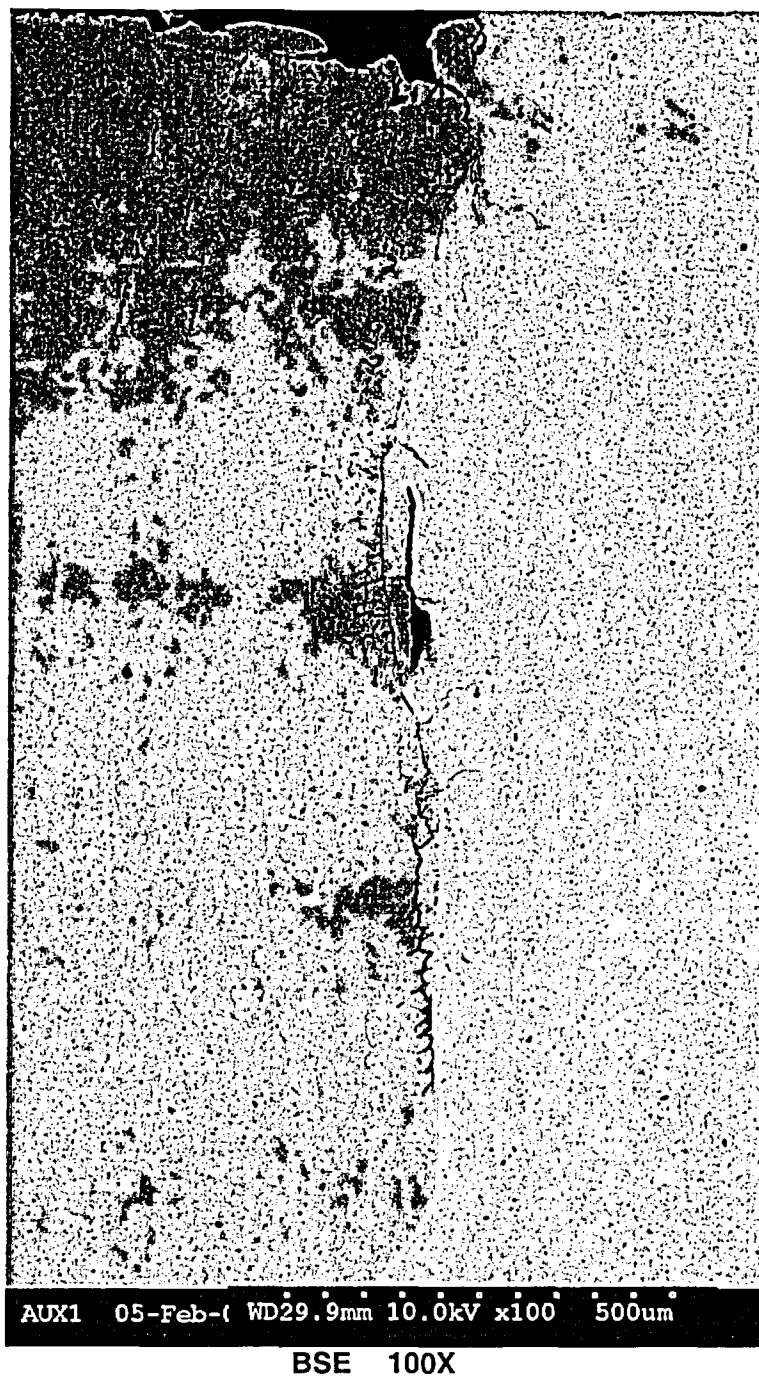
Figure 7.3.3.3: Low magnification BSE micrograph showing the cracking that initiated from the exposed cladding surface (left side of figure). The maximum crack depth is approximately 0.055" below the cladding surface.

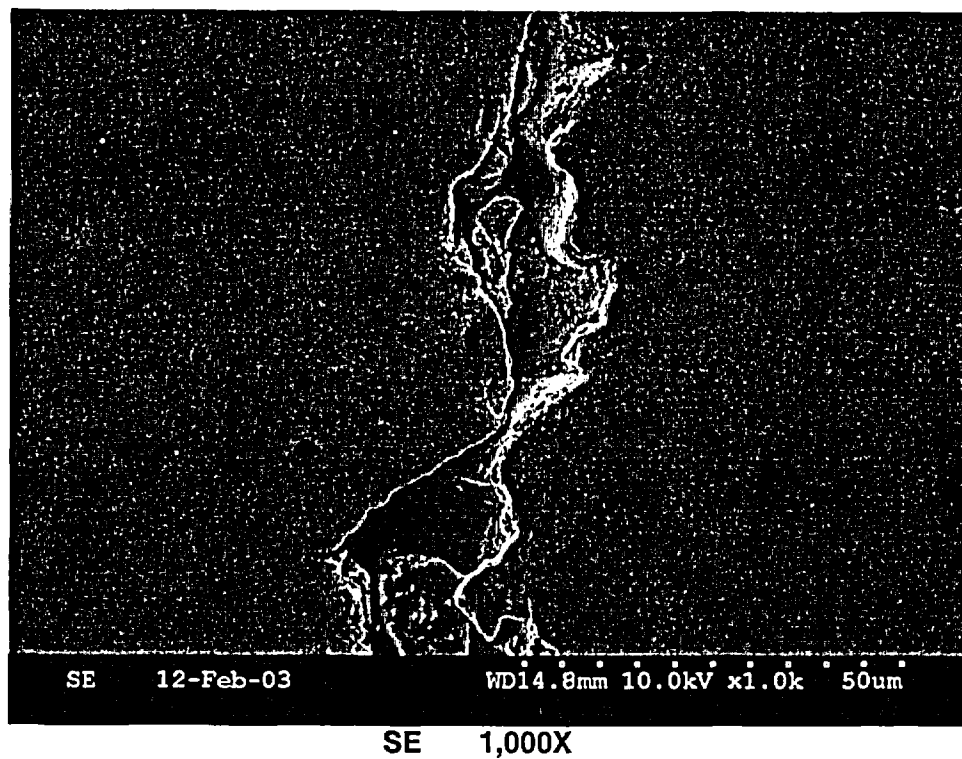
Figure 7.3.3.4: SE micrographs of the circumferential cracking in the J-groove weld. The maximum circumferential cracking depth is approximately 0.032" below the surface. Cracking was interdendritic in nature.

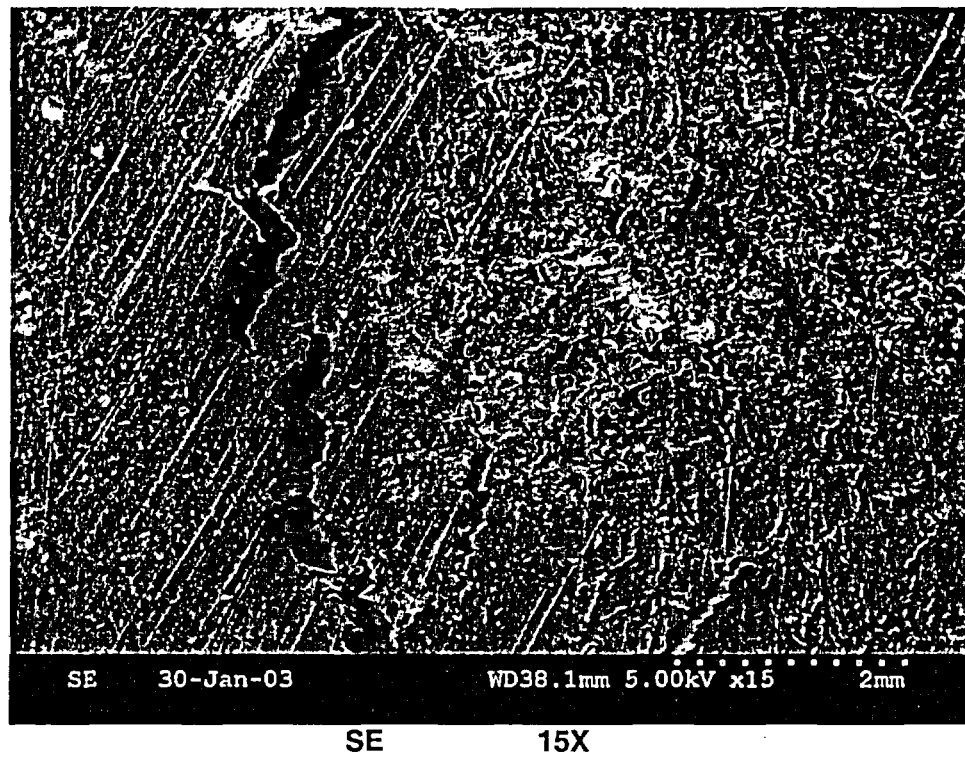
Figure 7.3.4.2: SE micrographs showing the shallow circumferential cracking in the J-groove weld. Cracking was interdentritic.

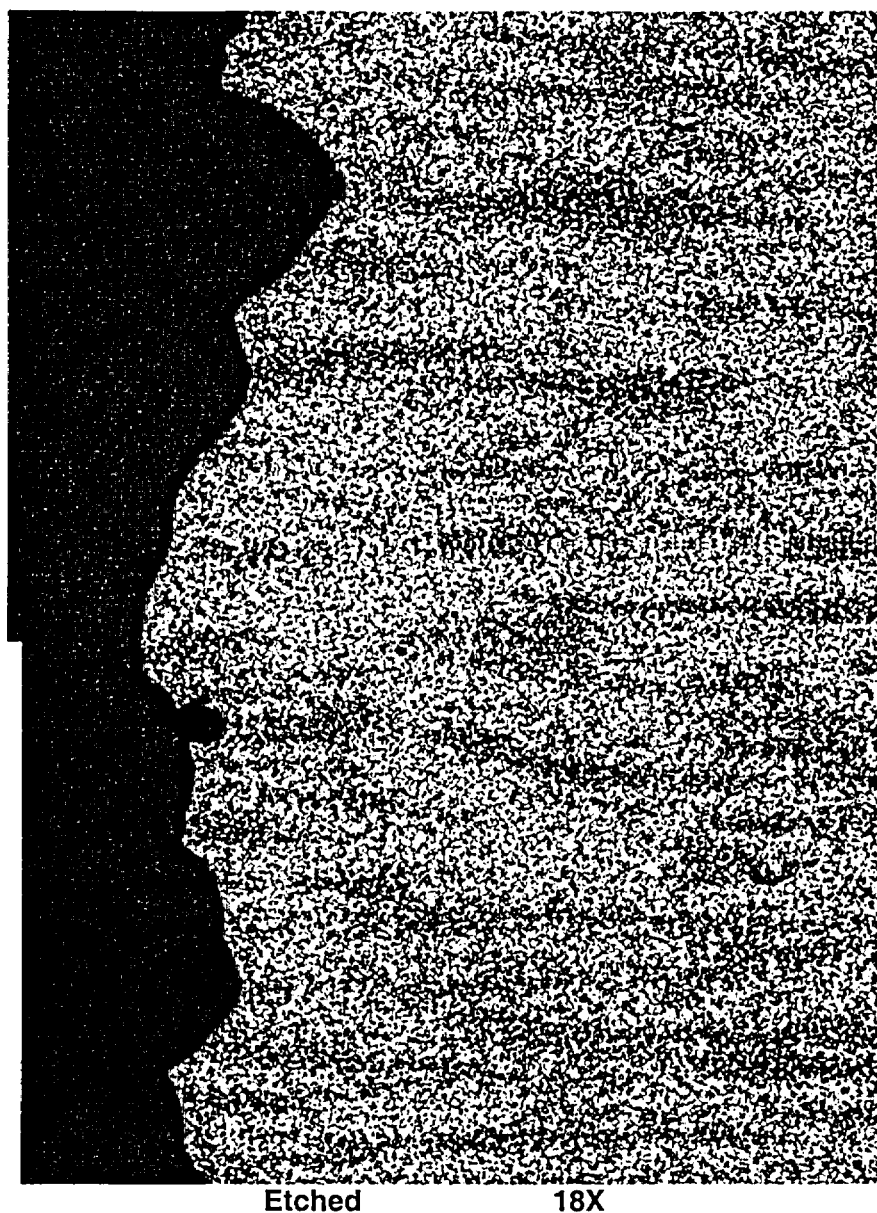
Figure 8.1.1.2: Low magnification micrograph showing horizontal striations aligned with the major axis of the RV head low alloy steel plate (SA-533, Gr. B (mod), Cl. 1). The striations are due to the segregation of carbides, which promote a slightly faster local corrosion rate along the striations. Note that this micrograph is a mirror image of Figure 8.1.1.1.

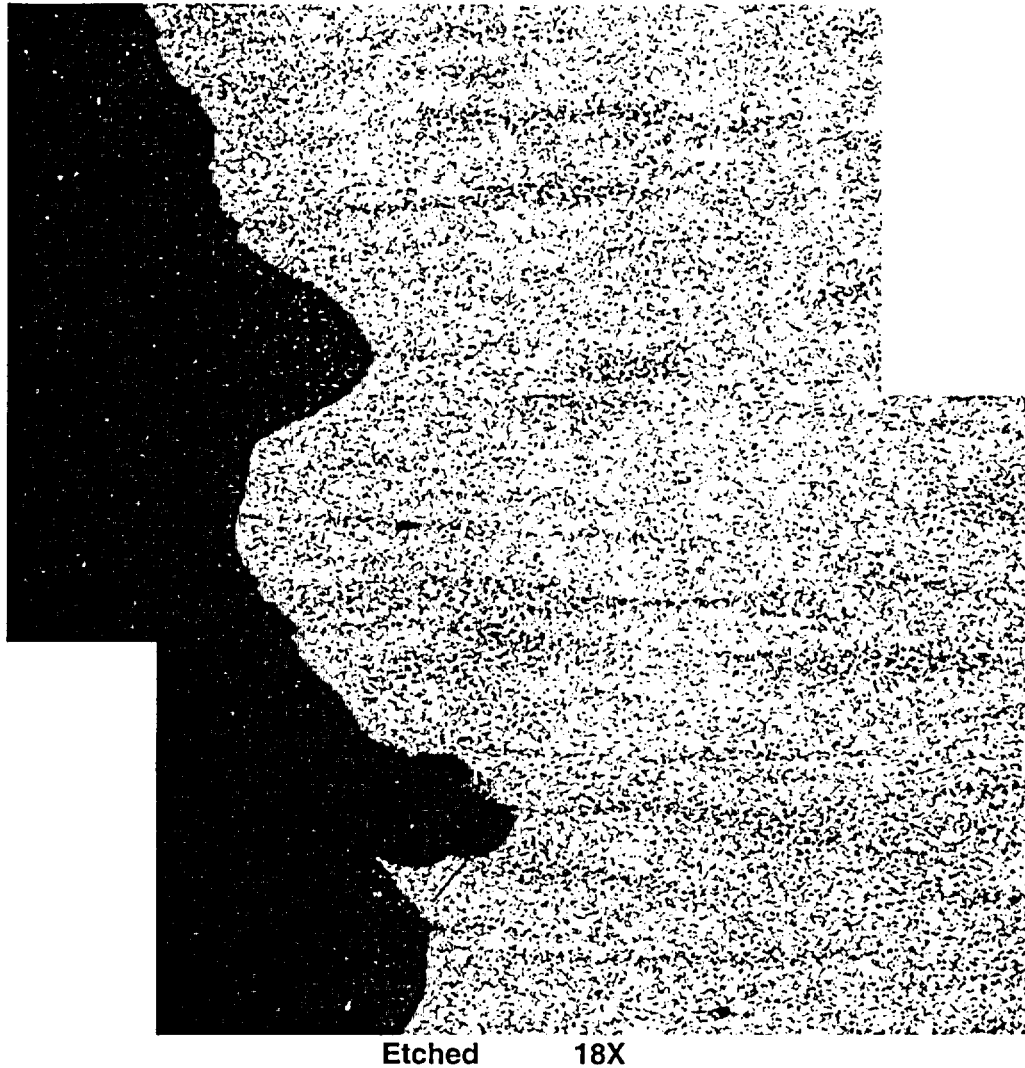
Figure 8.1.2.2: Higher magnification micrograph showing the horizontal striations aligned with the major axis of the RV head low alloy steel plate (SA-533, Gr. B (mod), Cl. 1). However, unlike Figure 8.1.1.3, the striations do not appear to promote a faster corrosion rate locally.

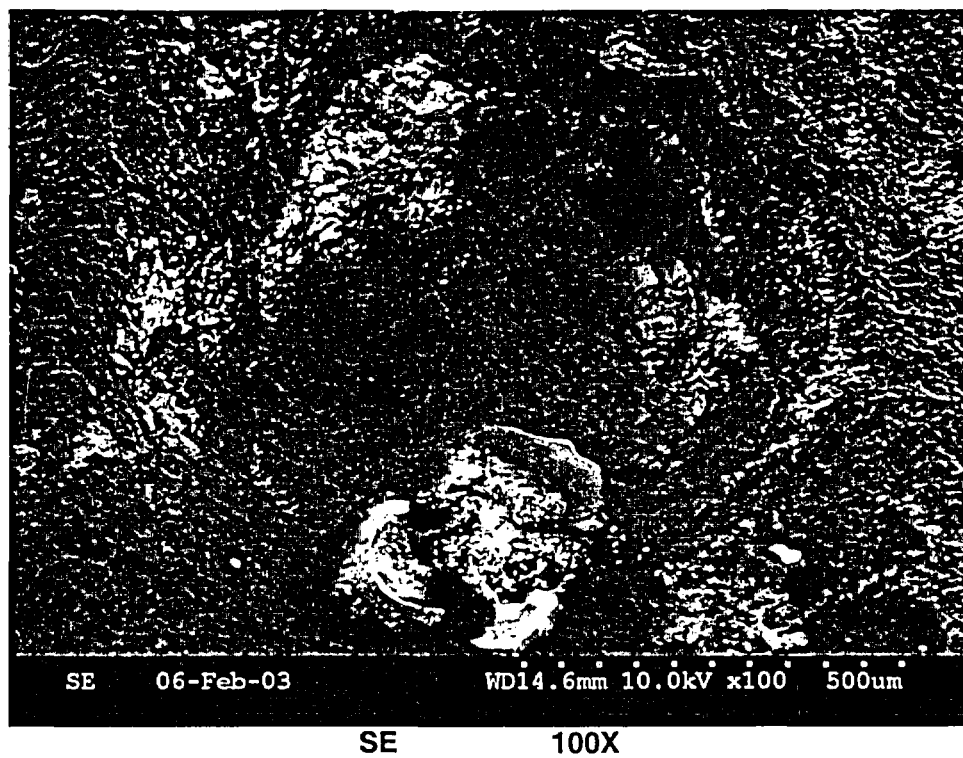
Figure 8.1.3.3: SE micrographs showing corrosion products on cavity side wall near 90°.

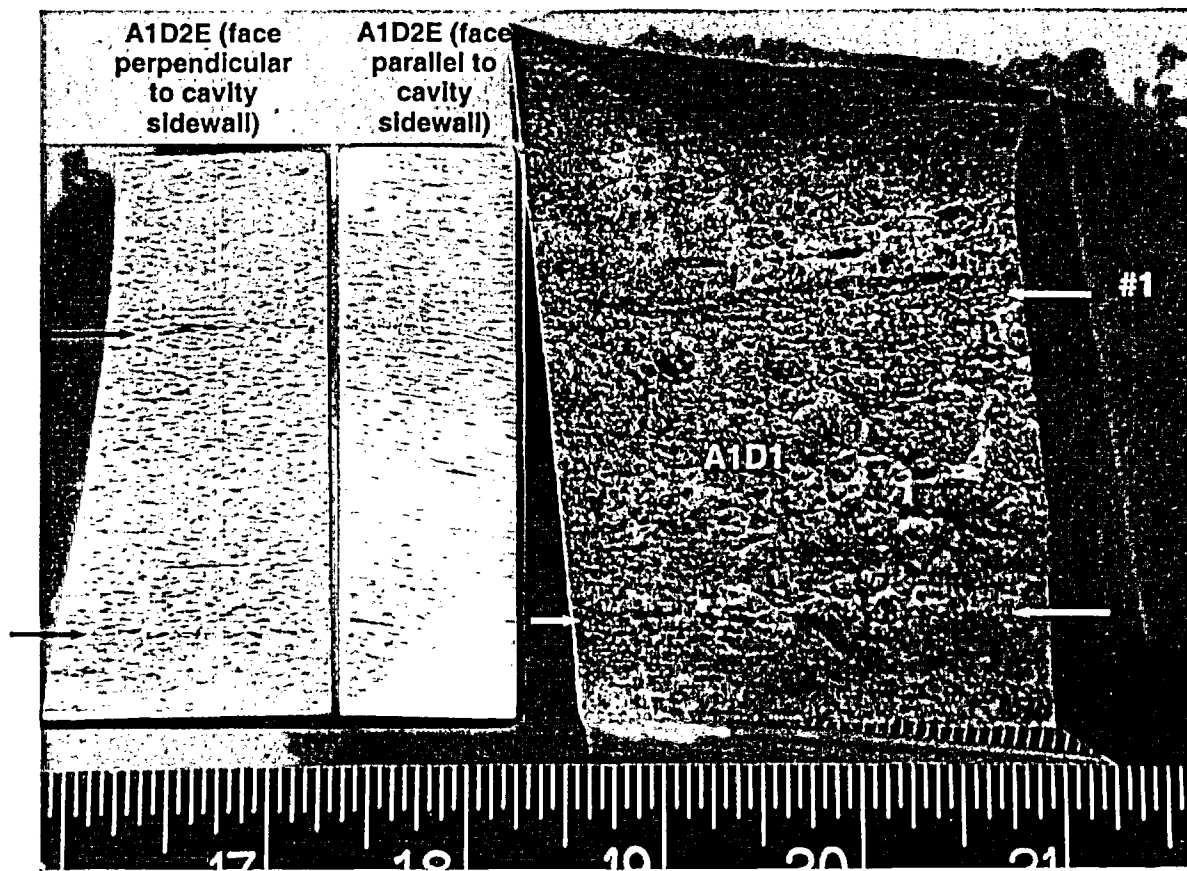
Figure 8.2.1.1: Low magnification photographs showing macro etch results. Arrows indicate corrosion grooves associated with corresponding micro-structural banding. Macro etch was performed on two surfaces of sample A1D2E ground with 400 grit paper. Etchant: 10% nital.

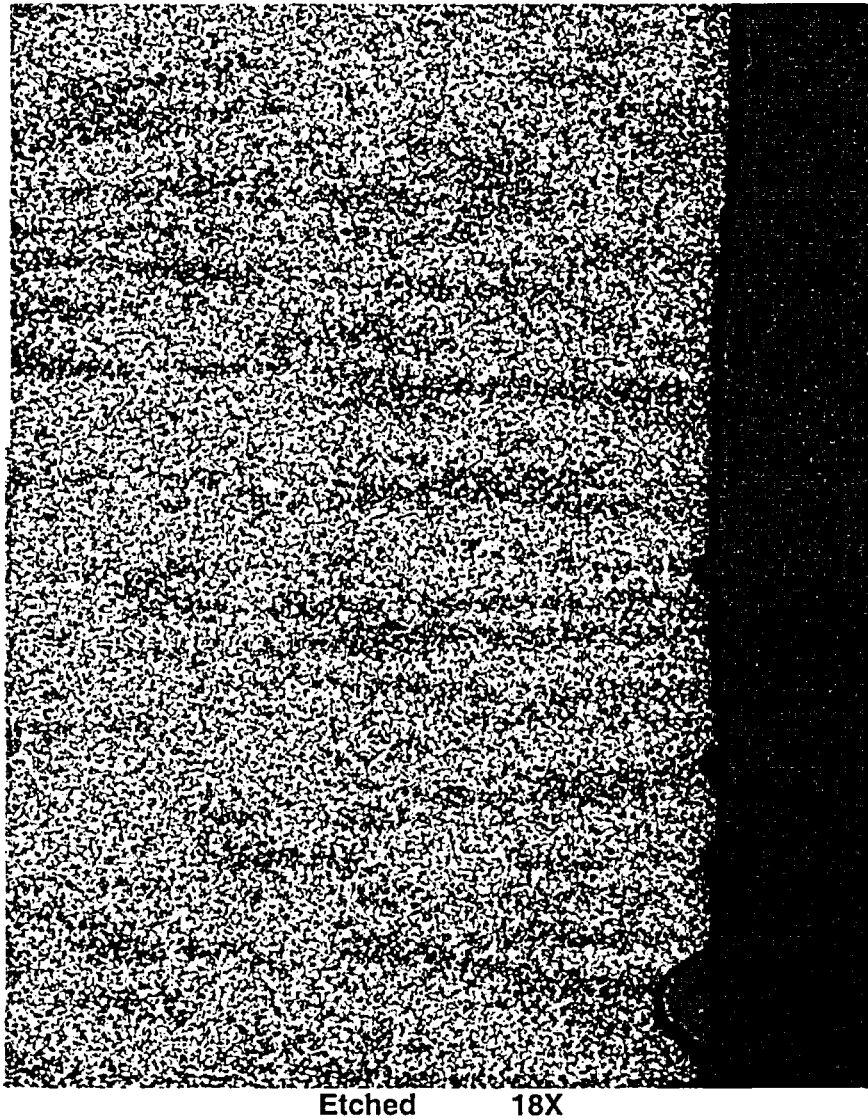
**Figure 8.2.2.2: Slightly higher magnification micrograph showing the horizontal striations aligned with the major axis of the RV head low alloy steel plate (SA-533, Gr. B (mod), Cl. 1). Striations appear to be caused by a very slightly faster local corrosion rate. Note that this micrograph is a mirror image of Figure 8.2.2.1.**

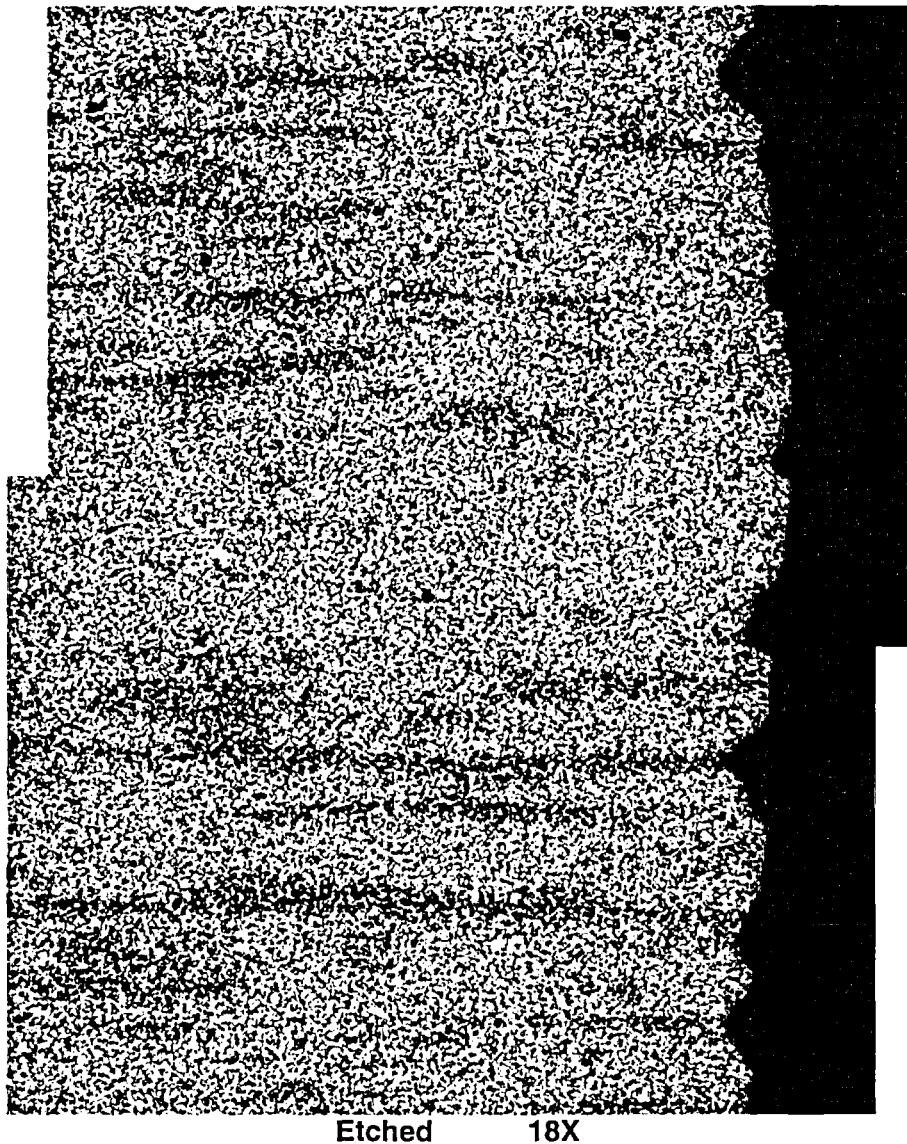
Etched 18X

**Figure 8.2.3.2: Higher magnification detail of Figure 8.2.3.1 showing the horizontal striations aligned with the major axis of the RV head low alloy steel plate (SA-533, Gr. B (mod), Cl. 1). Striations appear to be caused by a very slightly faster local corrosion rate.**

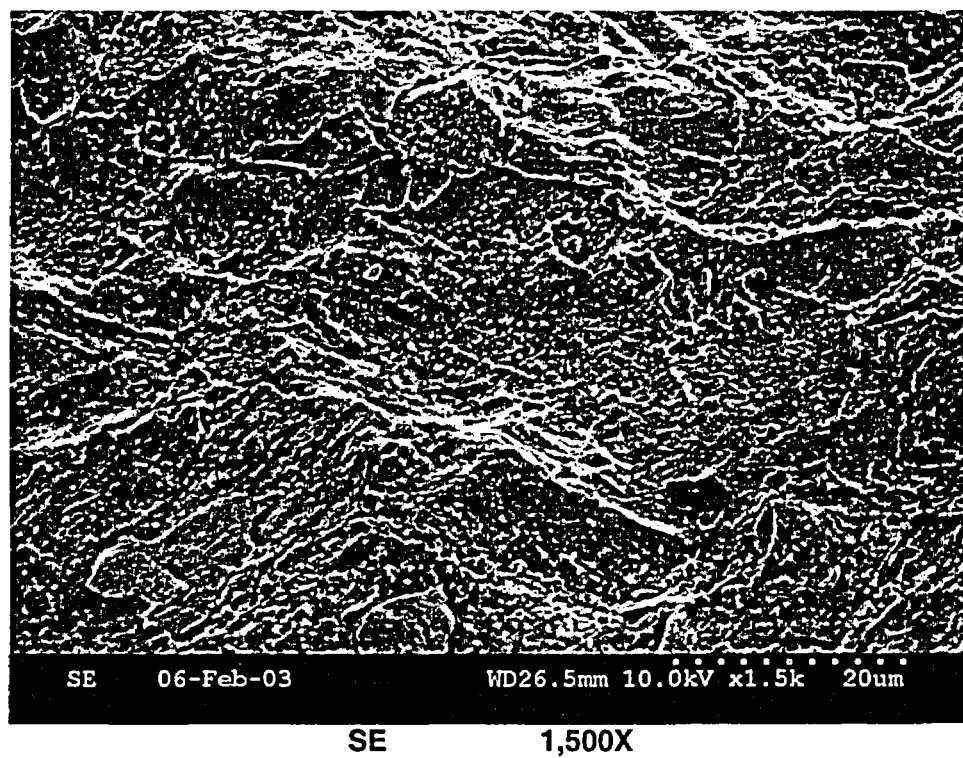
Figure 8.2.4.3: Higher magnification SE micrograph showing corrosion products on cavity side wall near 270°.

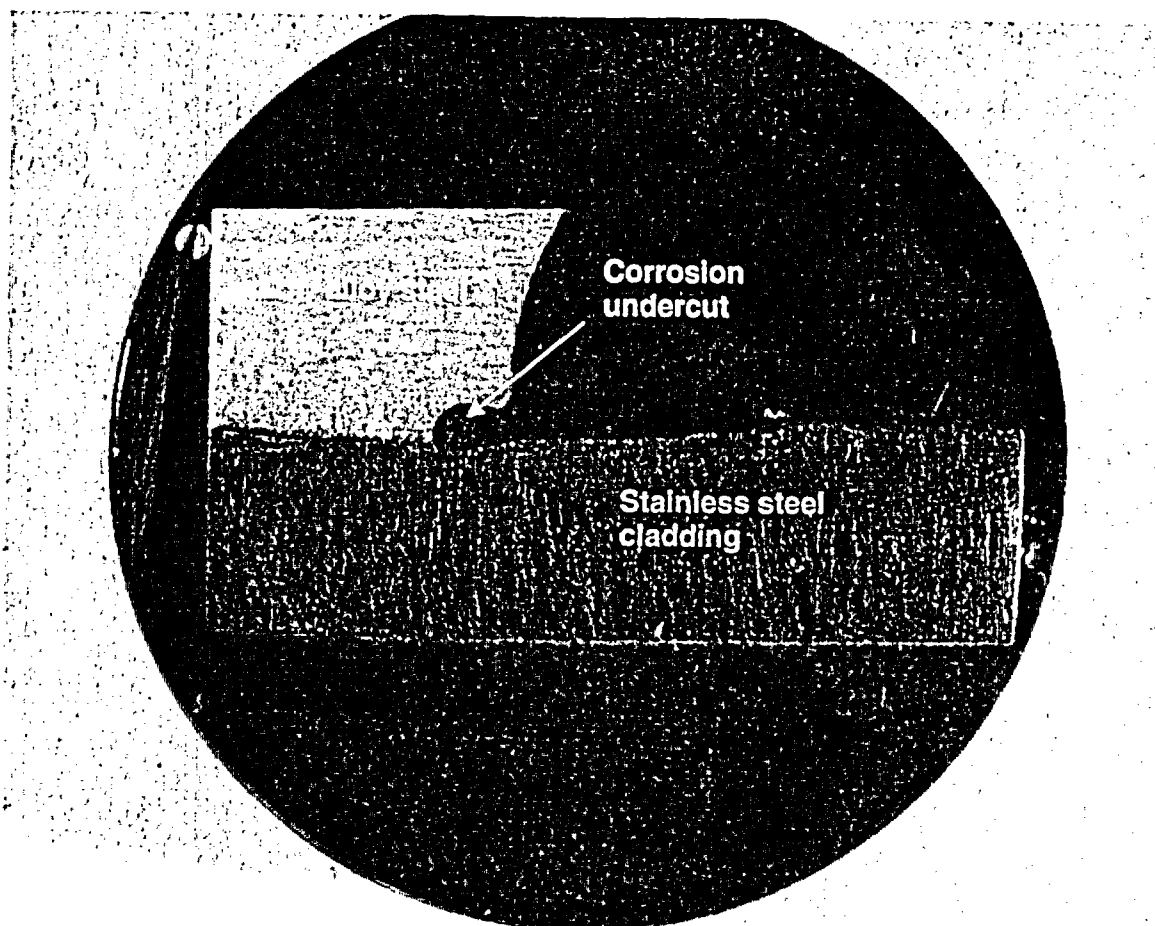
Figure 8.3.1.1: Macro photograph of metallographic mount A2A7D. Refer to Figures 5.1 and 5.11 for the sample location.
