Table 5.1: Sample identification listing for Piece A2A.

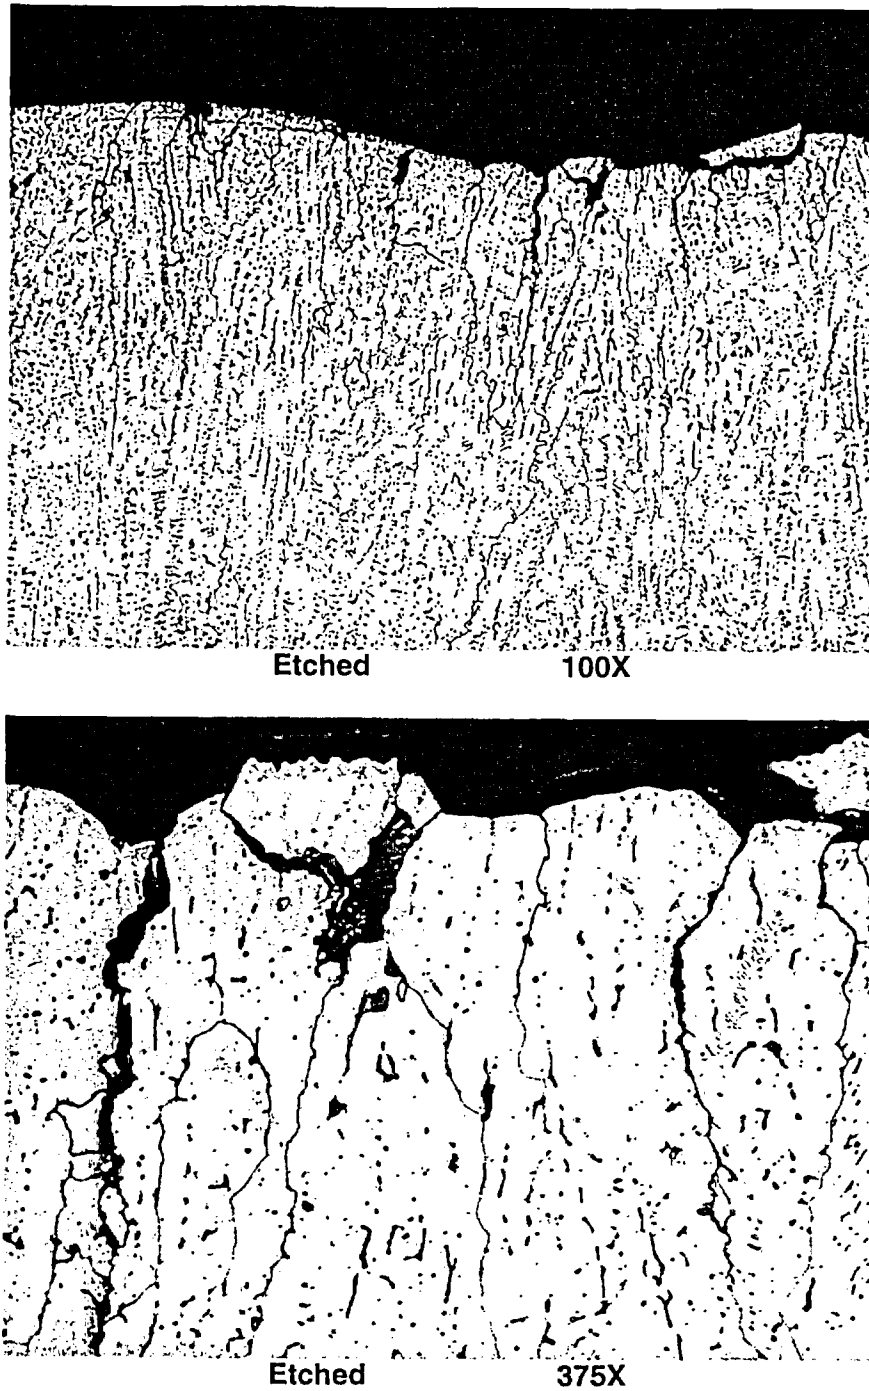
Figure 8.3.1.4: Micrographs showing intergranular attack (IGA) and intergranular or interdendritic cracking on the exposed cladding surface.

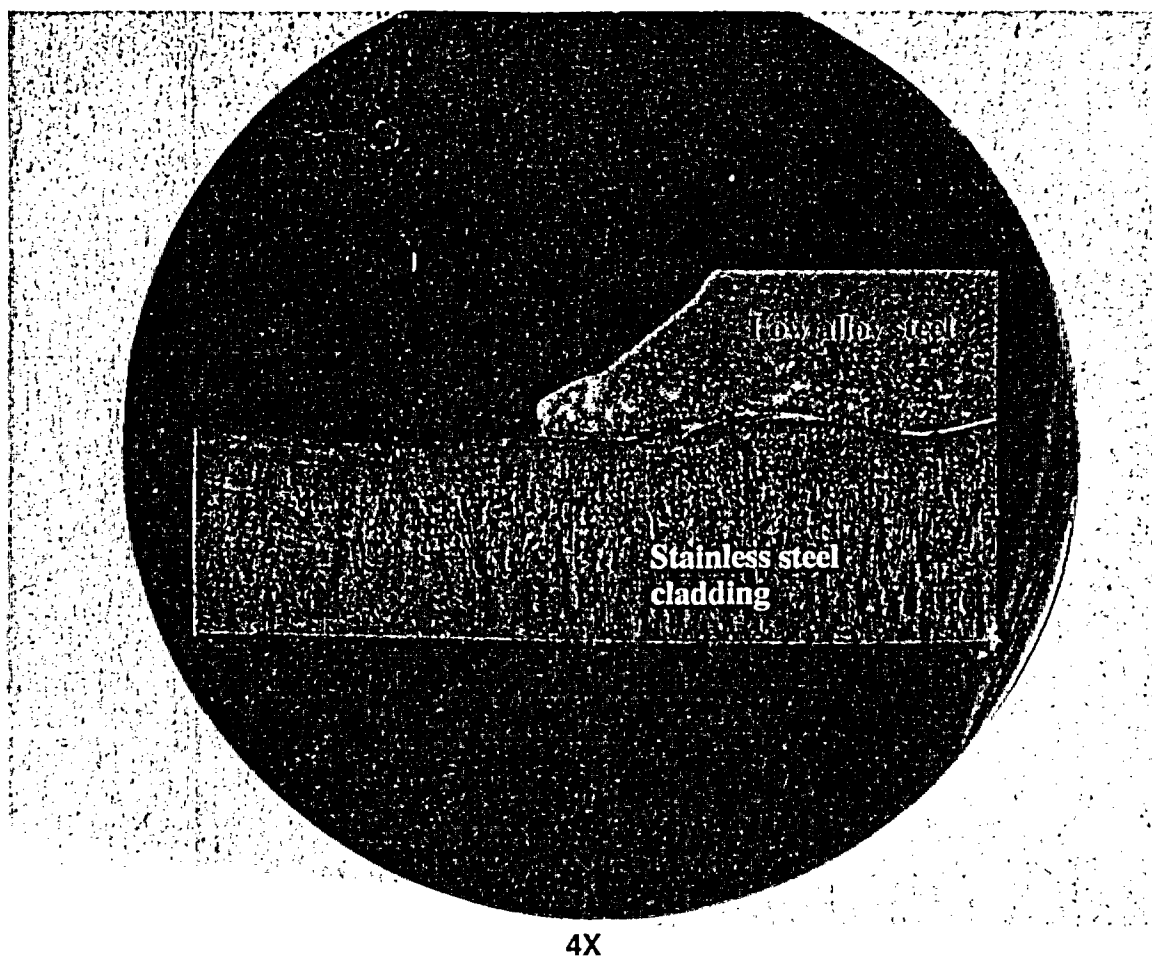
**Figure 8.3.2.1: Macro photograph of metallographic mount A2A7F. Refer to Figures 5.1 and 5.11 for the sample location.**

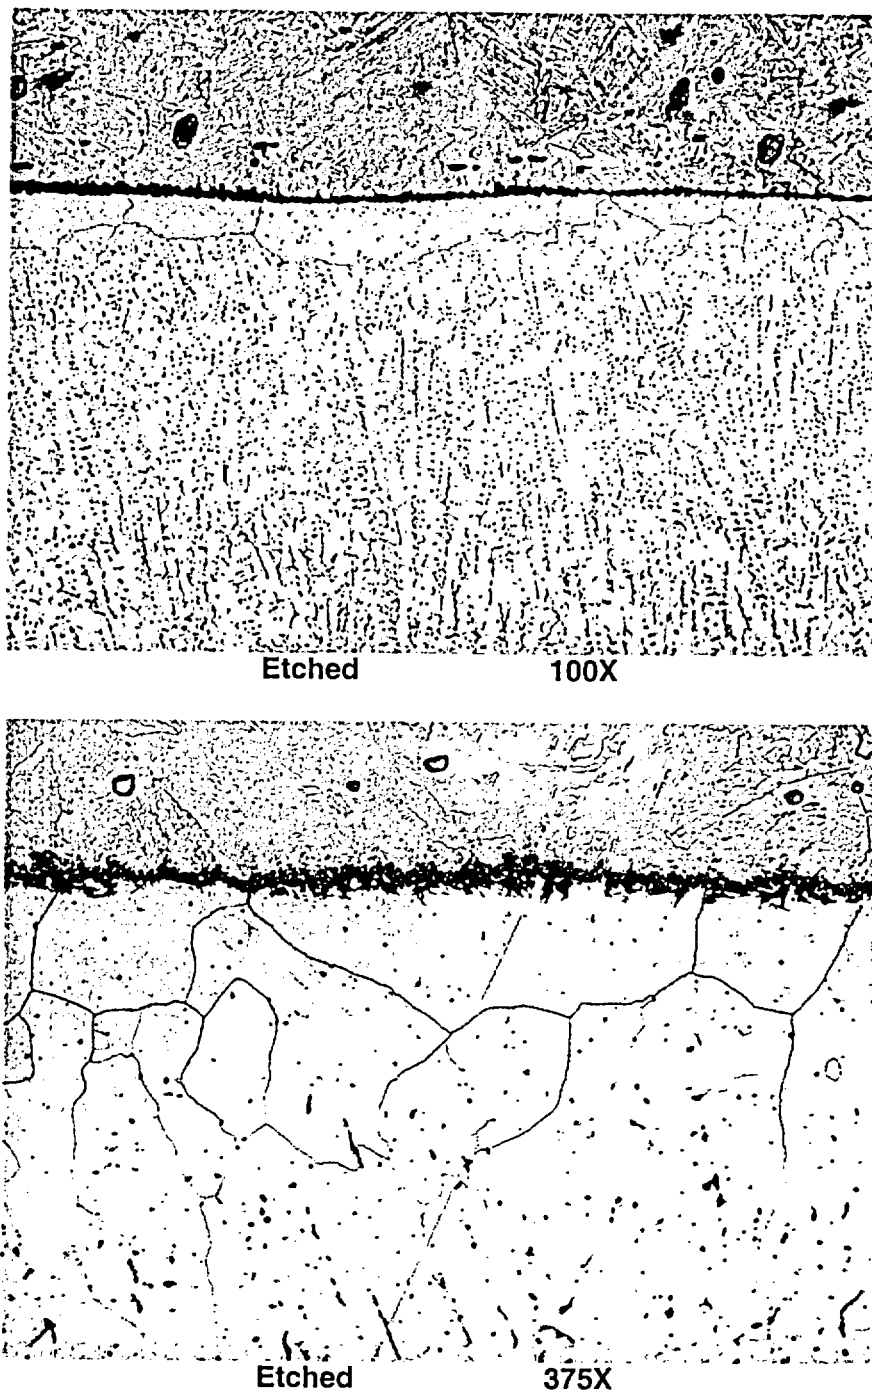
Figure 8.3.2.4: Micrographs showing the interface between the low alloy steel (above the fusion line) and the stainless steel cladding (below the fusion line).

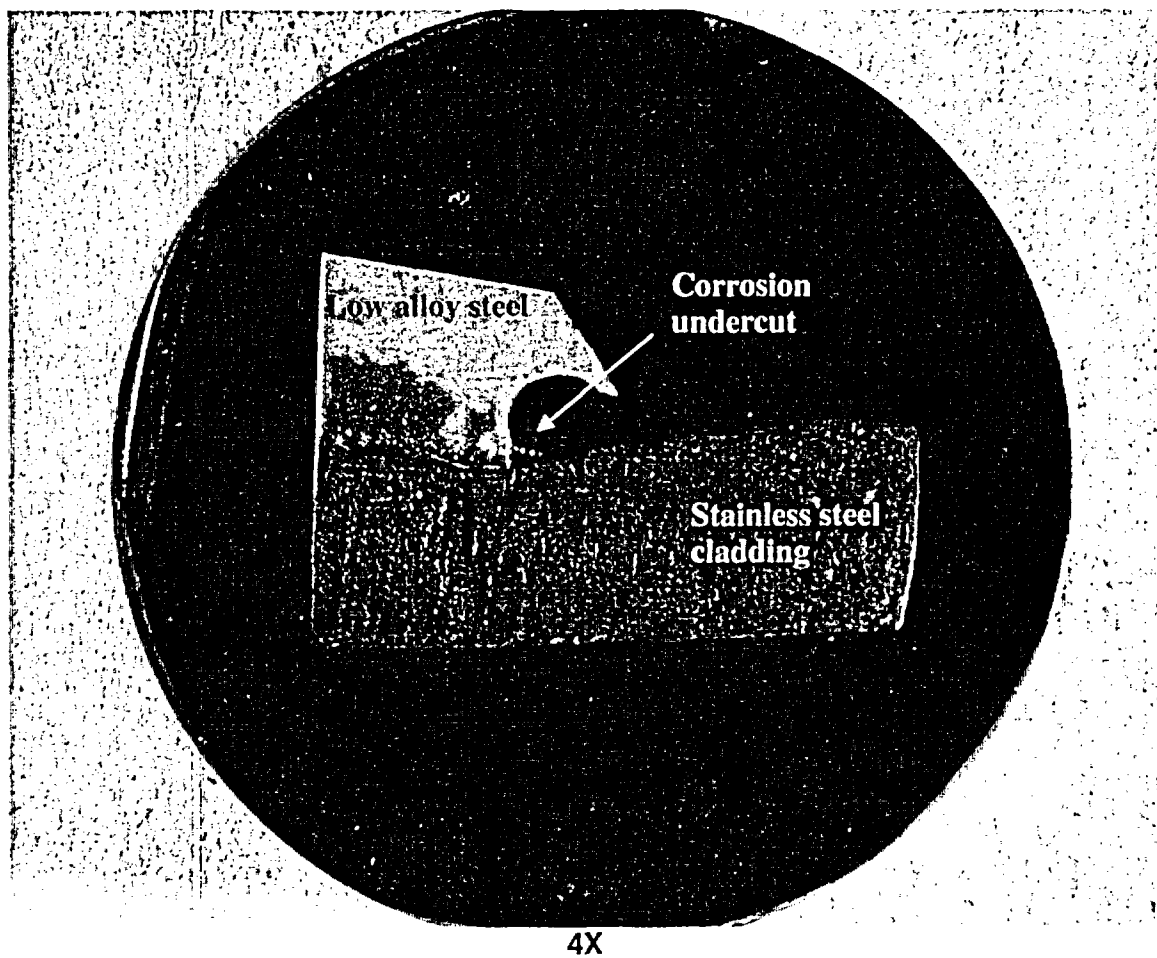
Figure 8.3.3.1: Macro photograph of metallographic mount A2A7K. Refer to Figures 5.1 and 5.11 for the sample location.
