**GENE-0000-0018-3359-NP, "Technical Assessment, Quad Cities Unit 2  
Steam Dryer Failure – Determination of Root Cause  
and Extent of Condition," Revision 0, dated August 2003  
[NON-PROPRIETARY VERSION]**

GENE-0000-0018-3359-NP

# **Quad Cities Unit 2**

### **Steam Dryer Failure – Determination of Root Cause and Extent of Condition**

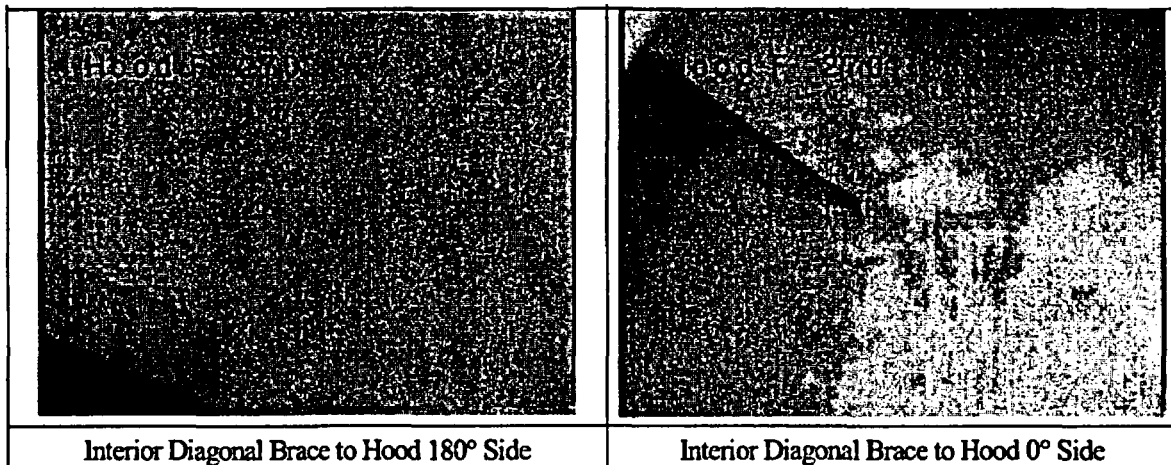
**Figure 2.3-6: Indications in the Brackets where the Angled Brace was Joined to the Outer Hood Plates**

Visual inspections were also conducted on the opposite side of the dryer with emphasis on Hood F. These inspections included the outer surfaces as well as the inner surfaces of the outer hood and the angled and vertical braces. Crack indications were found in several of the structures. On the interior of the hood, indications were observed on both

diagonal bracket to hood welds, extending into the base metal. The interior vertical brace on the 180° side of the unit was fractured on the upper end. No missing pieces or parts were observed. Figure 2.3-6 details the crack indications at the 0 and 180 degree stiffeners that were present on the interior of the outer hood. These indications were observed at the junction of the bracket to the vertical plate of the Hood F. The other end of the bracket could not be inspected due to the presence of air bubbles. These locations were chosen for additional metallographic evaluation.
