SEQUOYAH NUCLEAR PLANT (SQN) - UNIT 1 RESPONSE TO NRC ORDER  
EA 03-009, "ISSUANCE OF ORDER ESTABLISHING INTERIM  
INSPECTION REQUIREMENTS FOR REACTOR PRESSURE VESSEL HEADS AT  
PRESSURIZED WATER REACTORS"

TENNESSEE VALLEY AUTHORITY (TVA)  
SEQUOYAH NUCLEAR PLANT (SQN)

60-DAY RESPONSE TO NRC ORDER EA 03-009

TENNESSEE VALLEY AUTHORITY (TVA)  
SEQUOYAH NUCLEAR PLANT (SQN)  
UNIT 1  
PHOTOGRAPHS (IDENTIFIED AS FIGURES)

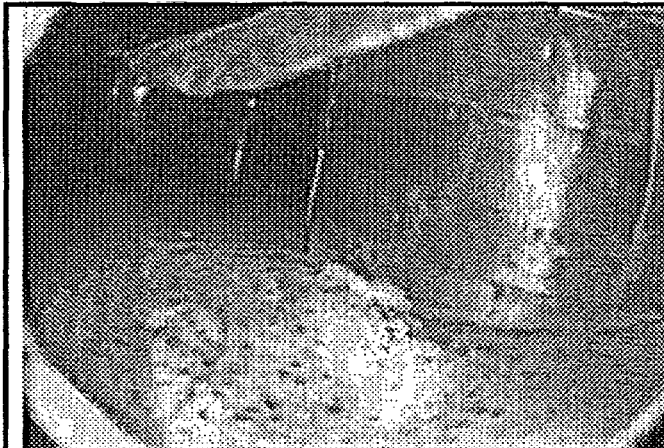
CRD Penetration. No.	Fig. Nos.	Exam Recommendations	Comments
3	1A, 1B	UT & PT (performed)	Suspected leaker-boron in annulus and on head with VT-2 exam
53	2A, 2B	UT (performed)	Masked from debris and boron - indeterminate
64	3A, 3B	UT (performed)	Masked from heavy debris - indeterminate
65	4A, 4B	UT (performed)	Masked from heavy debris - indeterminate
72	5A, 5B	UT (performed)	Masked with boron and heavy debris - indeterminate
73	6A, 6B	UT (performed)	Masked from boron - indeterminate
78	7A, 7B	(TVA plans to perform a visual examination next RFO)	Masked from boron - indeterminate

The CRD penetration No. 3 was identified as a potential "leaker" during the initial bare metal head examination and was subsequently scheduled for volumetric and surface examination. Supplemental UT examination showed no evidence of a leakage path signature on CRD penetration No. 3.

FIG. 1A - CRD 3 BEFORE CLEANING

In addition to the ultrasonic test (UT) examination, a manual liquid penetrant (PT) examination was performed on the control rod device (CRD) penetration No. 3 weld and adjacent base material.

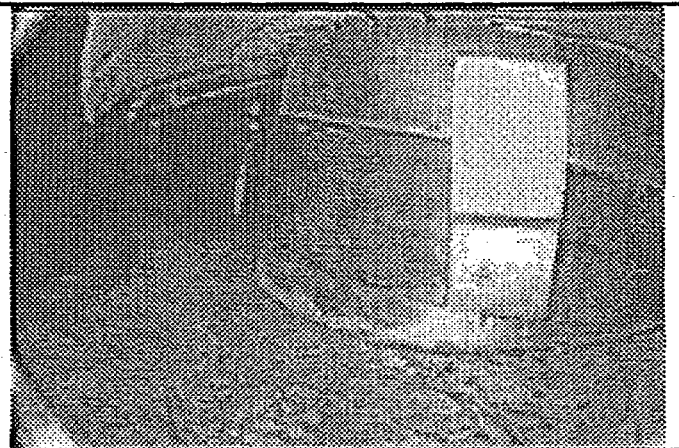
Supplemental UT examination showed no evidence of a leakage path signature on any of the Table 2 CRD penetrations. In addition, no recordable PT indications were found on CRD penetration No. 3. The penetration No. 78 could not be examined by UT due to thermocouple restrictions and is planned to be VT examined next refueling outage (cycle 13). A UT examination of all penetrations is scheduled for Unit 1 Cycle 15 refueling outage.

FIG. 1B - CRD 3 AFTER CLEANING

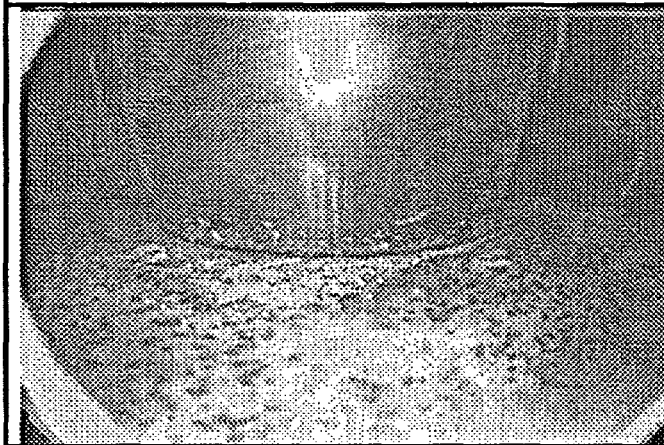
FIG. 2A - CRD 53 BEFORE CLEANING

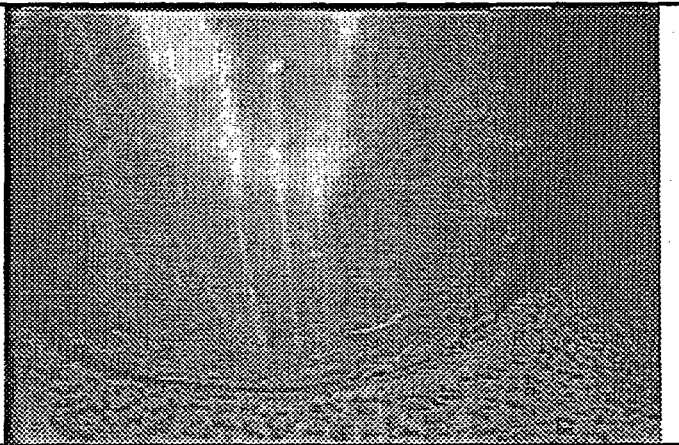
FIG. 2B - CRD 53 AFTER CLEANING

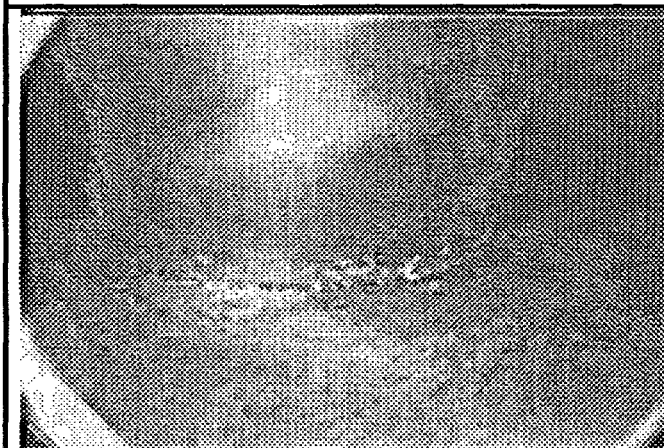
FIG. 3A - CRD 64 BEFORE CLEANING

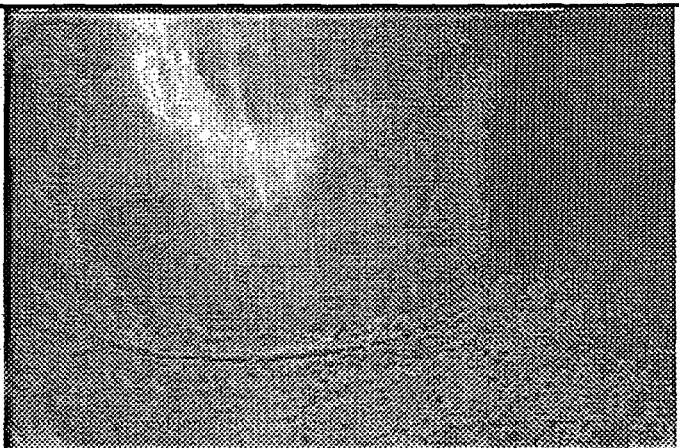
FIG. 3B - CRD 64 AFTER CLEANING

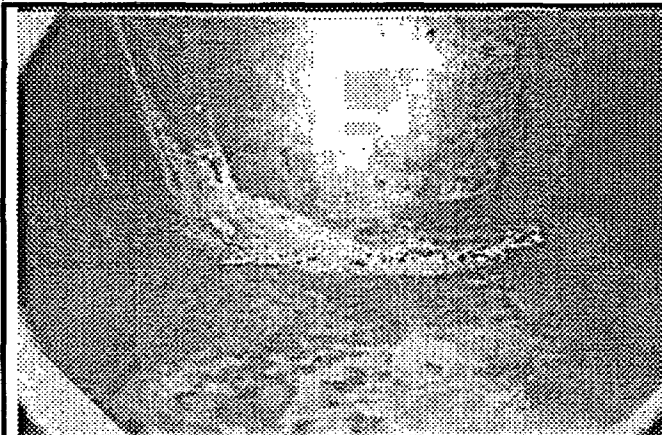
FIG. 4A - CRD 65 BEFORE CLEANING

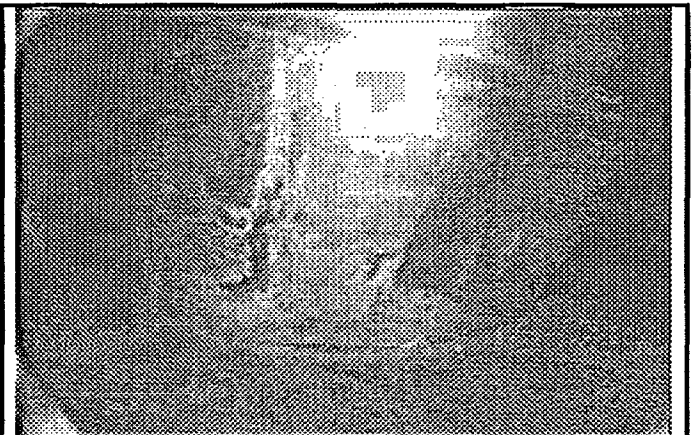
FIG. 4B - CRD 65 AFTER CLEANING

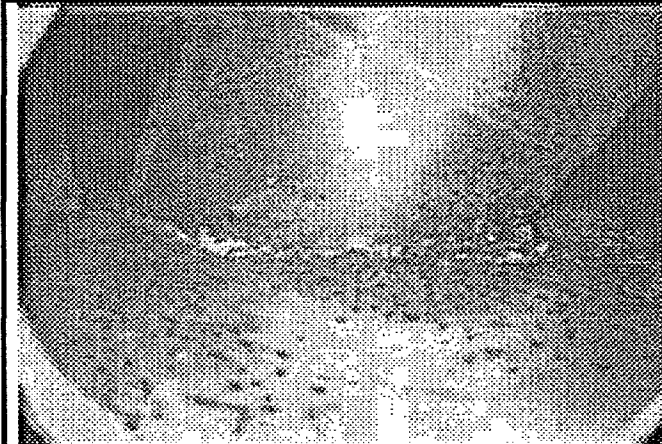
Prior to the commencement of examinations, the examination team was informed of a previous canopy seal weld leak detected in 1995 during Cycle 7. The canopy seal weld was located above control rod drive (CRD) penetration No. 73 and was identified as "A-5." Initially in 1995, the remaining boron from this leak prevented an effective examination of CRD penetration No. 73 and the adjacent penetrations (CRD penetration Nos. 72 and 78) from being performed.

Due to the indeterminate condition of these penetrations from boron buildup, these penetrations were identified for further evaluation. These areas were subsequently cleaned, and it was determined that no leakage was found to occur from these CRD penetrations. The penetrations were found acceptable by subsequent visual examination.

FIG. 5A - CRD 72 BEFORE CLEANING

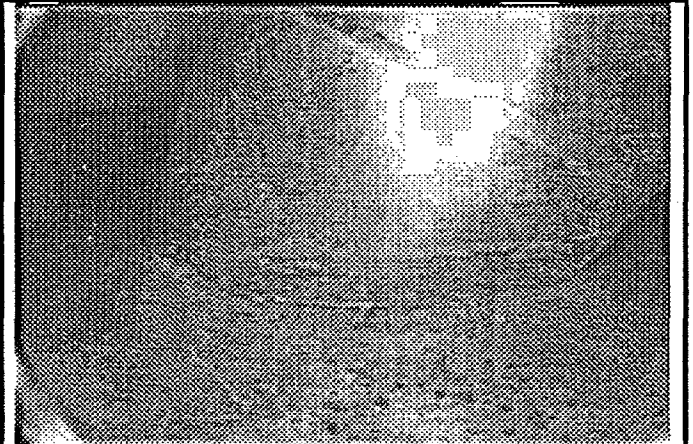
FIG. 5B - CRD 72 AFTER CLEANING

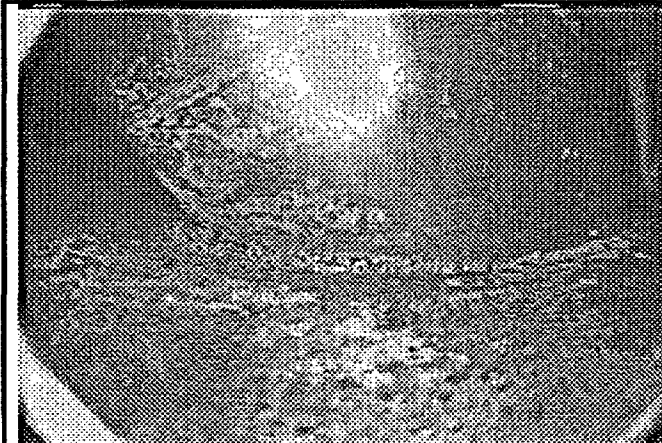
FIG. 6A - CRD 73 BEFORE CLEANING

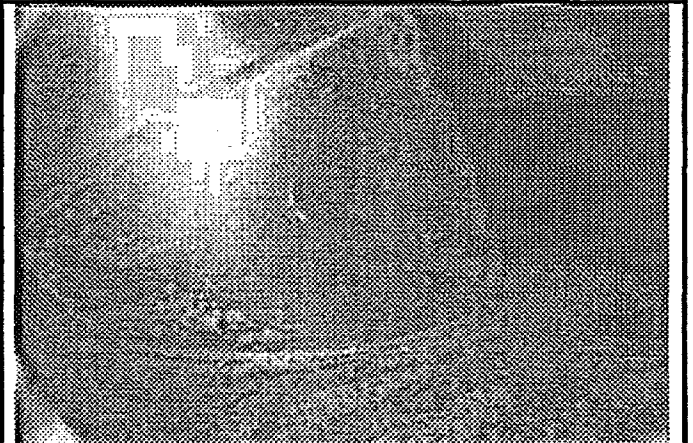
FIG. 6B - CRD 73 AFTER CLEANING

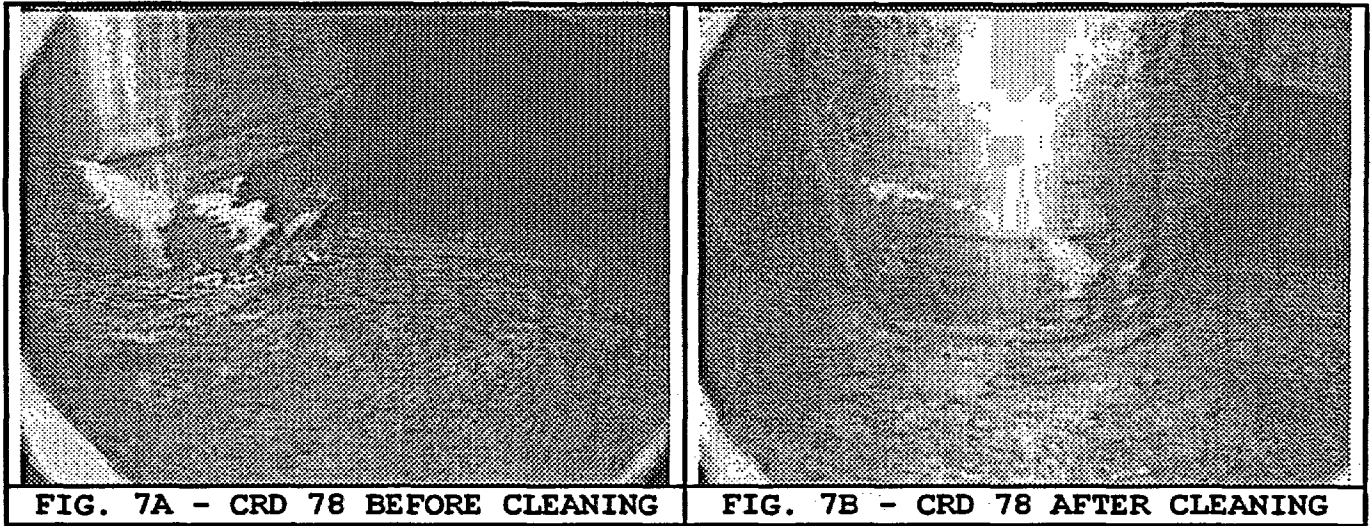
vacuum system to capture the sample. The representative sample of the substance at the penetration to head interface indicated the presence of boron. Further sampling of these accumulations and some residue near penetration No. 78 were taken. Isotopic analysis (Cesium 134/137 ratio) of the residue indicated that boron accumulations were from the reactor coolant system and could be dated back 10 to 12.5 years. A canopy seal on penetration No. 78 experienced leakage during cycle 6 operation that occurred 10 to 11.4 years ago. TVA determined that the canopy seal penetration No. 78 leakage was the likely source for these deposits.
